# Santa Fe Calvada Mine

Final Closure of a Heap Leach Facility

Case Study in Design and Construction of E-cells

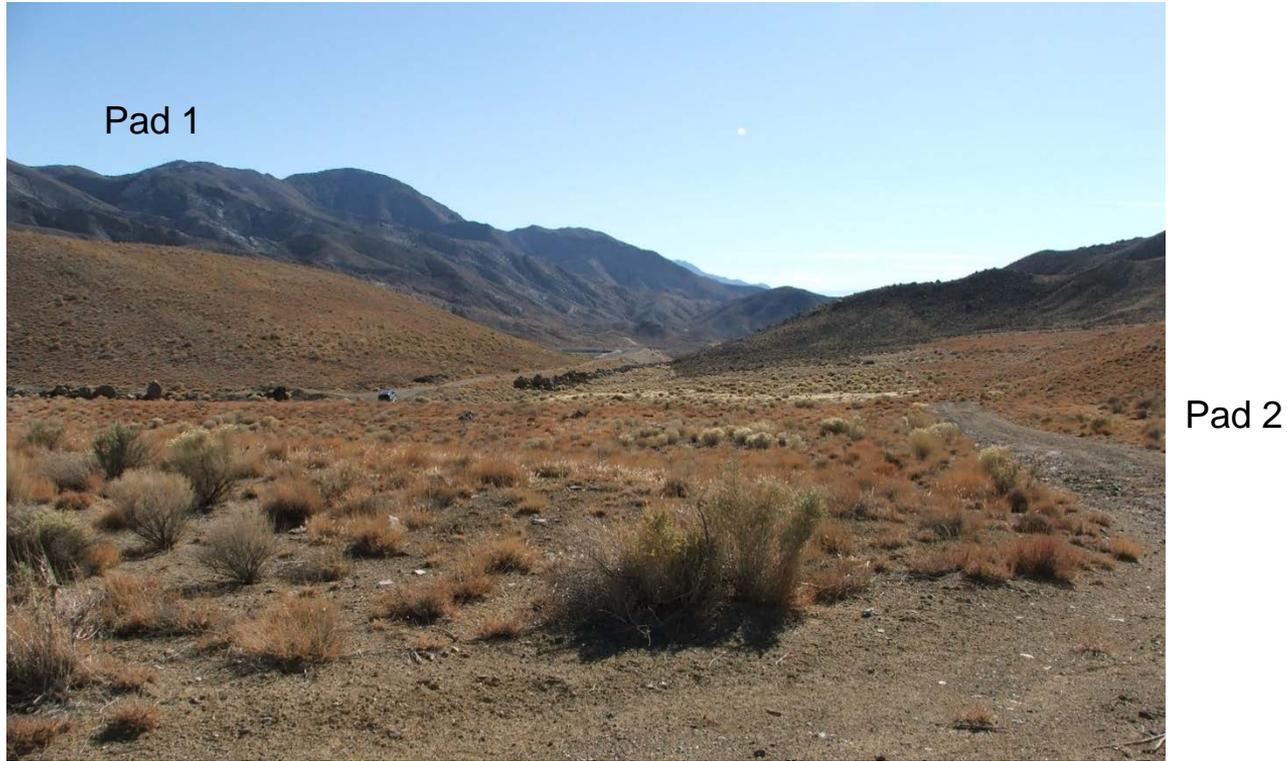
**Santa Fe Pad 1 and Pad 2 vegetation to compare with native vegetation in foreground**

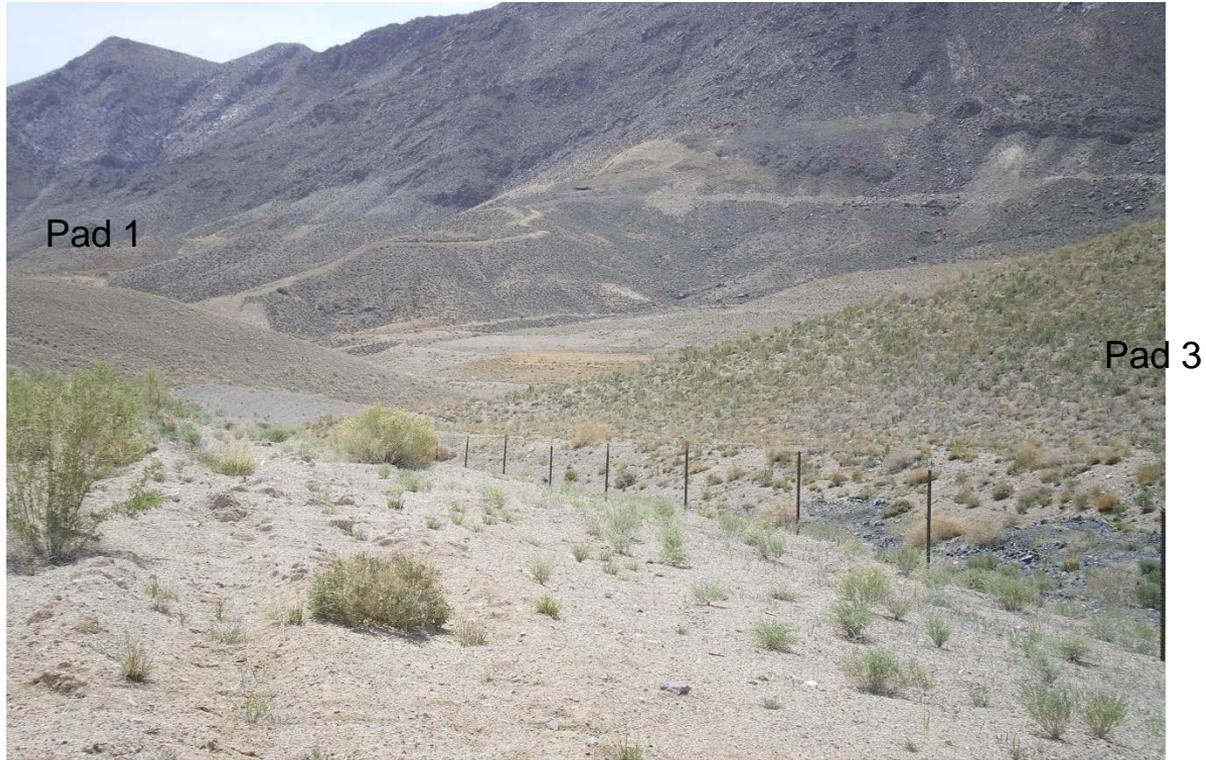
**Santa Fe Pad 1 and Pad 3 reclaimed condition**

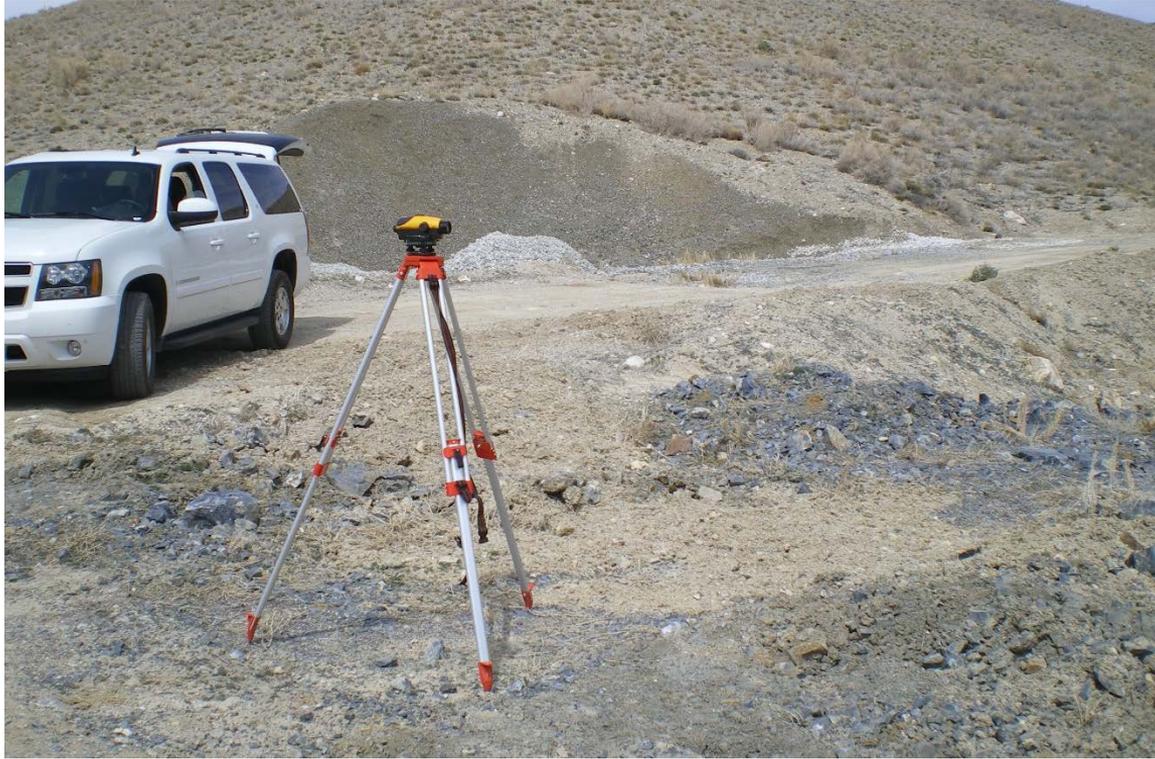
Santa Fe Pad 1 Southwest corner observation cut

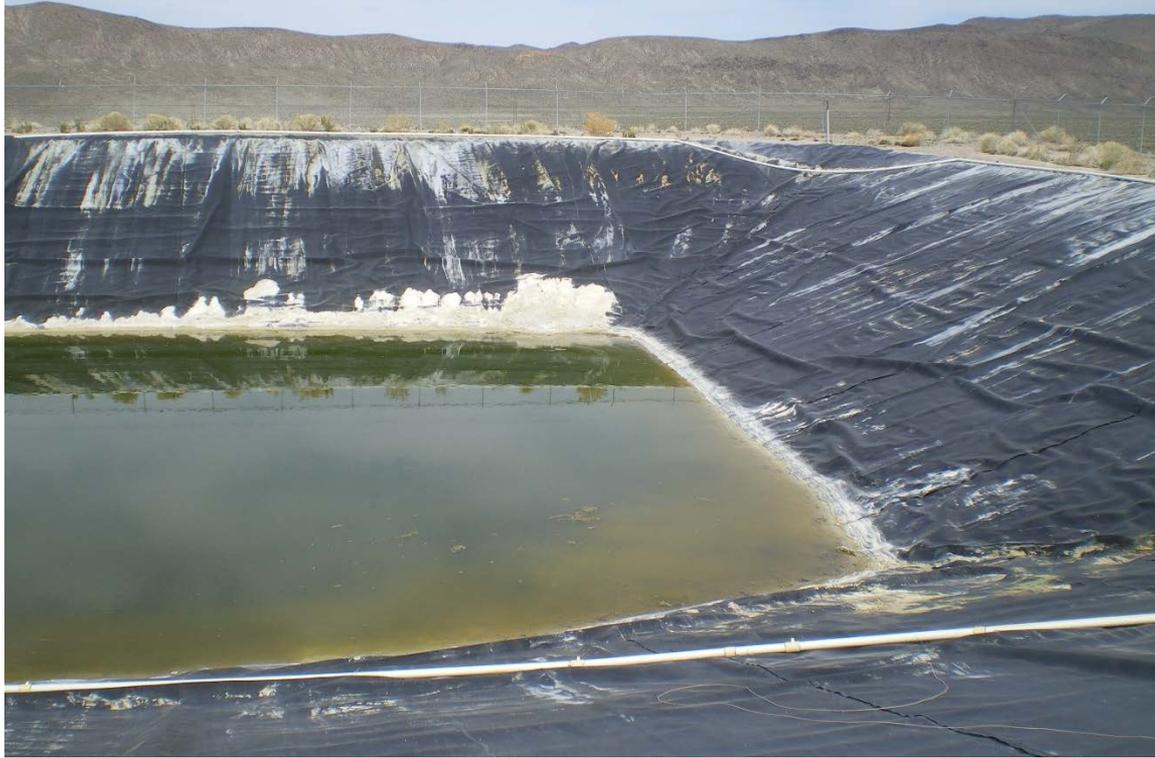
Calvada pond level typically stayed at this level

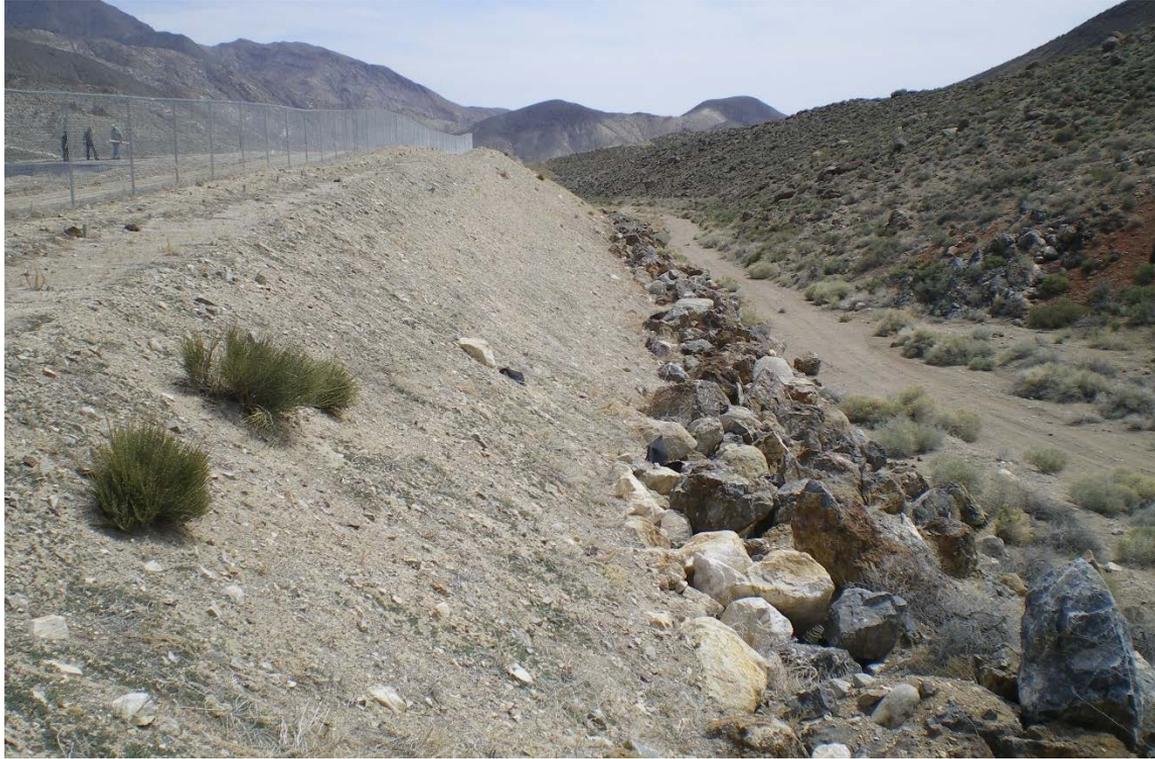
Santa Fe west pond slope with protective rip rap

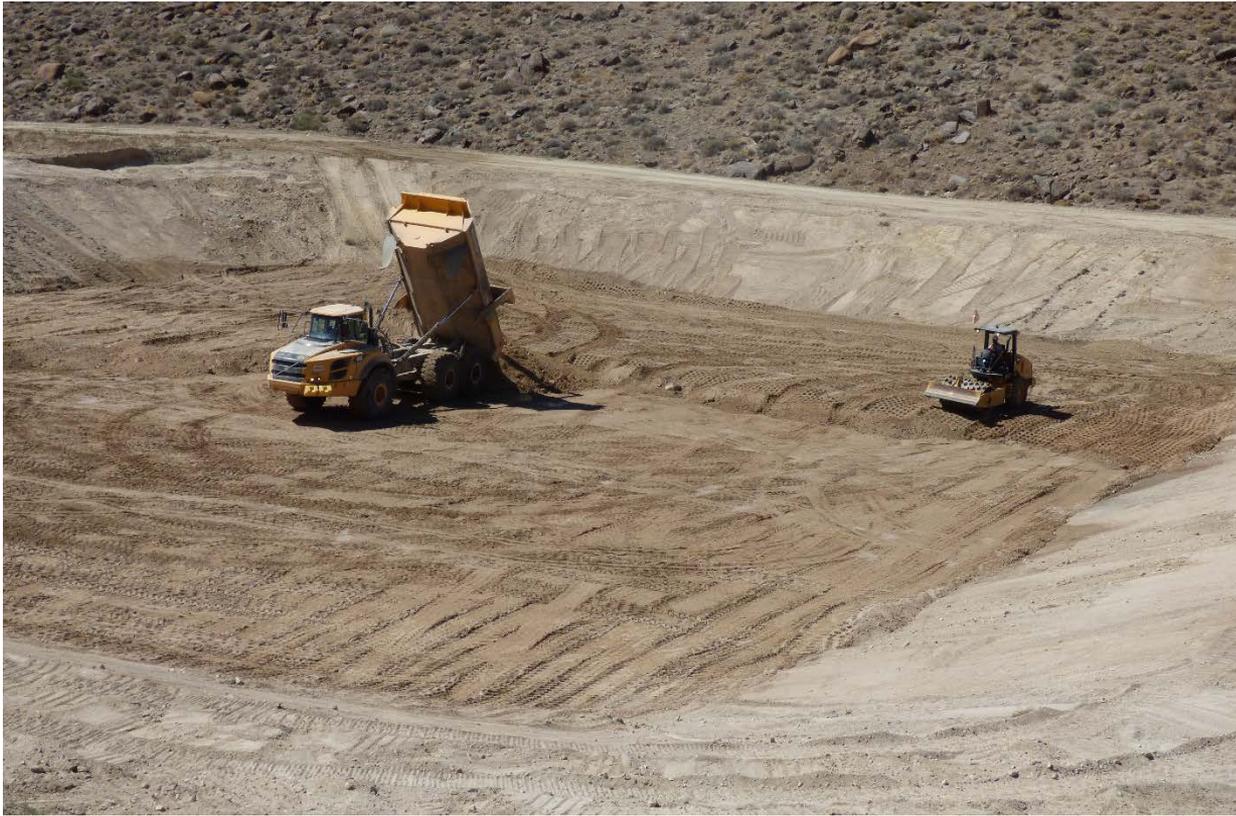
Santa Fe pond backfill to form E-cell base

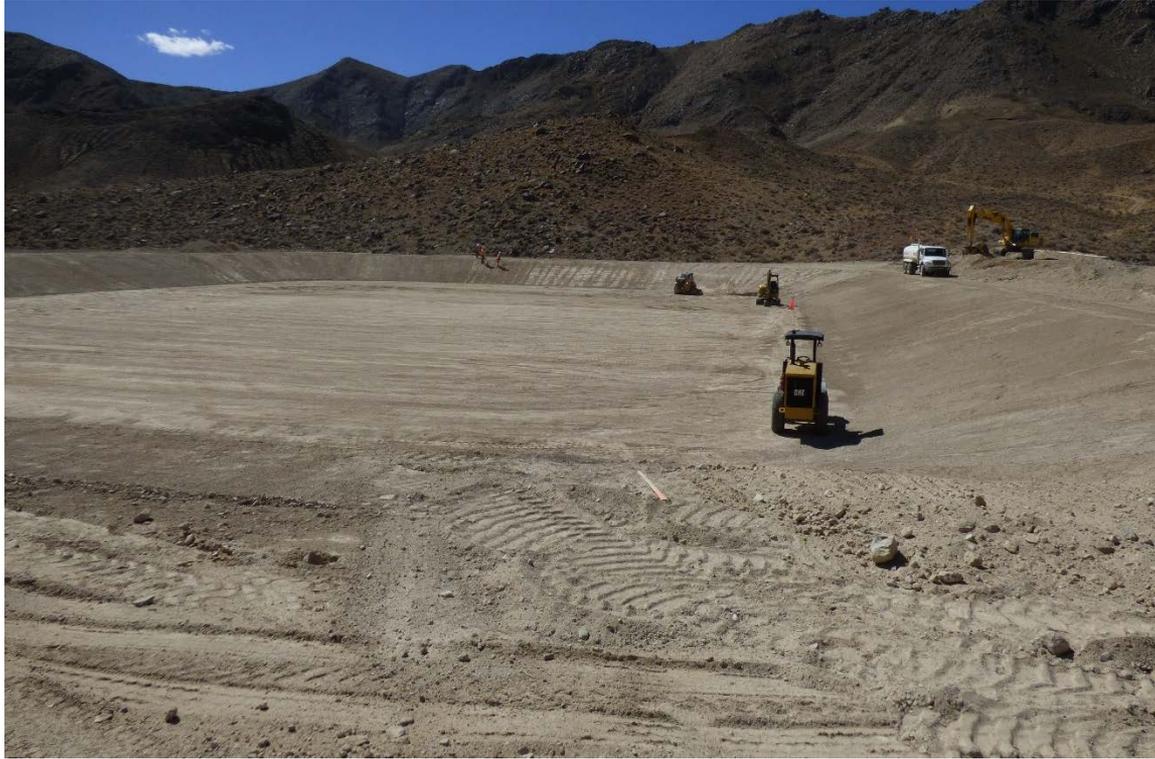
Santa Fe E-cell liner subgrade

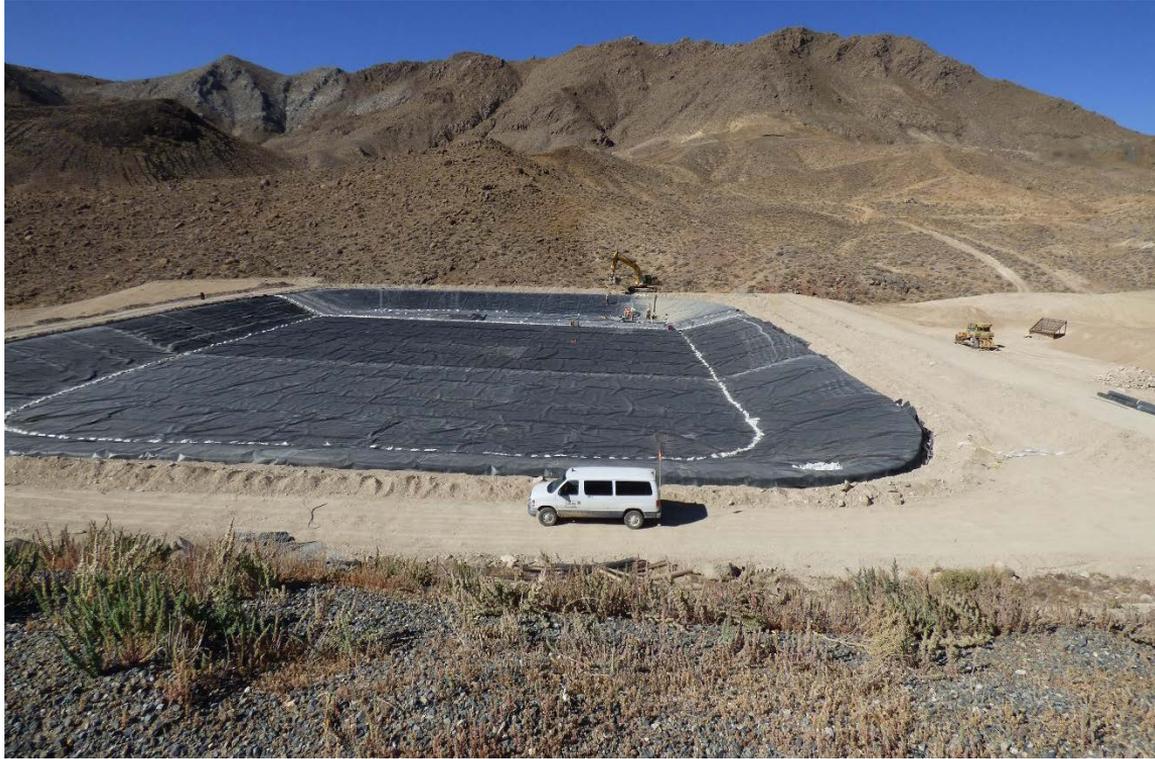
**Santa Fe Secondary liner installed**

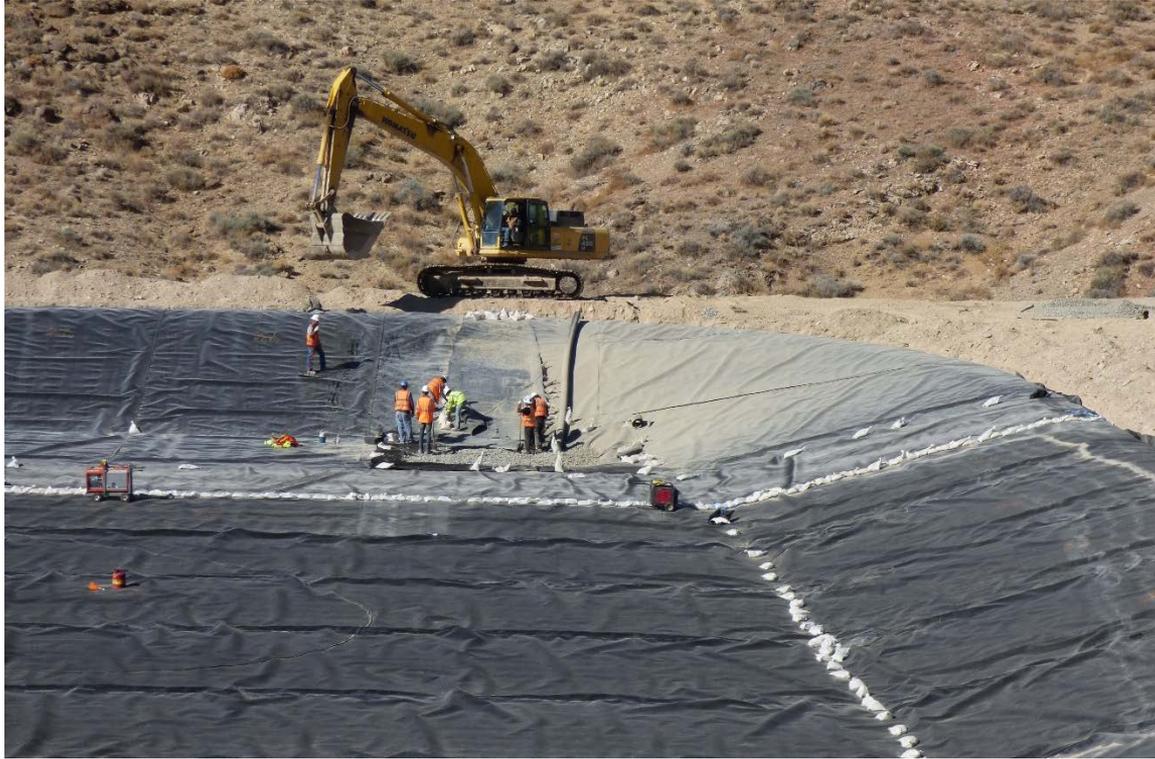
Santa Fe LCRS sump under construction

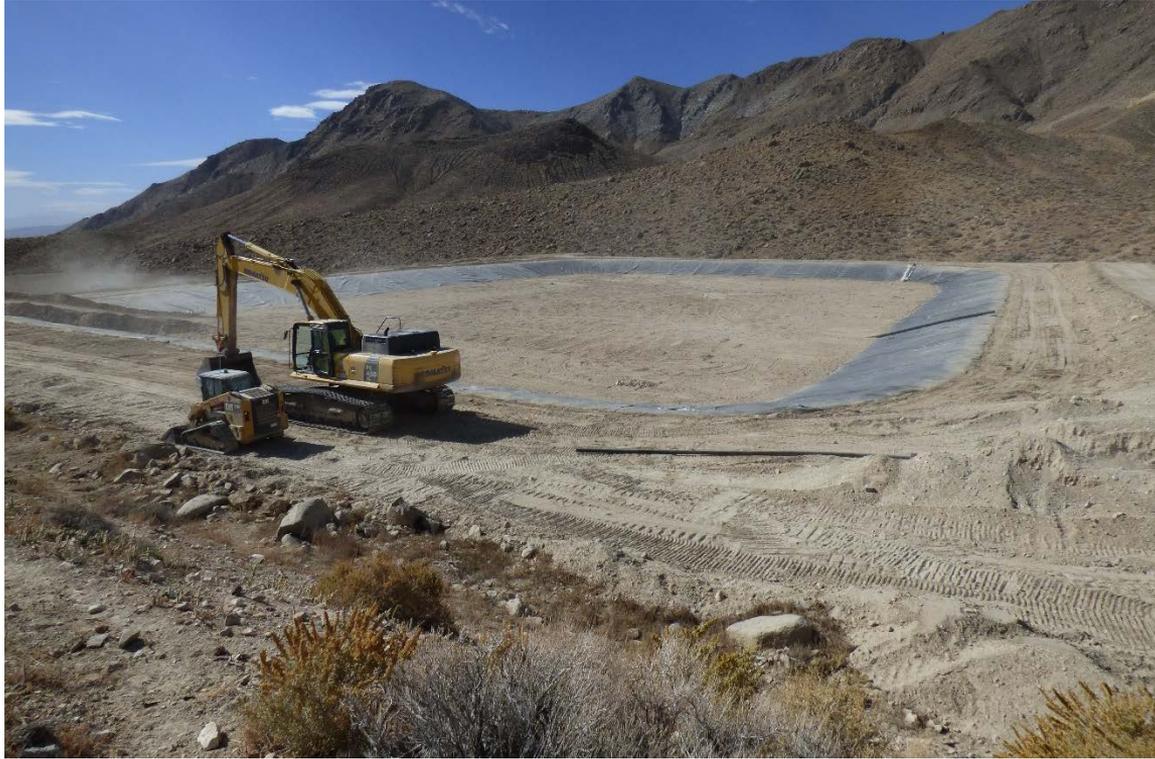
Santa Fe lower 2 feet of fill in place

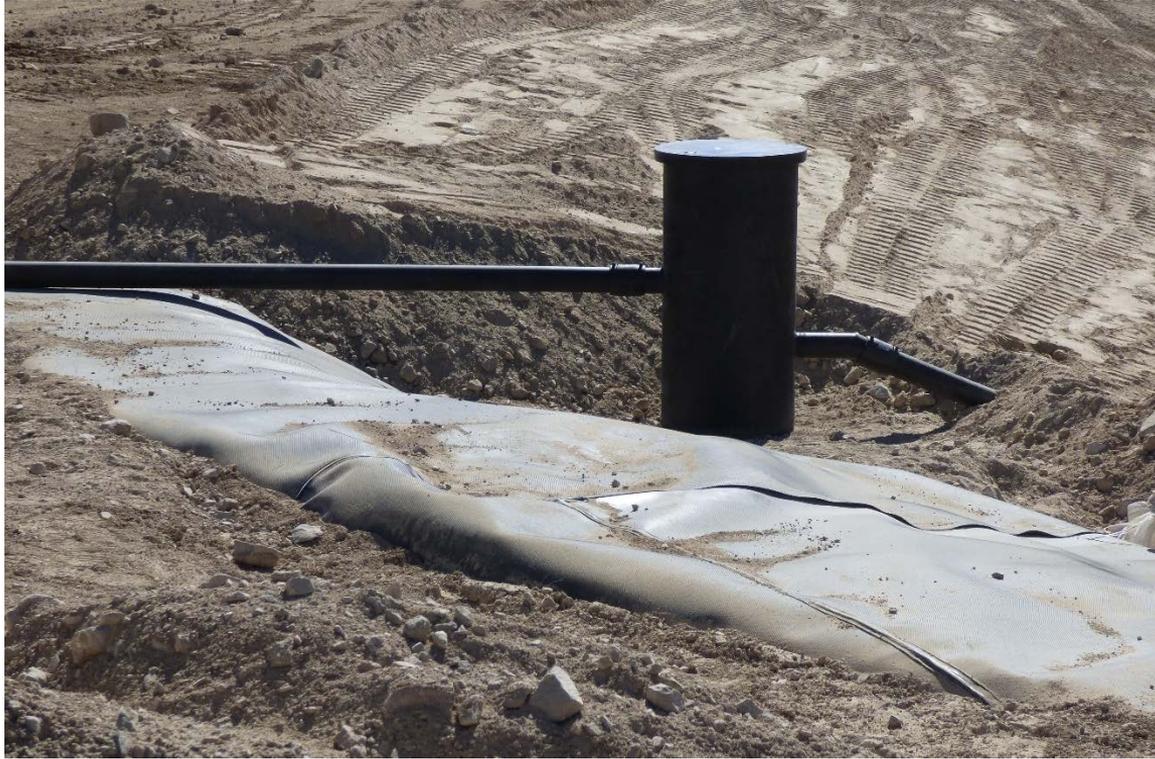
Santa Fe Distribution box in place

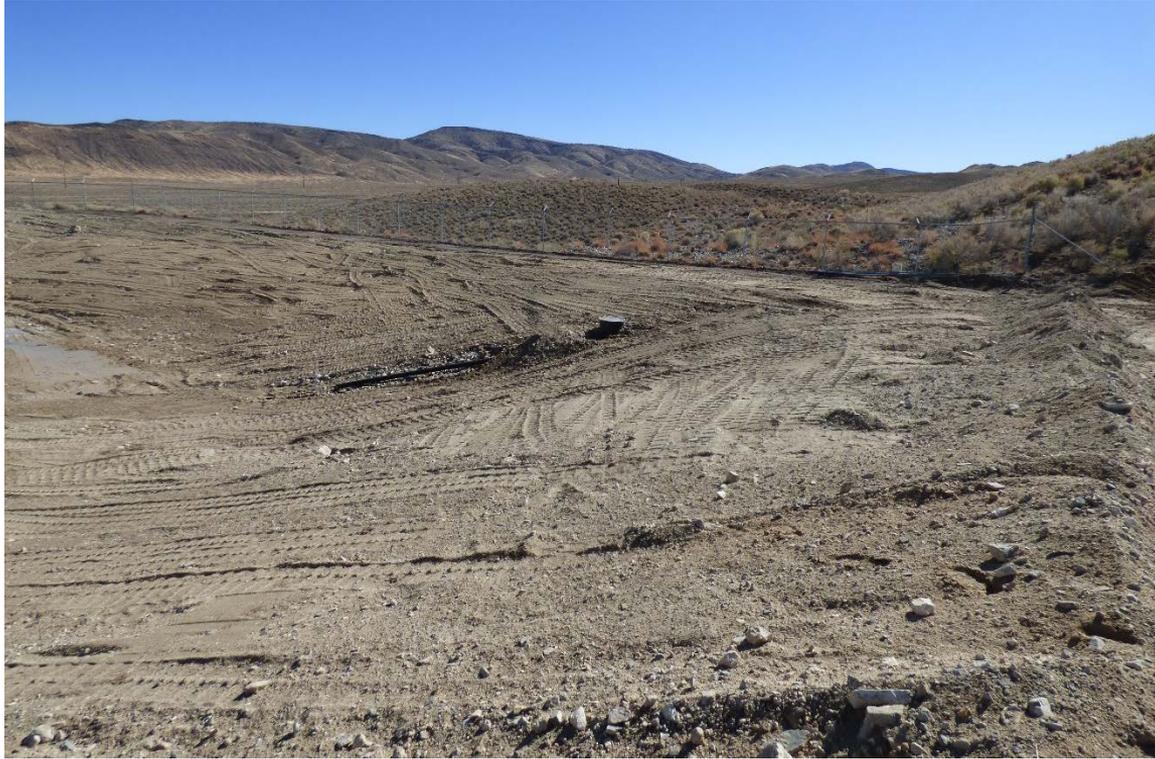
Calvada Distribution box completed

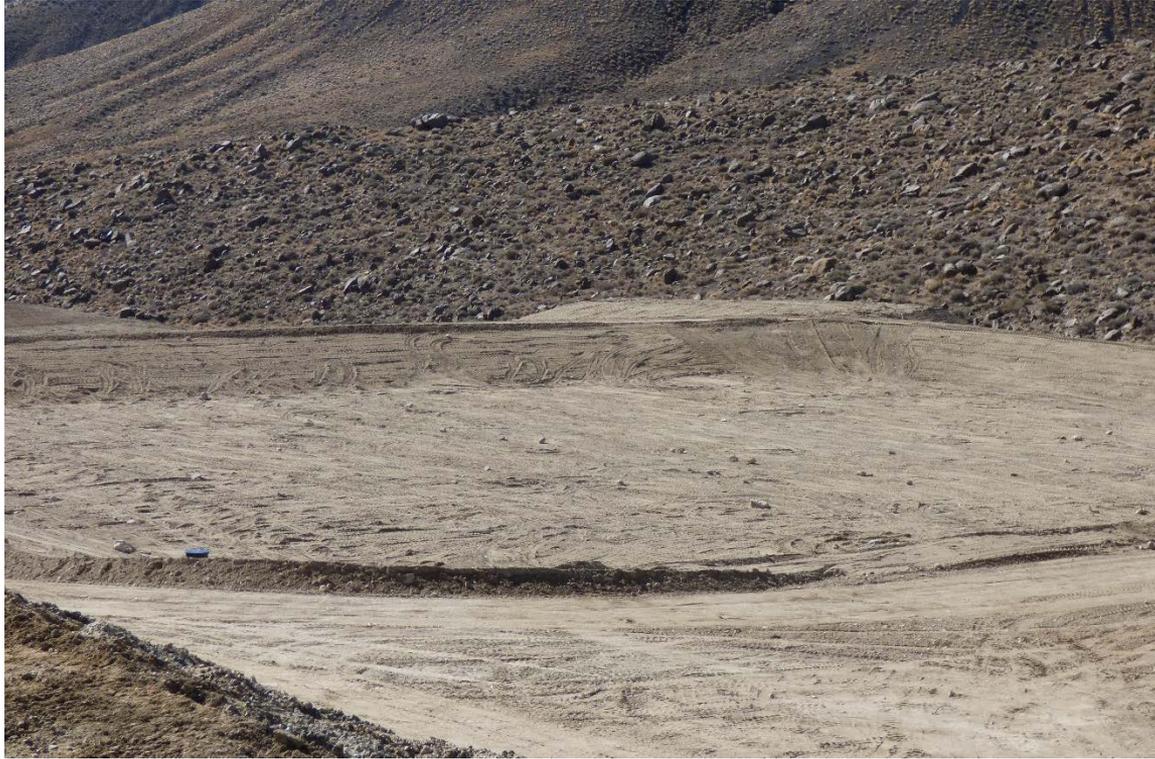
**Santa Fe Finished E-cell**

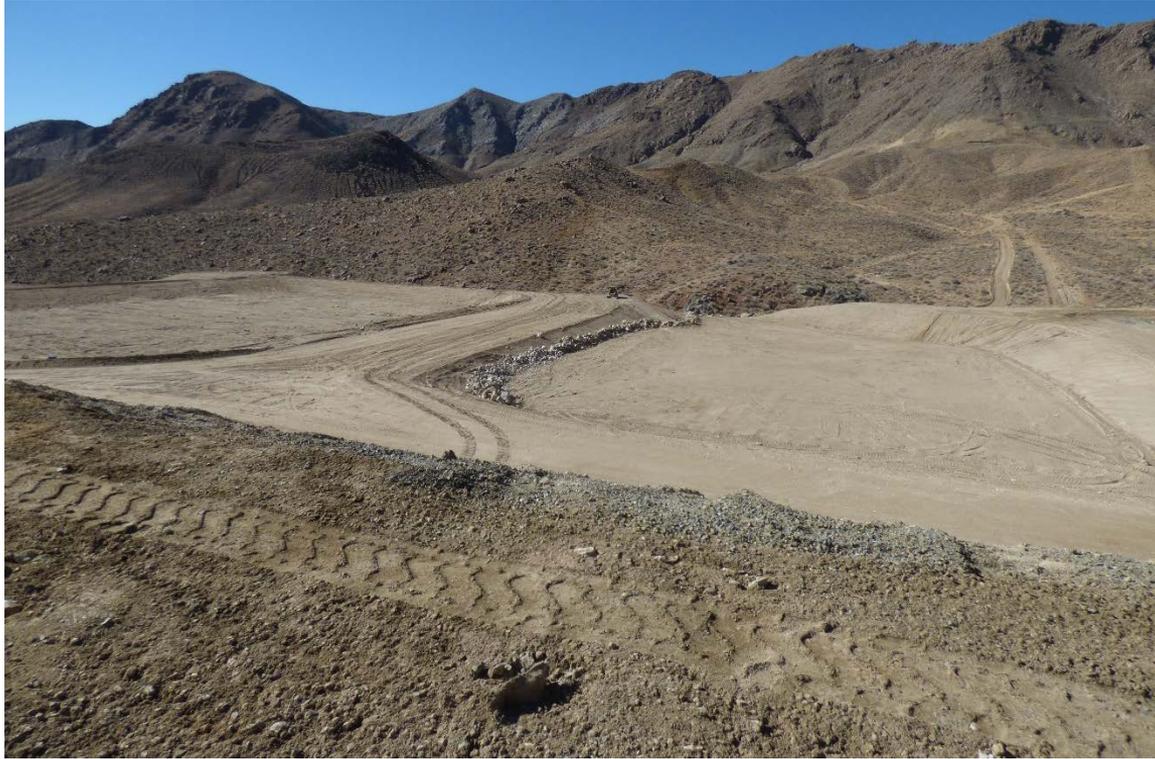
**Santa Fe E-cell completed with rip-rap upstream**

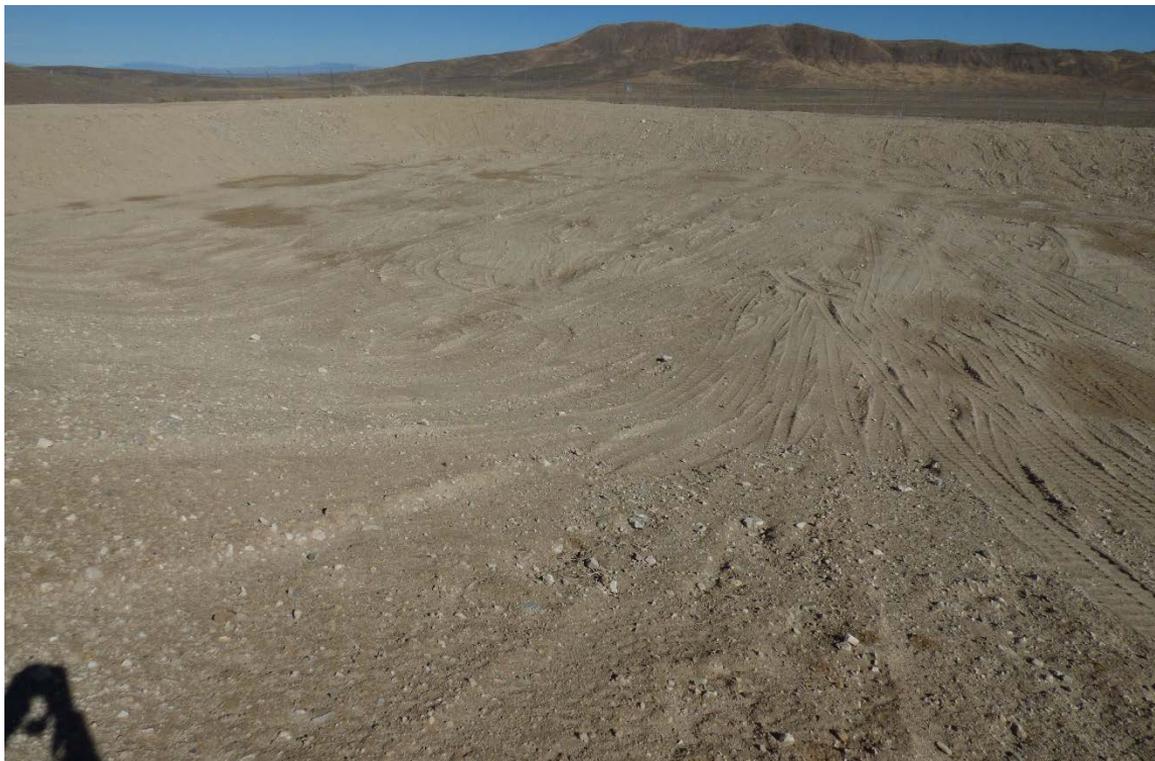
Calvada E-cell finished

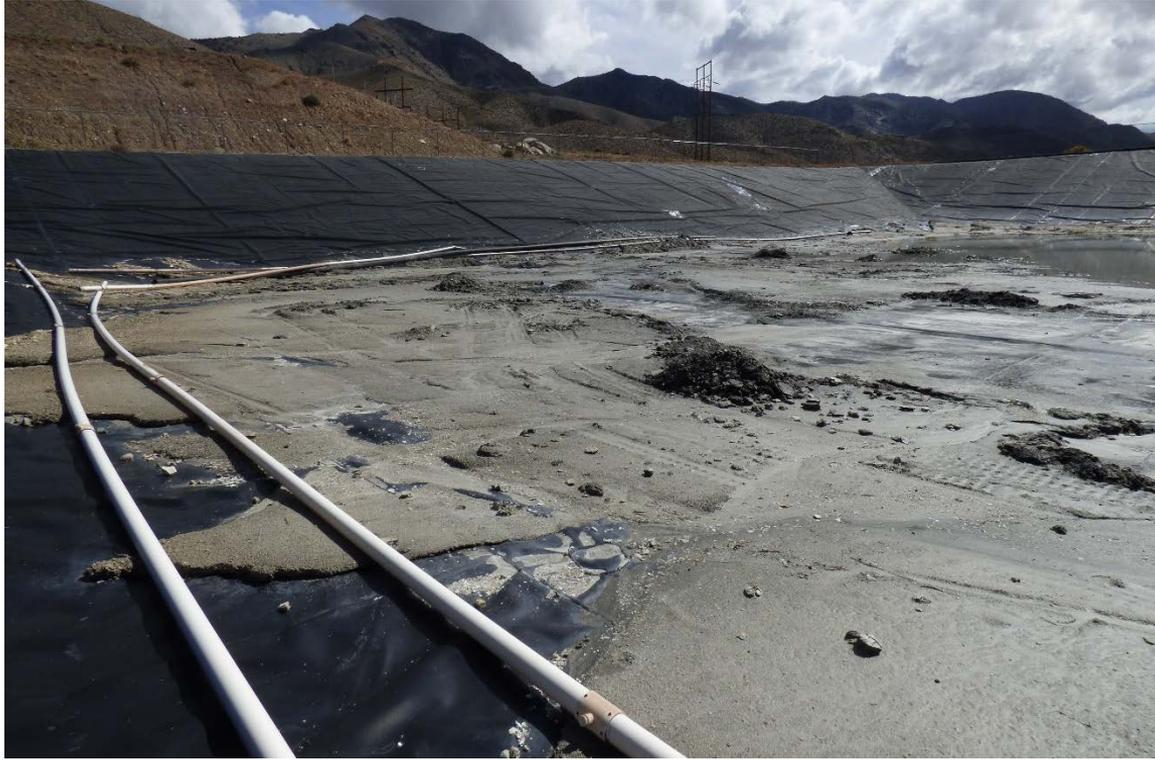
Santa Fe Pond 2 sampling damage

- The E-cells appear to be working as intended with no free water surface observed in first year (October 2016 through present.).
- A passive system can work for normal conditions.
- A free water surface can be expected with large events.
- Fencing is required to keep wildlife and people out of cells.
- Remove anything that may be removed causing damage such as Carbon or transformers.

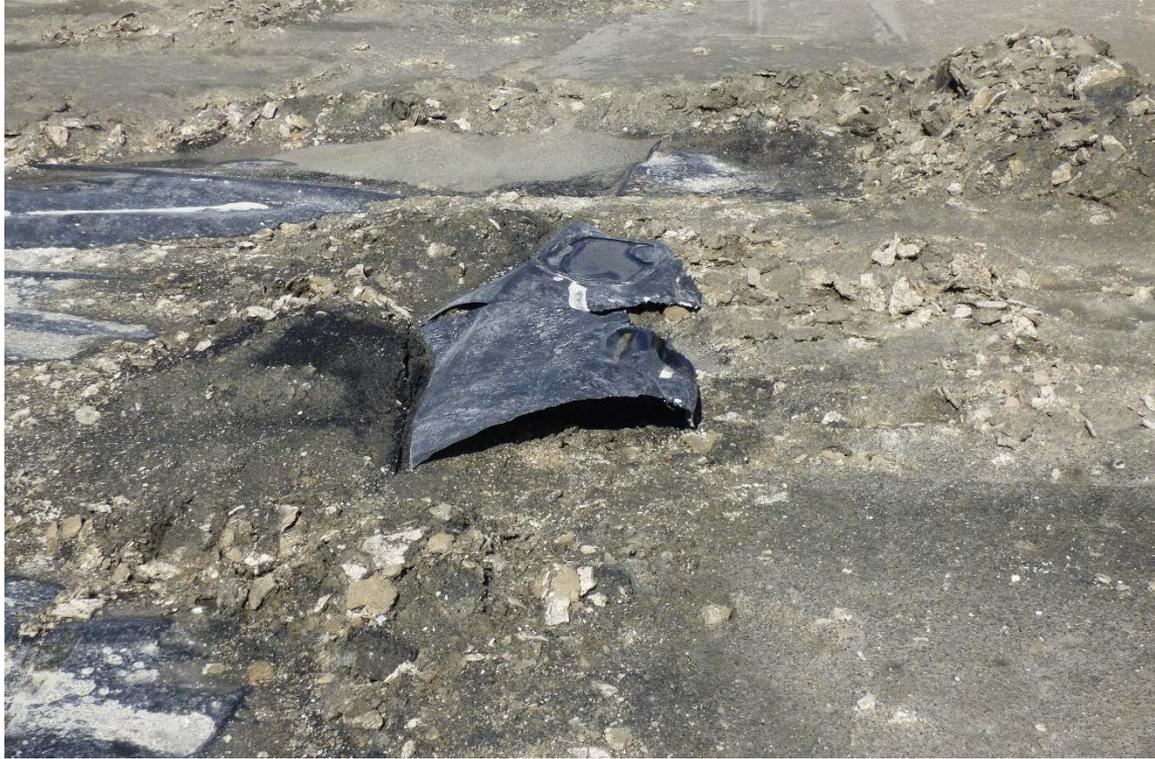
**Santa Fe Pond 2 pond damage by samplers assumed to be looking for carbon**

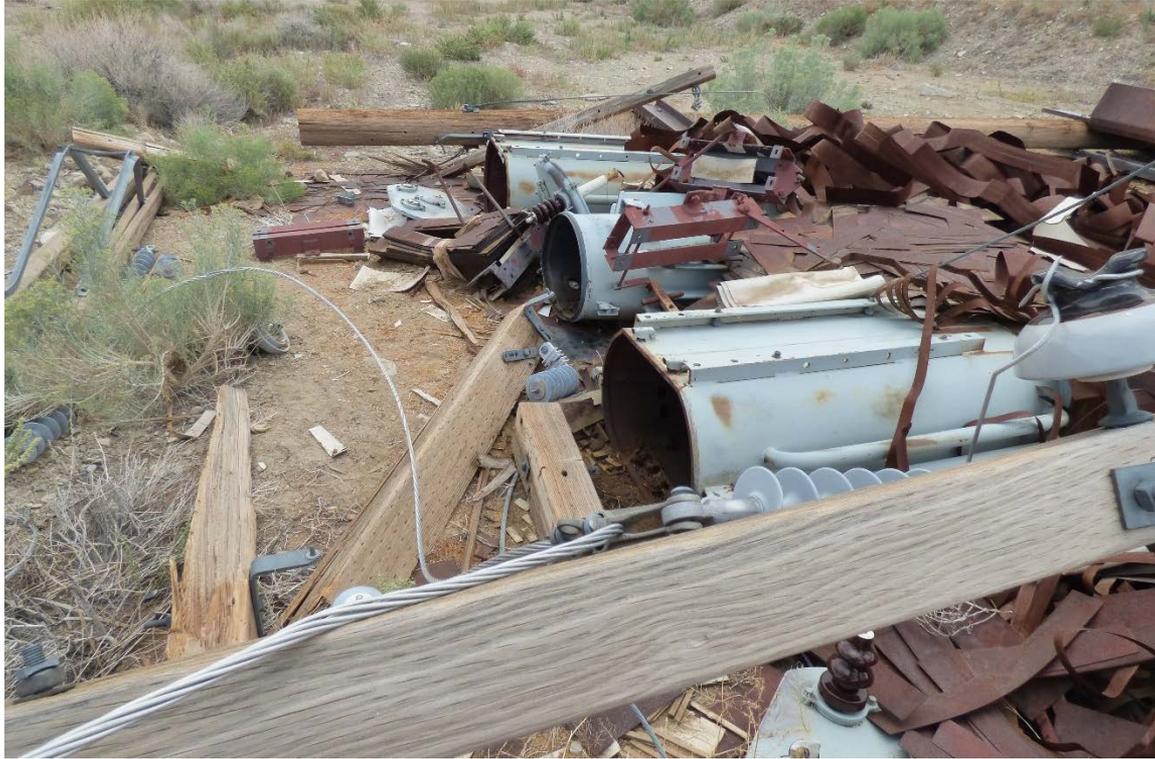
**Santa Fe transformers opened by copper thieves**
