**WETLAND DELINEATION IN THE RUSTENBURG
PLATINUM MINE PROJECT AREA AND A HIGH
LEVEL ASSESSMENT OF SELECTED RIVER
CROSSINGS, NORTH-WEST PROVINCE**

SRK Consulting (Pty) Ltd

May 2015

Prepared by:	Scientific Aquatic Services
Report author:	M. Aphane
Report Reviewer	S. van Staden (Pri. Sci. Nat)
Report Reference:	SAS 215053
Date:	May 2015

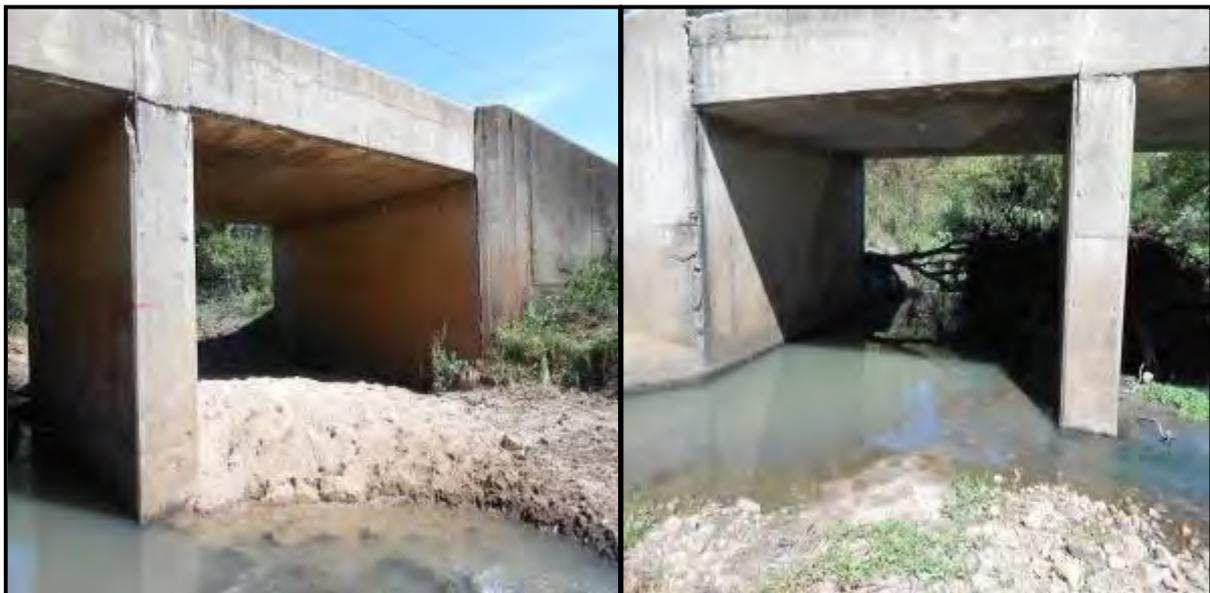
Figure 16: Sediment deposition and debris within the stream.

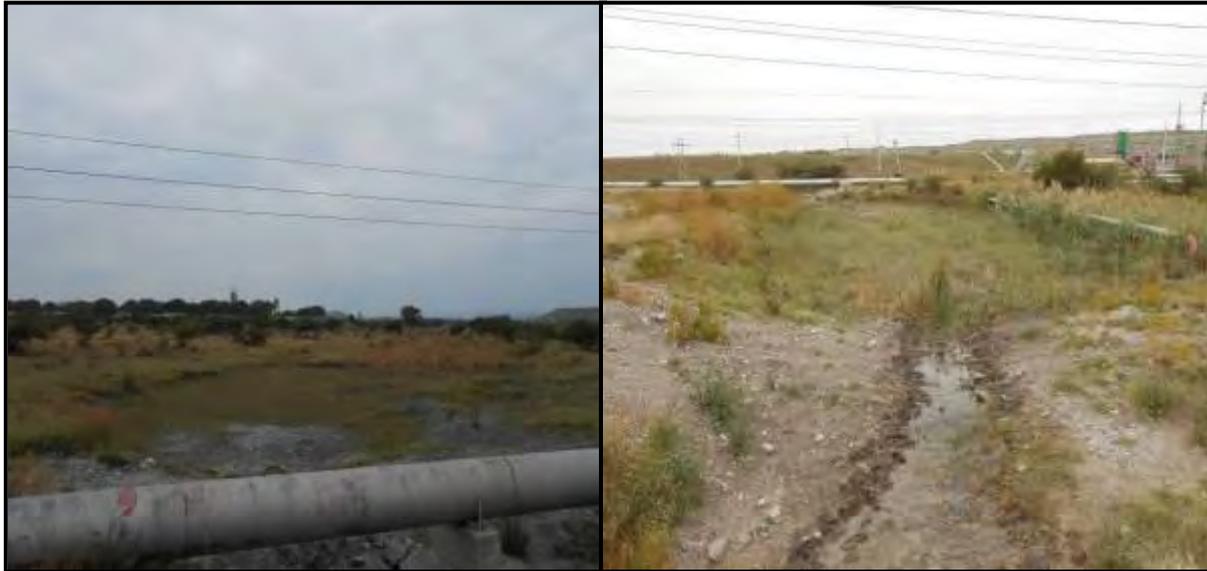
Figure 19: Erosion observed along the pipeline crossing within Klipgatspruit.

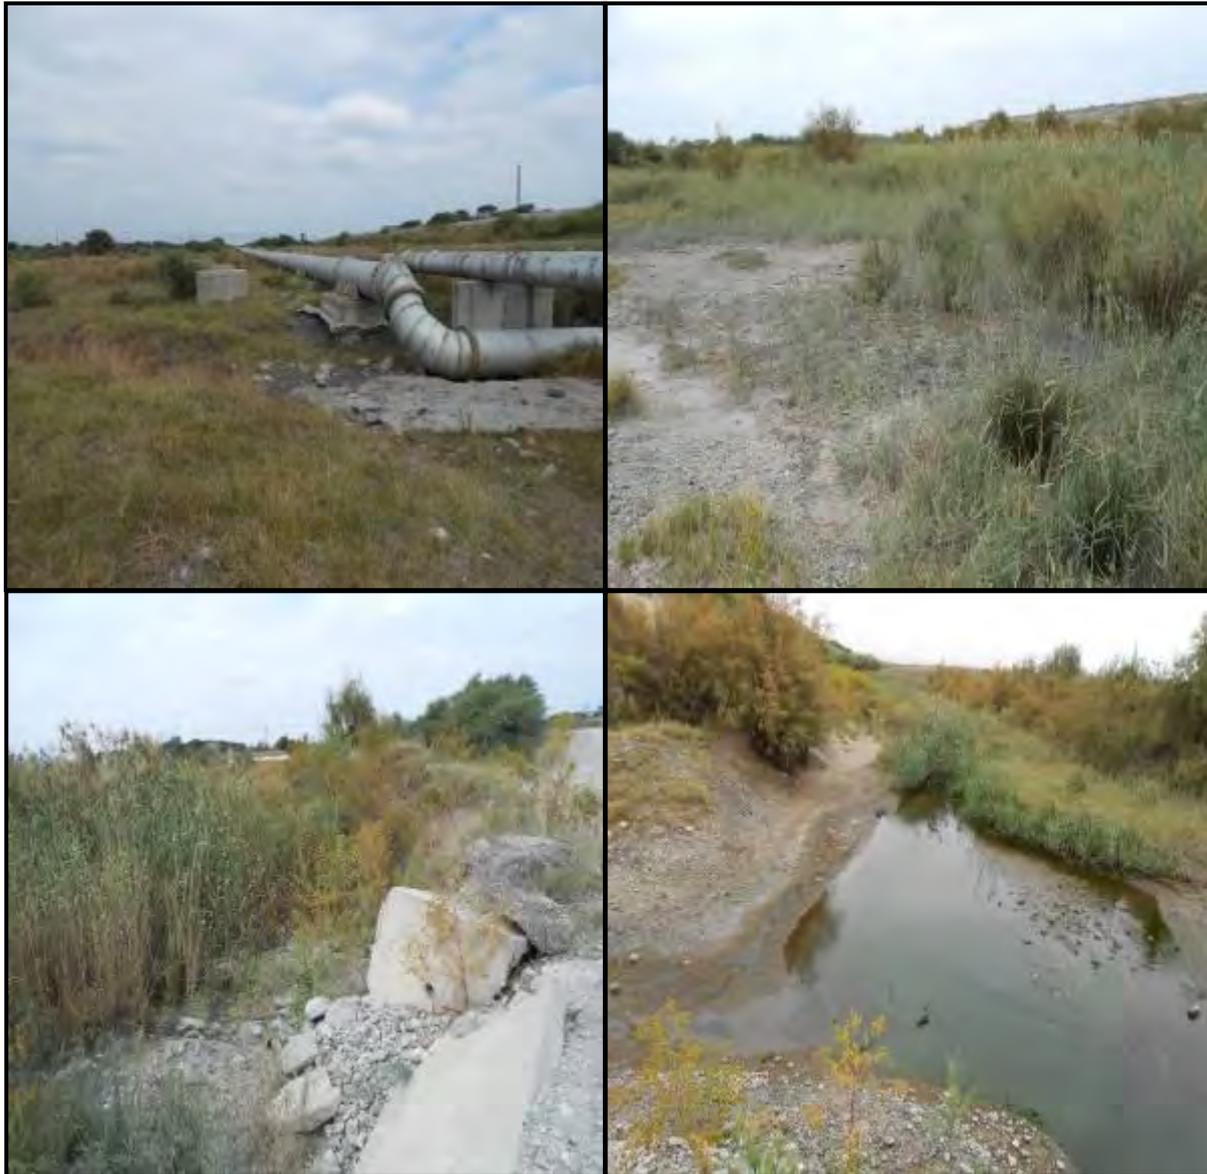
Figure 20: Disturbances within Klipgatspruit.

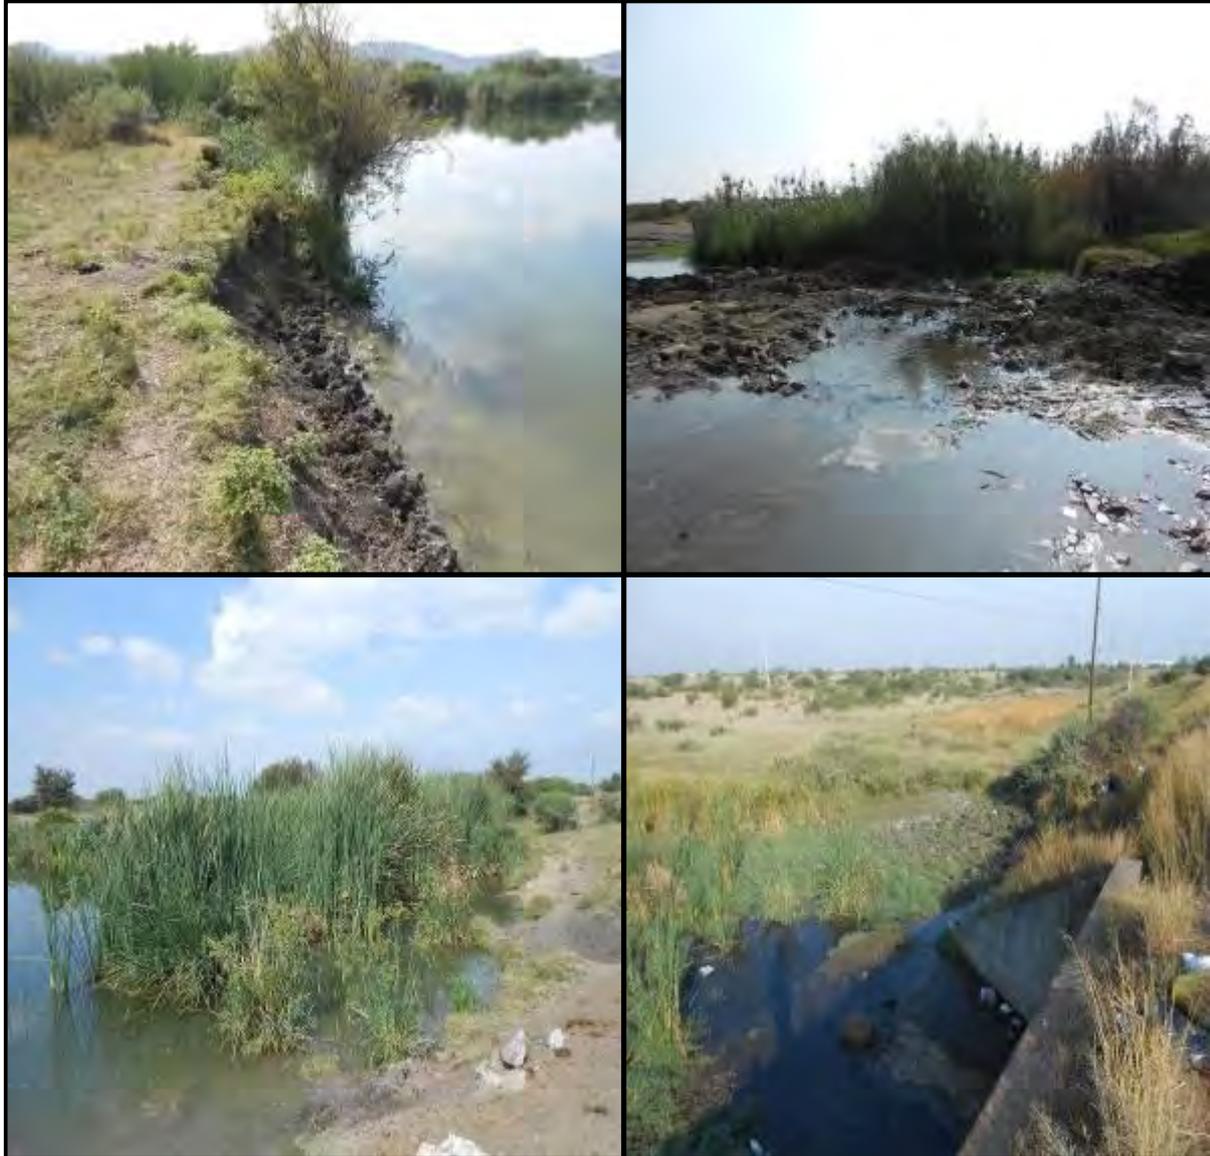
Figure 24: Representation of disturbances observed within Paardekraalspruit.

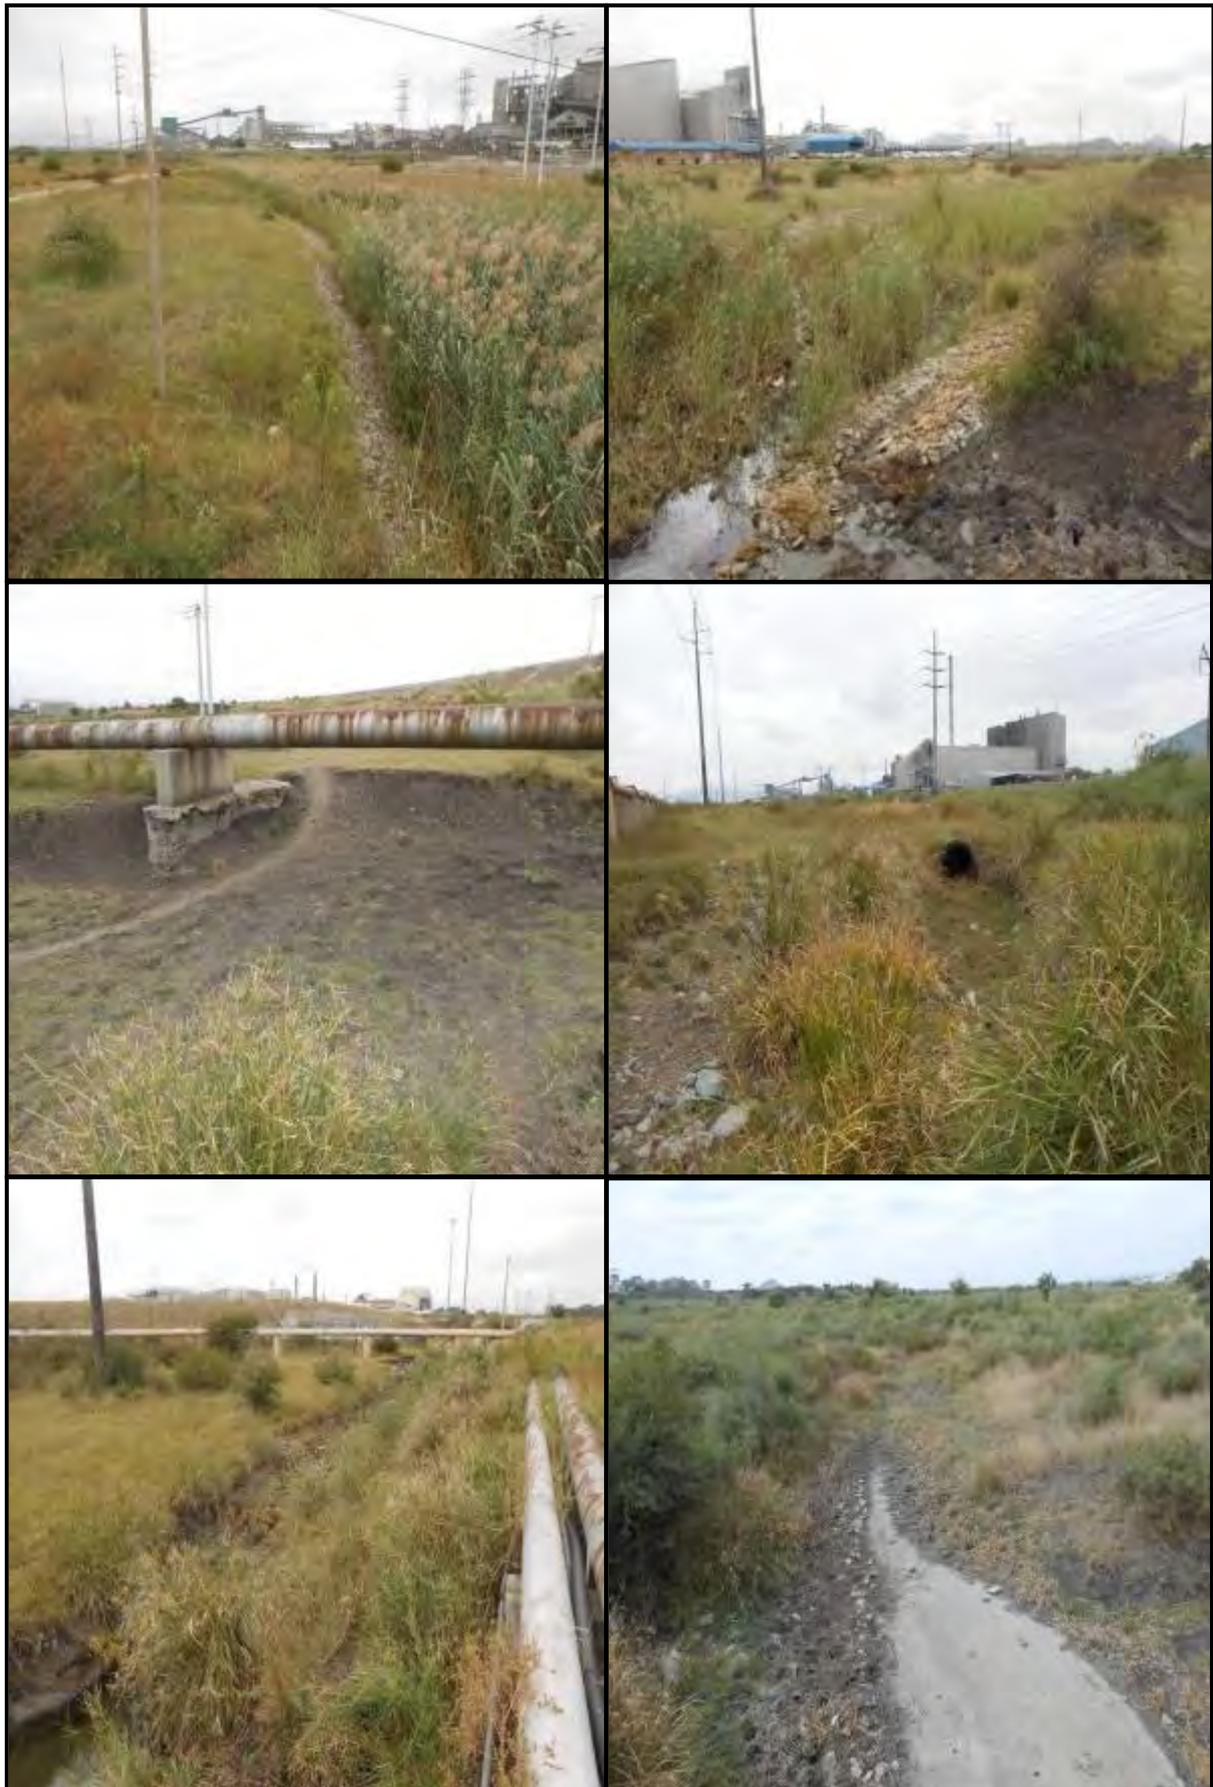
Figure 27: Disturbances within Klipfonteinspruit.

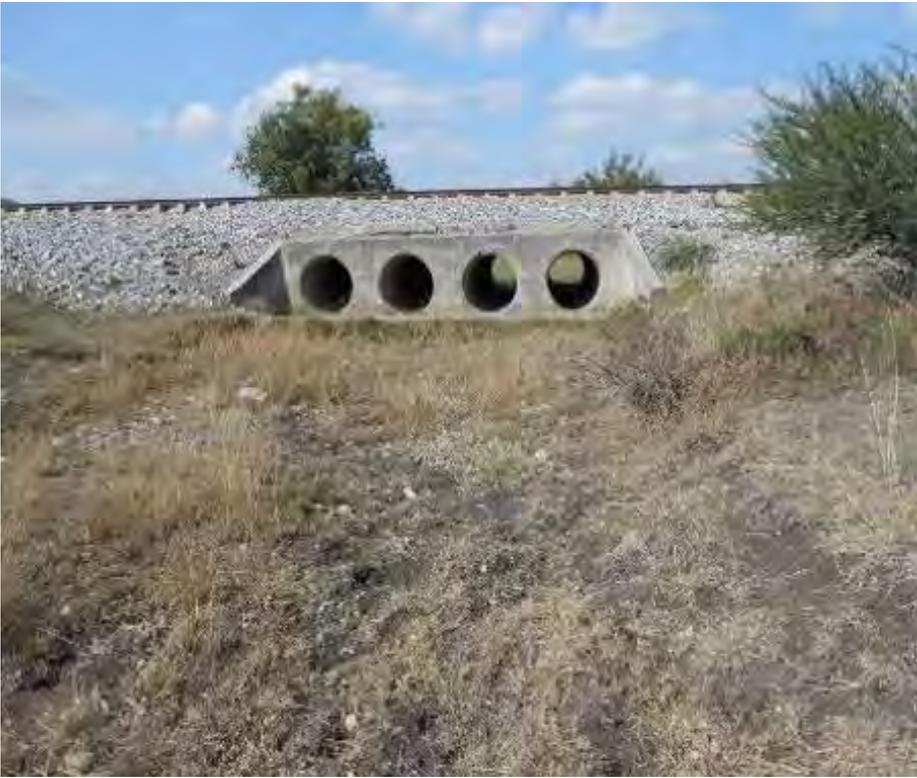
Present Ecological State	C
Wetland type	River
Morphology	Wide, shallow banks, ephemeral river. Culvert/bridge well-constructed; however the area adjacent to the culvert has been eroded due to the inherent vulnerability of the soils to erosion.
Riparian and in Stream Habitat	Acacia spp dominated bushveld vegetation; Instream ecology: well vegetated.
Vegetation	Alien species such as <i>Bonariensis verbena</i> and <i>Asparagus laricinus</i> have invaded the area, with <i>Acacia</i> tree species observed along the banks along the erosion gullies.
System Modifiers	Erosion, trampling and grazing by livestock.
Potential impacts of water use on environment	The culvert/bridge will not significantly negatively impact on any water users.
Socio-economic impacts of water use	The culvert/bridge will not significantly negatively impact on any water users.

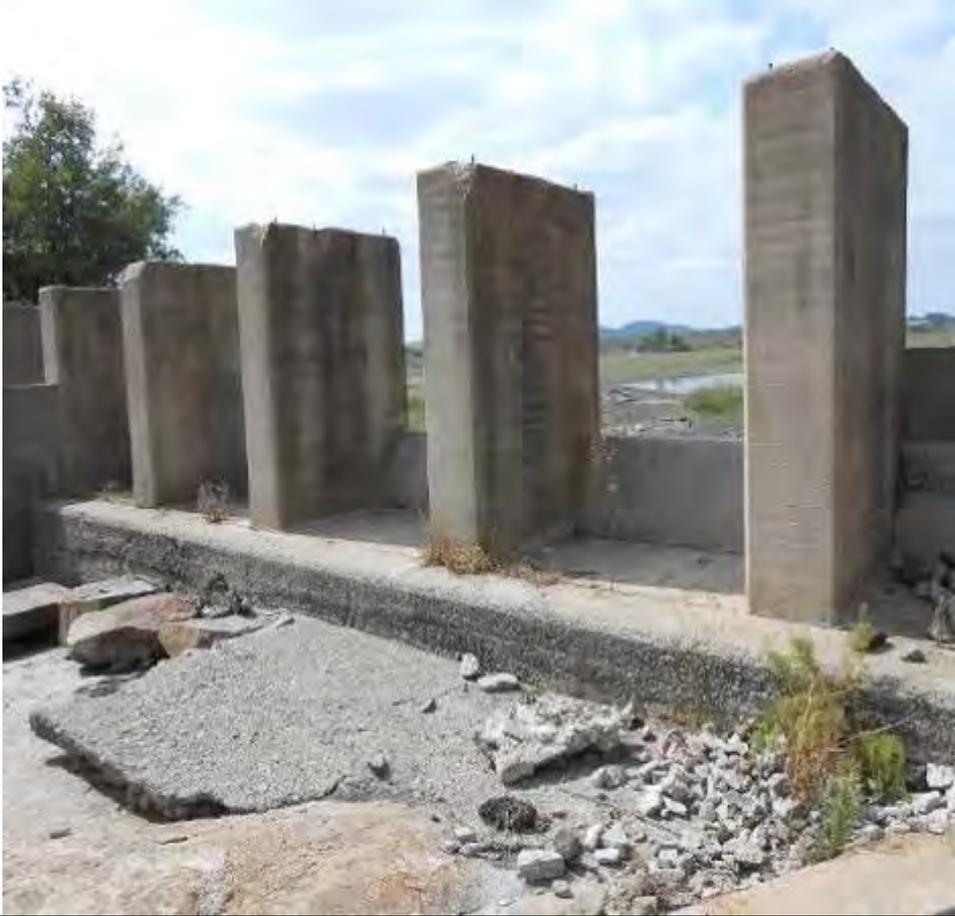
Present Ecological State	D
Wetland type	River/dam
Morphology	Very rocky area.
Riparian and in Stream Habitat	<i>Acacia</i> spp. dominated bushveld vegetation. Instream ecology: A puddle of water behind the dam wall, but most of the area was dry at the time of the study.
Vegetation	<i>Acacia</i> spp dominated the area and a stand of <i>Typha capensis</i> was observed just adjacent the dam wall.
System Modifiers	Dam wall. Overgrazing and trampling.
Potential impacts of water use on environment	The dam wall alters the flow of water.
Socio-economic impacts of water use	The dam wall might cause ponding upstream and dry conditions downstream.
Socio-economic advantages of water use	The dam wall might cause ponding upstream and dry conditions downstream.
Potential impacts of water use on water resource	The dam wall will cause a migration barrier.

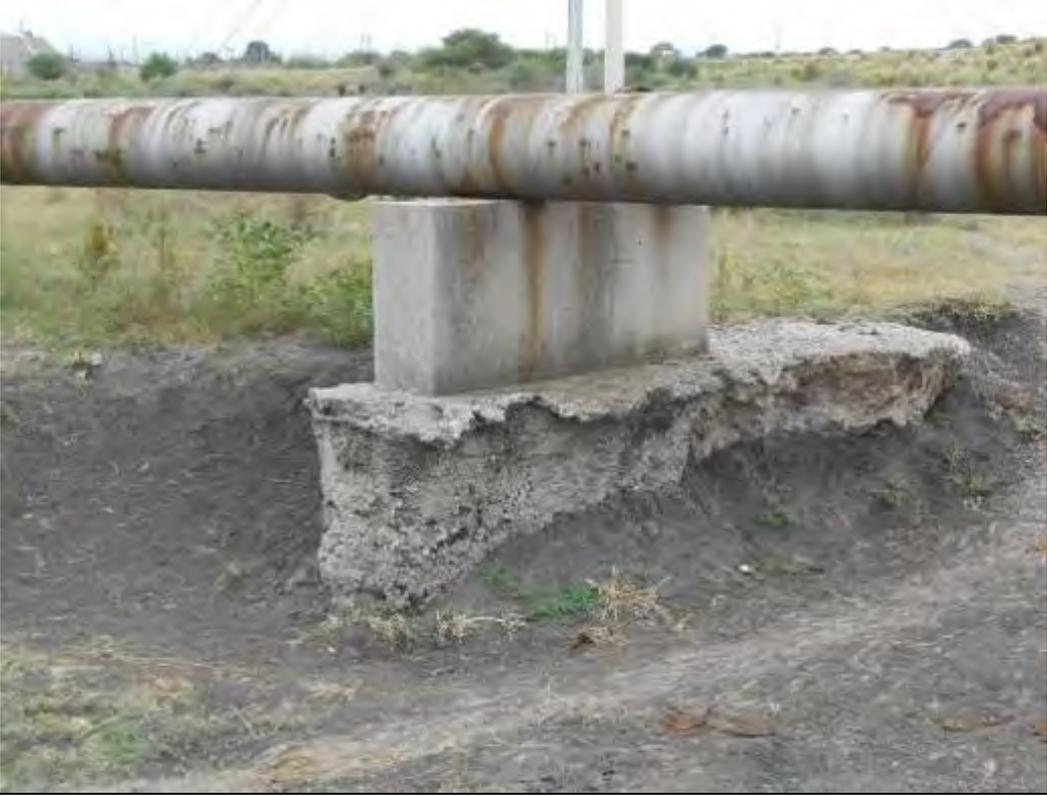
Present Ecological State	D (largely modified)
Wetland type	River
Morphology	Wide eroded channel.
Riparian and in Stream Habitat	Riparian vegetation sparse due to overgrazing and erosion; consists primarily of pioneer graminoid species and alien invasive species. Instream ecology: river dry at the time of the assessment.
Vegetation	<i>Asparagus larcinus</i> , <i>Cyperus sexangularis</i> <i>Flaveria bidentis</i>
System Modifiers	Trampling by livestock; erosion which puts a strain on the plinth supporting the pipeline.
Potential impacts of water use on environment	The pipeline will not significantly negatively impact on any water users.
Socio-economic impacts of water use	The pipeline will not significantly negatively impact on any water users.
Socio-economic advantages of water use	The pipeline will not significantly negatively impact on any water users.

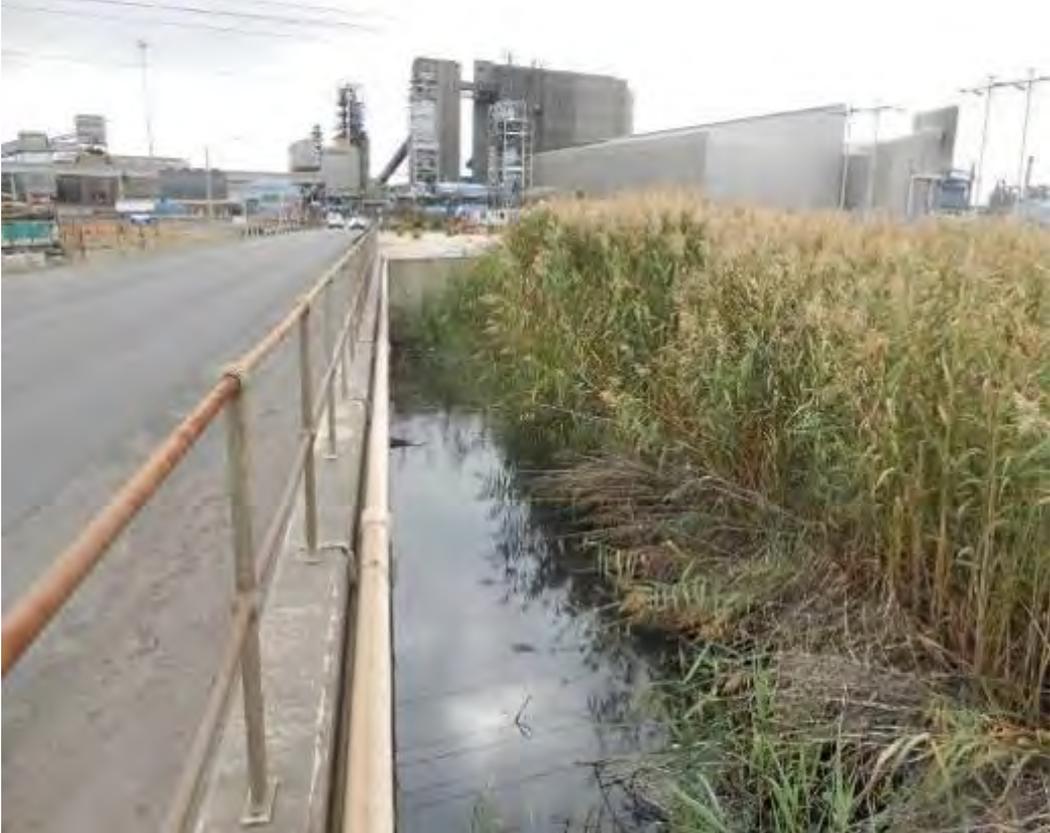
Present Ecological State	C
Wetland type	River
Morphology	The channel is mostly eroded on the area just below the bridge.
Riparian and in Stream Habitat	Primarily herbaceous and graminoid floral species, little to no overhanging vegetation. Instream ecology: inundation below the bridge
Vegetation	<i>Phragmites australis</i> , <i>Cyperus sexangularis</i> , <i>Asclepias fruticosa</i> , <i>Tagetes minuta</i> .
System Modifiers	The feature is augmented due to discharge from the mining area. Bridge crossing increasing water input within the river.
Potential impacts of water use on environment	The road crossing will not significantly negatively impact on any water users.
Socio-economic impacts of water use	The road crossing will not significantly negatively impact on any water users.

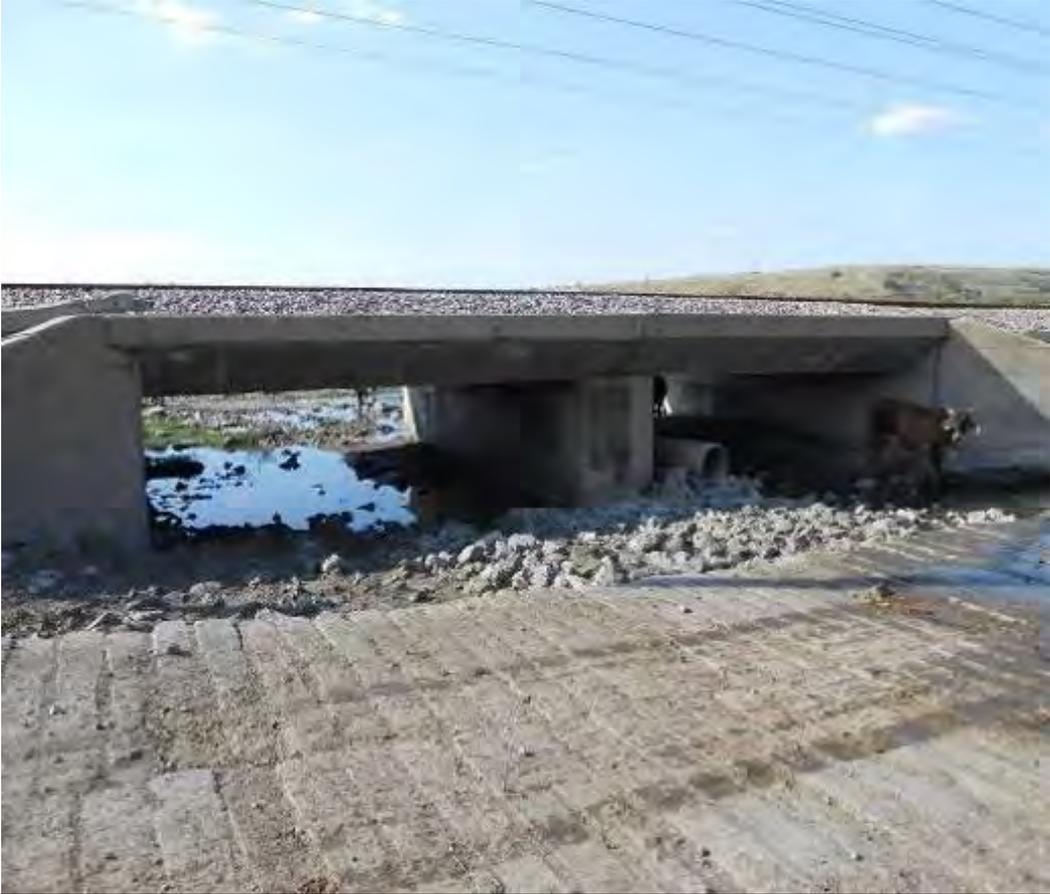
Present Ecological State	D
Wetland type	River
Morphology	The channel is not deep and it is more tramped below the crossing.
Riparian and in Stream Habitat	Acacia species dominated bushveld vegetation. Instream ecology:
Vegetation	<i>Cyperus sexangularis</i> , <i>Cynodon dactylon</i> , <i>Typha capensis</i> , <i>Acacia</i> spp.
System Modifiers	Infiltration due to paved surface which further increases runoff. Erosion. Livestock grazing and trampling.
Potential impacts of water use on environment	The railway crossing will not significantly negatively impact on any water users.
Socio-economic impacts of water use	The railway will not significantly negatively impact on any water users.
Socio-economic advantages of water use	The railway line is utilised for the mining operations.
Potential impacts of water use on water resource	The railway is not considered likely to have a significant impact on the resource; however the culvert will alter water flow patterns and there will be reduced infiltration since the area is cemented just below the culvert.

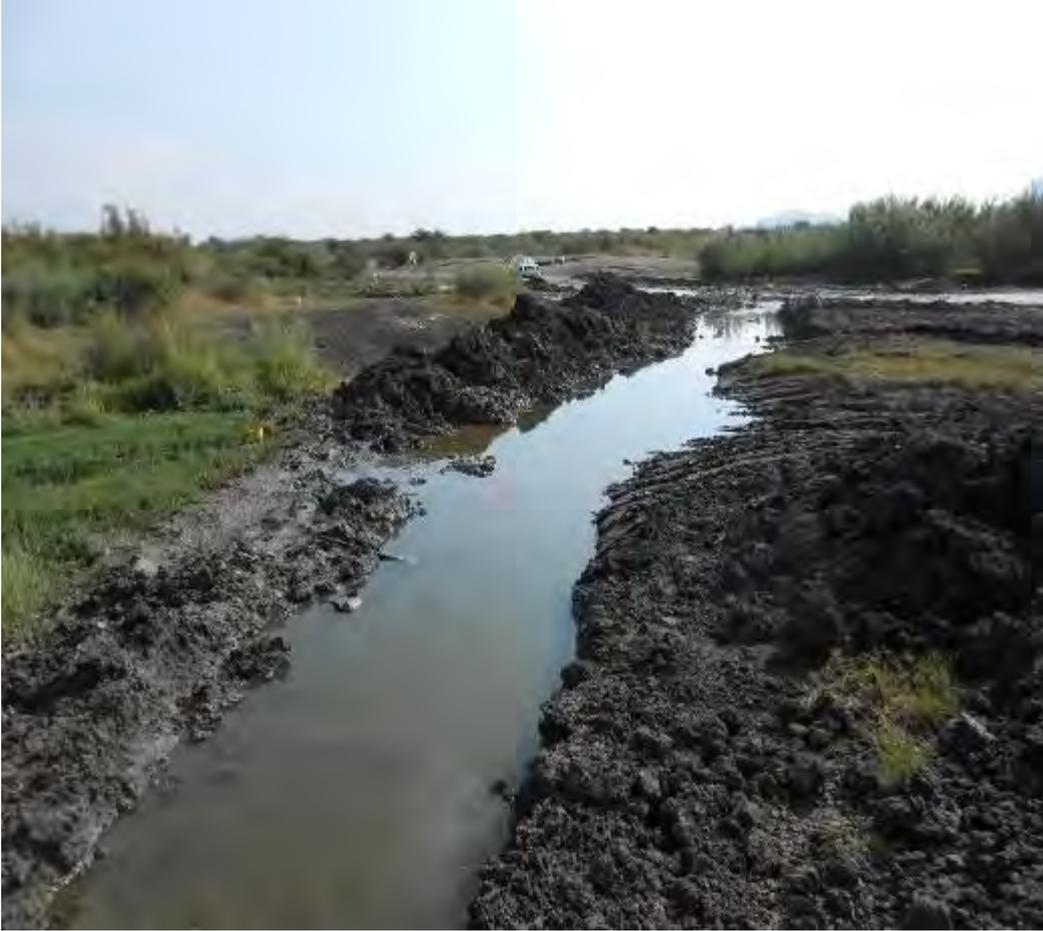
Present Ecological State	D
Wetland type	River
Morphology	Wide, relatively shallow channel, Inundation.
Riparian and in Stream Habitat	Inundated with runoff from the road and overflow from the adjacent dam.
Vegetation	<i>Phragmites australis</i> , <i>Rhus lancea</i> , <i>Cynodon dactylon</i> , <i>Tamarix ramosissima</i> , <i>Asparagus larinicus</i>
System Modifiers	Excavations. Erosion.
Potential impacts of water use on environment	The diversion will redirect the flow of water and cause drying up in areas where there used to be flowing water or water available to users.
Socio-economic impacts of water use	The diversion will result in lack of water in certain areas as a result of water not being able to flow to those areas.
Socio-economic advantages of water use	The diversion will not significantly negatively impact on any water users

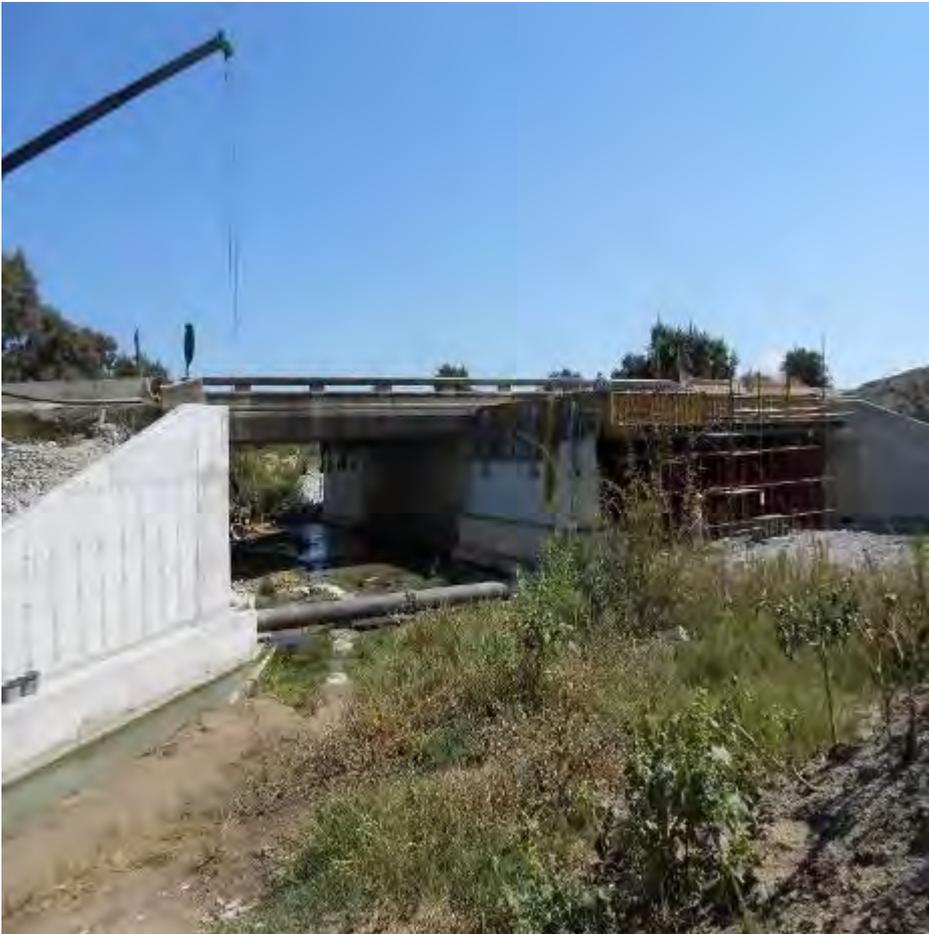
Present Ecological State	D
Wetland type	River
Morphology	Wide, relatively shallow channel.
Riparian and in Stream Habitat	Water flow ceased due to construction.
Vegetation	<i>Xanthium stramonium</i> , <i>Flaveria bidentis</i> , <i>Eragrostis gummiflua</i> , <i>Sporobolus africanus</i>
System Modifiers	Road bridge construction. Erosion. Stockpiling.
Potential impacts of water use on environment	The road crossing will not significantly negatively impact on the environment.
Socio-economic impacts of water use	The road crossing will not significantly negatively impact on any water users.
Socio-economic advantages of water use	The road crossing plays an important role in providing connectivity in the area, particularly to the local community, thereby allowing economic activity in the area.

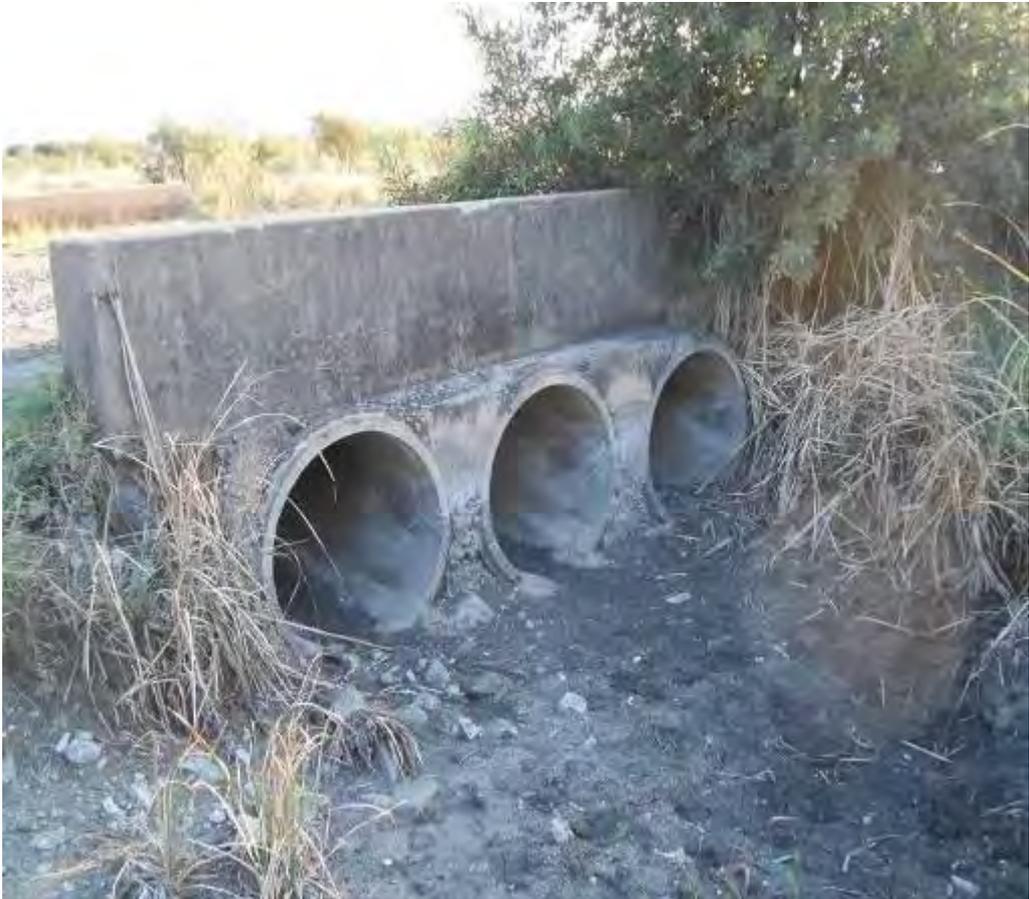
Present Ecological State	C
Wetland type	River
	Narrow, shallow channel, Dry river bed.
Riparian and in Stream Habitat	Dry at the time of the assessment.
Vegetation	<i>Typha capensis</i> , <i>Cyperus sexangularis</i> , <i>Asparagus ;laricinus</i> , <i>Tagetes minuta</i> , <i>Cirsium vulgare</i> , <i>Eragrostis curvula</i> , <i>Sesbania sesban</i> , <i>Verbena bonariensis</i>
System Modifiers	Erosion. Cattle trampling and grazing.
Potential impacts of water use on environment	The road crossing will not significantly negatively impact on the environment.
Socio-economic impacts of water use	The road crossing will not significantly negatively impact on any water users.
Socio-economic advantages of water use	The road crossing plays an important role in providing connectivity in the area.
Potential impacts of water use on water resource	Alterations to streamflow patterns during flow periods. Due to erosion, there will be sediment deposition.

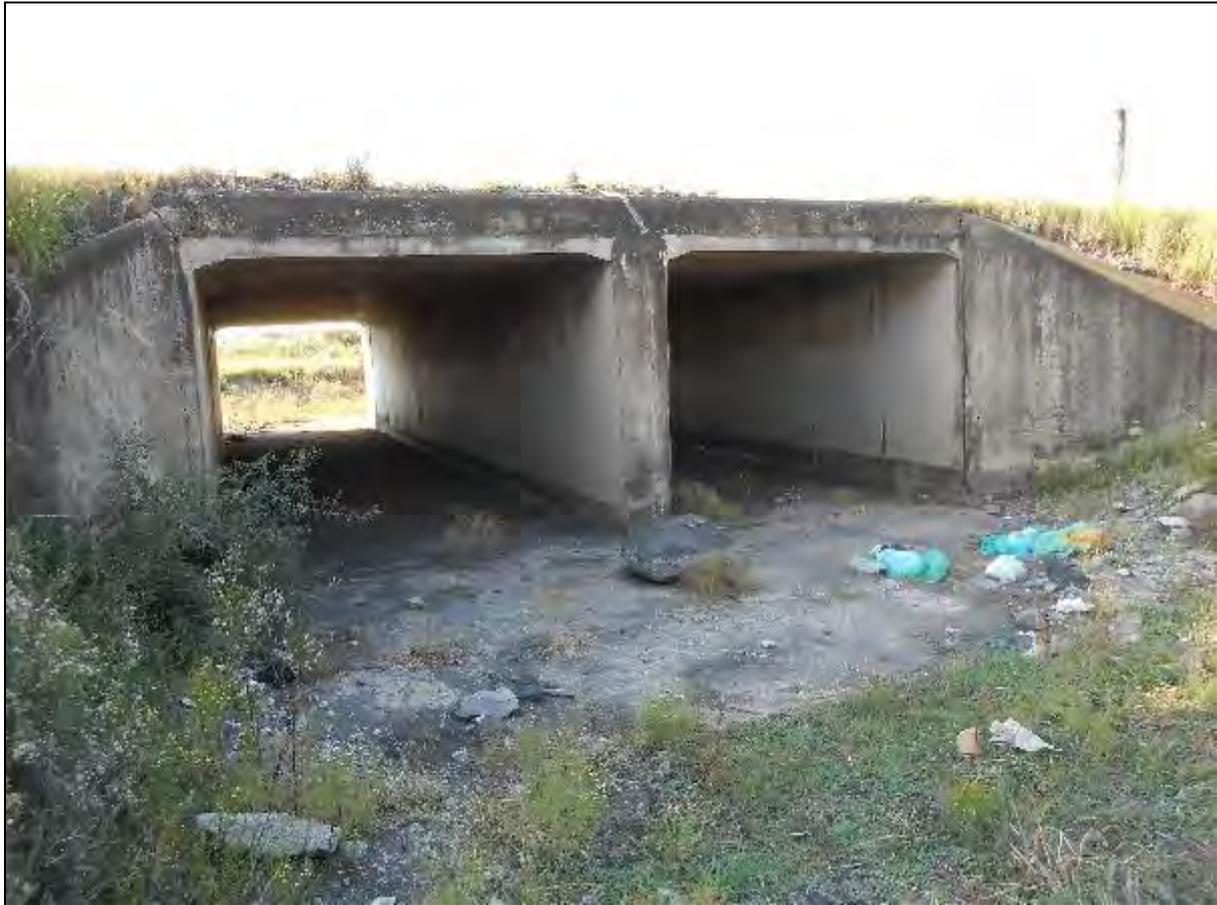
Figure 67: Culvert Bridge indicating the artificial habitat within the structure.

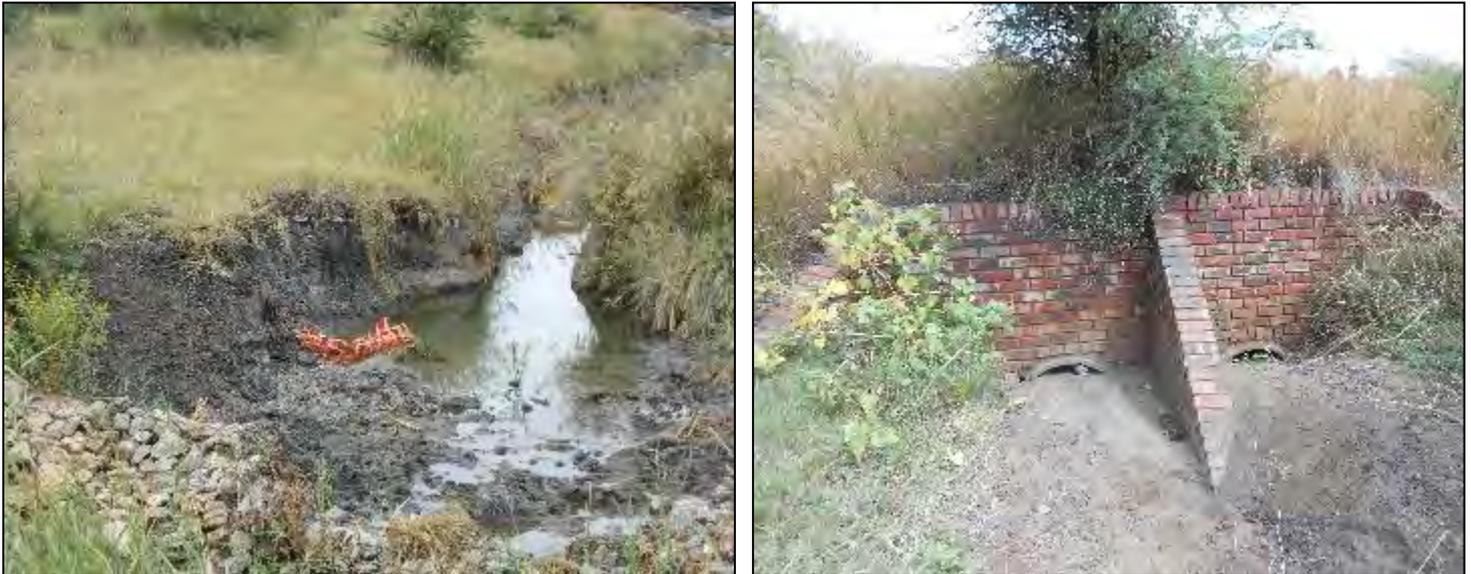
Figure 68: Erosion and Sedimentation evident at crossings within the RPM boundary.

- Any areas where bank failure is observed, due to the effects of bridge crossings, should be immediately repaired by reducing the gradient of the banks to a 1:3 slope and where deemed necessary, installing support structures;

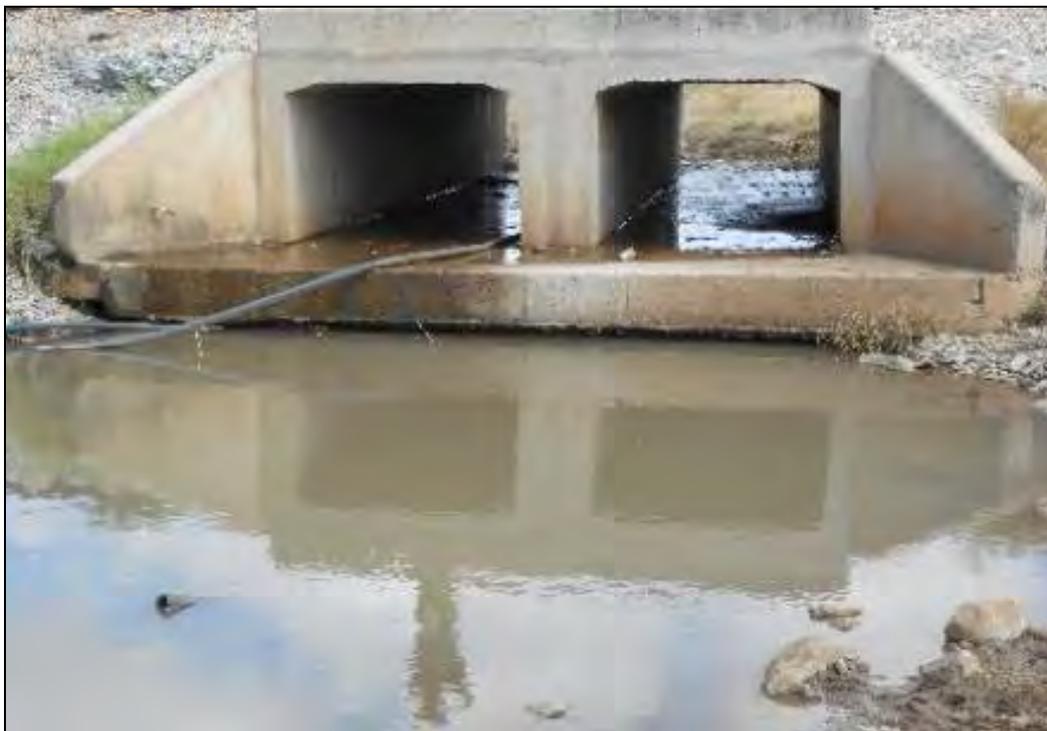
Figure 69: Culvert Bridge indicating the scouring and undermining of the Culvert structure resulting in altered stream hydrology.

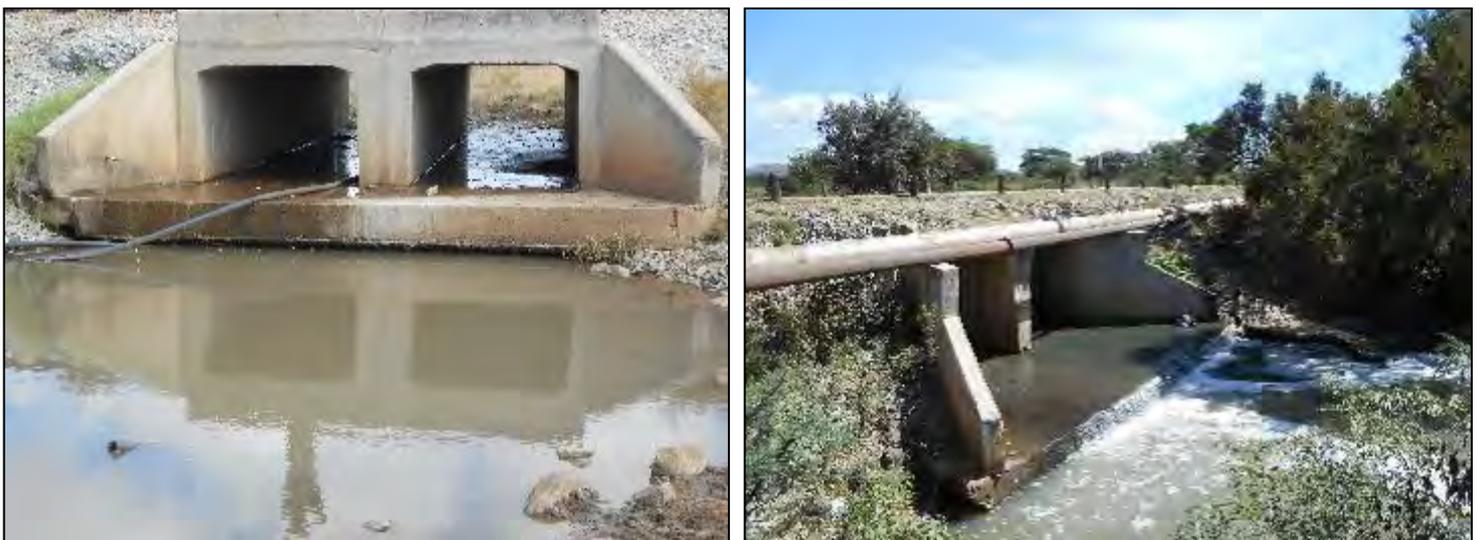
Figure 71: Culvert Bridge indicating elevation drops at biomonitoring sites.

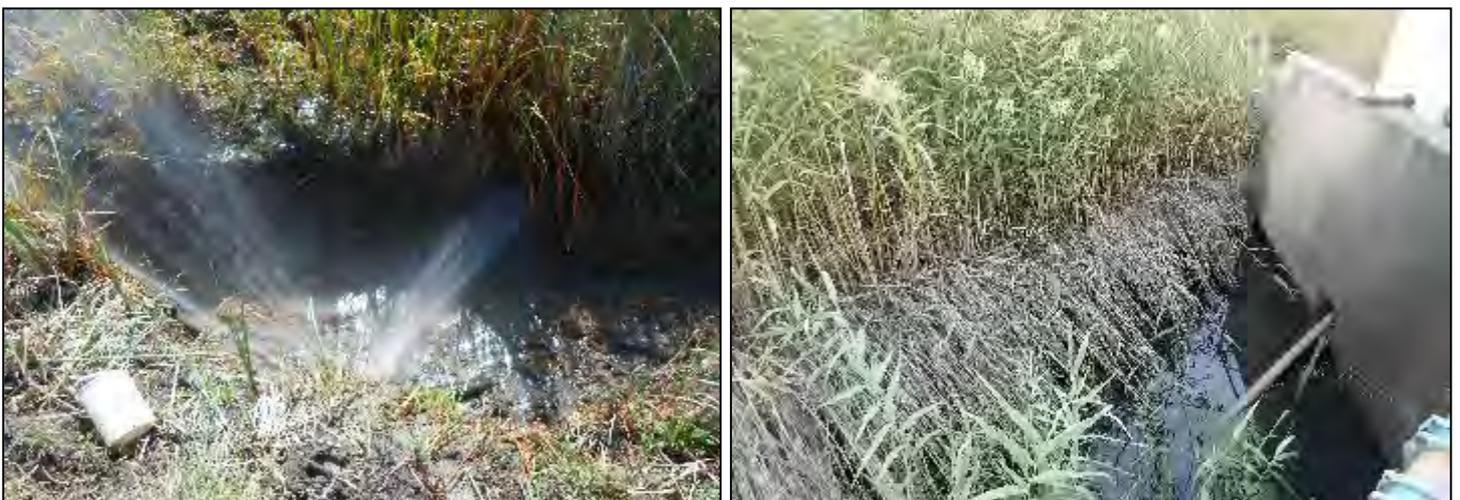
Figure 73: Leaking pipes within the RPM operations boundary.

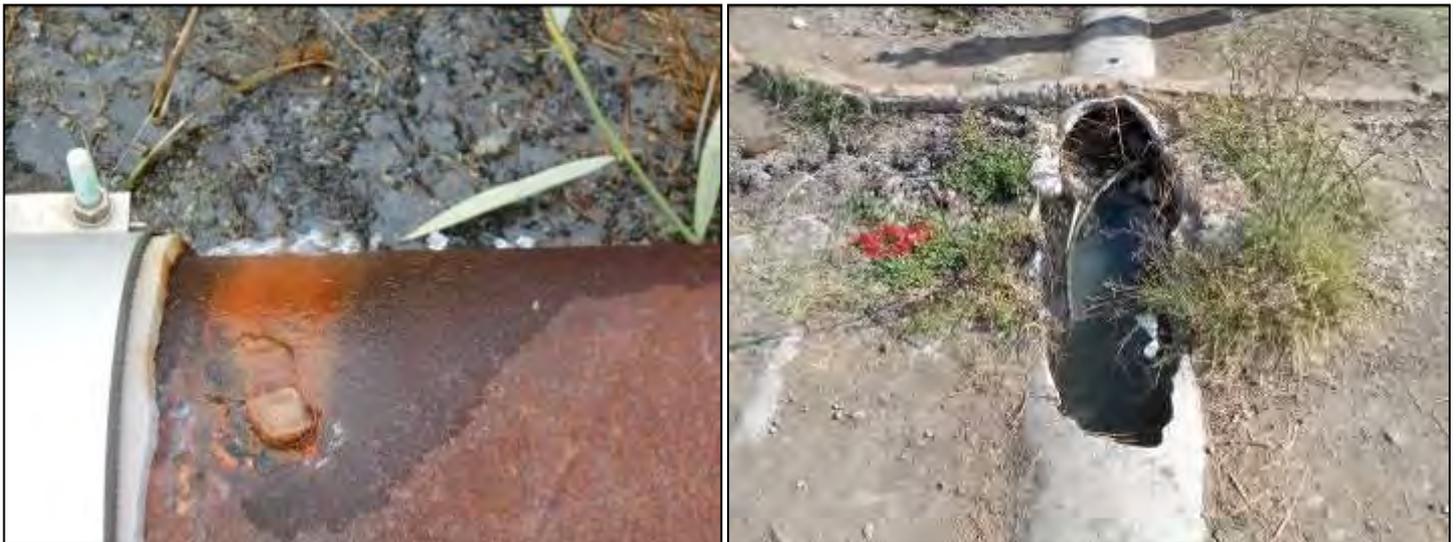
Figure 74: Leaking pipes within the RPM operations boundary and broken pipes within the rural residential area.
