Slope failure at the Paraná shoreline, Argentina

Alejo O. Sfriso

Juan Larrague

A 80000 m², 3.5 m high embankment for a container yard was constructed on the right margin of the Paraná de las Palmas River in Zárate, Argentina. An additional temporary embankment, 3.5 m high, was put on top of it to speed up the consolidation process of underlying soft Postpampeano clays and organic soils. The construction of the preload embankment took about four months. The preload was delayed in a small area of 6000 m² because of harbour activities. Several months later, and using the same equipment, the contractor completed the preload embankment of this small area within ten days. One day after completion of the preload, a massive slope failure occurred. In this paper, the results of the analyses of the slope failure, the remediation action undertaken and some comments on the behavior of the soils at the Paraná shoreline are presented.

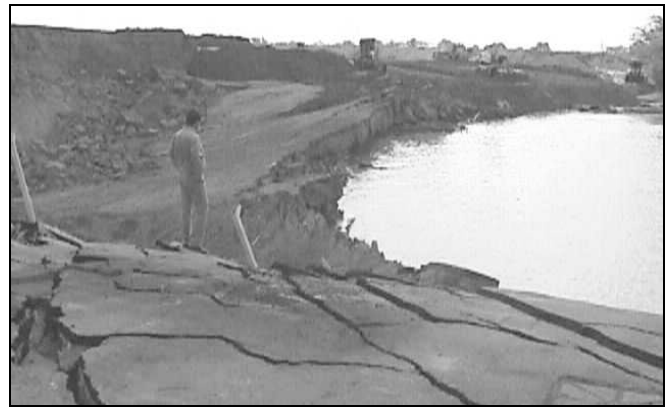
Figure 4. Sliding mass as seen from the wharf.

One day after the completion of this PE, a massive slope failure occurred. Within a few seconds a 100 m by 40 m surface settled more than 2.50 m. The recently placed preload

material, as well as the underlying permanent fill, fell into the river. The whole sliding area was flooded.

Figure 4 shows the sliding mass as seen from the wharf. The large inclination of the previously horizontal, flat surface is easily noticeable at the central left part of the picture. Fortunately, no people, equipment or any other facilities were at or near the sliding area.

- Remaining soils from the PE were removed the same day of the slope failure.
- The embankment surface immediately behind the failure area was reshaped, and a 1:1 slope surface was cut and sealed.
- Tension cracks behind the sliding mass were excavated and back filled with soil.
- The failure surface was trimmed and reshaped manually. Cracks within the failed area were carefully filled with sand and soil and sealed at surface.

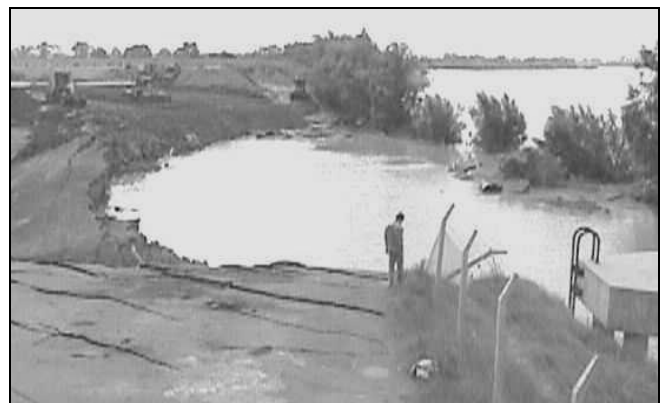
Figure 5. Coastline vegetation shifted 20 m into the river.

Figure 5 is another view from the same place, showing that the coastline vegetation moved some 20 m into the river. One of the authors is there for scaling reference.

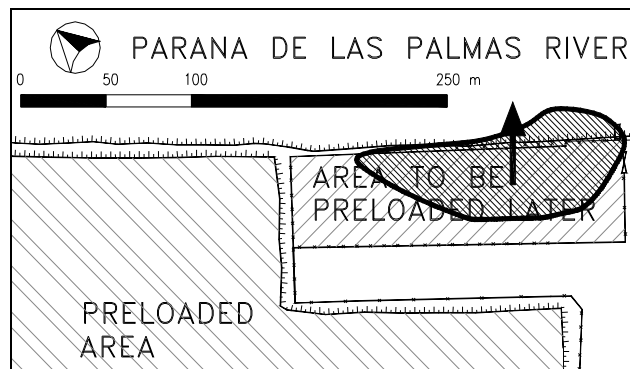
Figure 6. Sketch with sliding mass shown.

A topographic survey was conducted to evaluate the magnitude and depth of the failed soil mass. At the same time, some preliminary stability computations were performed, because there was an immediate need of a reliable undrained shear strength value of the soils at the assumed sliding surface. Figure 6 shows the sketch of the plan view and the failure area.

There was immediate agreement among the design engineers that the most probable cause of failure was a too high construction speed, because it was already known that the coastline slope was not stable under a fully undrained fill+PE surcharge. Water had been at its mean level the days before the failure occurred, so this particular source of soil overstressing was disregarded.

Therefore, the remediation program was limited to a slow placement of the fill after

compaction of the remaining materials, and a simple monitoring program to be maintained during the earthworks. No further inconveniences happened, and the embankment was completely repaired and, eventually, preloaded to the design height.

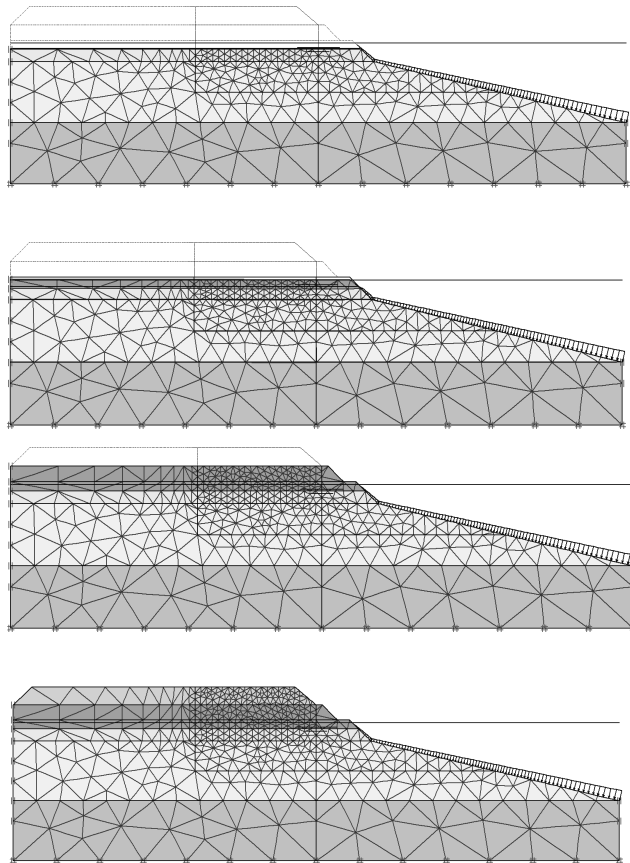
Figure 7. Mesh and construction stages.

A FE mesh with 938, fifteen node triangular elements was used. Figure 7 shows the construction stages considered.

The first construction stage is the natural shoreline, so no pore pressure build up was allowed there. Second stage is the placement of the first two meters of compacted fill, which happened long time before this project started, and was also modeled as a drained stage. Third stage is the placement of the permanent fill and the fourth stage is the placement of the preload embankment.

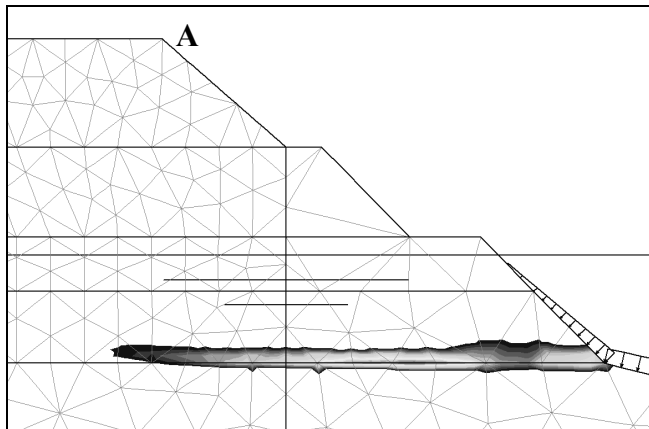
Figure 8. Strain increments at the onset of failure. Undrained analysis.

The partially consolidated model yielded no failure, whereas the fully undrained model failed at about 40%-60% of the full preload stage.

Onset of failure was not a slope stability problem but the squeeze of a very soft plastic layer, as shown in Figure 8, where only strain increments above mean value were plotted. This plot shows which portions of the model are increasing their velocity without control, and thus suggests where failure starts from.

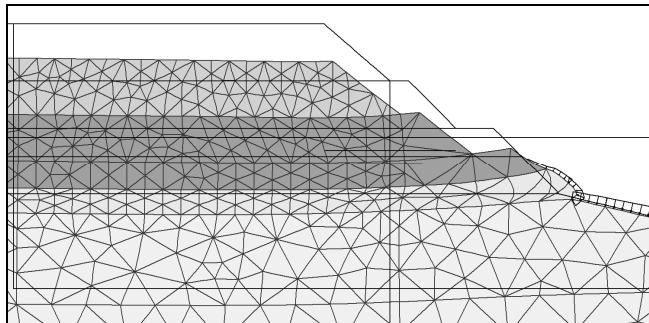
Figure 9. Settlements in partially drained analysis. Máx settlement is 1.25 m.

Figure 9 shows the deformed mesh of the second model. A 1.20 m max. settlement was achieved but movements eventually ceased, in a similar performance to that of reality.

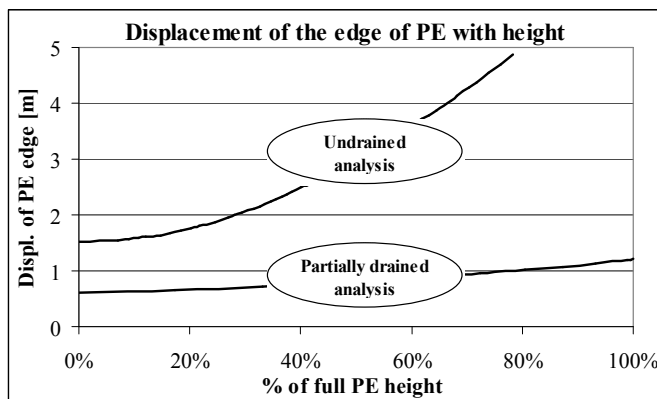
Figure 10. Displacement of the edge of PE during placement of the preload.

Figure 10 shows the displacement of the edge of the preload embankment, marked as “A” in Figure 8. It can be seen that total settlement for the partially drained model is 1.20 m, and that it’s behaviour is stable, whereas the undrained analysis began to fail at about 40% of the full PE load.
