Skoenmakers River Maintenance

River rehabilitation

DRAFT REPORT Rev 1

June 2015

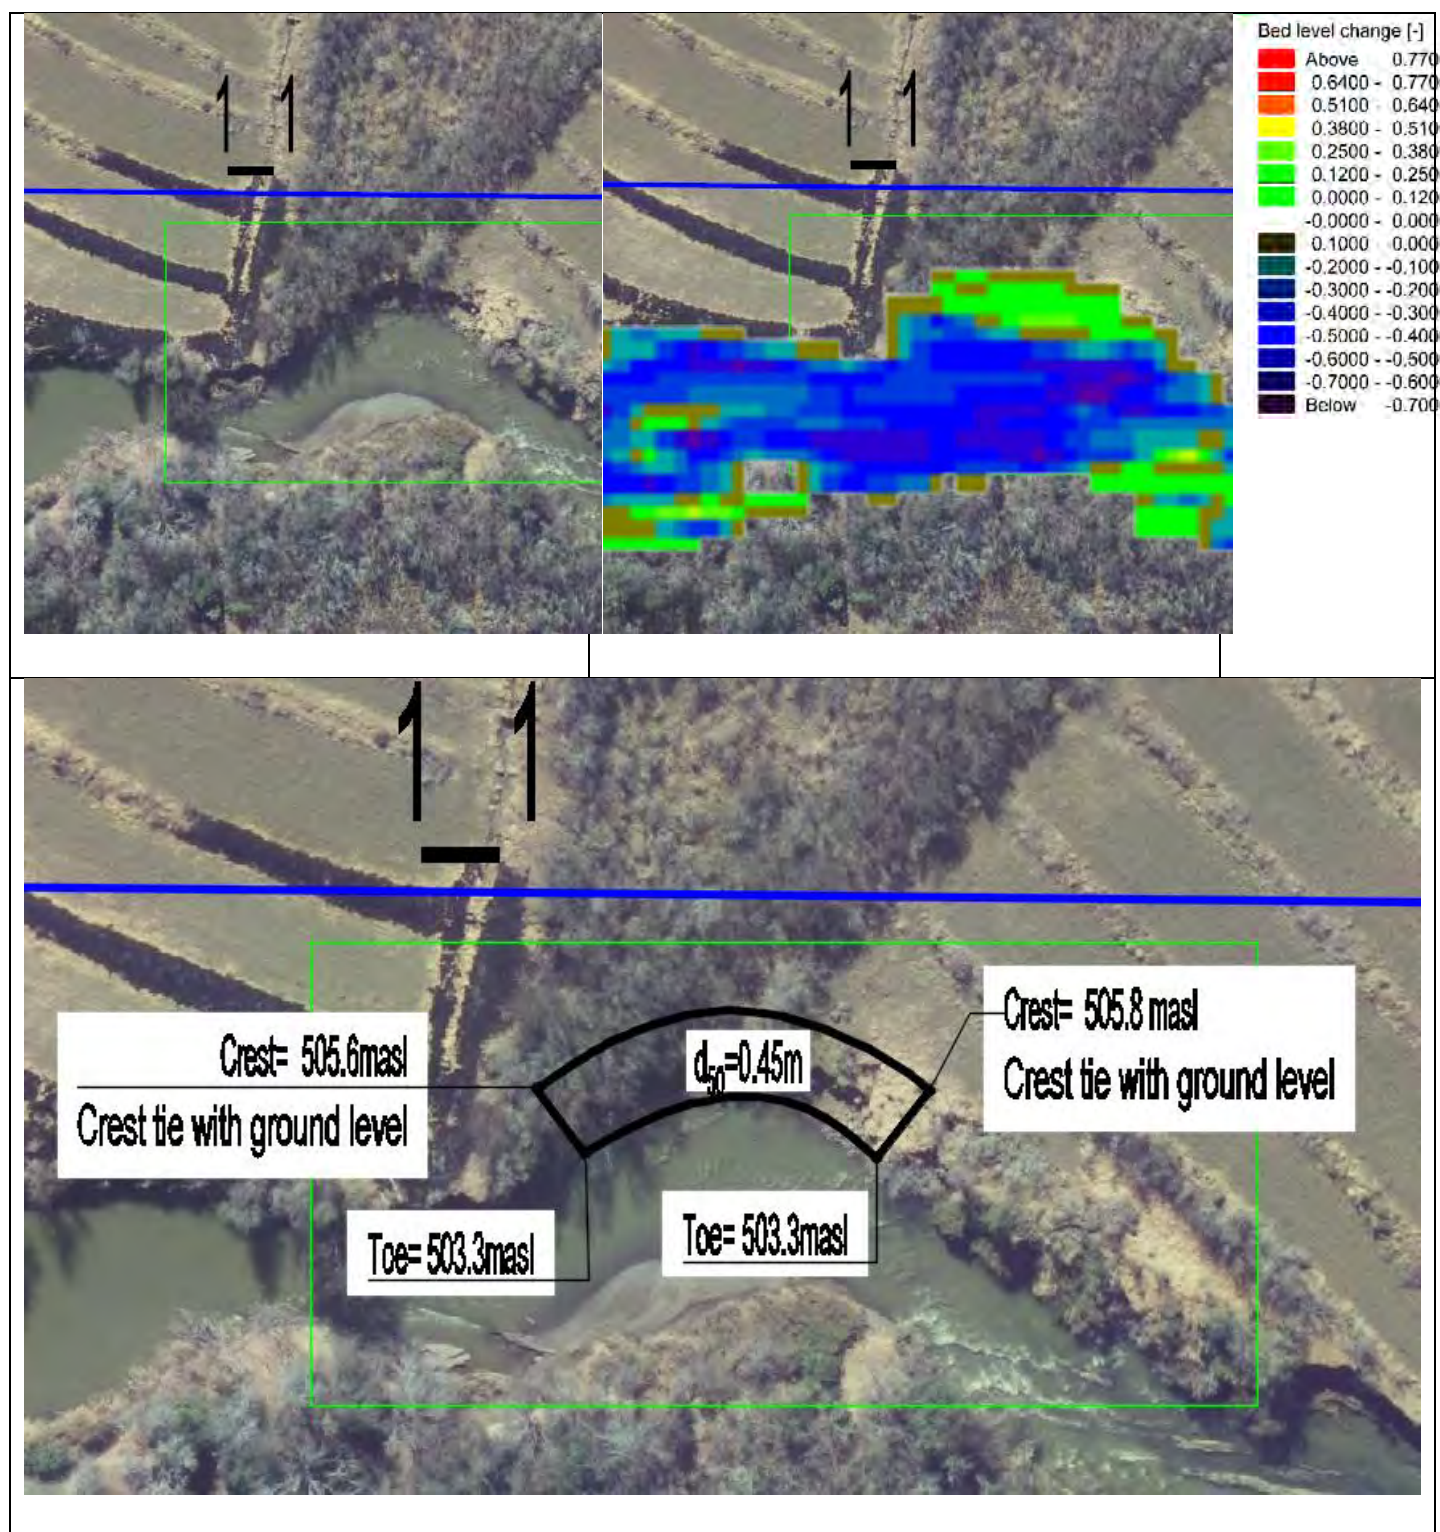
Appendix 2: Zone 1_1 Q10 flood peak scour pattern and proposed scour protection

This area is within the servitude and has unstable banks encroaching farmland. Riprap $d_{50} = 0.45$ m was found to be appropriate. A typical layout and elevations are shown in Appendix 2.

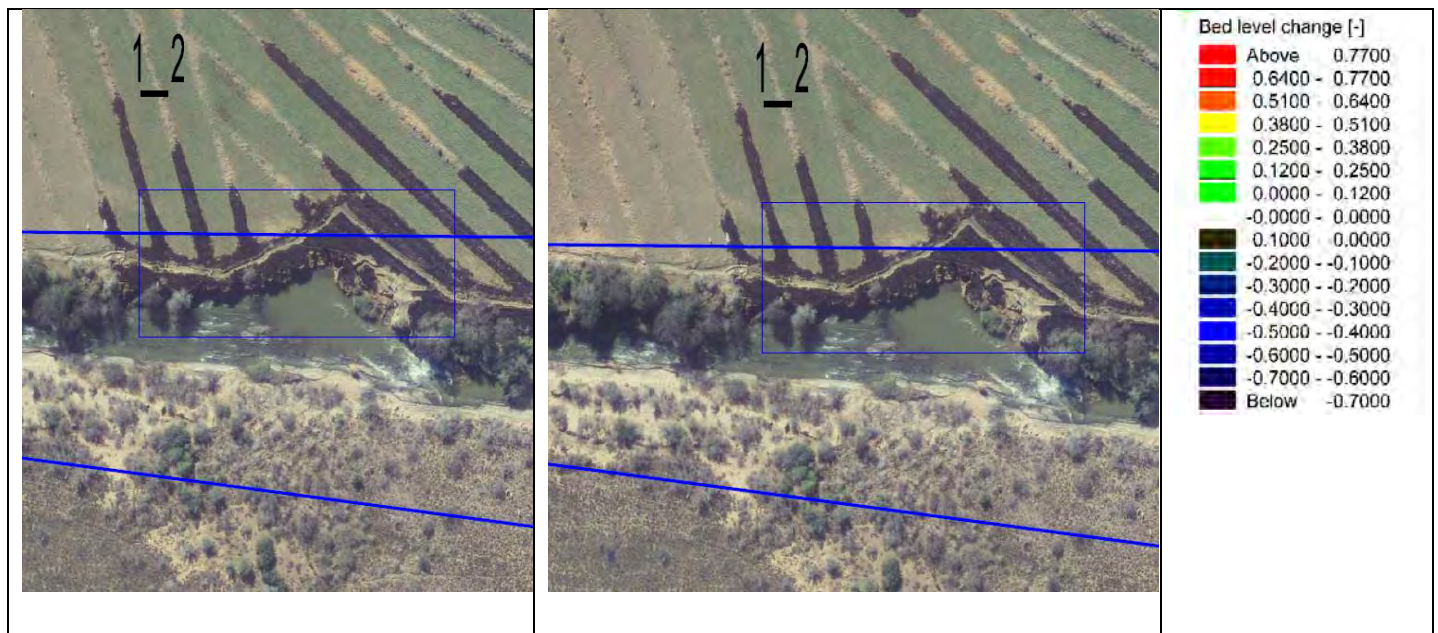
Appendix 3: Zone 1_2 Q10 flood peak scour pattern

This area is within the servitude and has unstable banks. Due to the bedrock at the location, the banks do not need protection and the servitude seems incorrect. This zone is shown in Appendix 3.

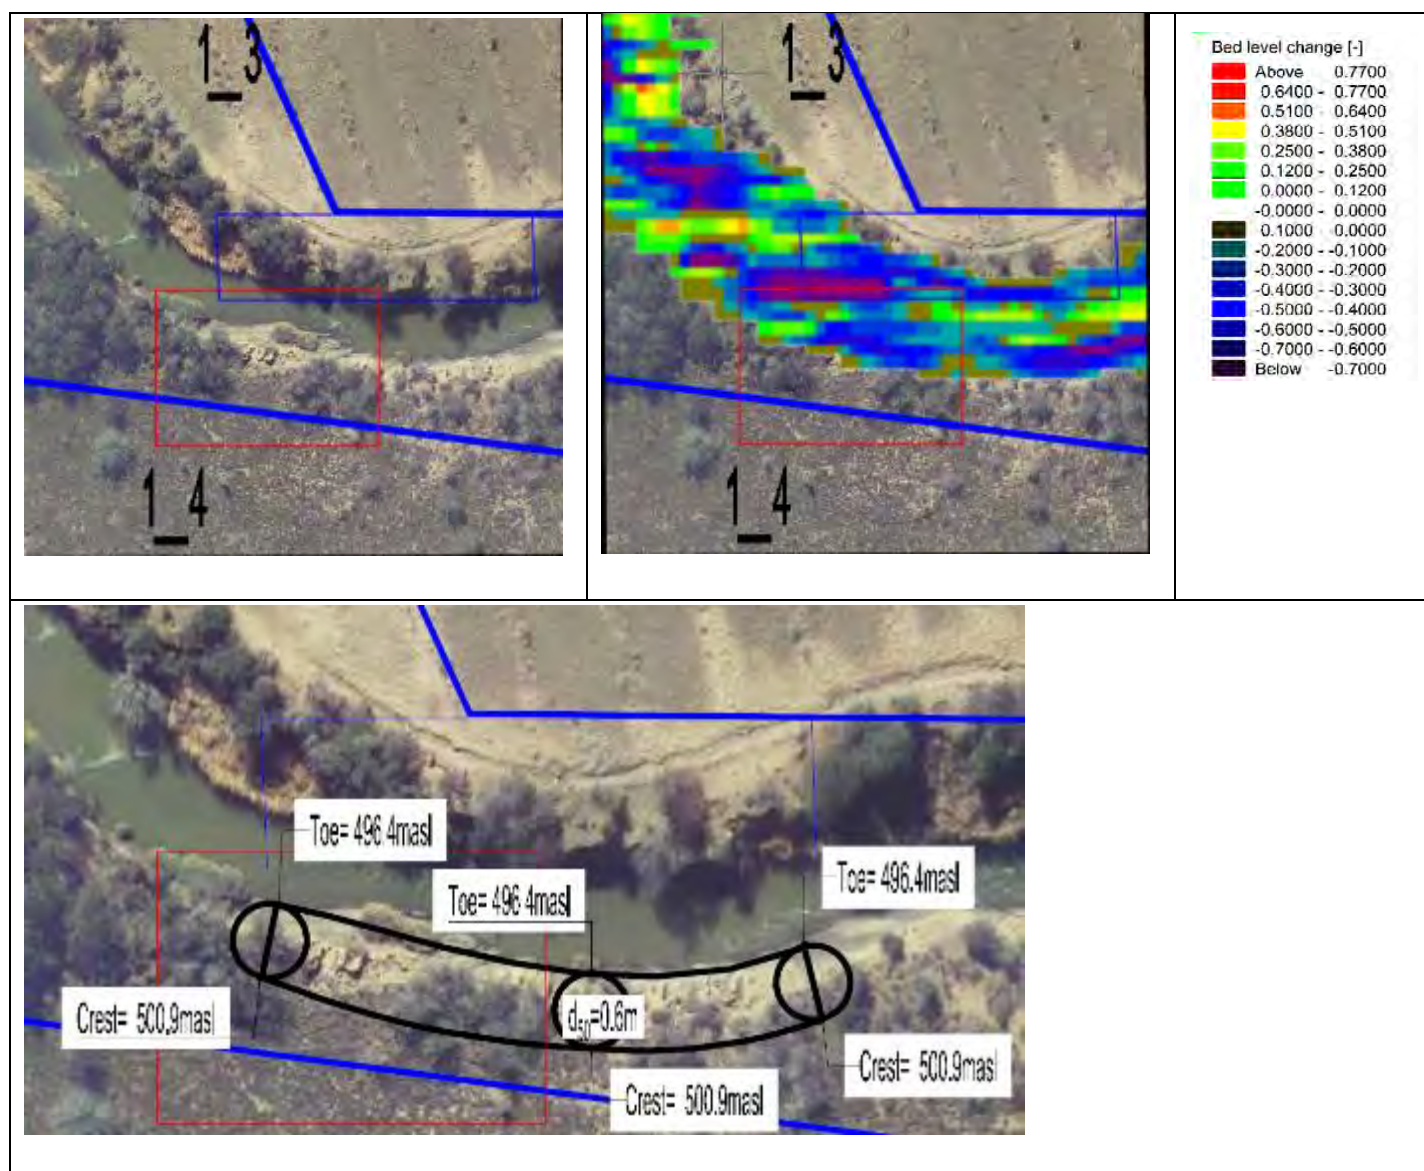
Appendix 4: Zone 1_3 and 1_4 Q10 flood peak scour pattern and proposed scour protection

This area is within the servitude and protection does not seem necessary. A typical layout is shown in Appendix 4.

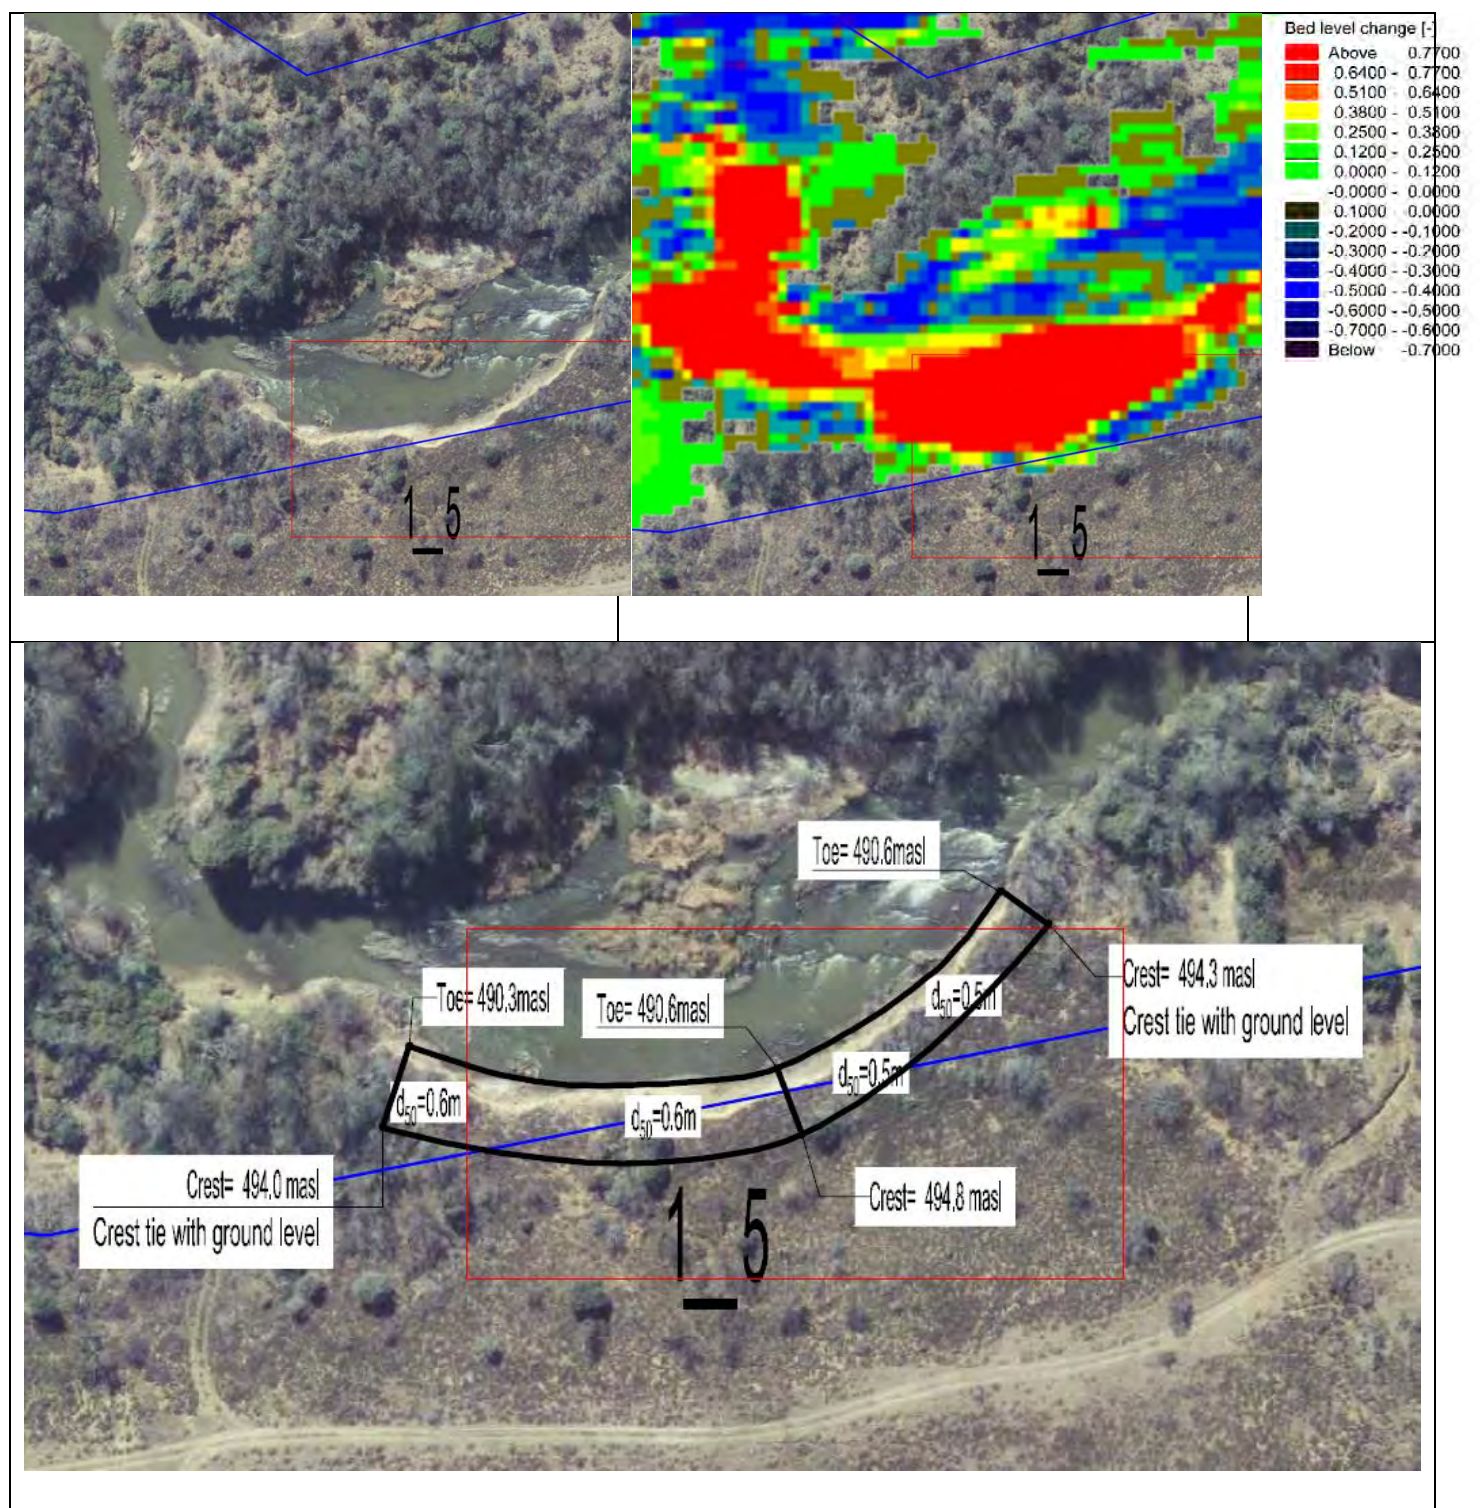
Appendix 5: Zone 1_5 Q10 flood peak scour pattern and proposed scour protection

This area is within the servitude and has unstable banks encroaching a road. $d_{50} = 0.5$ to $d_{50} = 0.6$ m was found to be appropriate. A typical layout and elevations are shown in Appendix 5.

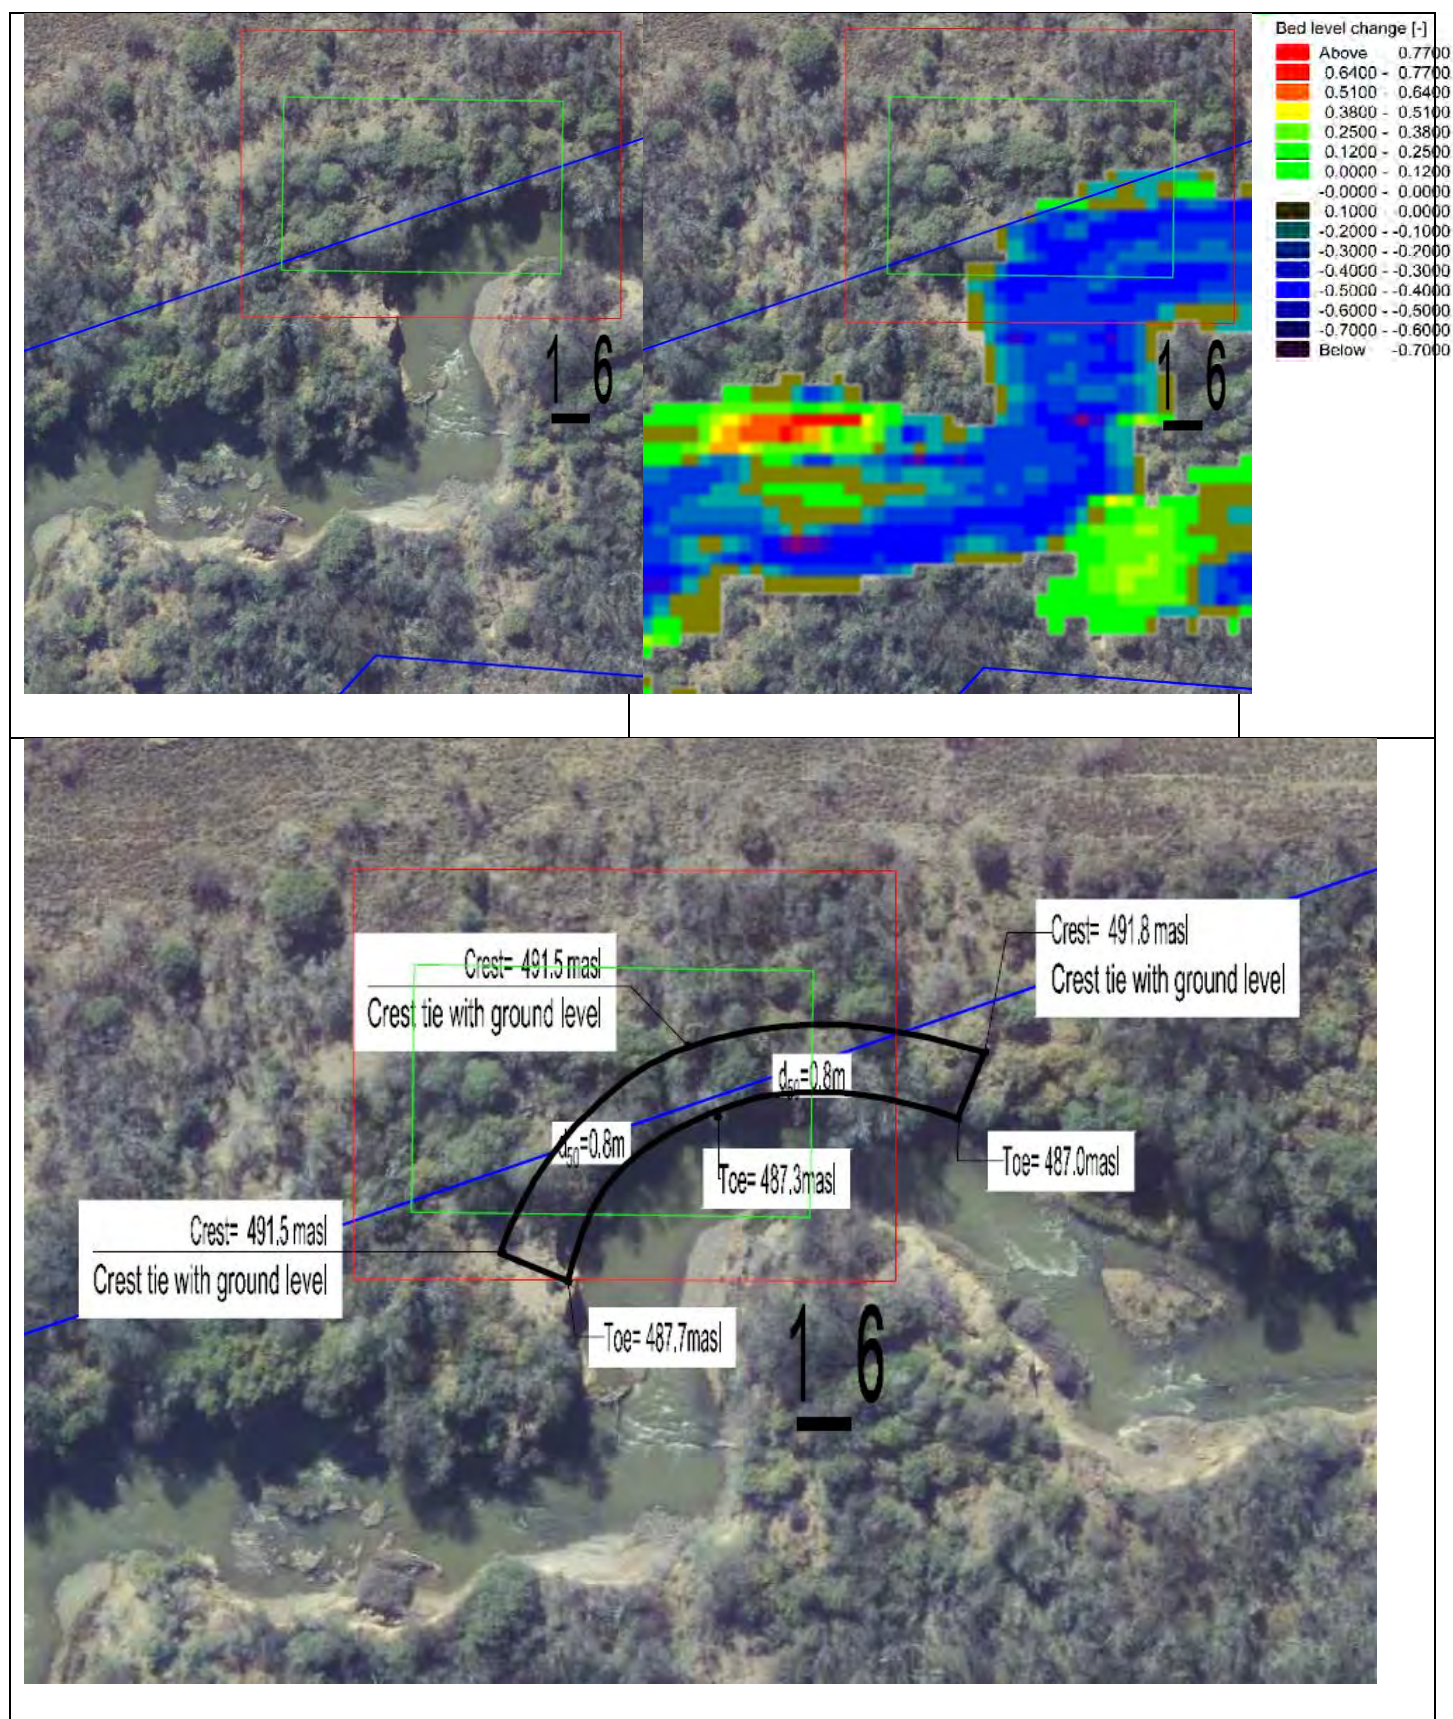
Appendix 6: Zone 1_6 Q10 flood peak scour pattern and proposed scour protection

This area has unstable banks crossing the servitude. $d_{50} = 0.8$ m was found to be appropriate. A typical layout and elevations are shown in Appendix 6.

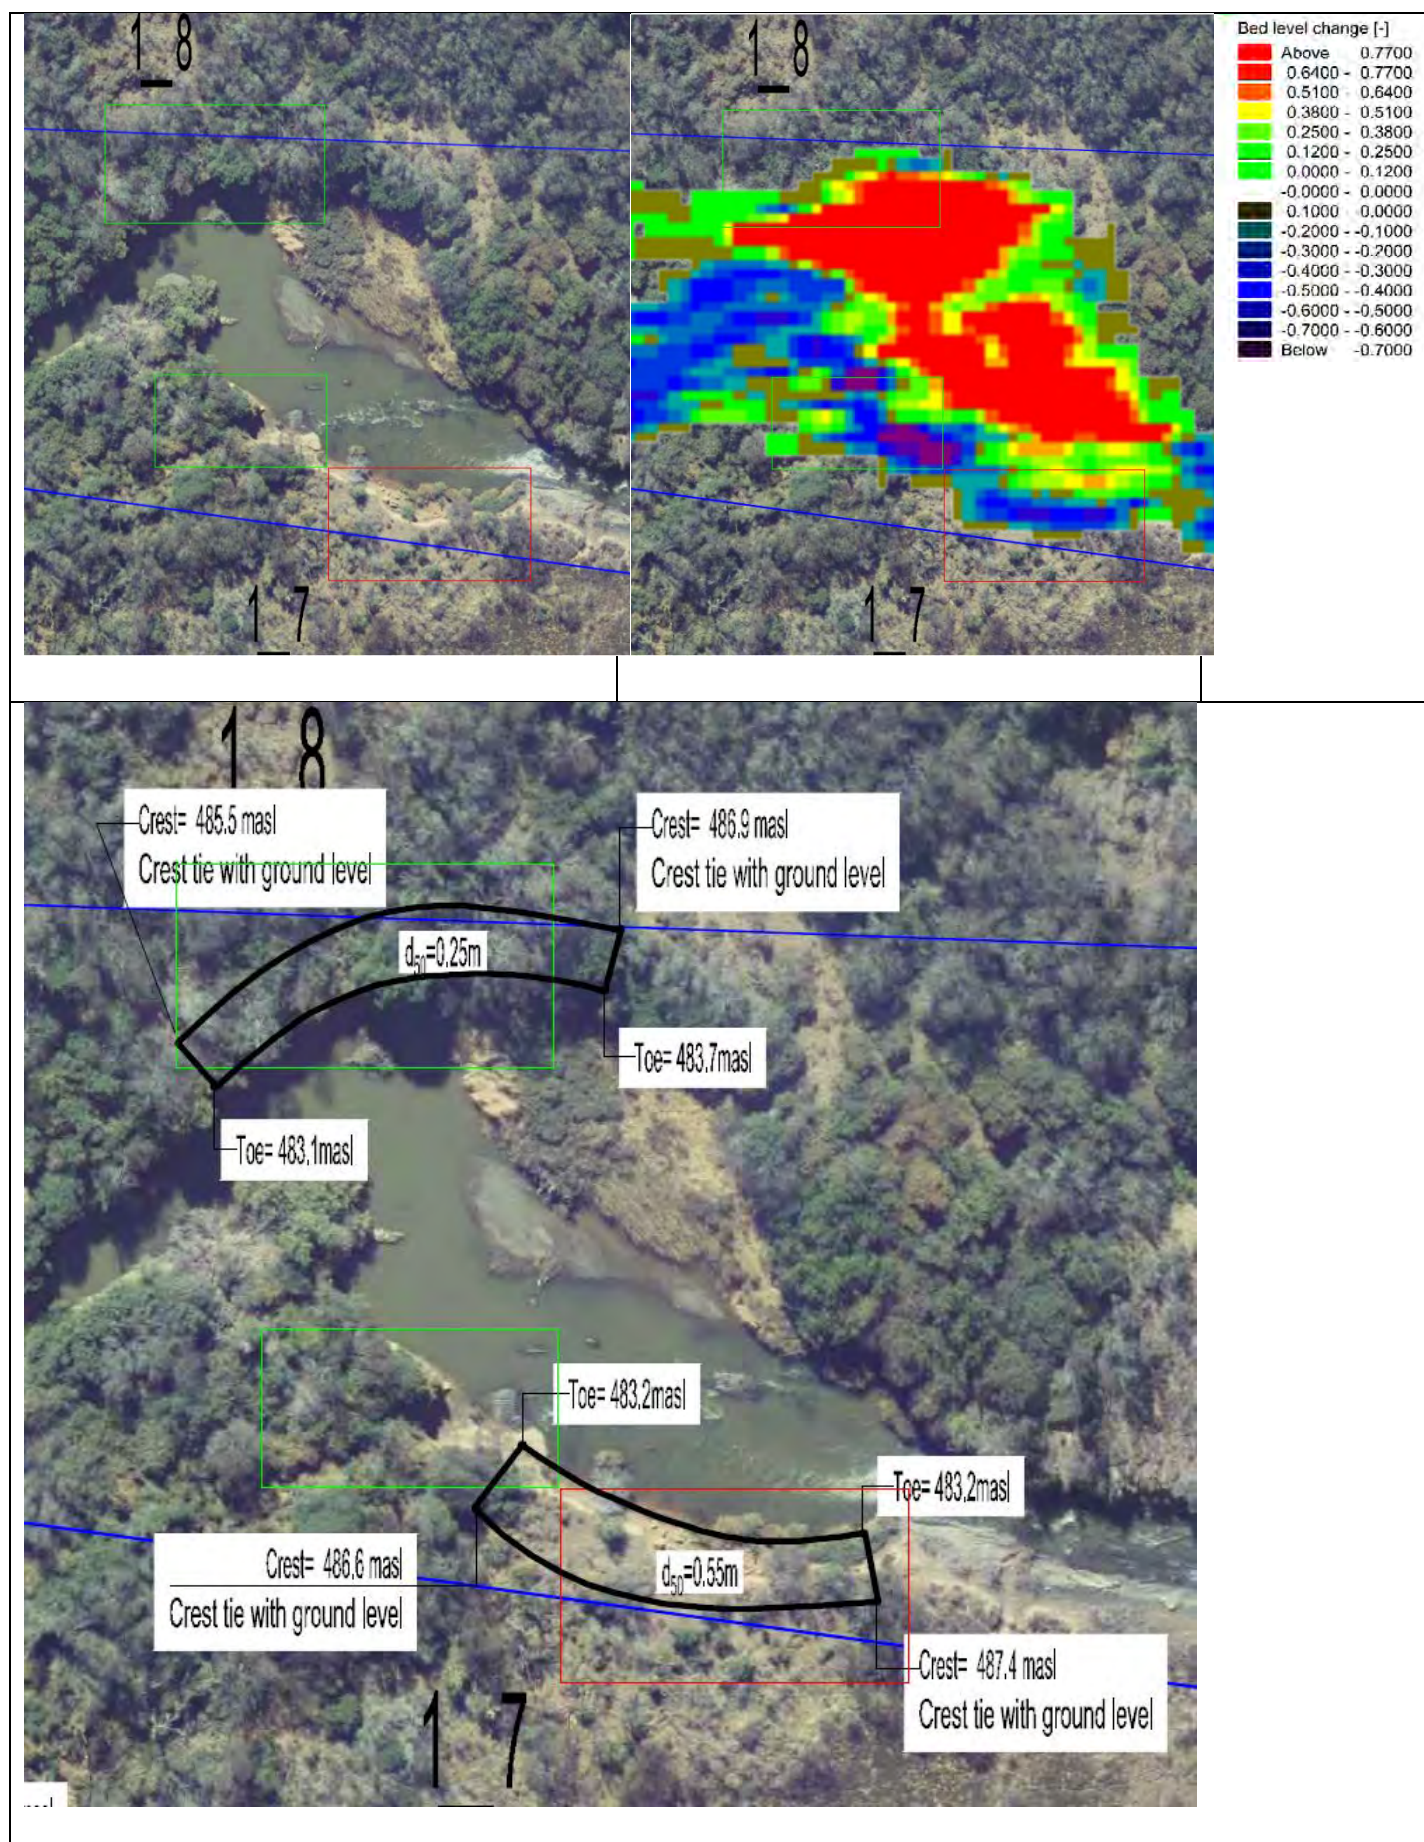
Appendix 7: Zone 1_7 and 1_8 Q10 flood peak scour pattern and proposed scour protection

This area are within the servitude but encroaching the servitude. $d_{50} = 0.55$ m was found to be appropriate. A typical layout and elevations are shown in Appendix 7.

This area has banks partially crossing the servitude. $d_{50} = 0.25$ m was found to be appropriate. A typical layout and elevations are shown in Appendix 7.

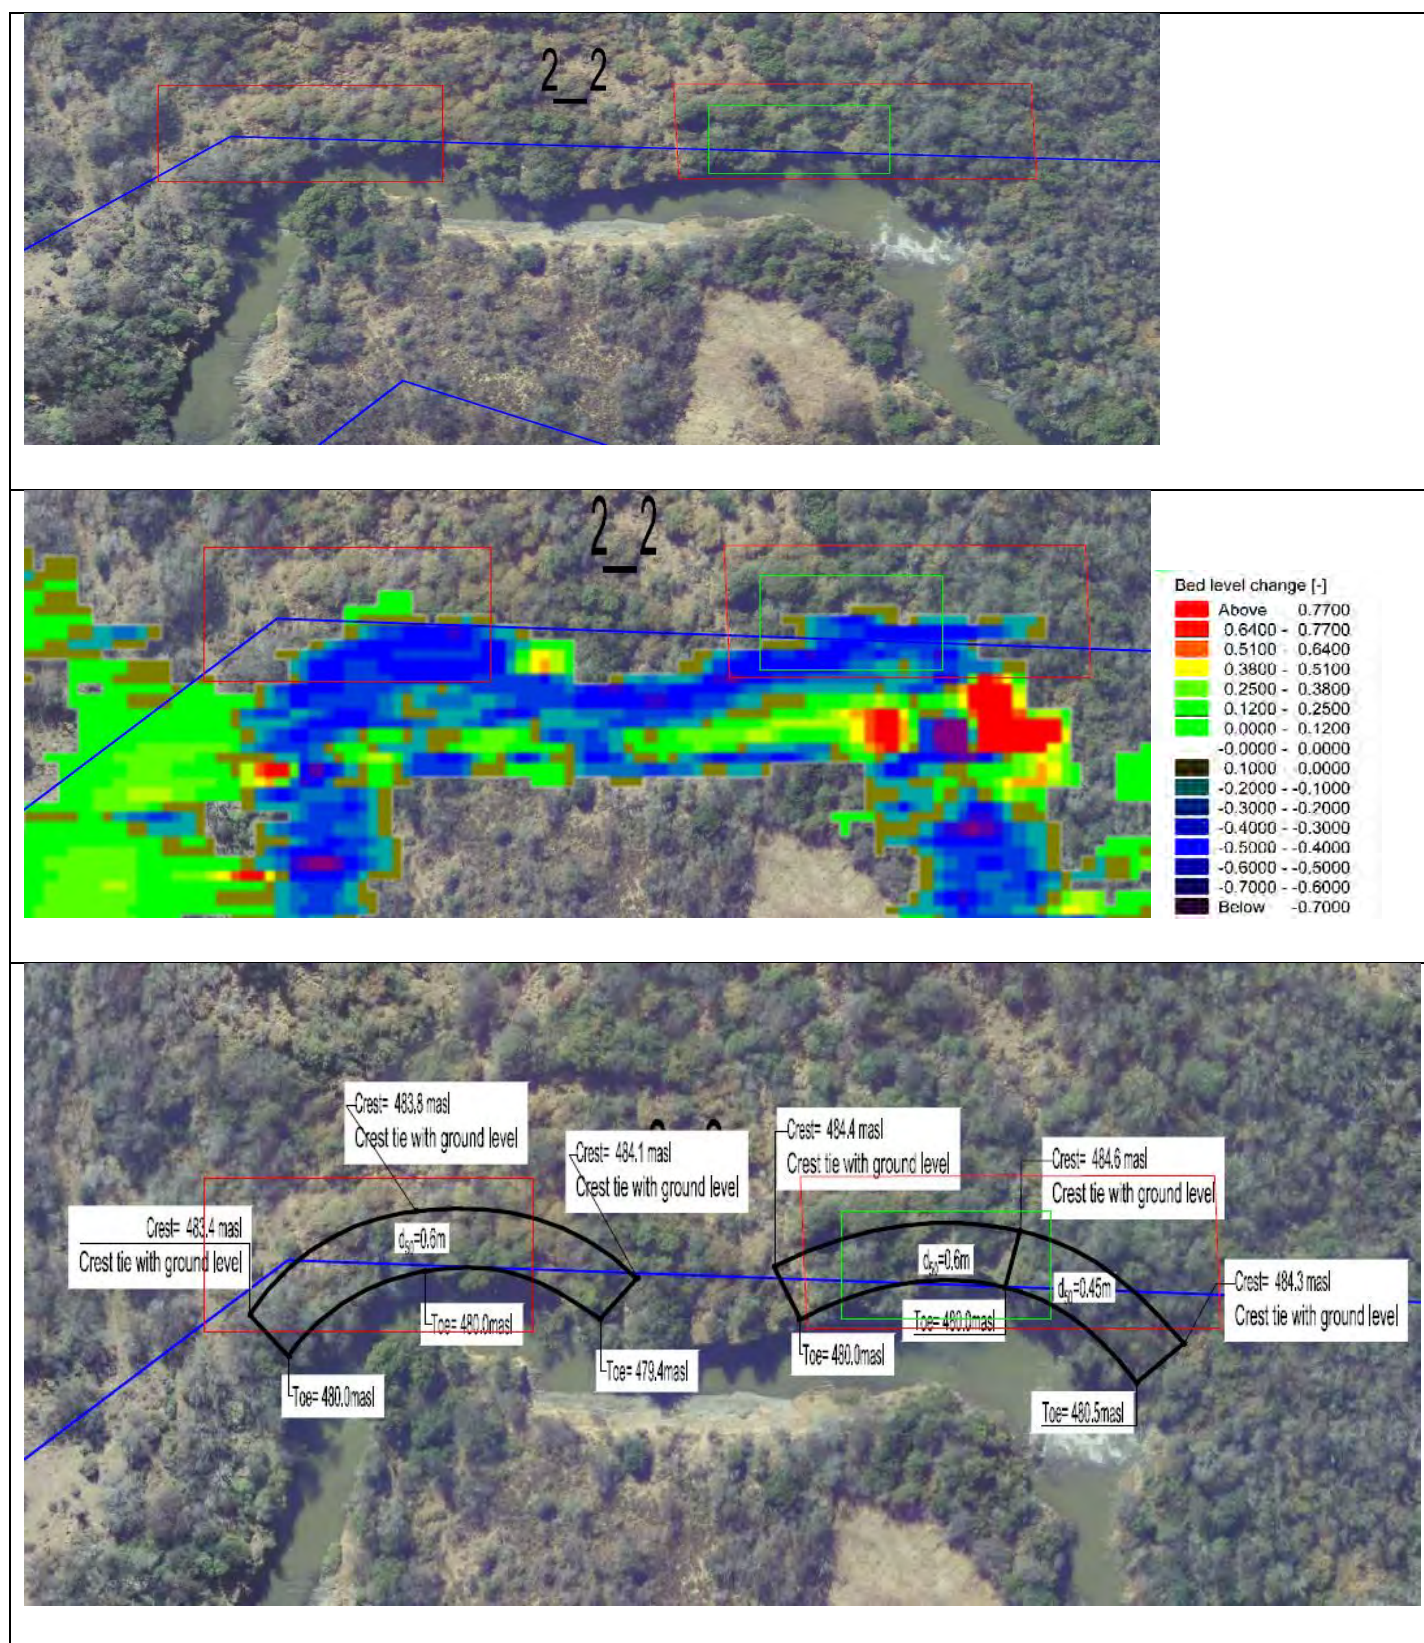
Appendix 10: Zone 2_2 Q10 flood peak scour pattern and proposed scour protection

This area has unstable banks crossing the servitude. $d_{50} = 0.45$ m and $d_{50} = 0.6$ m was found to be appropriate. A typical layout and elevations are shown in Appendix 10.

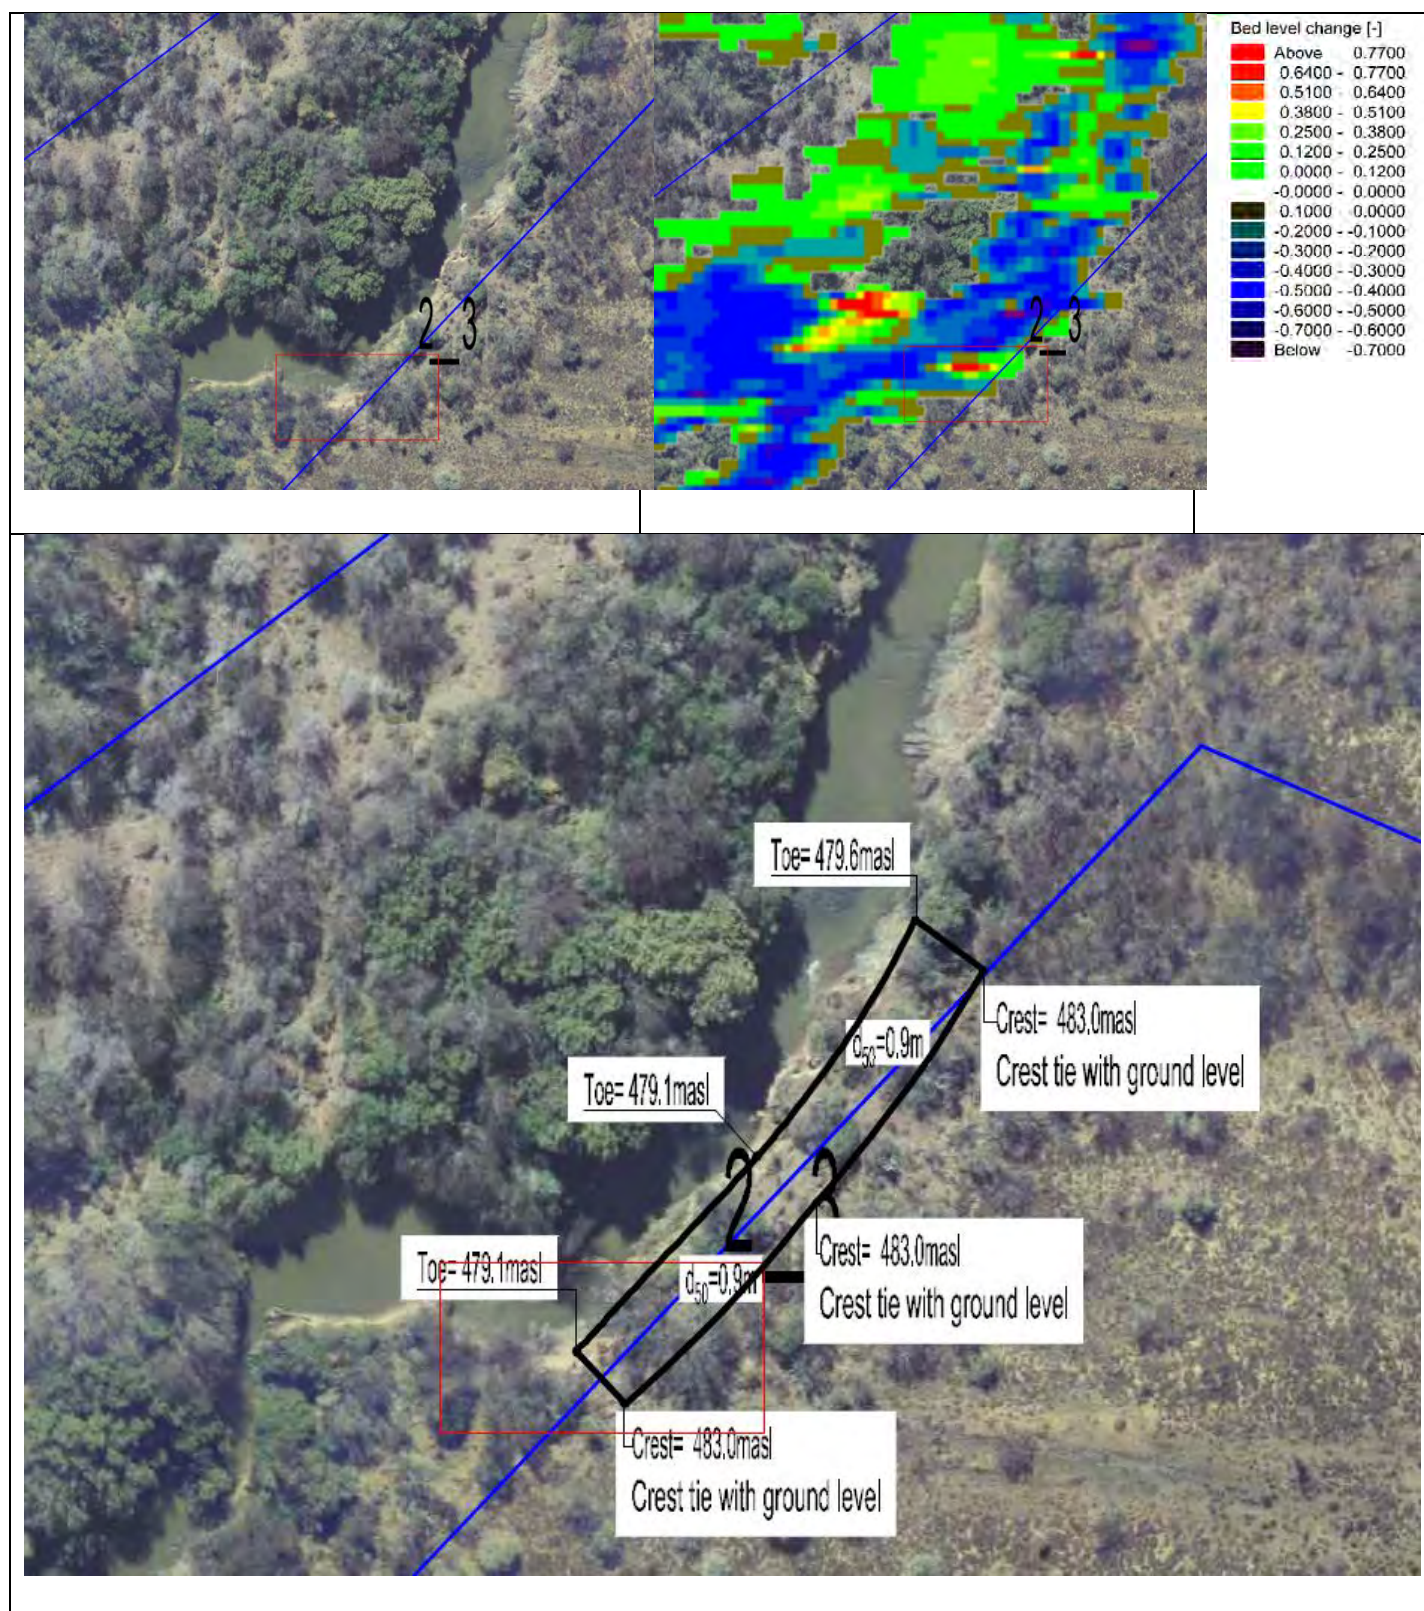
Appendix 11: Zone 2_3 Q10 flood peak scour pattern and proposed scour protection

This area has unstable banks are encroaching on the servitude. $d_{50} = 0.9$ m was found to be appropriate. A typical layout and elevations are shown in Appendix 11.

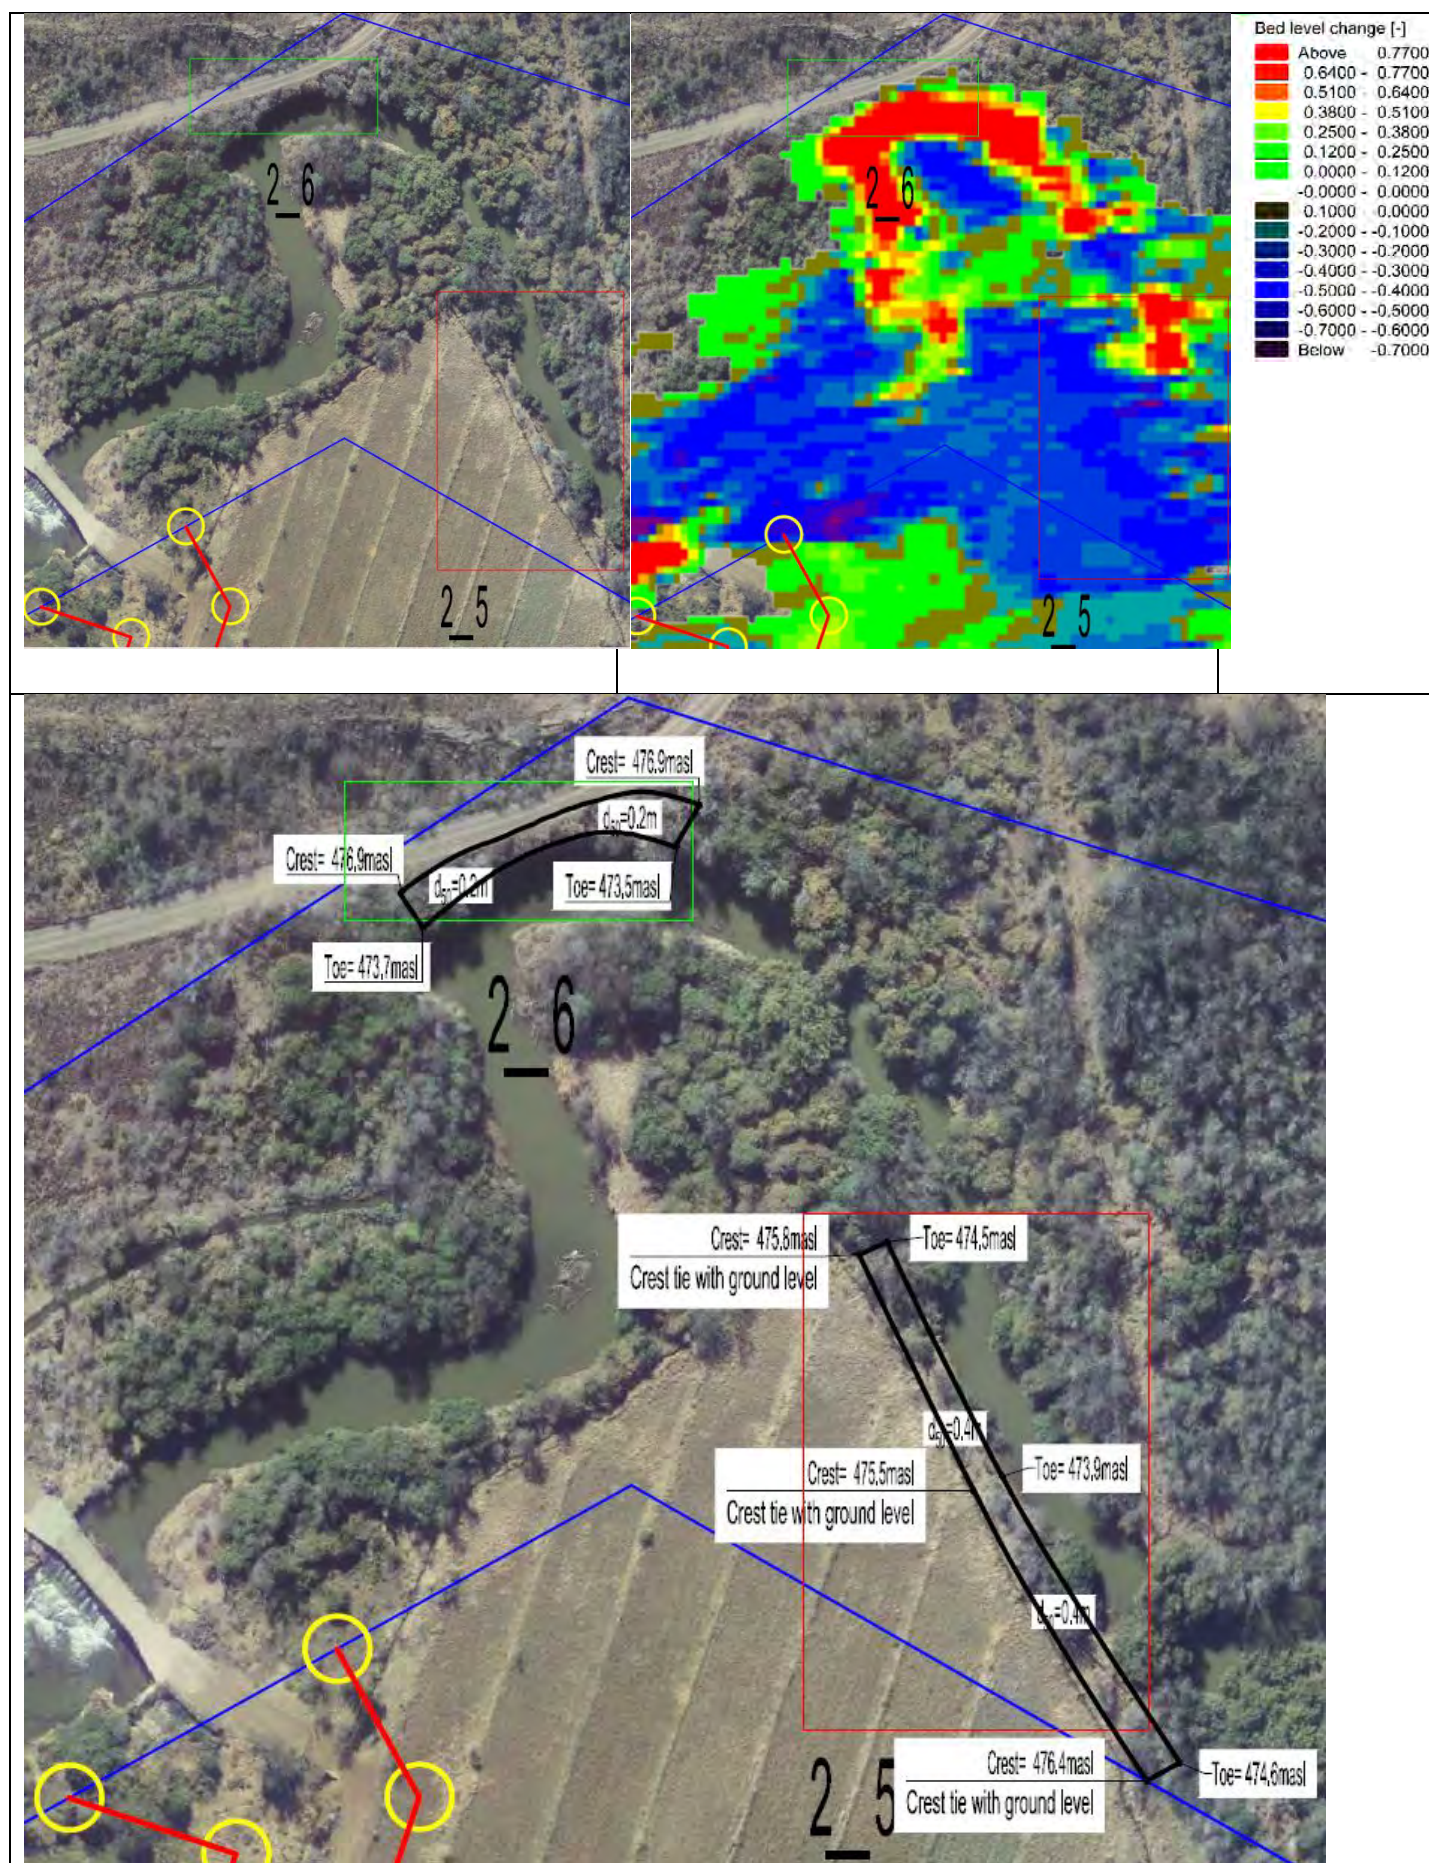
Appendix 13: Zone 2_5 and 2_6 Q10 flood peak scour pattern and proposed scour protection

This area is within the servitude but encroaches farmland that is within the servitude. $d_{50} = 0.4$ m was found to be appropriate. A typical layout and elevations are shown in Appendix 13.

This area is within the servitude but has unstable banks that encroach a road. $d_{50} = 0.2$ m was found to be appropriate. A typical layout and elevations are shown in Appendix 13.

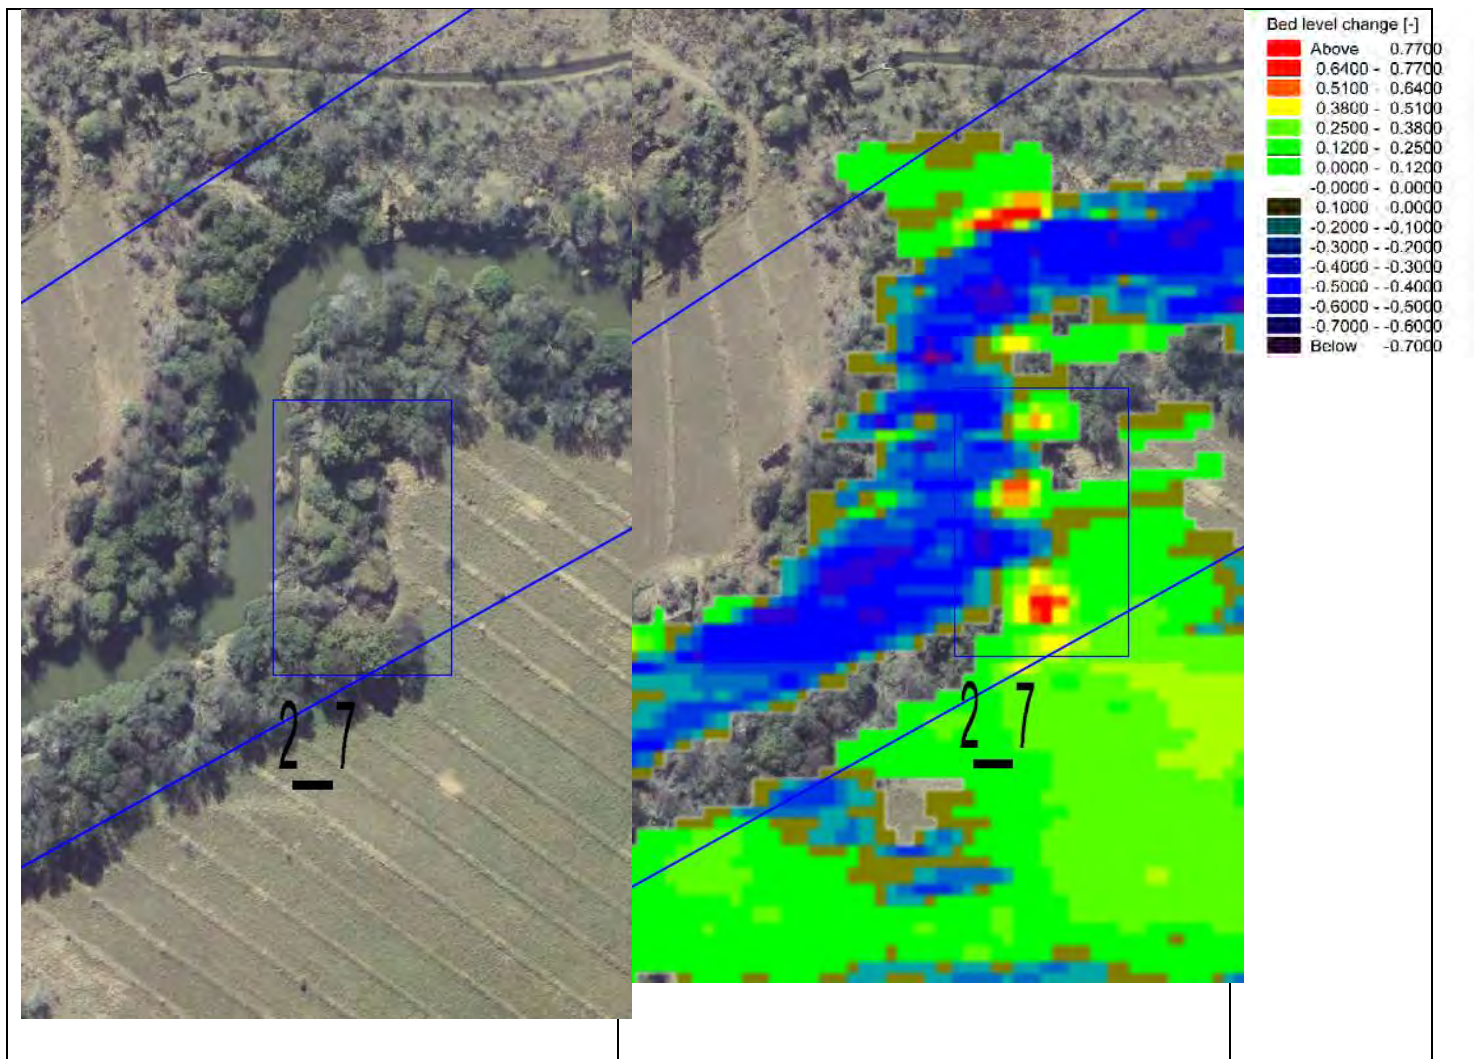
Appendix 14: Zone 2_7 Q10 flood peak scour pattern

This area is within the servitude but encroaches farmland that is within the servitude. Protection does not seem necessary. A typical layout and elevations are shown in Appendix 14.
