Skoenmakers River Maintenance

River rehabilitation

DRAFT REPORT Rev 1

June 2015

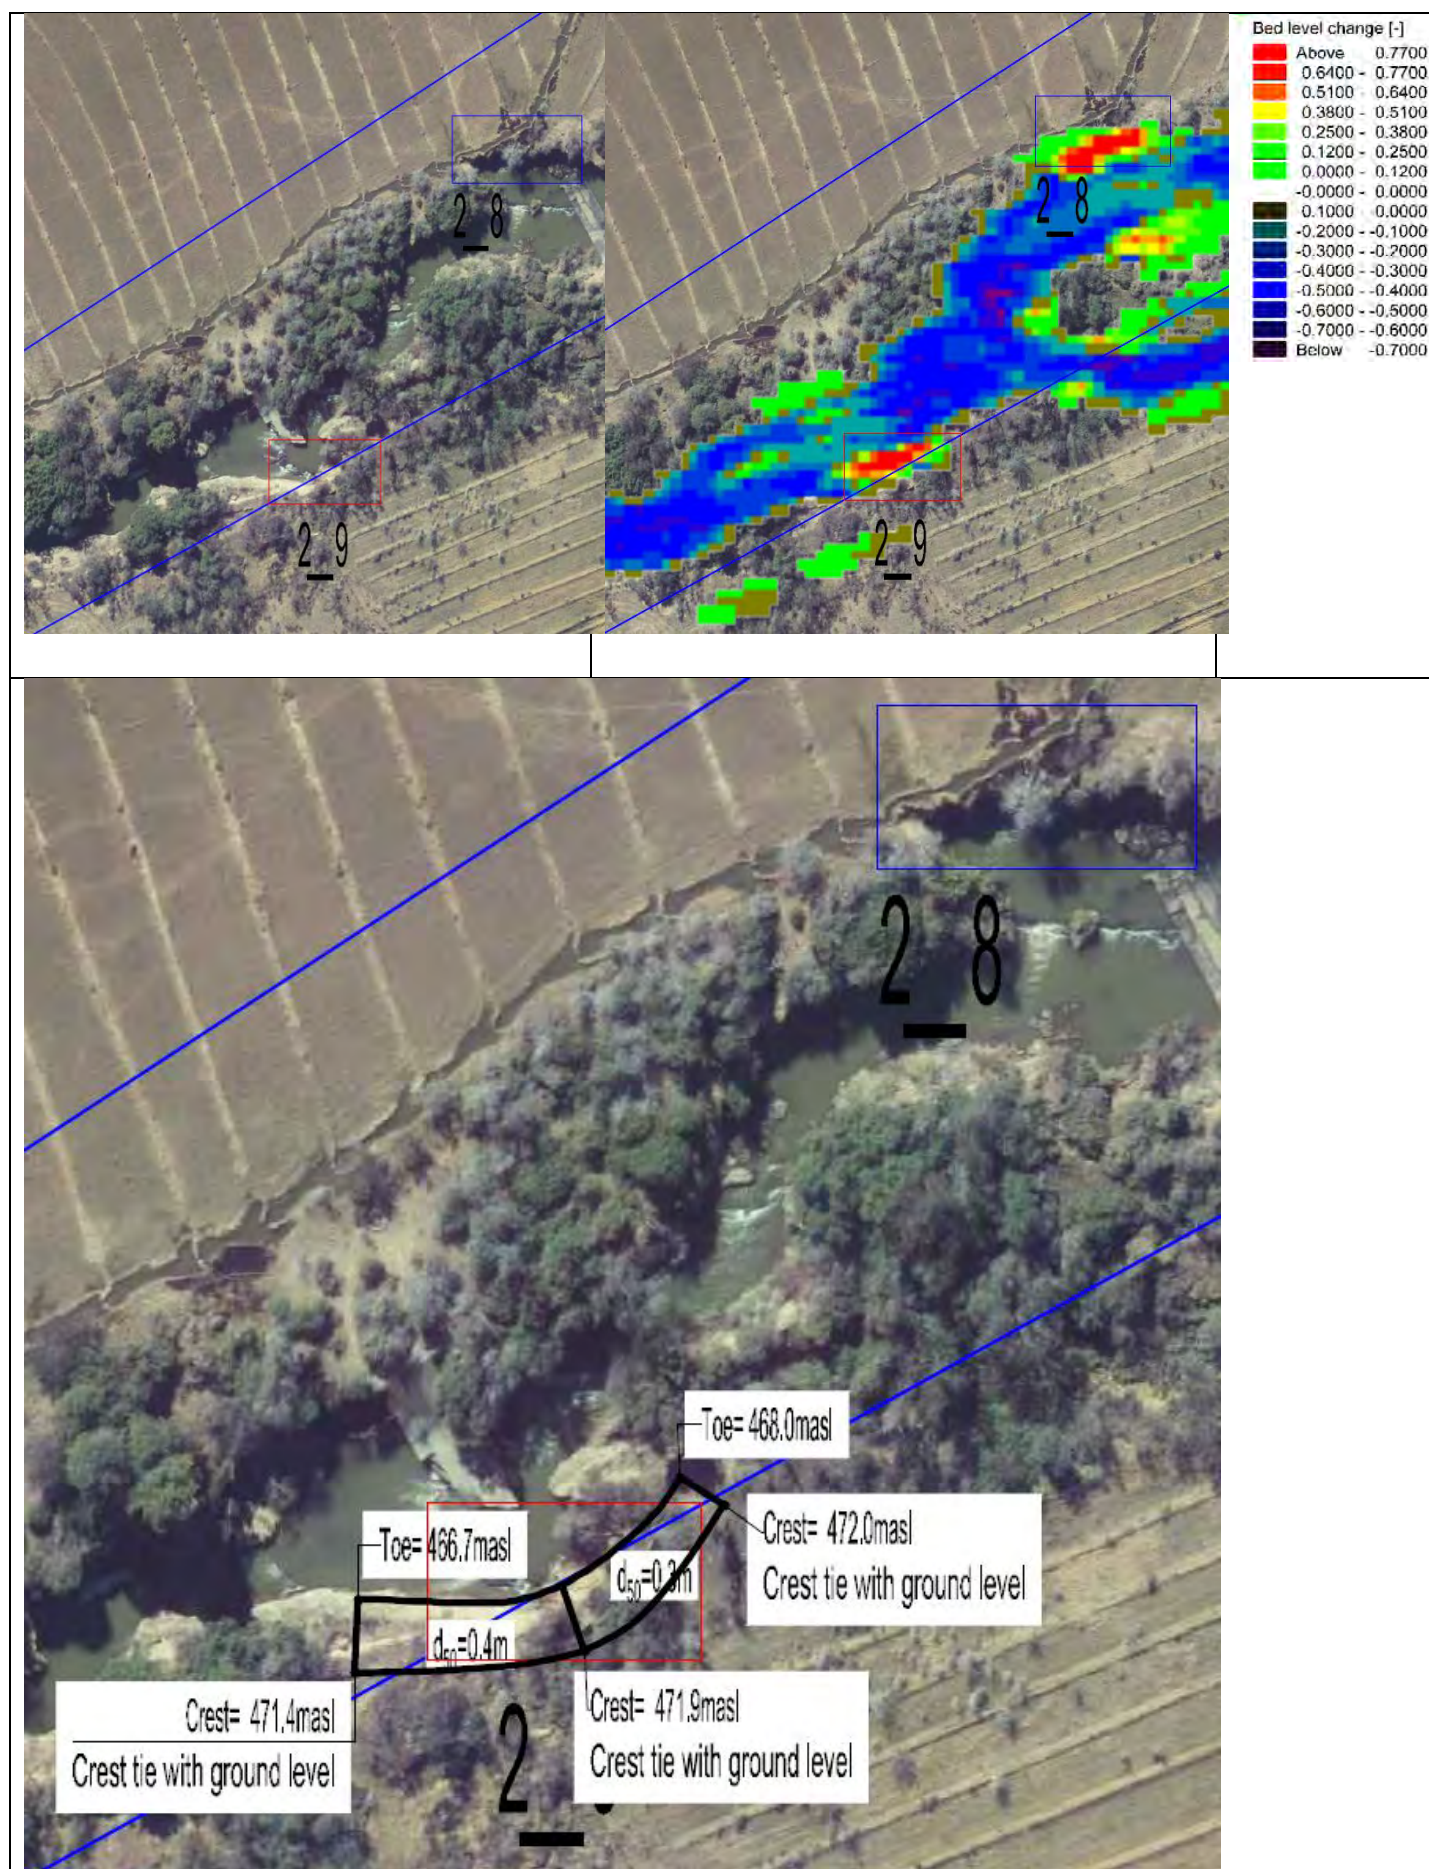
Appendix 15: Zone 2_8 and 2_9 Q10 flood peak scour pattern and proposed scour protection

The banks are encroaching the servitude and farmland. $d_{50} = 0.3$ m and $d_{50} = 0.4$ m were found appropriate. This area is shown in Appendix 15.

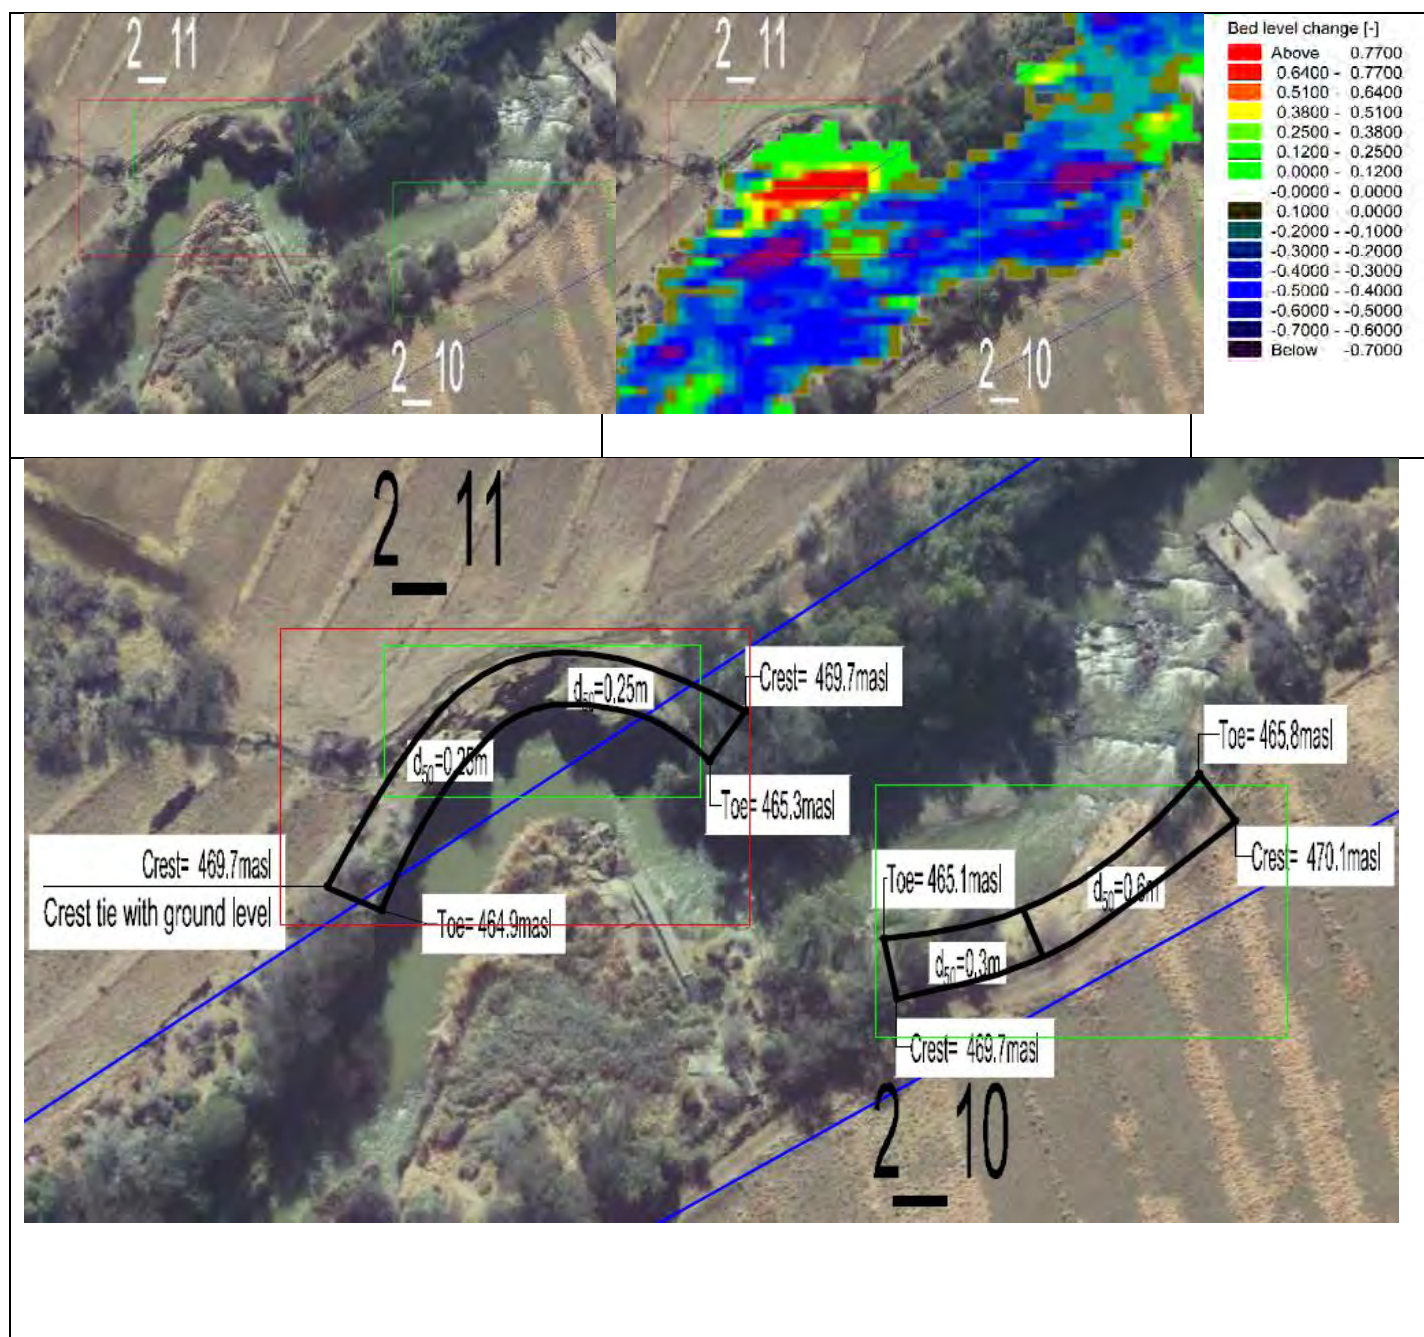
Appendix 16: Zone 2_10 and 2_11 Q10 flood peak scour pattern and proposed scour protection

The banks are encroaching the road but within the servitude. $d_{50} = 0.3$ m and $d_{50} = 0.6$ m were found appropriate. This area is shown in Appendix 16.

The unstable banks are crossing the servitude and encroaching onto farmland. $d_{50} = 0.25$ m was found appropriate. This area is shown in Appendix 16.

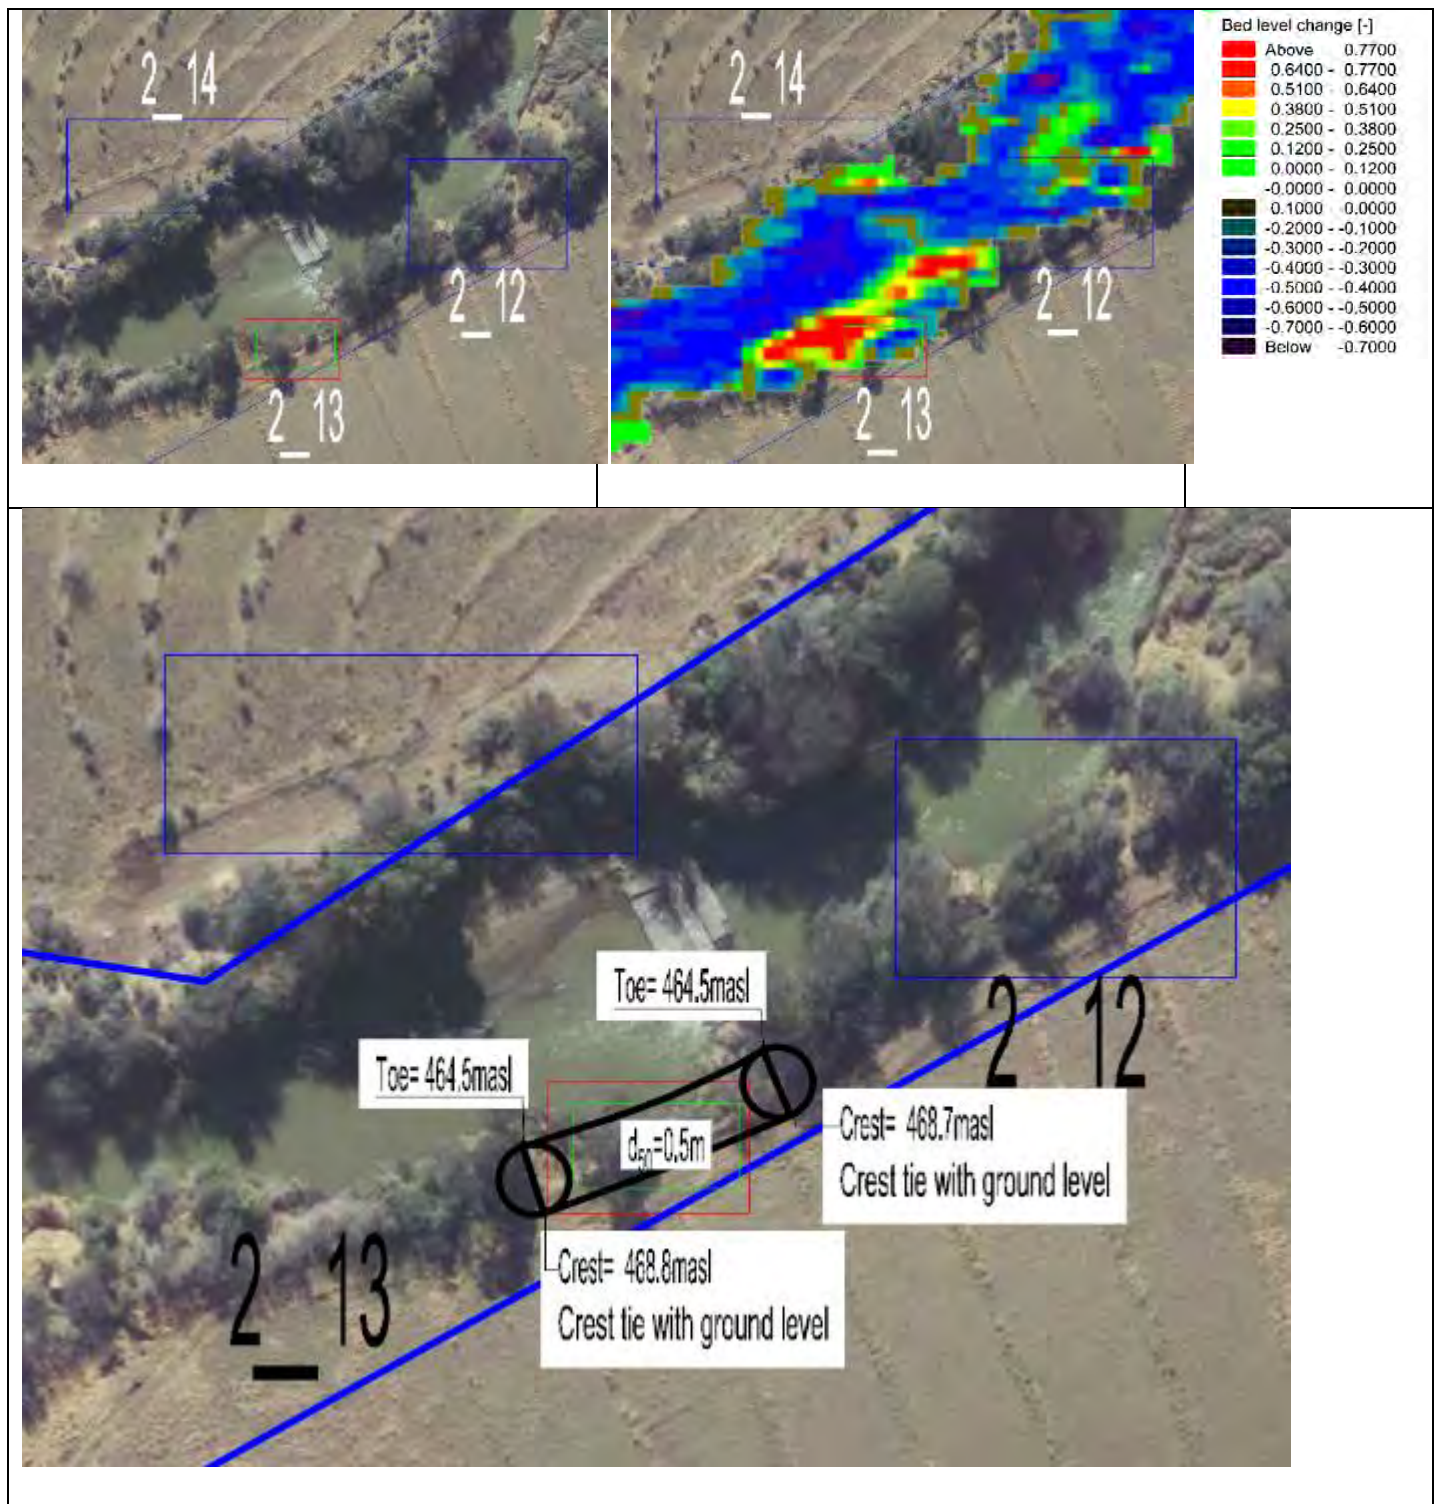
Appendix 17: Zone 2_12, 2_13 and 2_14 Q10 flood peak scour pattern and proposed scour protection

The unstable banks are encroaching the servitude and farmland. $d_{50} = 0.5$ m was found appropriate. This area is shown in Appendix 17.

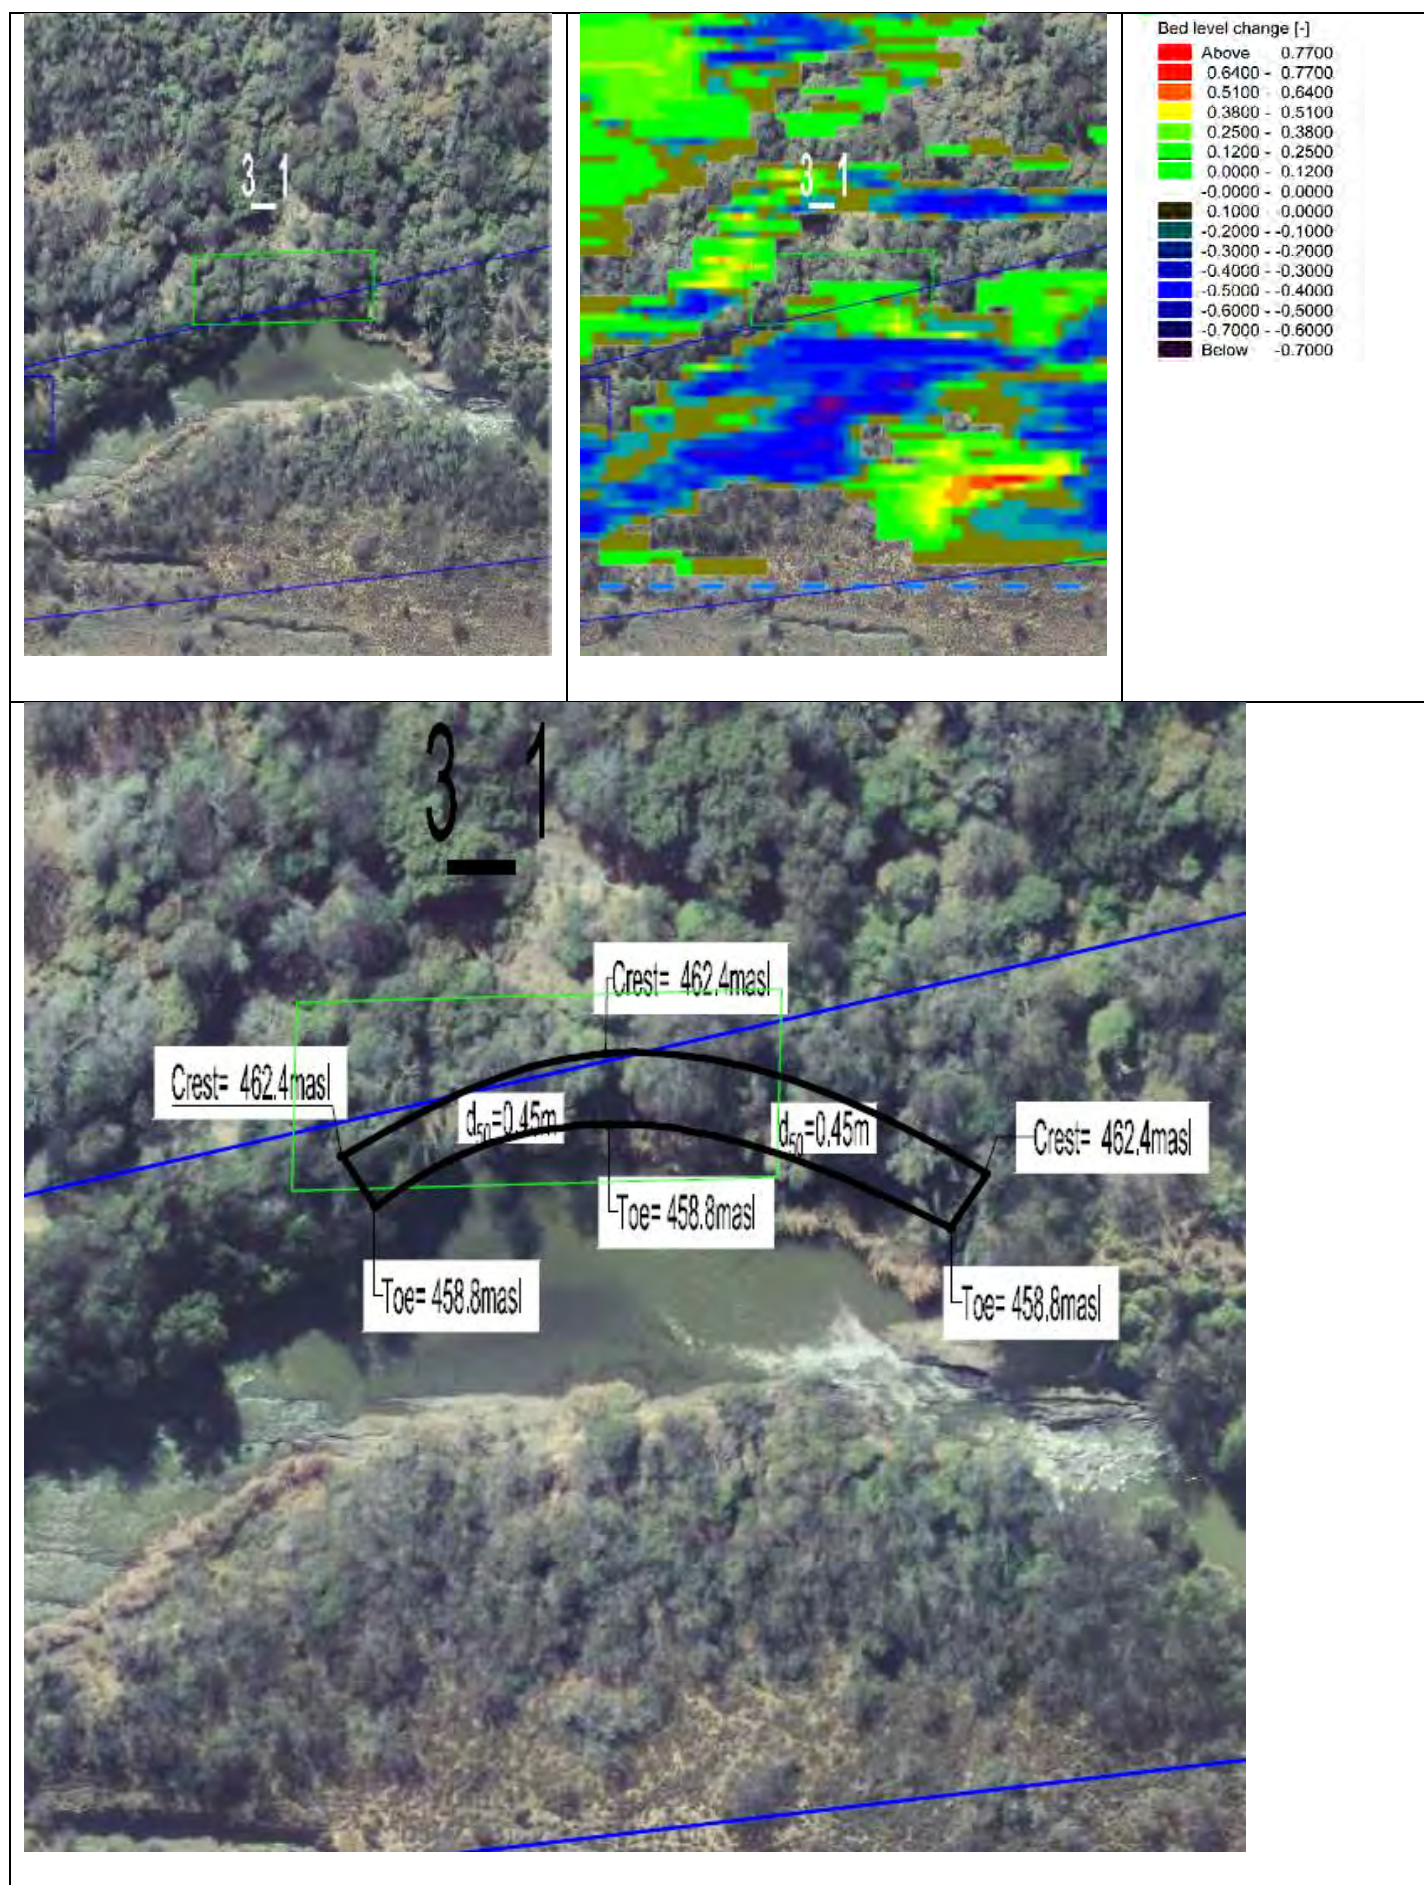
Appendix 20: Zone 3_1 Q10 flood peak scour pattern and proposed scour protection

The zone has unstable banks crossing the servitude. $d_{50} = 0.45$ m was found appropriate. This area is shown in Appendix 20.

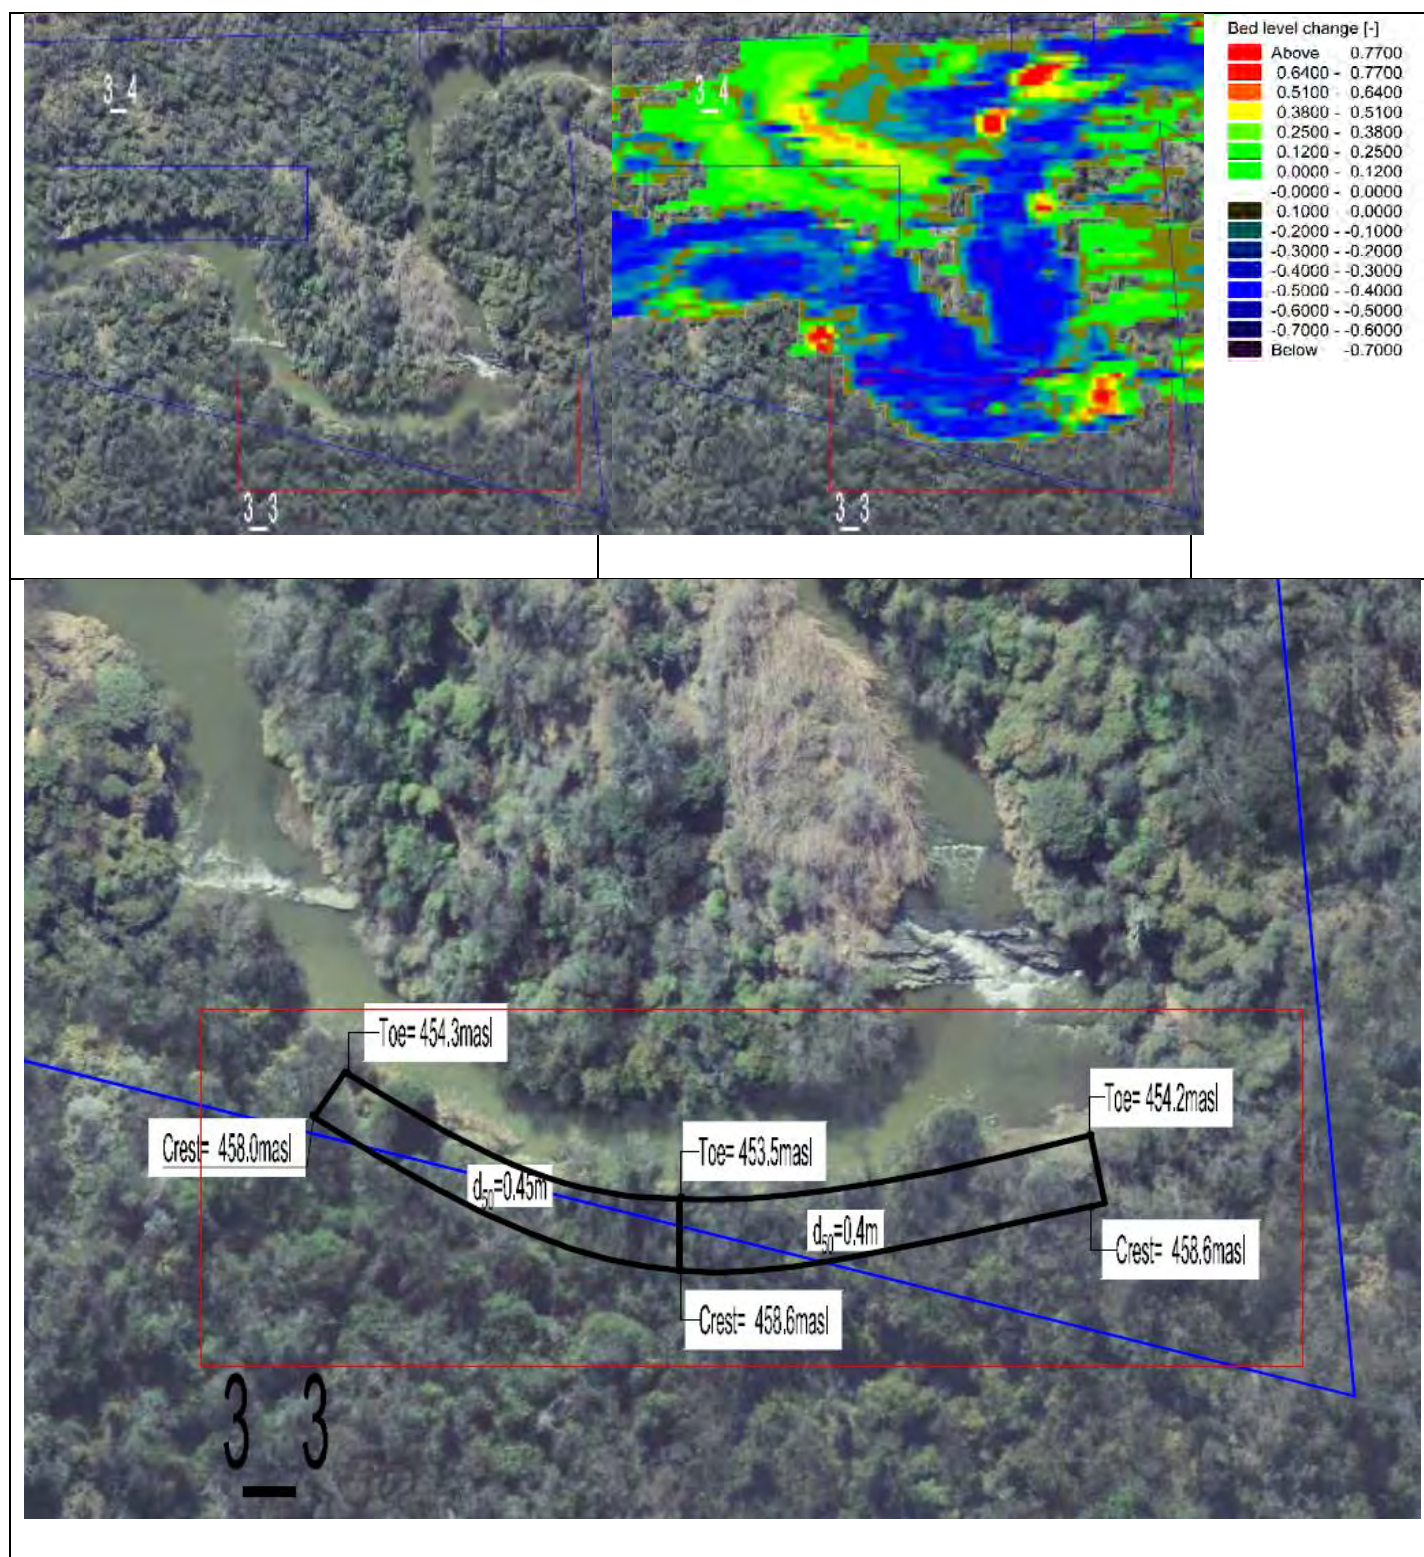
Appendix 22: Zone 3_3 and 3_4 Q10 flood peak scour pattern and proposed scour protection

The zone has unstable banks crossing the servitude. $d_{50} = 0.4$ m and $d_{50} = 0.45$ m were found appropriate. This area is shown in Appendix 22.

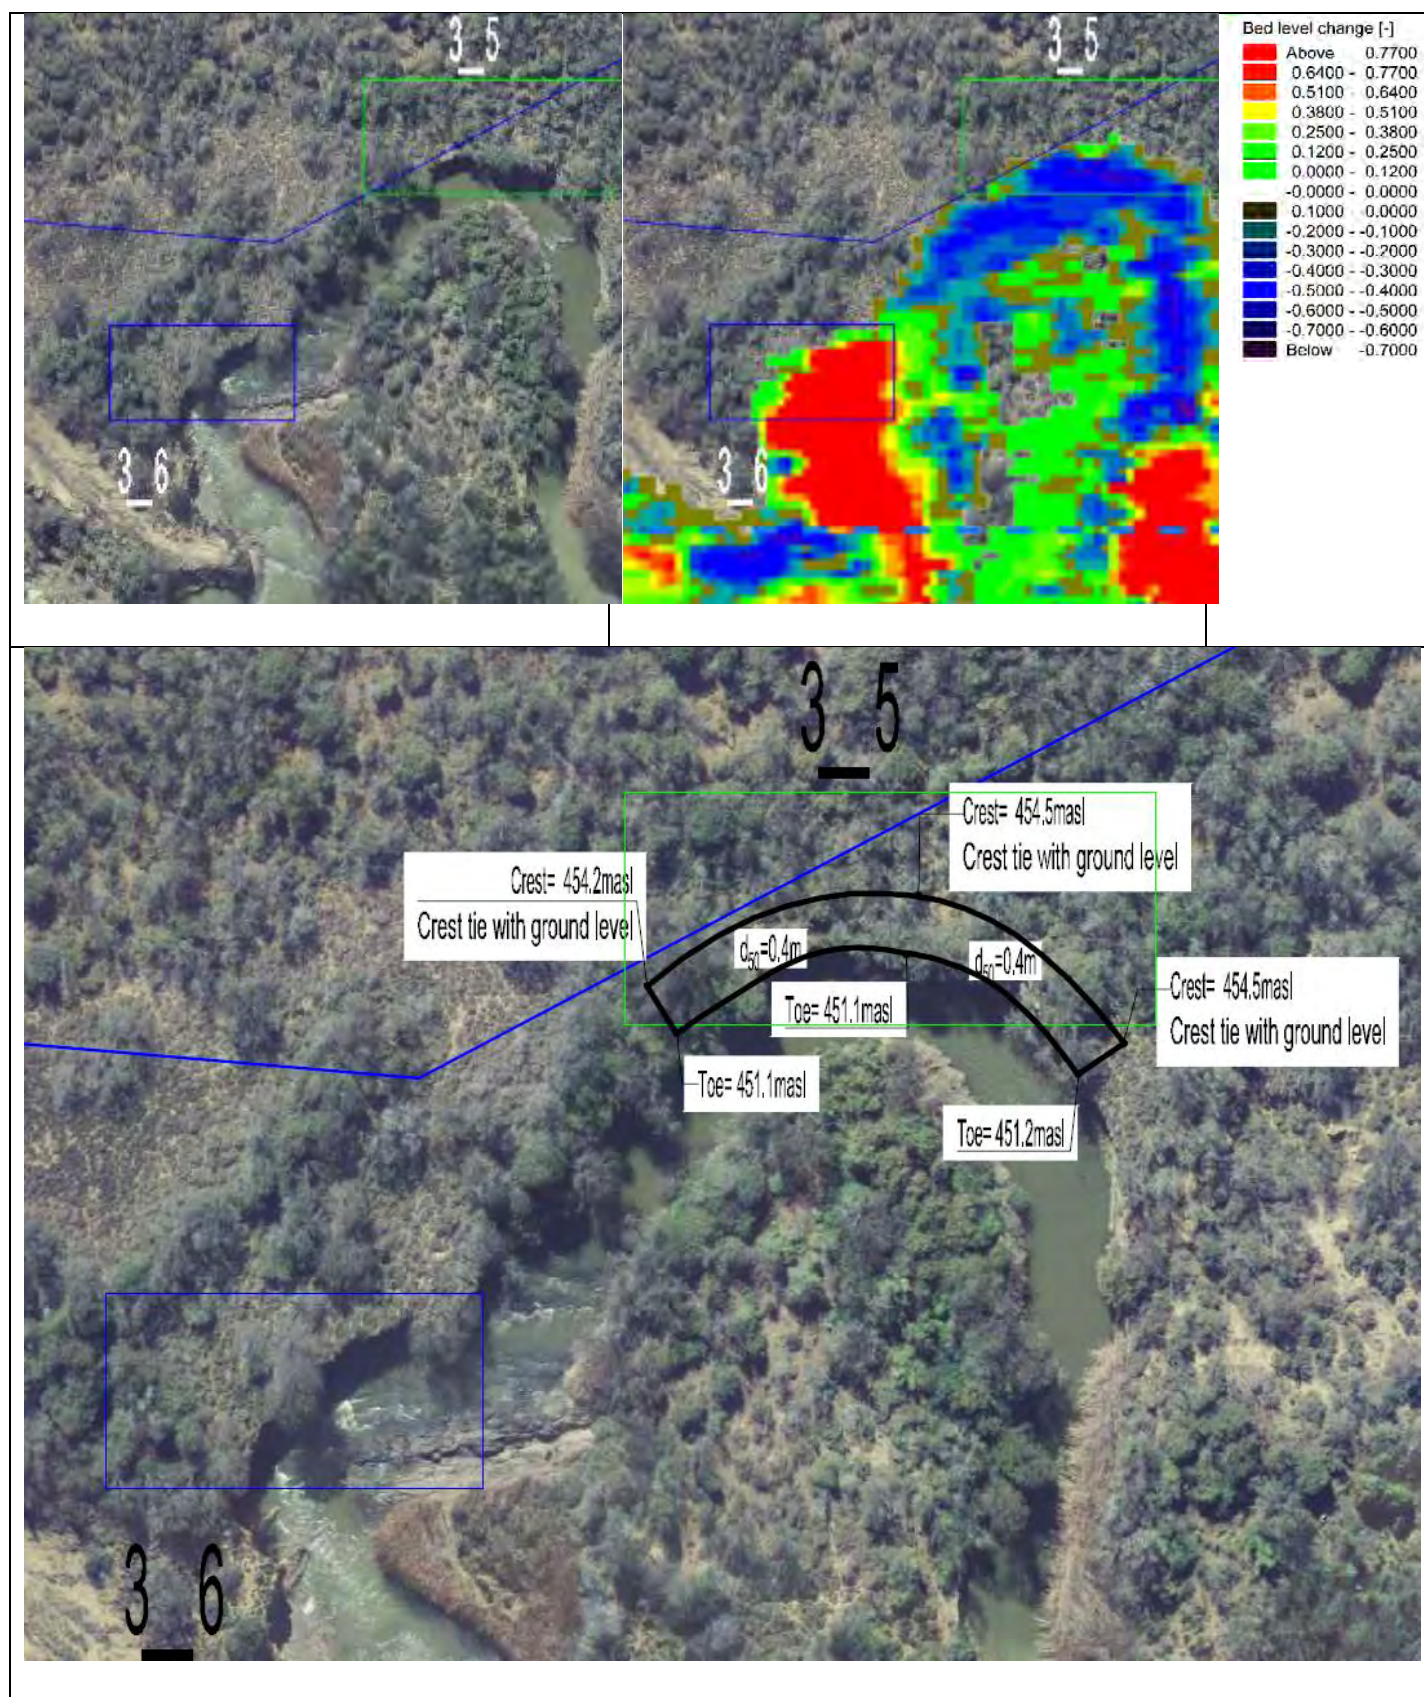
Appendix 23: Zone 3_5 and 3_6 Q10 flood peak scour pattern and proposed scour protection

The zone has unstable banks crossing the servitude. $d_{50} = 0.4$ m was found appropriate. This area is shown in Appendix 23.

The zone has unstable banks but within the servitude. Protection was found not necessary. This area is shown in Appendix 23.

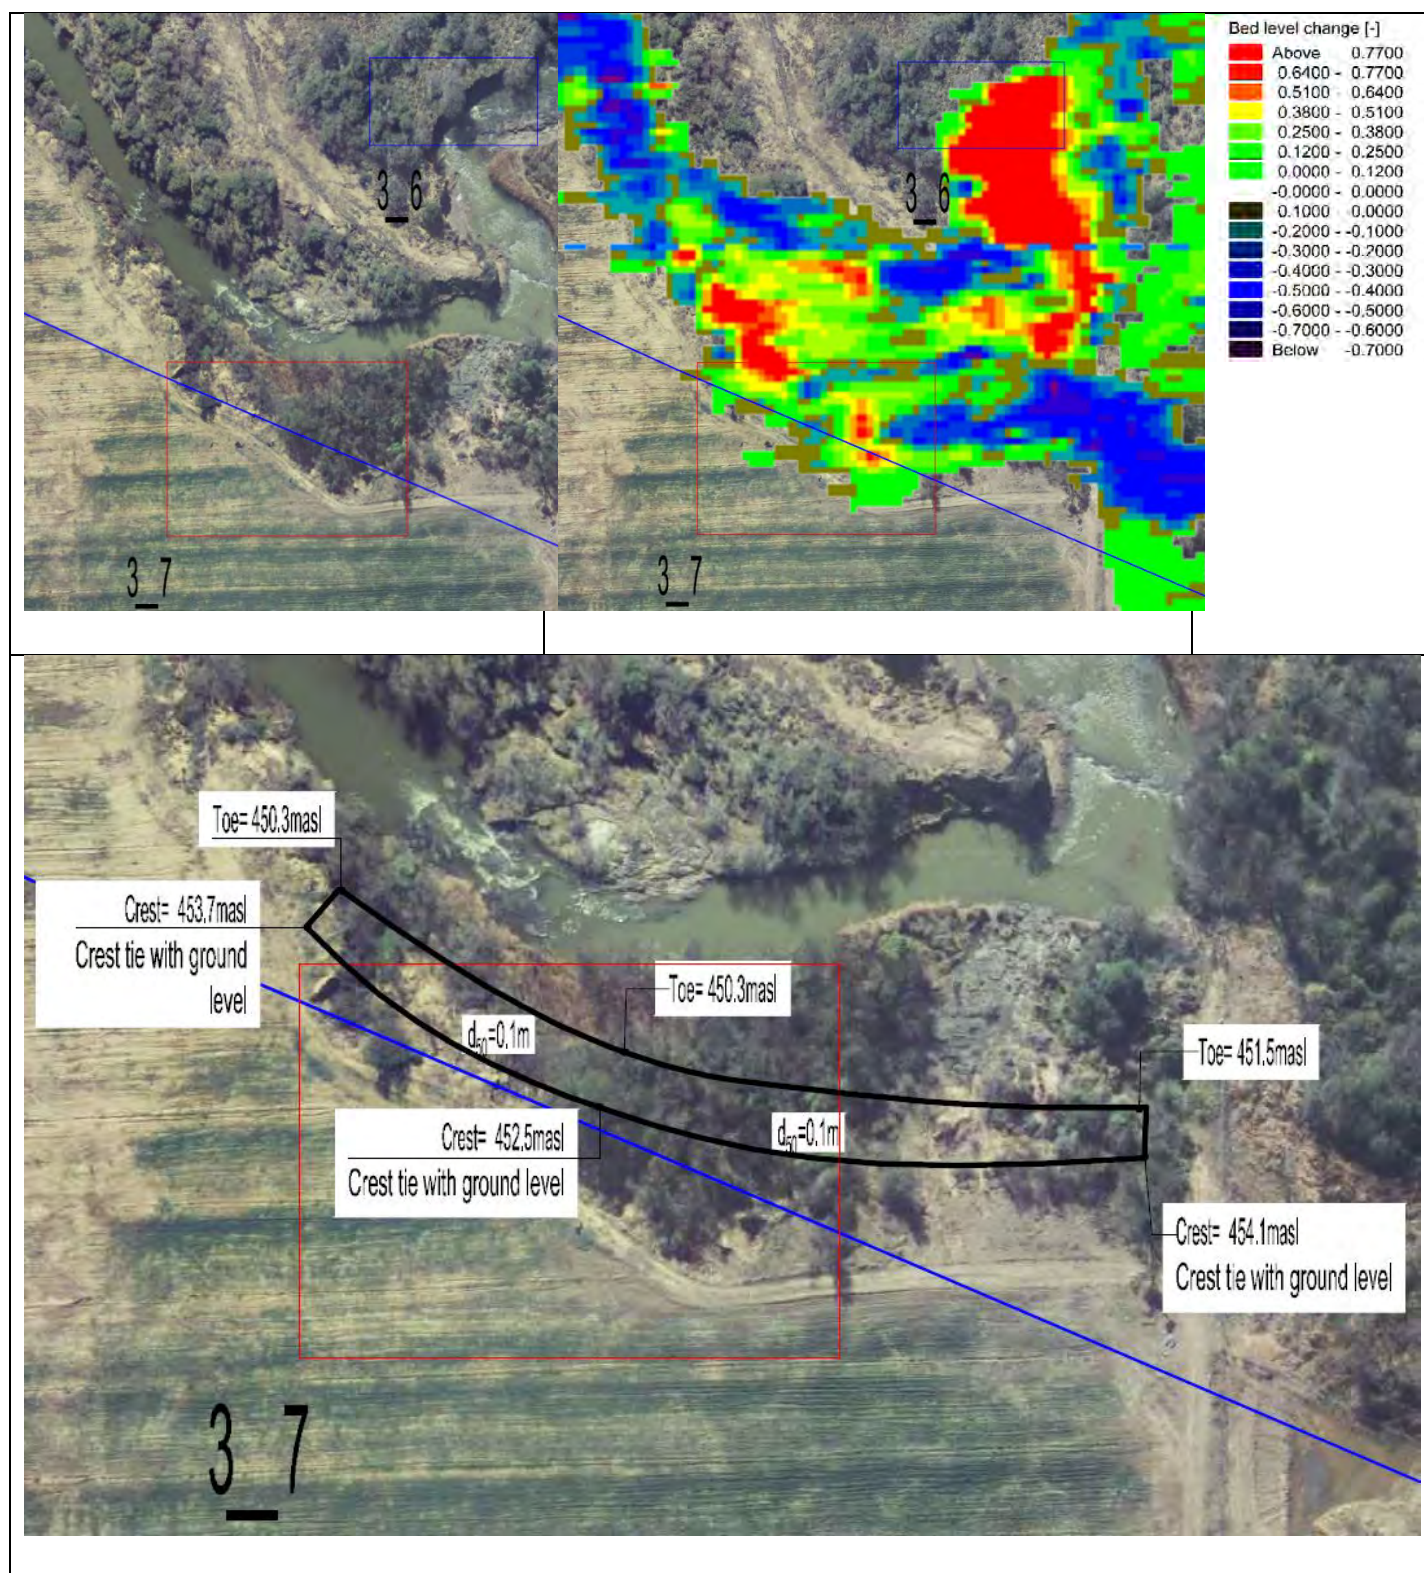
Appendix 24: Zone 3_6 and 3_7 Q10 flood peak scour pattern and proposed scour protection

The zone has unstable banks encroaching the servitude and road. $d_{50} = 0.1$ m was found appropriate. This area is shown in Appendix 24.

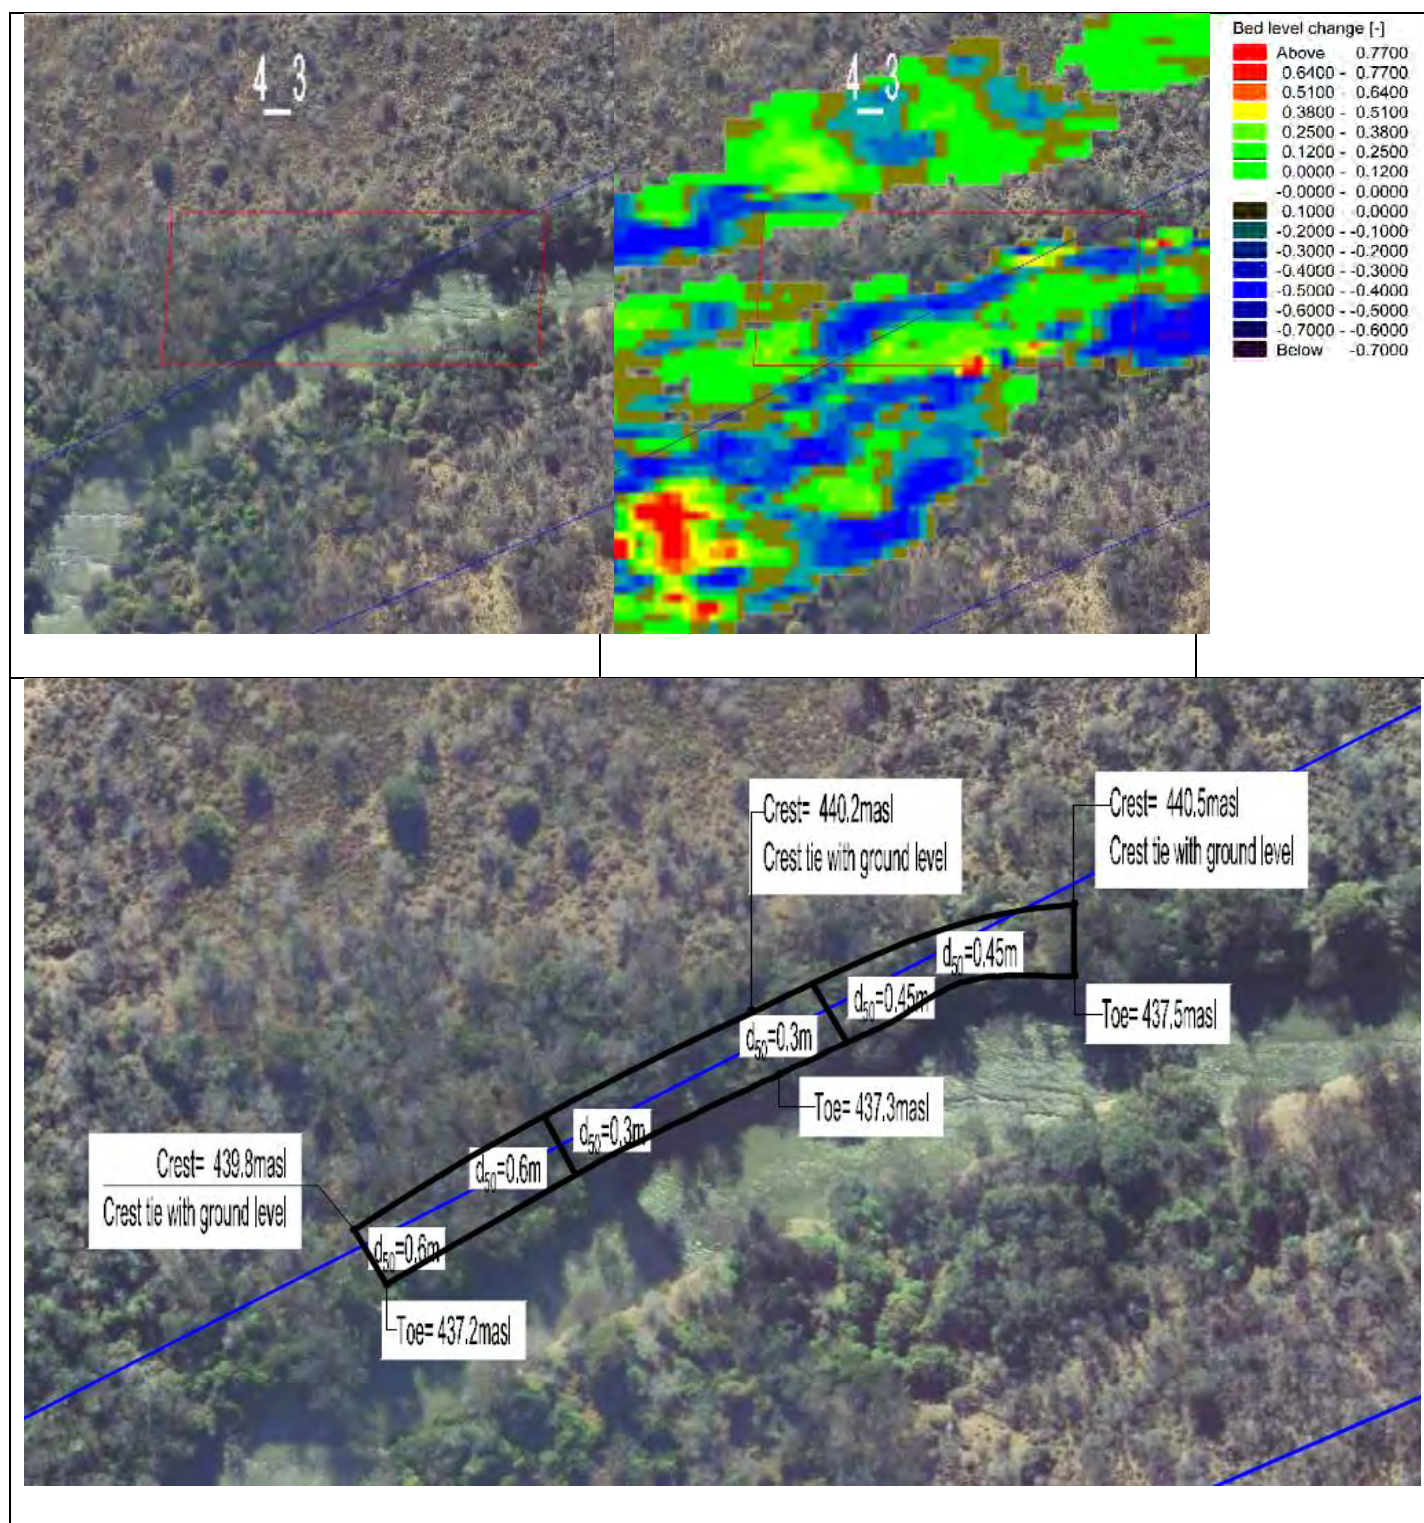
Appendix 30: Zone 4_3 Q10 flood peak scour pattern and proposed scour protection

The zone has unstable banks crossing the servitude. $d_{50} = 0.3$ m, $d_{50} = 0.45$ m and $d_{50} = 0.6$ m was found appropriate. This area is shown in Appendix 30.

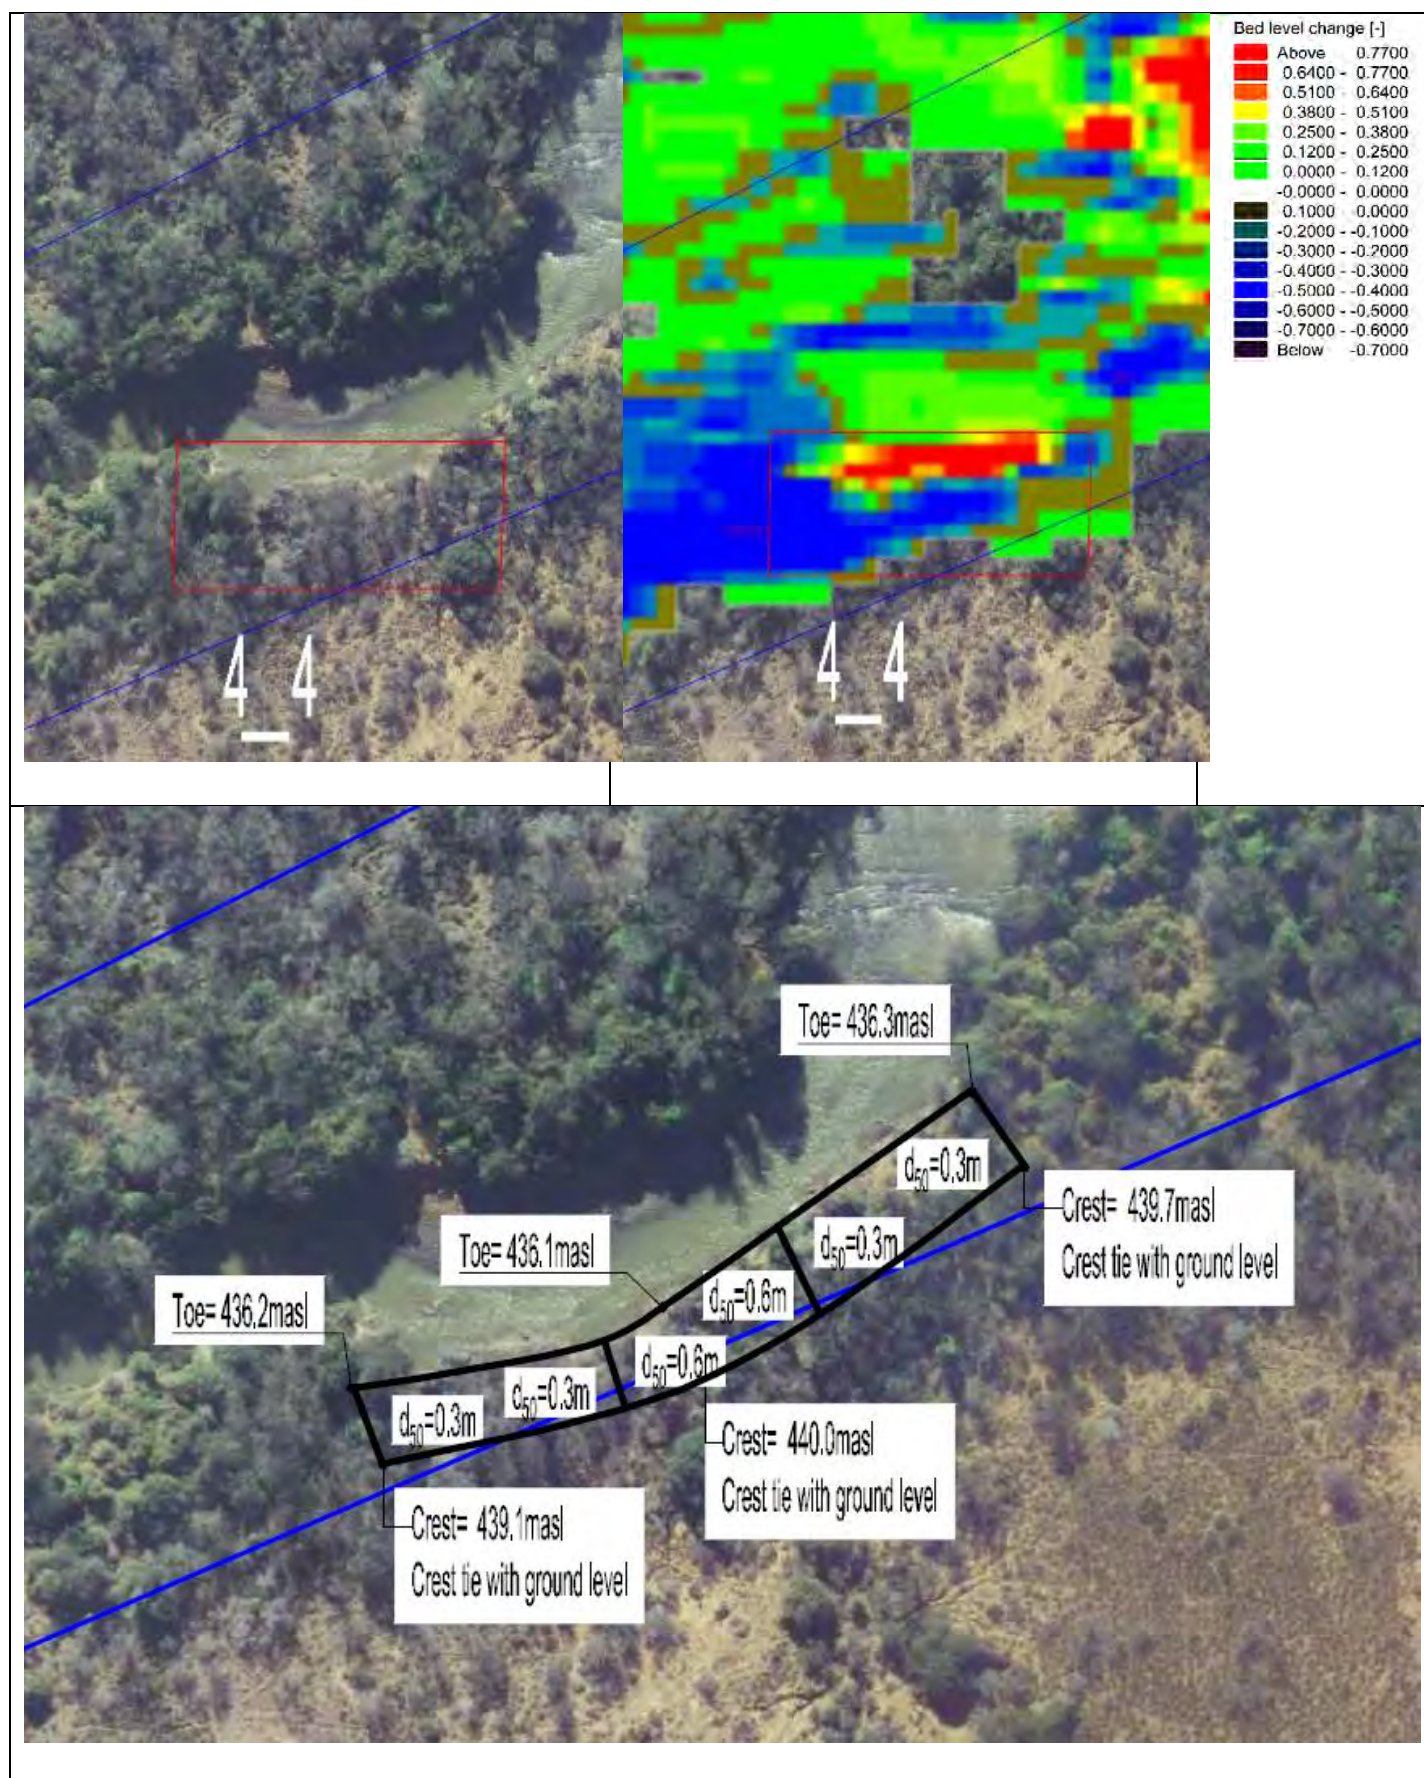
Appendix 31: Zone 4_4 Q10 flood peak scour pattern and proposed scour protection

The zone has unstable banks crossing the servitude and encroaching the road. $d_{50} = 0.3$ m and $d_{50} = 0.6$ m was found appropriate. This area is shown in Appendix 31.
