Skoenmakers River Maintenance

River rehabilitation

DRAFT REPORT Rev 1

June 2015

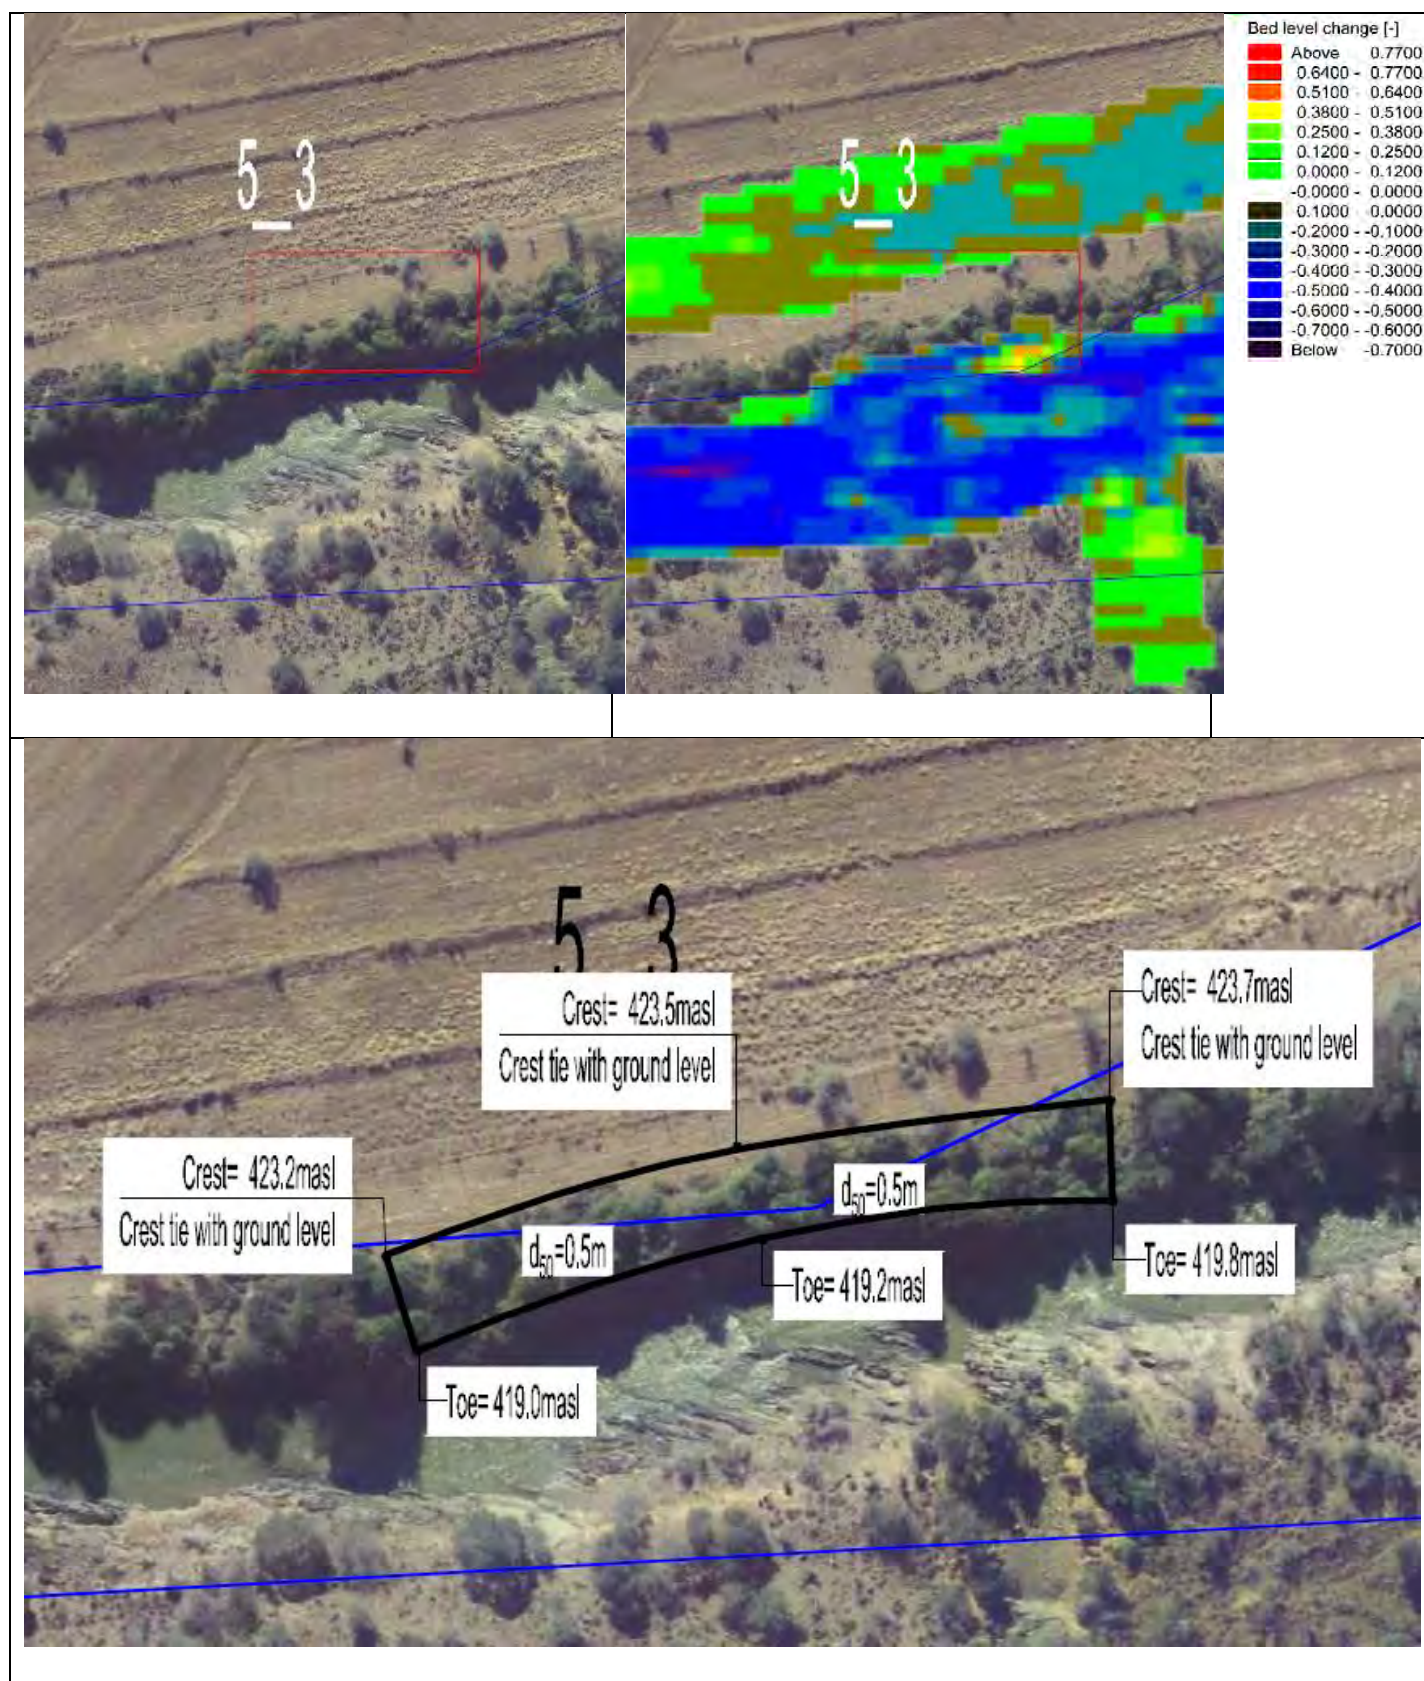
Appendix 36: Zone 5_3 Q10 flood peak scour pattern and proposed scour protection

The zone has banks crossing the servitude and encroaching farmland. $d_{50} = 0.5$ m was found appropriate. This area is shown in Appendix 36.

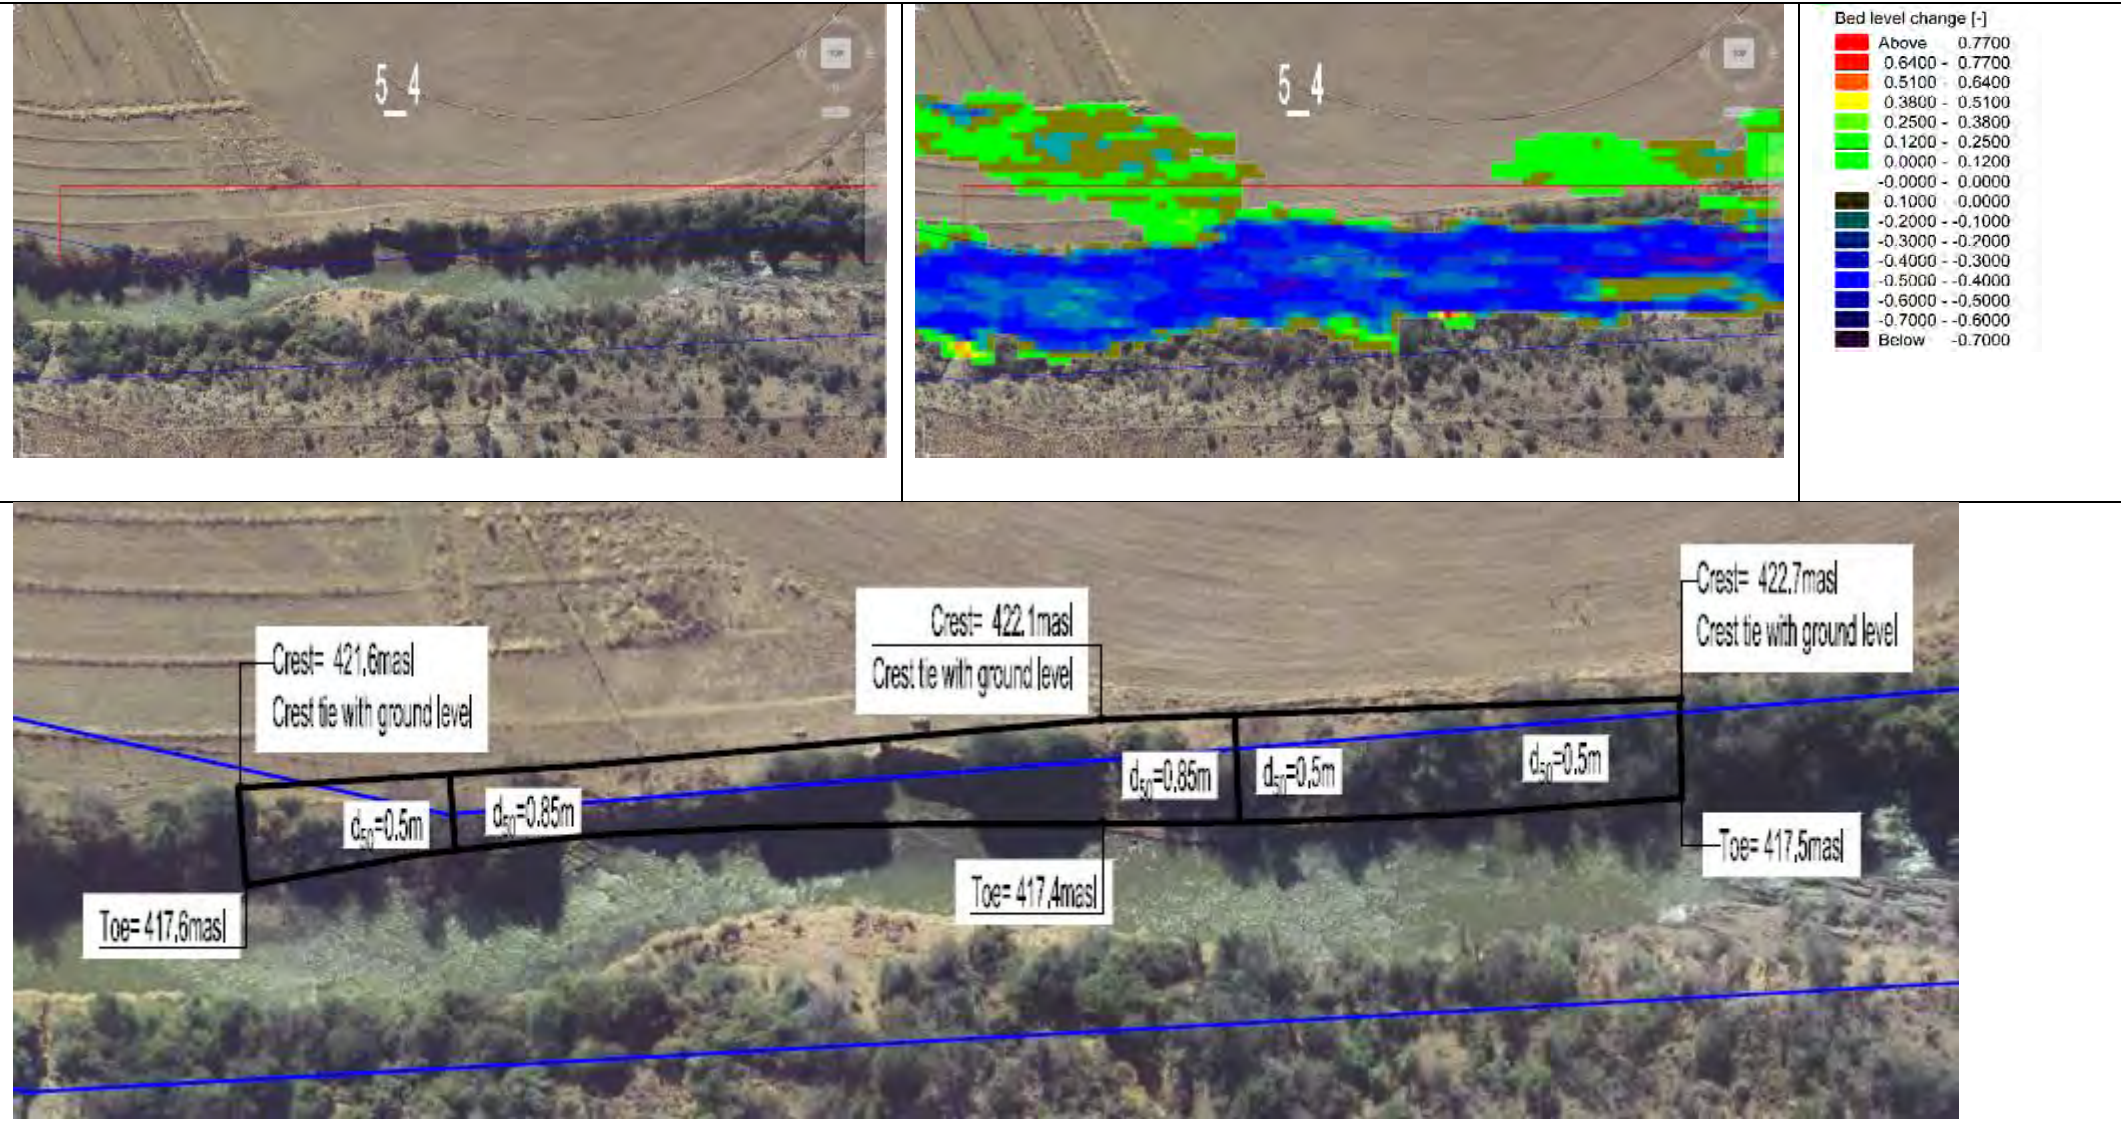
Appendix 37: Zone 5_4 Q10 flood peak scour pattern and proposed scour protection

The zone has banks crossing the servitude. $d_{50} = 0.5$ m and $d_{50} = 0.85$ m was found appropriate. This area is shown in Appendix 37.

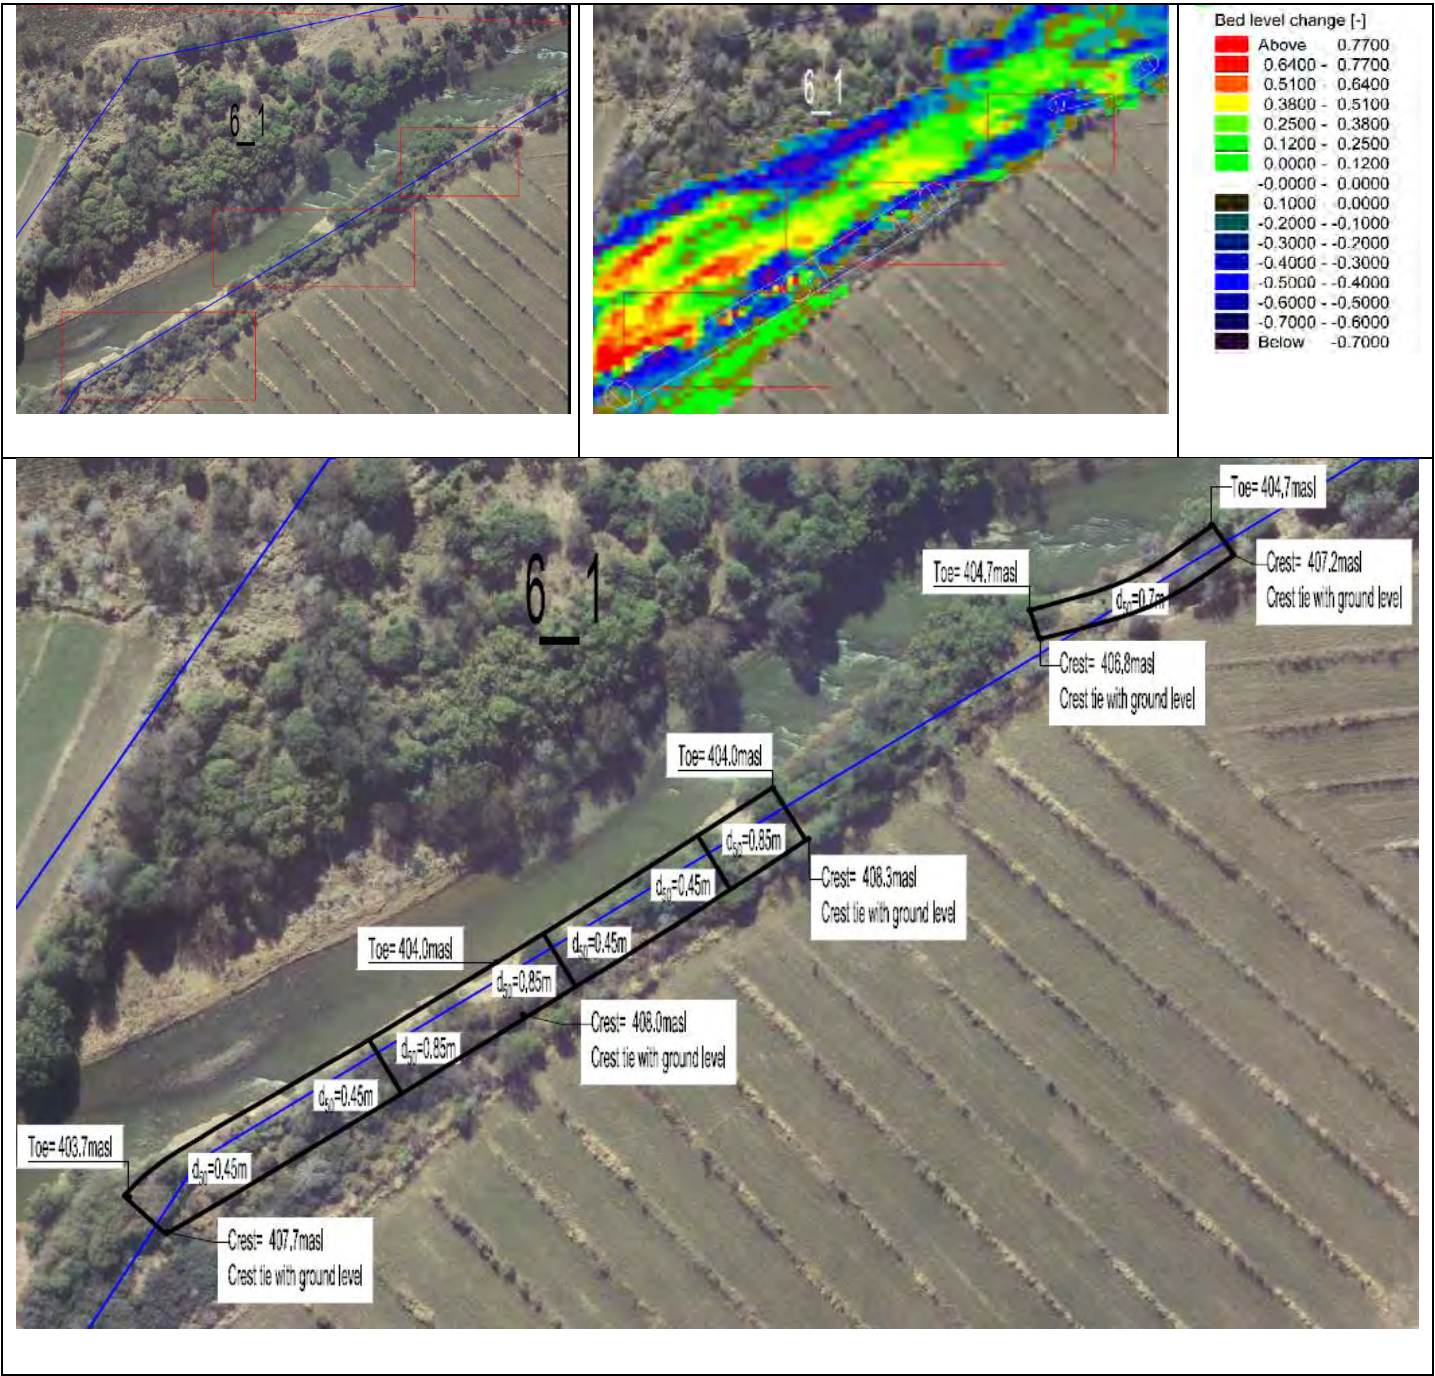
Appendix 42: Zone 6_1 Q10 flood peak scour pattern and proposed scour protection

The zone has banks crossing the servitude and encroaching farmland. $d_{50} = 0.45$ m, $d_{50} = 0.7$ m and $d_{50} = 0.85$ m were found appropriate. This area is shown in Appendix 42.

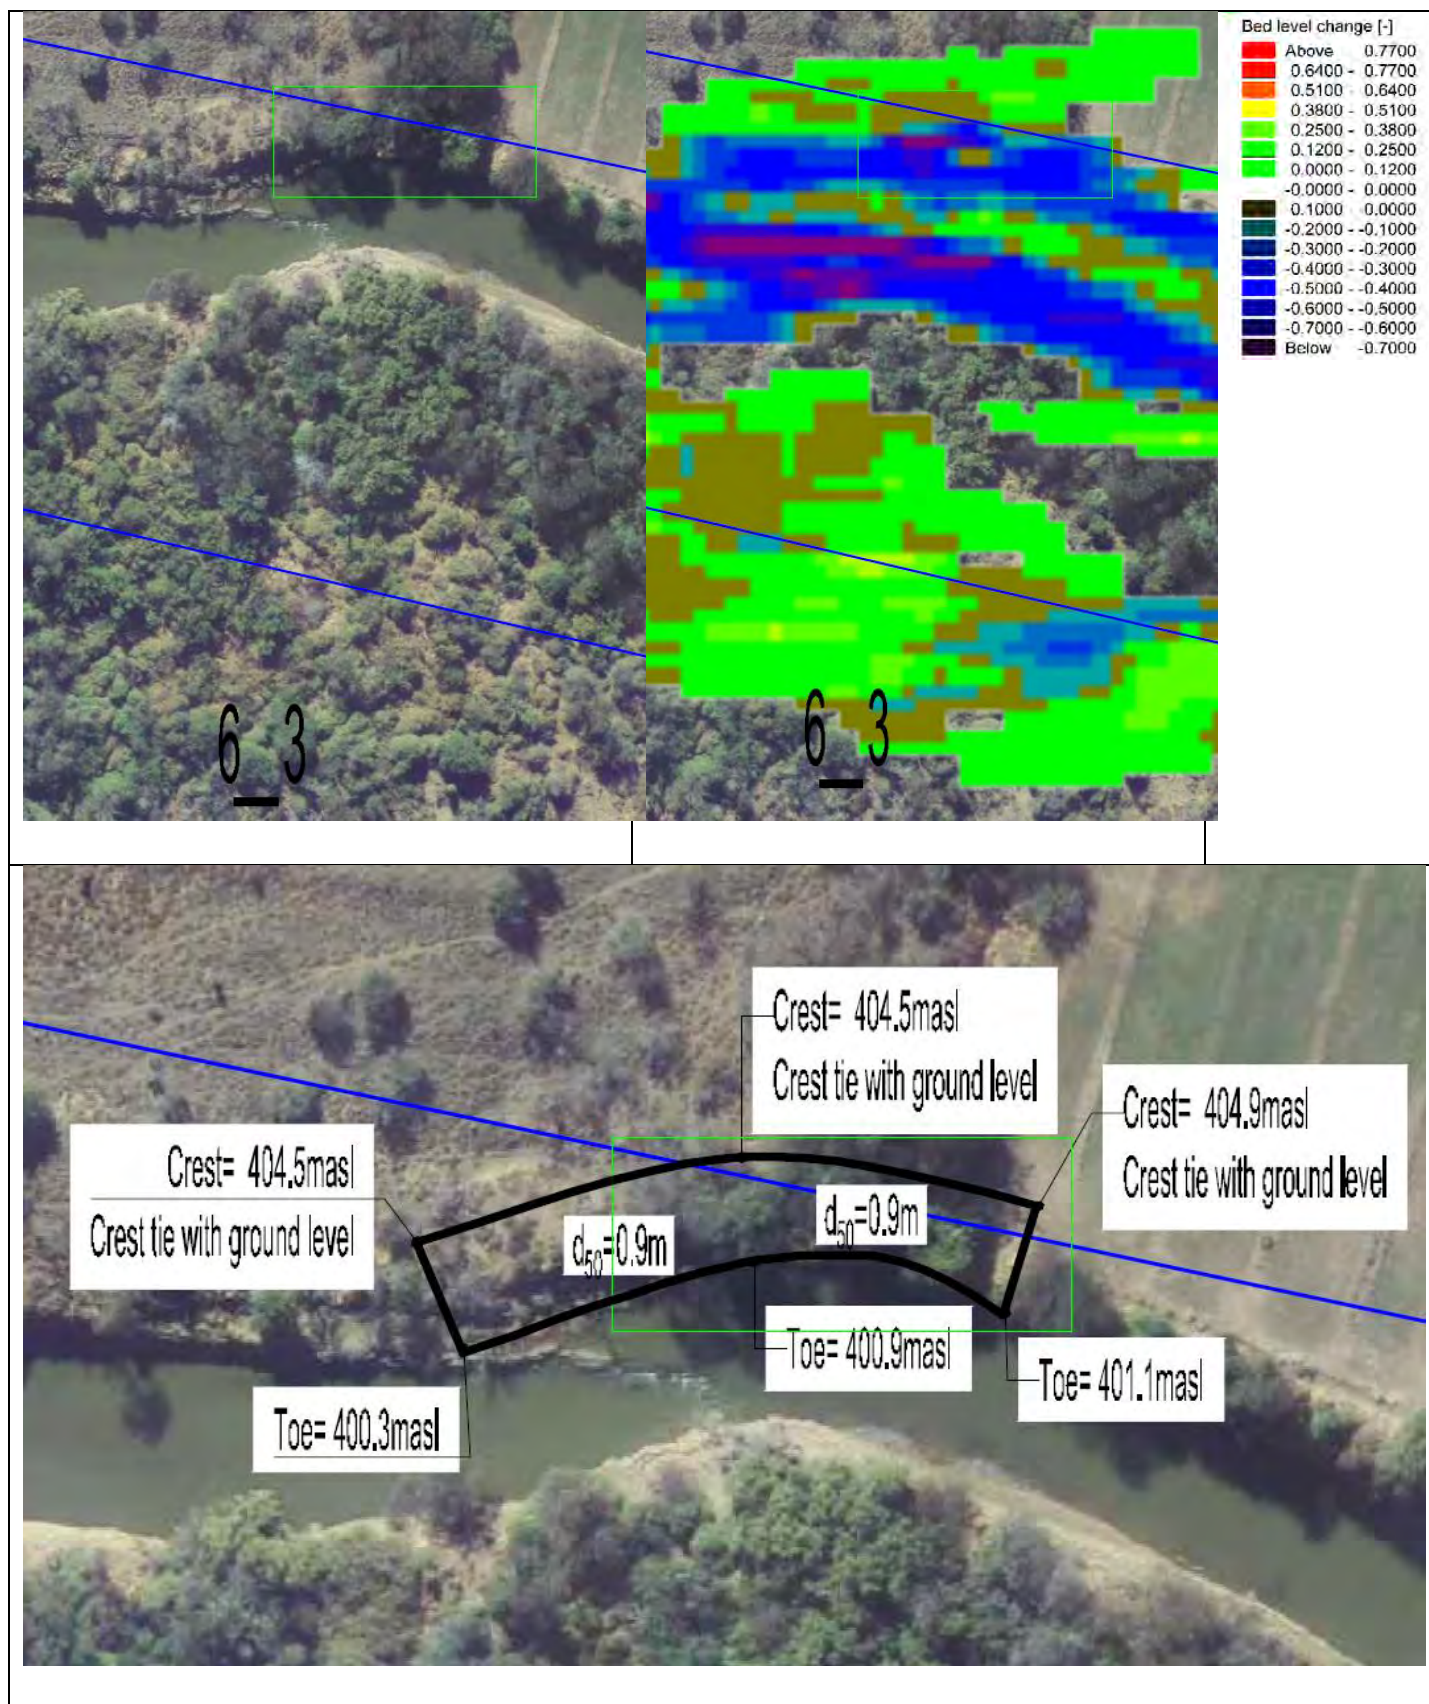
Appendix 44: Zone 6_3 Q10 flood peak scour pattern and proposed scour protection

The zone has banks crossing the servitude and encroaching farmland. $d_{50} = 0.9$ m was found appropriate. This area is shown in Appendix 44.

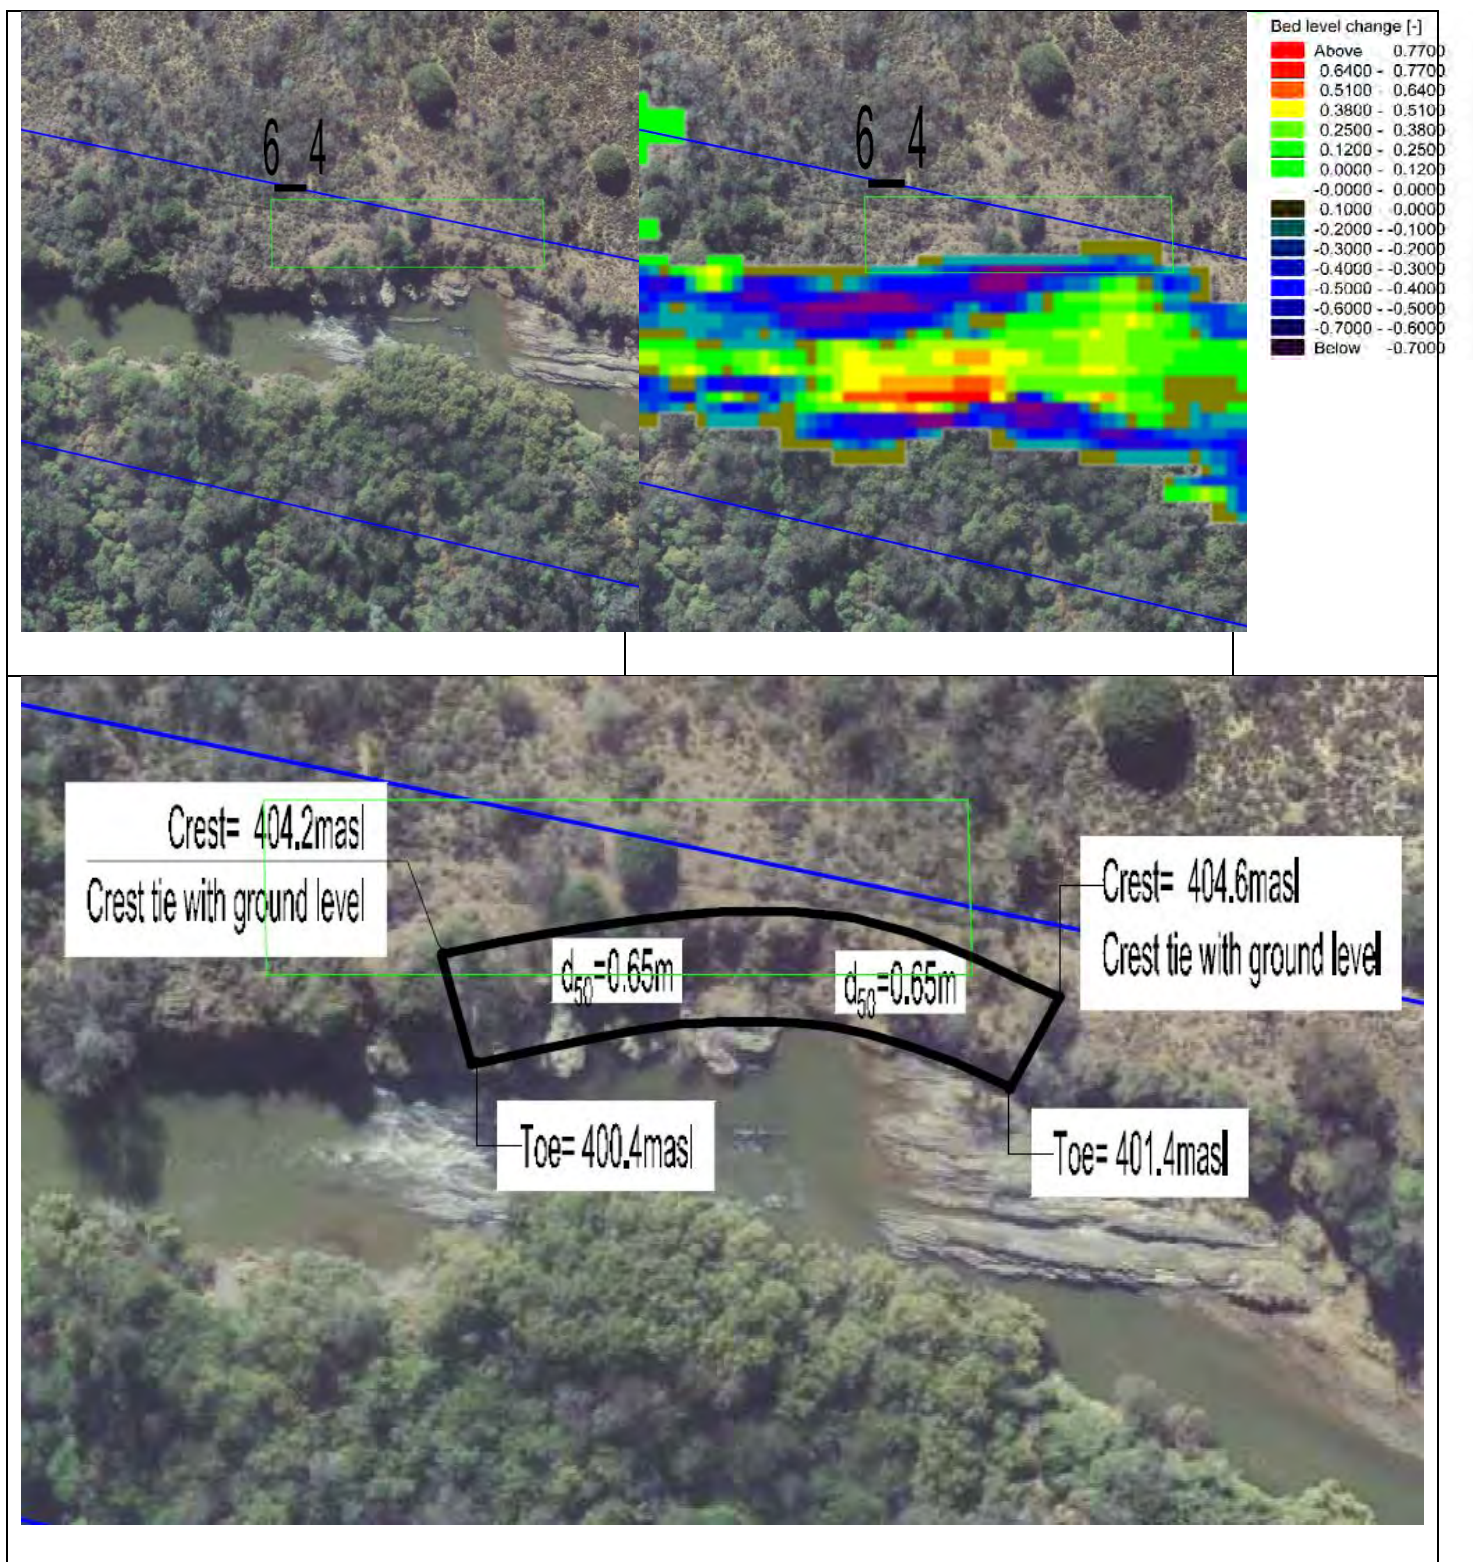
Appendix 45: Zone 6_4 Q10 flood peak scour pattern and proposed scour protection

The zone has banks crossing the servitude but with bedrock outcropping. $d_{50} = 0.65$ m was found appropriate. This area is shown in Appendix 45.

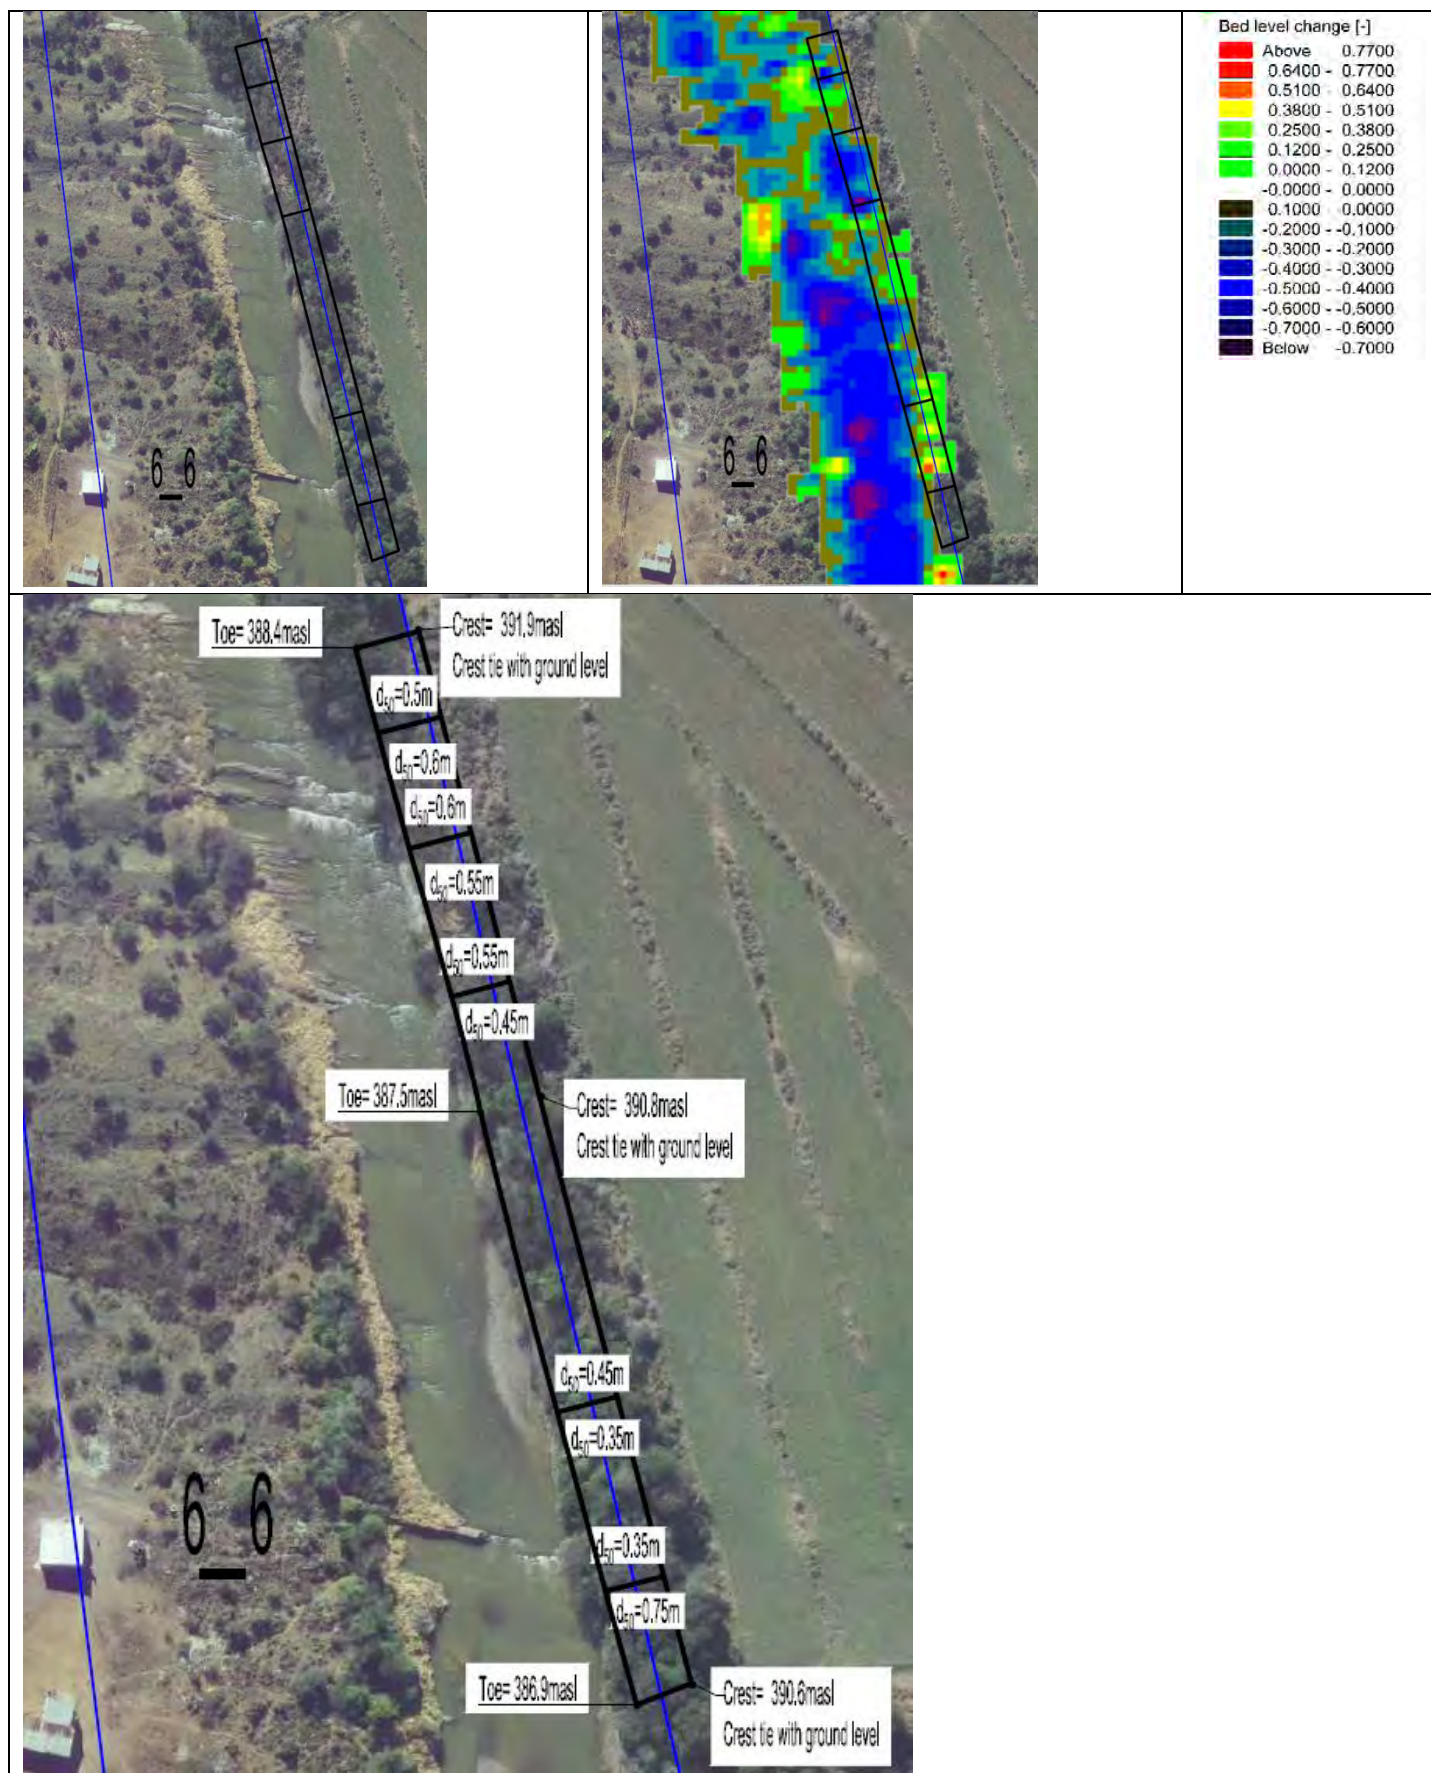
Appendix 47: Zone 6_6 Q10 flood peak scour pattern and proposed scour protection

The zone has banks crossing the servitude and encroaching farmland. $d_{50} = 0.35$ m, $d_{50} = 0.45$ m, $d_{50} = 0.55$ m, $d_{50} = 0.6$ m and $d_{50} = 0.75$ m were found appropriate. This area is shown in Appendix 47.

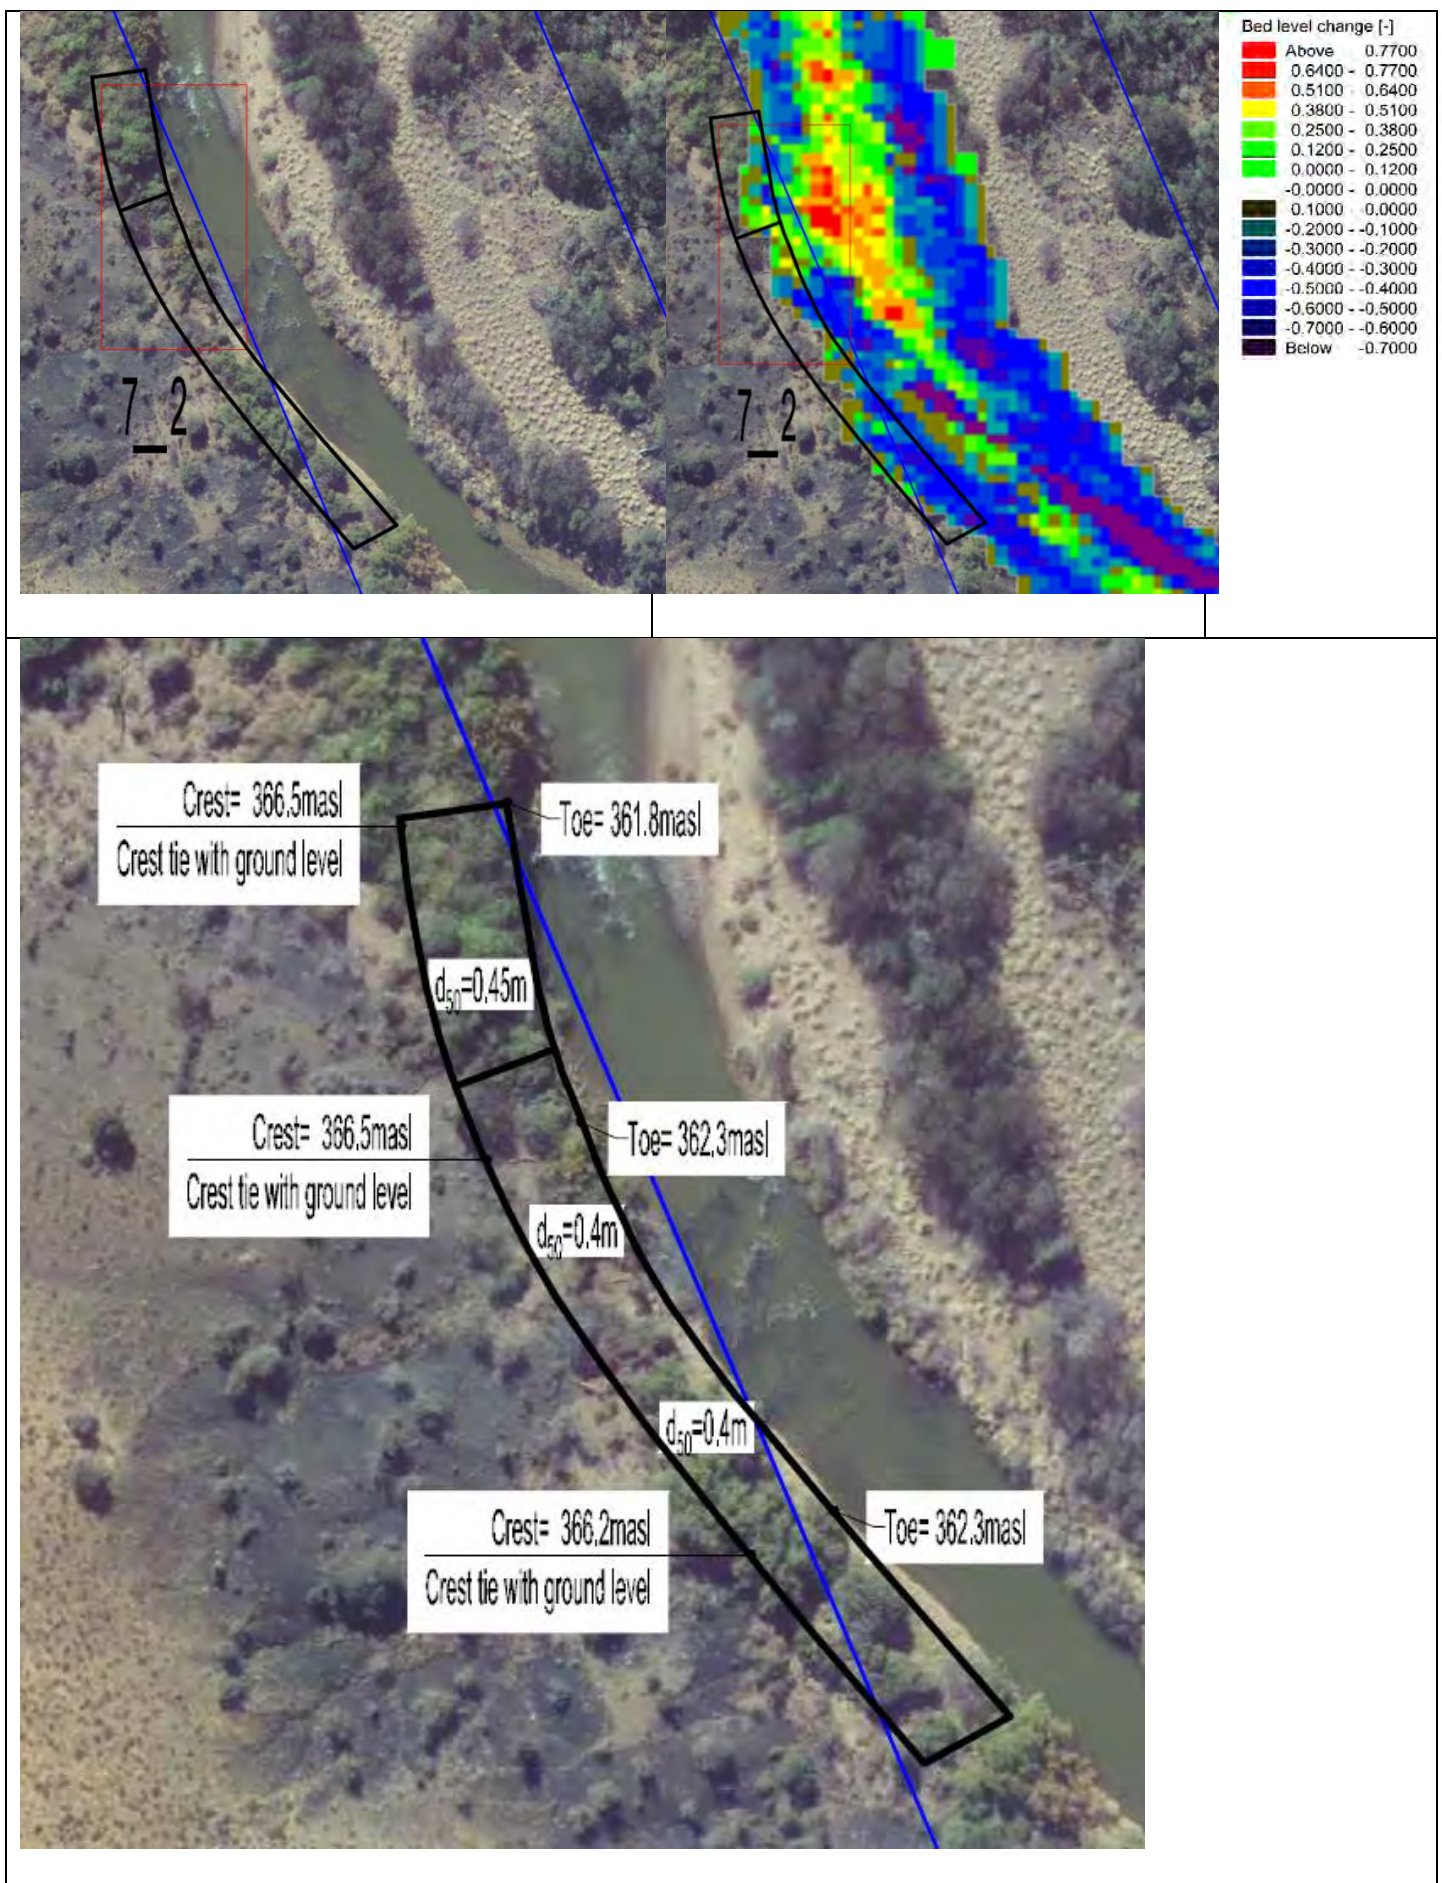
Appendix 50: Zone 7_2 Q10 flood peak scour pattern and proposed scour protection

The zone has banks crossing the servitude. $d_{50} = 0.4$ m and $d_{50} = 0.45$ m was found appropriate. This area is shown in Appendix 50.

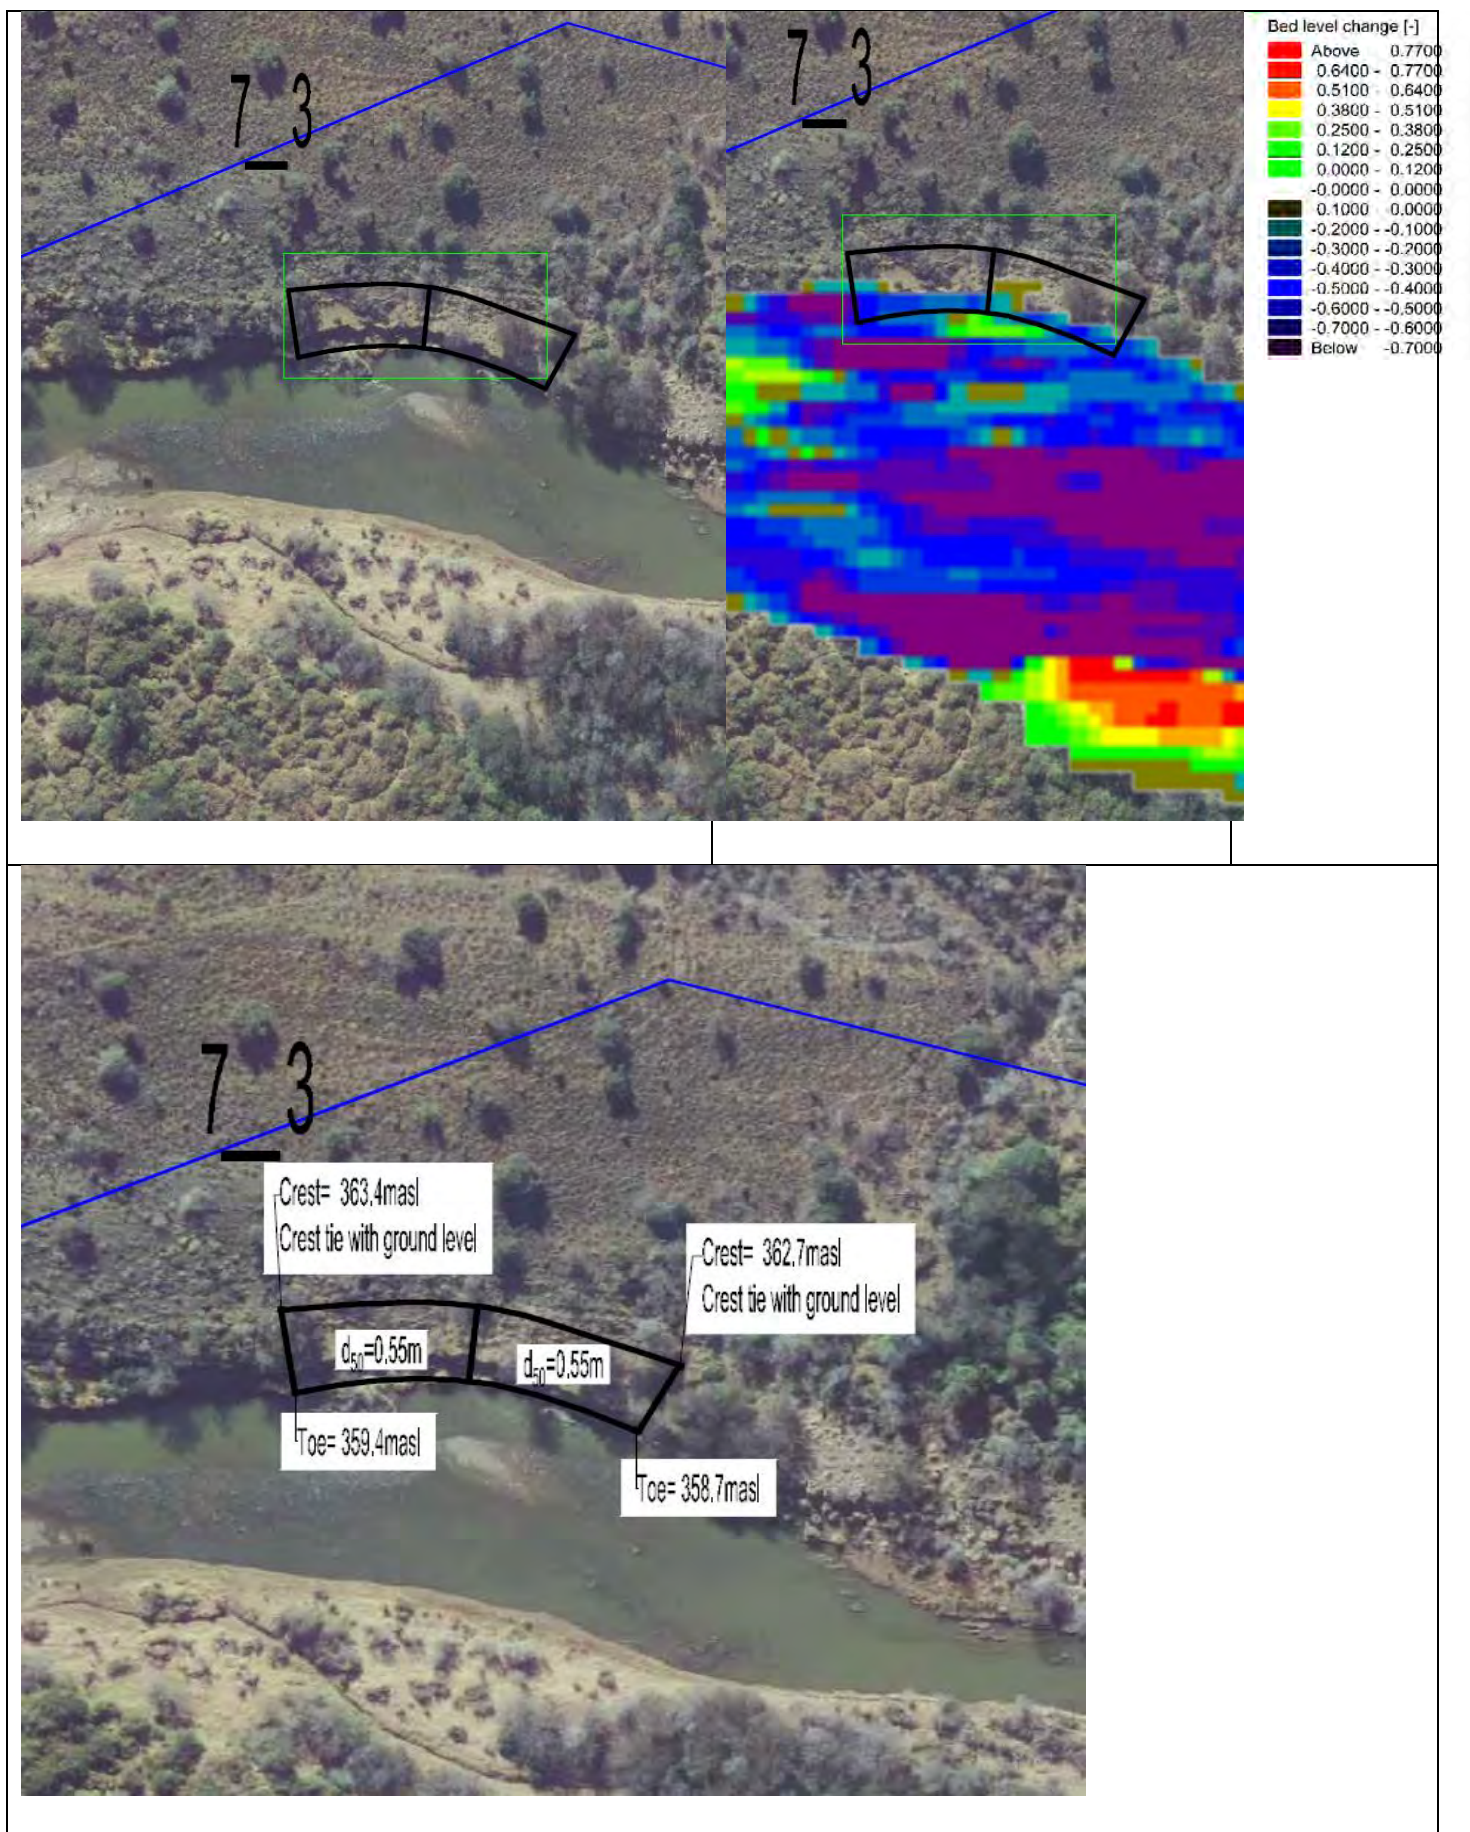
Appendix 51: Zone 7_3 Q10 flood peak scour pattern and proposed scour protection

The zone has unstable banks within the servitude. $d_{50} = 0.55$ m was found appropriate. This area is shown in Appendix 51.

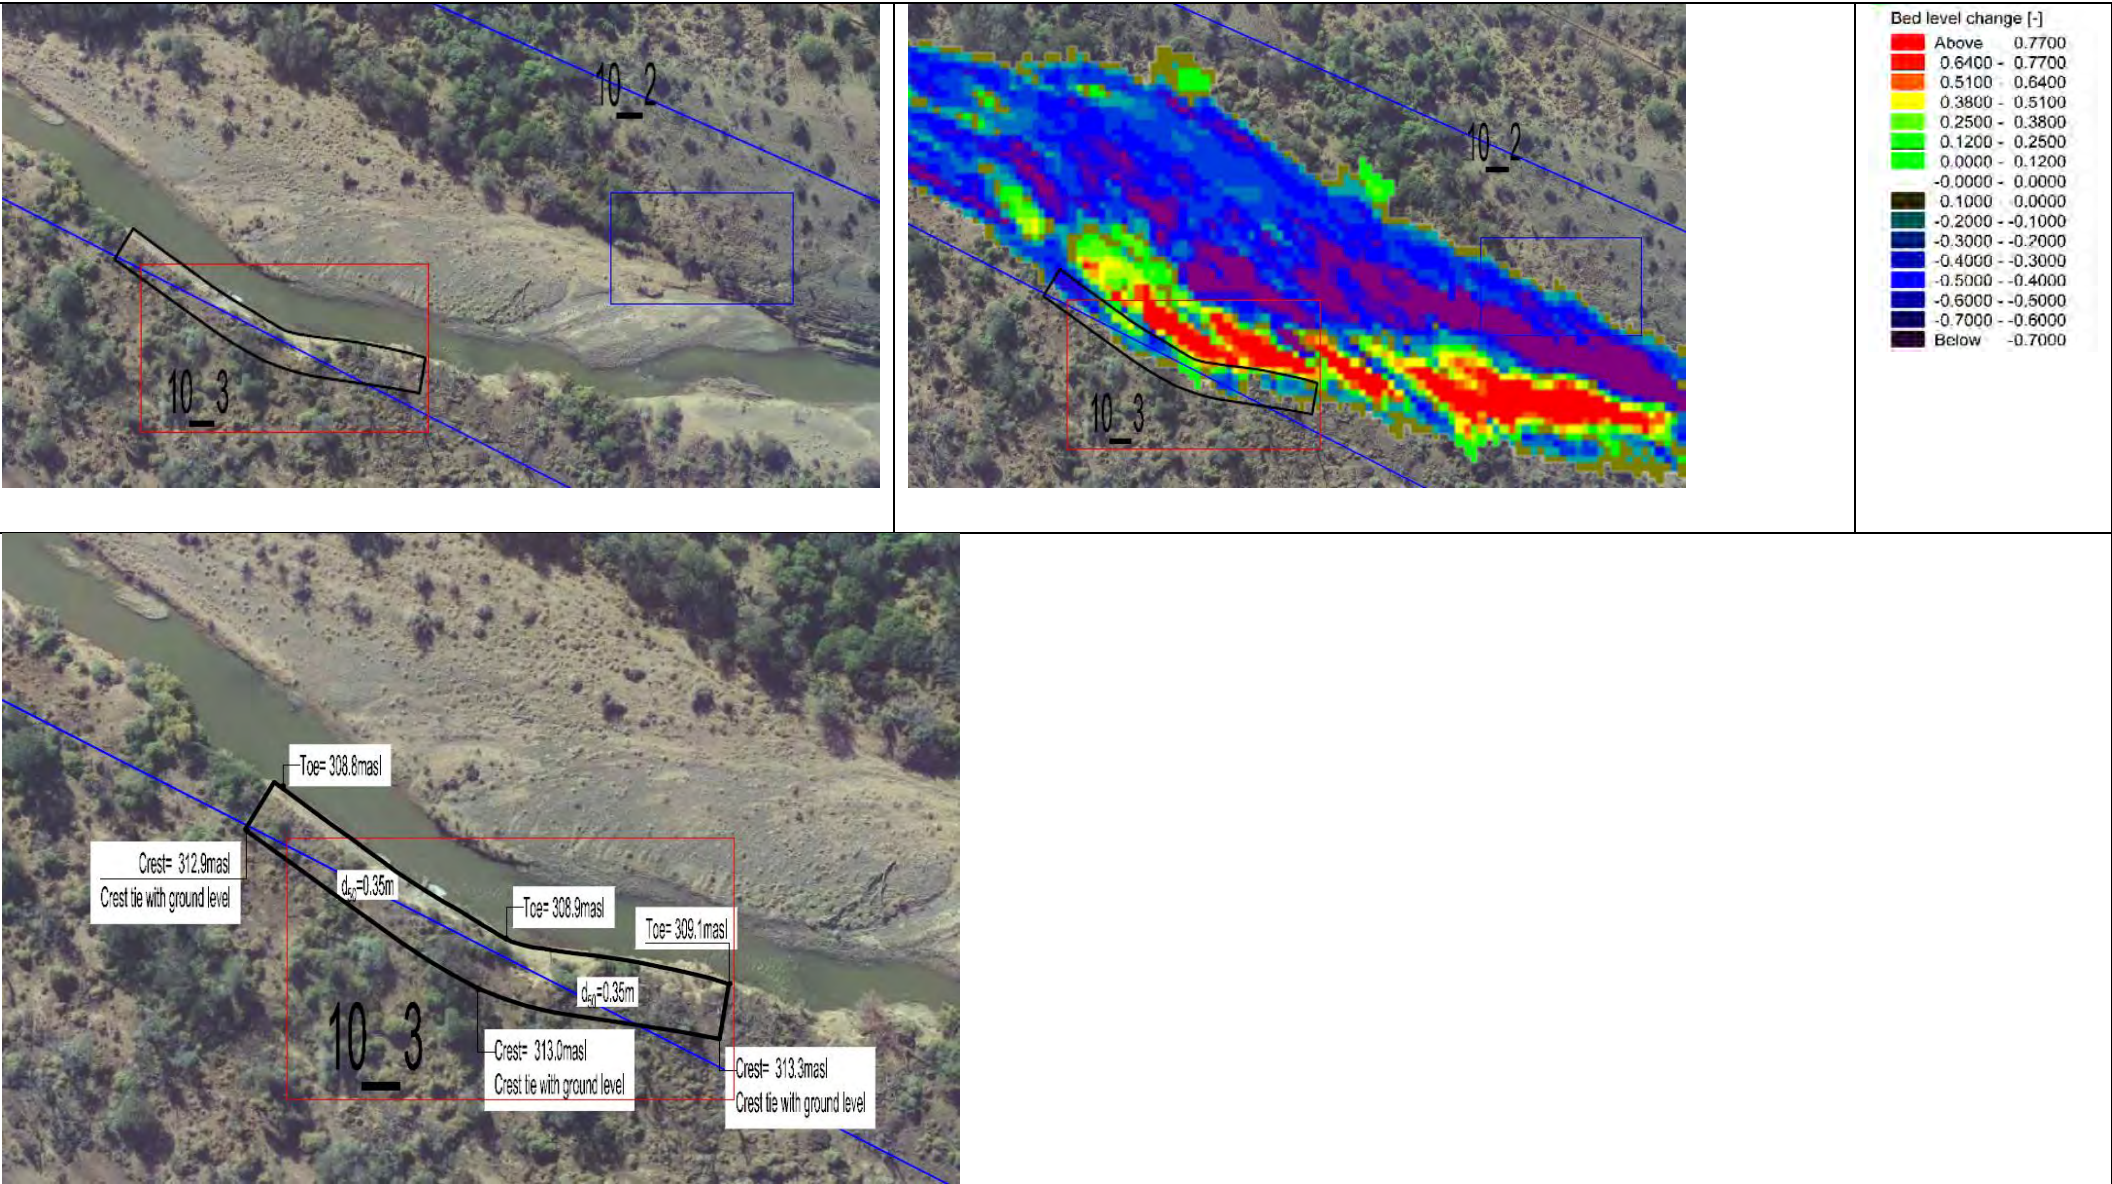
Appendix 63: Zone 10_2 and 10_3 Q10 flood peak scour pattern and proposed scour protection

The zone has banks crossing the servitude. $d_{50} = 0.35$ m was found appropriate. This area is shown in Appendix 63.
