Skoenmakers River Maintenance

River rehabilitation

DRAFT REPORT Rev 1

June 2015

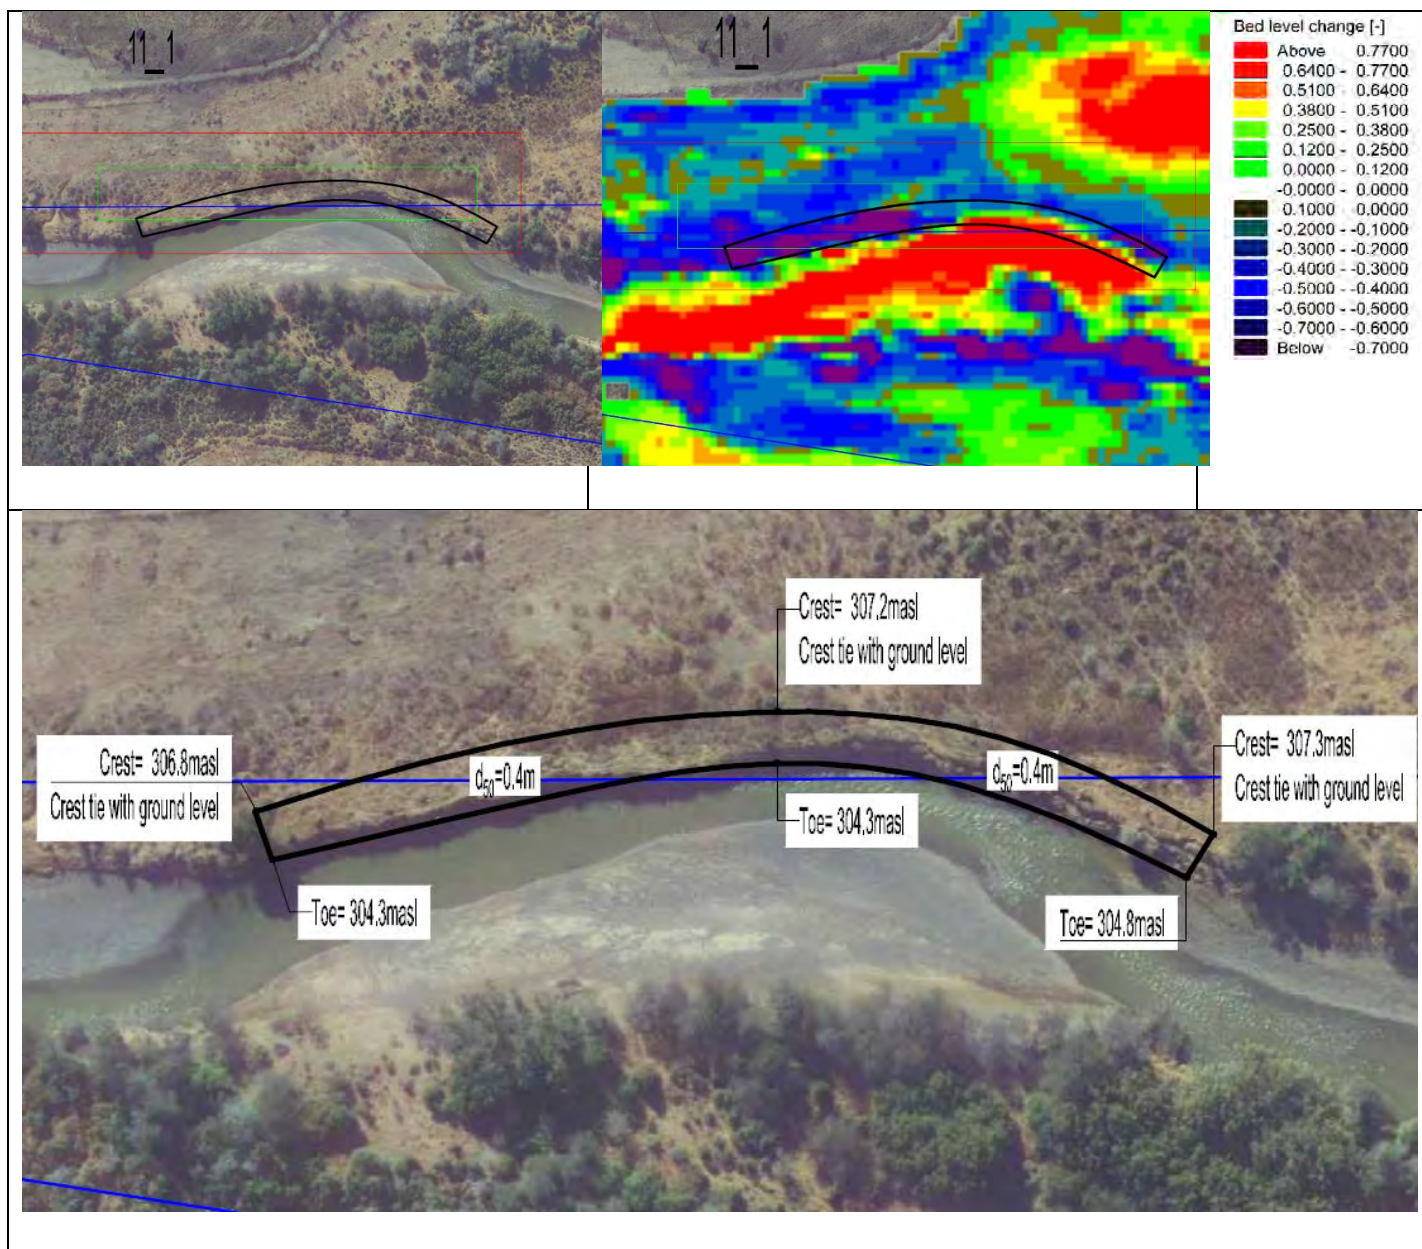
Appendix 66: Zone 11_1 Q10 flood peak scour pattern and proposed scour protection

The zone has unstable banks crossing the servitude and flow is on a wide floodplain. $d_{50} = 0.4$ m, was found appropriate. This area is shown in Appendix 66.

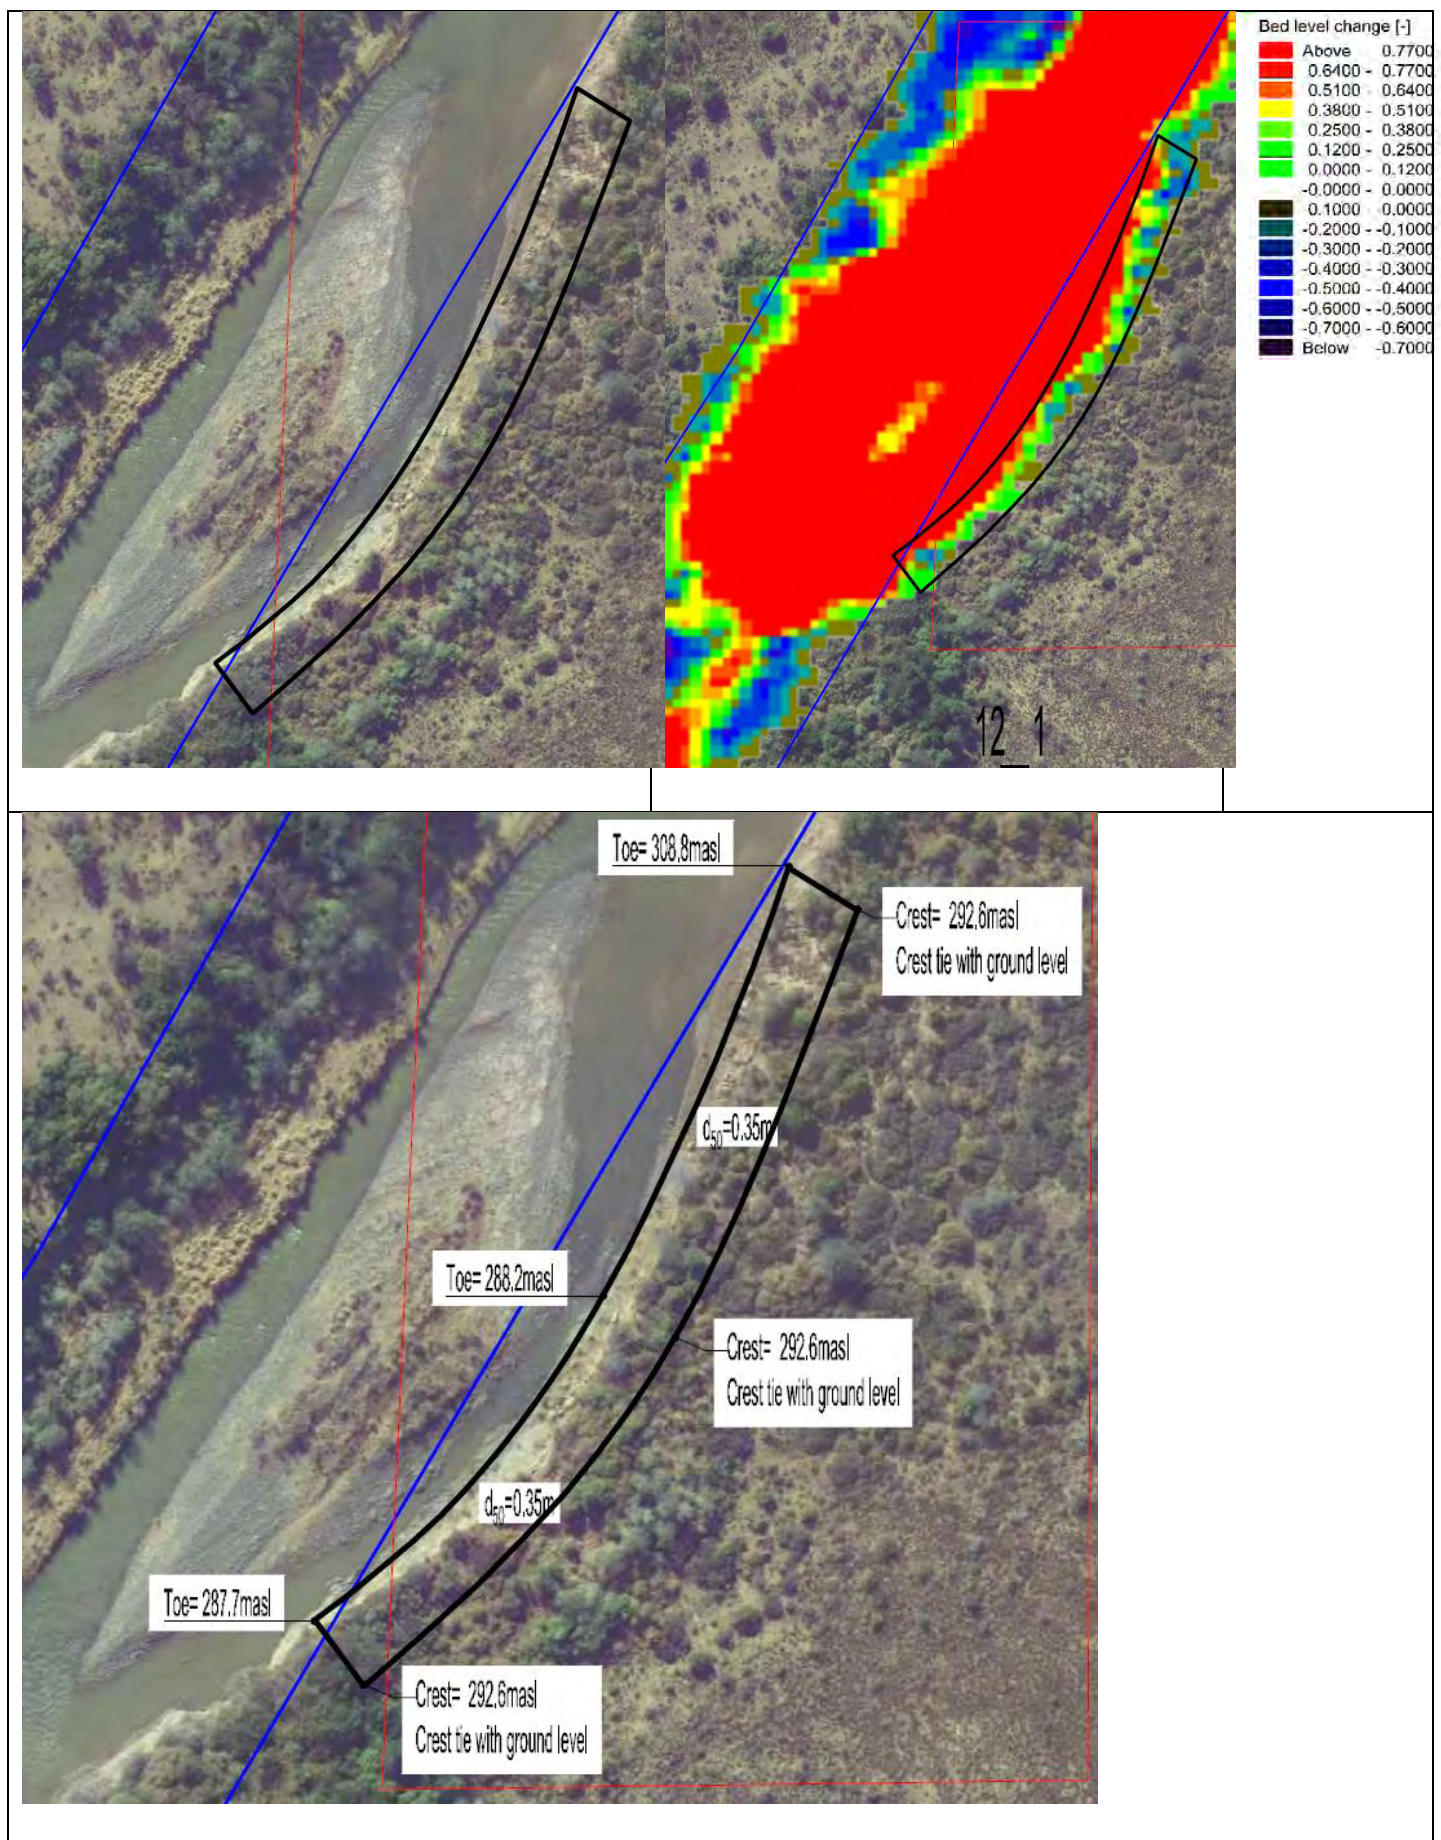
Appendix 70: Zone 12_1 Q10 flood peak scour pattern and proposed scour protection

The zone has unstable banks crossing the servitude. $d_{50} = 0.35$ m was found appropriate. This area is shown in Appendix 70.
