## **FROZEN CORE DAM PERFORMANCE: FOUR YEARS POST CONSTRUCTION**

Megan Miller, PEng, SRK Consulting (Canada) Inc., Vancouver, BC, Canada  
Maritz Rykaart, PhD, PEng, SRK Consulting (Canada) Inc., Vancouver, BC, Canada

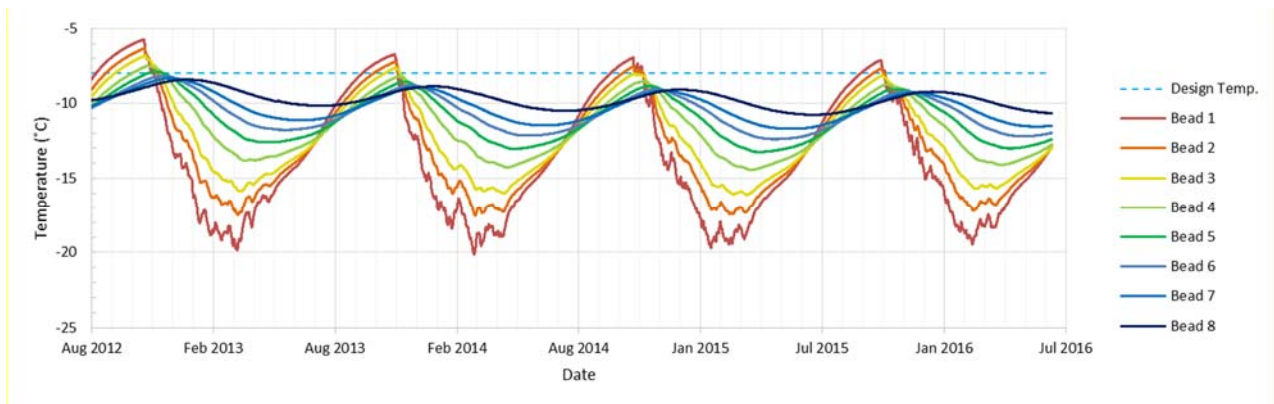
Foundation and core temperature for the North Dam are all at or below design temperatures, with the exception of one vertical GTC in the key trench at station 0+175 m (ND-VTS-175-KT); which has shown a steady cooling trend since 2012. Since completion of construction, all core GTC measurements have cooled slightly, and all core GTCs are measuring temperatures well below  $-2^{\circ}\text{C}$ , with the warmest temperature measured in the last year being approximately  $-5^{\circ}\text{C}$ . While these temperatures are colder than design, and colder than thermal modelling would predict, these values can easily be explained by the lack of water along the upstream face of the dam. Production has not yet started and therefore water levels within the TIA are only marginally higher than the original lake level, with less than 1.5 m of water against the dam face. The lack of latent heat of water along the upstream face and the increased freezing during the winter months have allowed the core temperatures to become colder than expected.

Unlike the core, key trench foundation temperature measurements indicate that after construction the foundation temperatures in a few places were warmer than design temperatures. In 2012, the ground temperature cables ND-VTS-175-KT, ND-VTS-085-KT and ND-VTS-040-KT all had some foundation measurements warmer than  $-8^{\circ}\text{C}$ , with no areas warmer than  $-5.7^{\circ}\text{C}$ . Since 2012 a cooling trend has been observed, and all foundation measurements for both ND-VTS-085-KT and ND-VTS-040-KT are now below  $-8^{\circ}\text{C}$  (Figure 5 and Figure 6). While ND-VTS-175-KT (Figure 7) still has two beads warmer than design temperature, the maximum measured temperature in the last monitoring year is  $-7.1^{\circ}\text{C}$ , and the measured temperatures have decreased more than  $1^{\circ}\text{C}$  since 2012.

Figure 5: Temperature versus time of GTC ND-VTS-175-KT

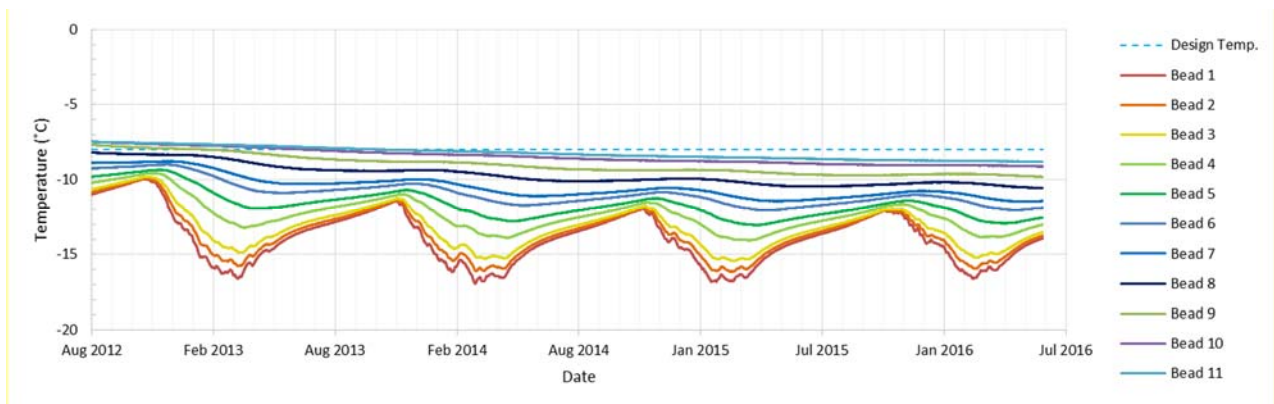
Figure 6: Temperature versus time of GTC ND-VTS-085-KT

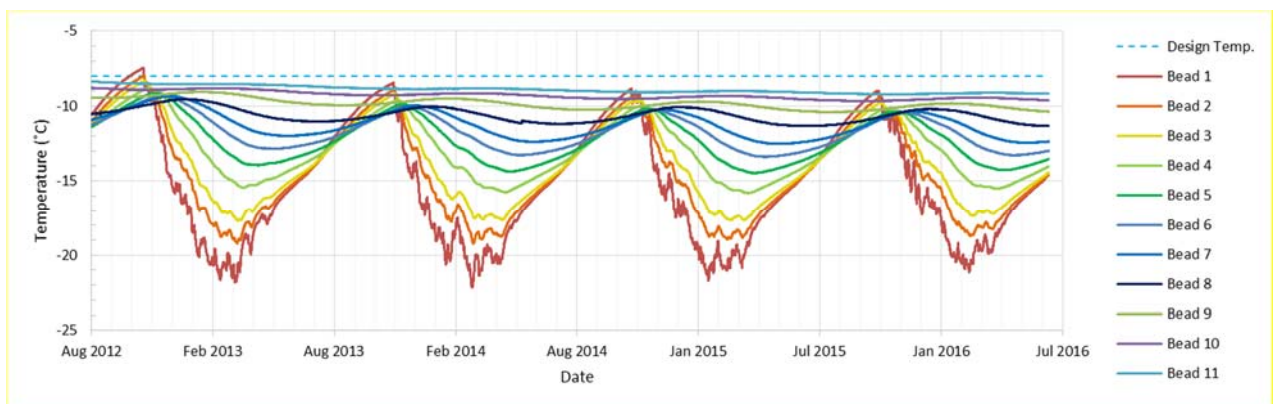
Figure 7: Temperature versus time of GTC ND-VTS-040-KT

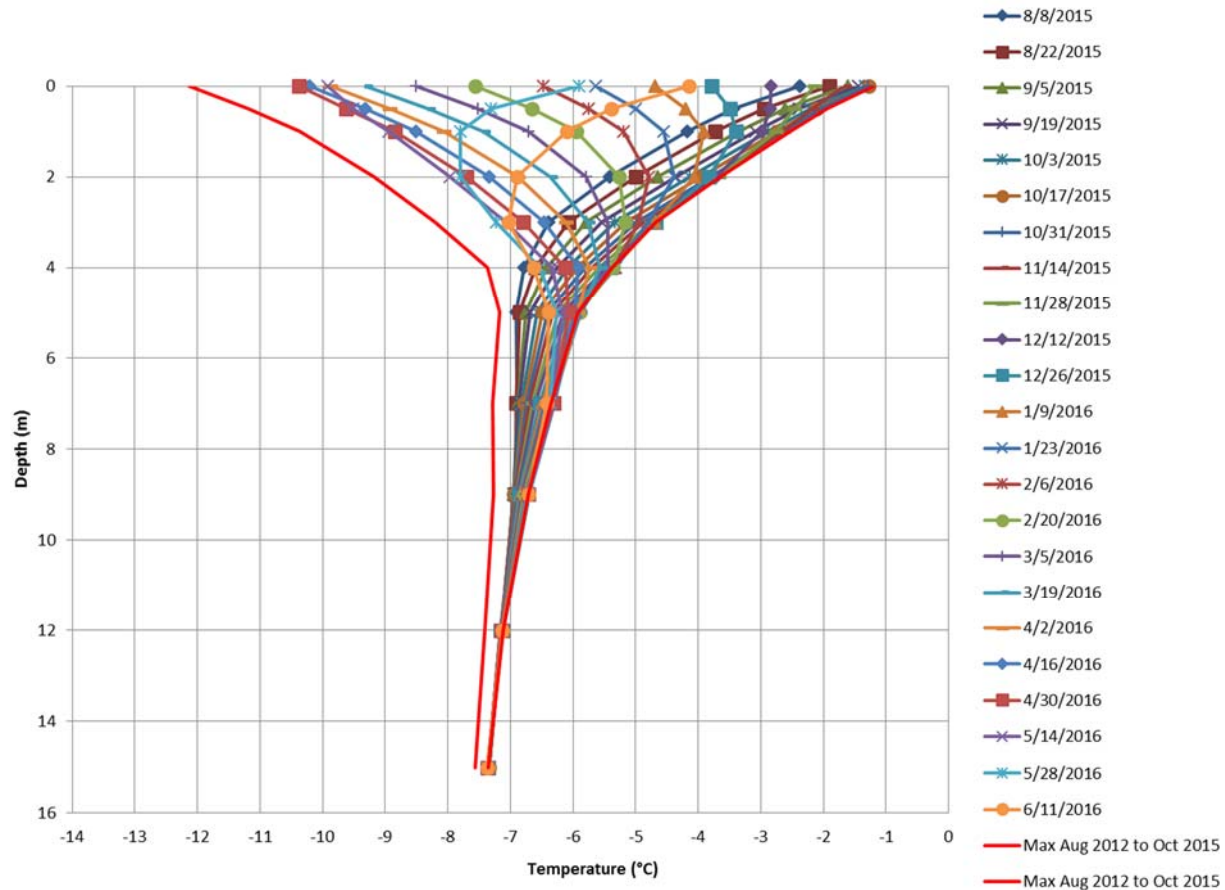
The maximum measured temperatures of near surface beads for vertical GTCs upstream and downstream of the key trench have been between  $0^{\circ}\text{C}$  and  $-2^{\circ}\text{C}$  since 2015. These warmer temperatures are consistent with the design thermal modeling, and are a function of the ambient conditions. Figure 8 provides an example of this for the upstream vertical GTC at station 0+085 m.

Figure 8: 2015-2016 Temperature profile of GTC ND-VTS-085-US

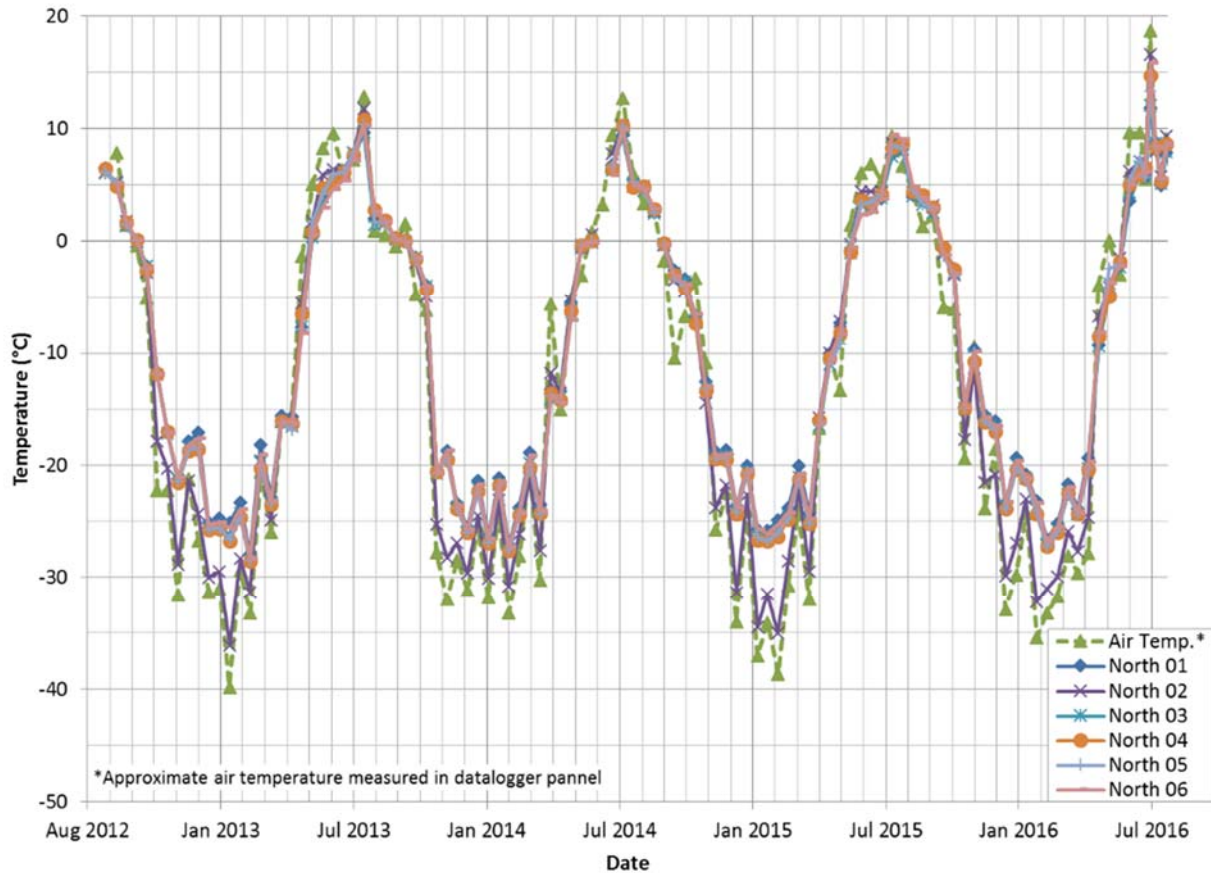
Thermosyphon pipe temperatures and horizontal GTC measurements both indicate that eleven of the twelve installed thermosyphons are working as expected. Temperature measurements for North 02, however indicate that it has not been functioning correctly since monitoring started. Figure 8 shows the measured pipe and air temperatures for the north thermosyphons versus time since 2012. The non-functioning thermosyphon is however not impacting the dam performance as illustrated by the thermal data.

Figure 8: North thermosyphon pipe temperature versus air temperature

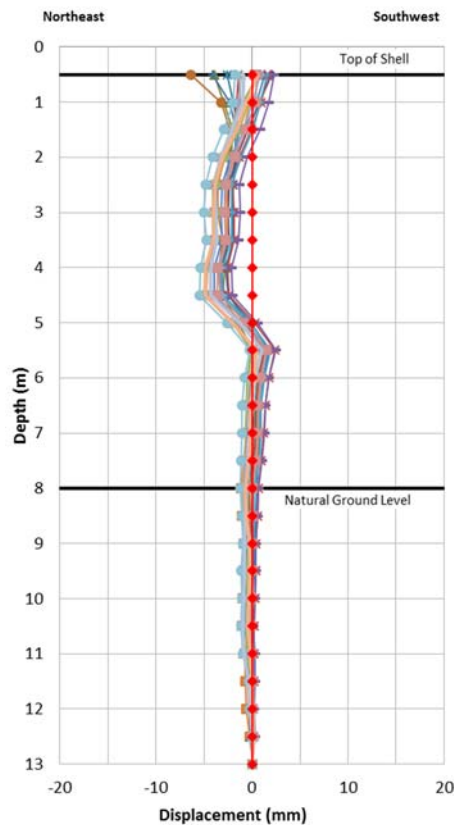
Deformations measured by the deep survey monitoring points, the crest survey monitoring points and the inclinometers has generally been small. The measured horizontal and vertical displacement of the crest survey monitoring points and the deep monitoring points has been less than 10 mm which is close to survey accuracy. Deformations along the inclinometer profiles have shown only small displacements (less than 20 mm) in the portion of the profile which is within the shell of the dam, and displacements within the foundation material are very small with a maximum measured displacement of 5 mm.

Figure 2: Typical Longitudinal Displacement of Incliner

As expected the measured horizontal and vertical displacements of the surficial survey monitoring points are larger than the crest and deep survey points, with measurements in the range of 20 mm. All of these results suggest that the dam is not currently experiencing creep deformation.
