Geophysical imaging of permafrost conditions along the northern Yukon Alaska Highway

Greg A. Oldenborger & Anne-Marie LeBlanc
Geological Survey of Canada, Ottawa, ON, Canada
Chris W. Stevens
SRK Consulting Inc., Anchorage, AK, USA
Jason Chartrand
Geological Survey of Canada, Ottawa, ON, Canada
Benoit Loranger
Université Laval, Québec, QC, Canada

Challenges from North to South
Des défis du Nord au Sud

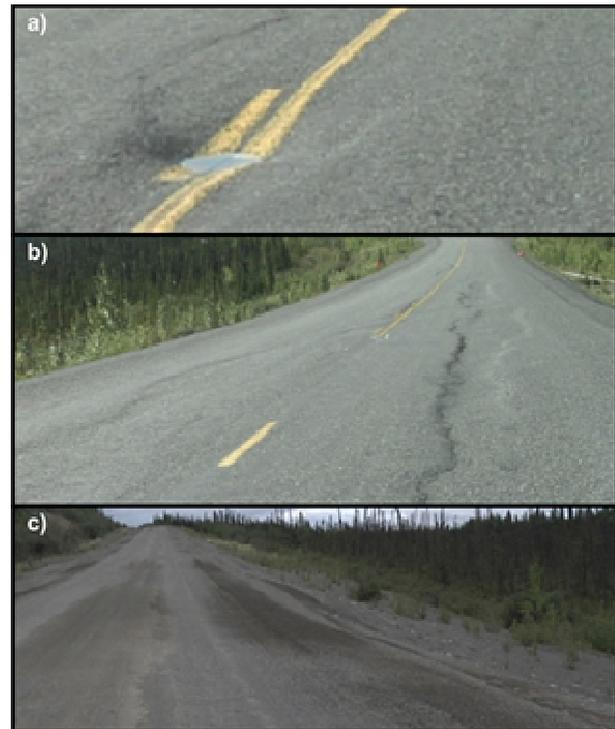
damage was related to thaw settlement which was classified as 1) local settlement occurring over a small area, 2) linear settlement occurring as elongate damage in any direction, and 3) general settlement occurring over large areas and affecting significant portions of the road surface and/or embankment. Local settlement includes damage such as sinking guardrails, isolated sinkholes and small depressions (Figure 2a). Linear settlement includes damage such as elongated depressions, cracking of the road surface or embankment and culvert failure (Figure 2b). General settlement includes large sections of differential settlement over the road and/or embankment (Figure 2c). In addition, the severity of the observed damage was classified in a purely relative sense as light, medium or severe.

Figure 2. a) Localized damage: punctual thaw settlement, km 1896.2, 2011. b) Linear damage: longitudinal settlement, km 1896.4–1896.2, 2011. c) General damage: differential settlement, km 1894.4–1894.3, 2012.

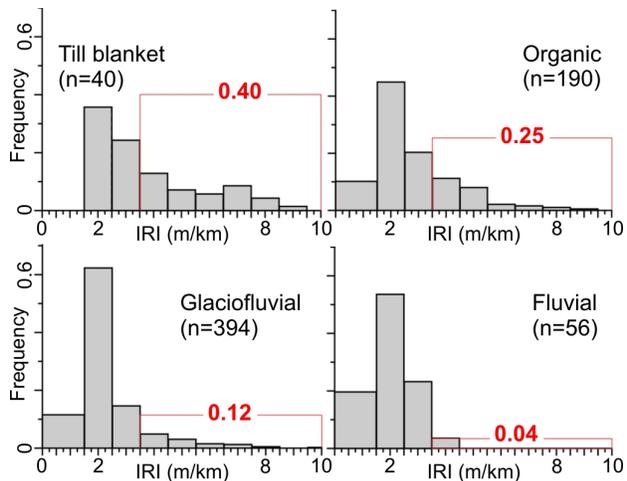
We analysed the International Roughness Index (IRI) measurements (provided by YHPW) from Kluane Lake to the Canada-US border for the year 2010 (Figure 3). IRI represents cumulative vertical displacement of a sprung mass relative to a vehicle axle over a 100 m distance. Very poor highway conditions most frequently occur within Till and Organic surficial units for which ICE is encountered at a range of depths; poor IRI regions are also encountered for units with no observed ICE, although other types of ground ice may be present (Oldenborger et al., 2015). Surficial geology units with better IRI distributions are glaciofluvial, fluvial, colluvial and eolian. Causes of surface roughness may reside below the depth

Figure 3. IRI measurements for km 1684.0–1902.5 classified as good: 0.0–1.5 m/km, ok: 1.5–2.5 m/km, poor: 2.5–3.5 m/km and very poor: 3.5–10 m/km. The portion of very poor conditions is indicated in red.

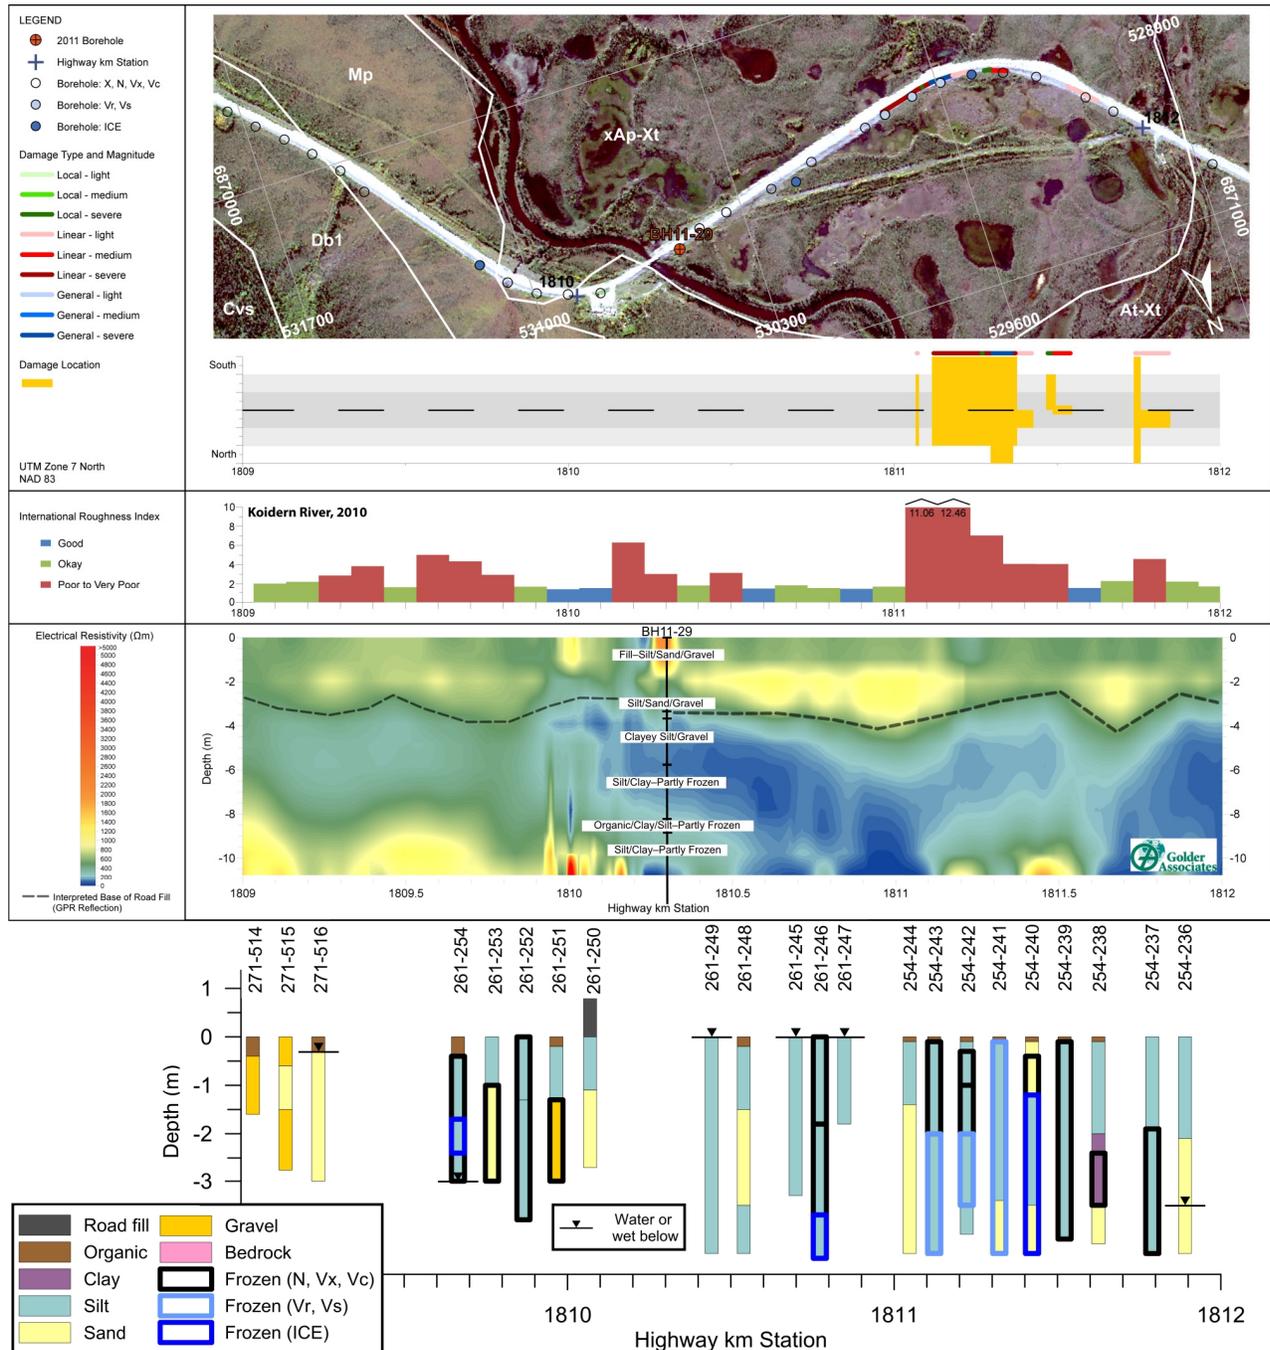
The Koidern River highway section extends from km 1811.1–1814.0 (Figure 1) and crosses a fluvial plain consisting of silt with organic surface cover (Figure 4). Geotechnical boreholes indicate that the sediment texture transitions from mostly silt with sand to sand and gravel across nearby fluvial terraces. The highway section extends across thermokarst terrain which closely follows the limit of the silt-rich fluvial plain. Boreholes confirm that ground ice is a major component of the cryostratigraphy (boreholes 261-254 to 254-237).

Highway damage along the Koidern River section was identified in 2010 mostly as light-to-severe linear settlement coincident with poor to very poor IRI measurements. Conversely, poor and very poor IRI measurements are not necessarily accompanied by observable surface damage as classified here using vehicle-level photographs. Observable damage appears to be confined to the thermokarst terrain and related to observations of ground ice, whereas poor to very poor IRI measurements extend across thermokarst terrain into morainal tills with no observed ground ice (boreholes 271-514 to 271-516).

Despite the multiple borehole observations of ground ice, recovered electrical resistivity is generally low along the Koidern River section. The transition from the more resistive morainal tills (300–800 Ω m) to silt-rich ground (<400 Ω m) is apparent near 1809.9 km. From there, a conductive anomaly extends below the interpreted depth of road fill from 1810–1812 km which corresponds to the extent of the thermokarst terrain and may result from

appreciable unfrozen water in the silty sediments. Observed damage does not seem to be related to the conductive anomaly over its entire length. In fact, the observed damage and the historical ground ice observations occur within a region of increased resistivity (1811.1–1811.6 km). This zone of increased resistivity is interpreted to represent ice-rich frozen ground that is undergoing degradation in the midst of relatively unfrozen and wet, but more stable ground. After repairs in 2010,

the IRI measurements over the interpreted frozen ground continued to increase whereas the remaining IRI values, although poor, remained the same (Oldenborger et al., 2015).

The frozen sediment in the 2011 borehole BH11-29 may be manifest as the increase in resistivity at approximately 8 m depth. However, resolution loss at depth and model smoothness make identification of a transition at this depth difficult, and the conductive

Figure 4. Koidern River section: surficial geology (Lipovsky and Bond, 2014), damage observations, IRI measurements, geophysical survey results (Hammond, 2013), geotechnical borehole record (Lister, 2011) and sediment texture and ground ice data from 1993 (Lipovsky, 2009).

anomaly at the bottom of BH11-29 is very likely an artefact. The increase in resistivity at approximately 7 m depth at the eastern end of the section is interpreted as a weak bedrock signature. Also due to resolution loss, the magnitude of the recovered resistivity is not likely representative of the true resistivity, but a bedrock interpretation is consistent with surficial mapping of

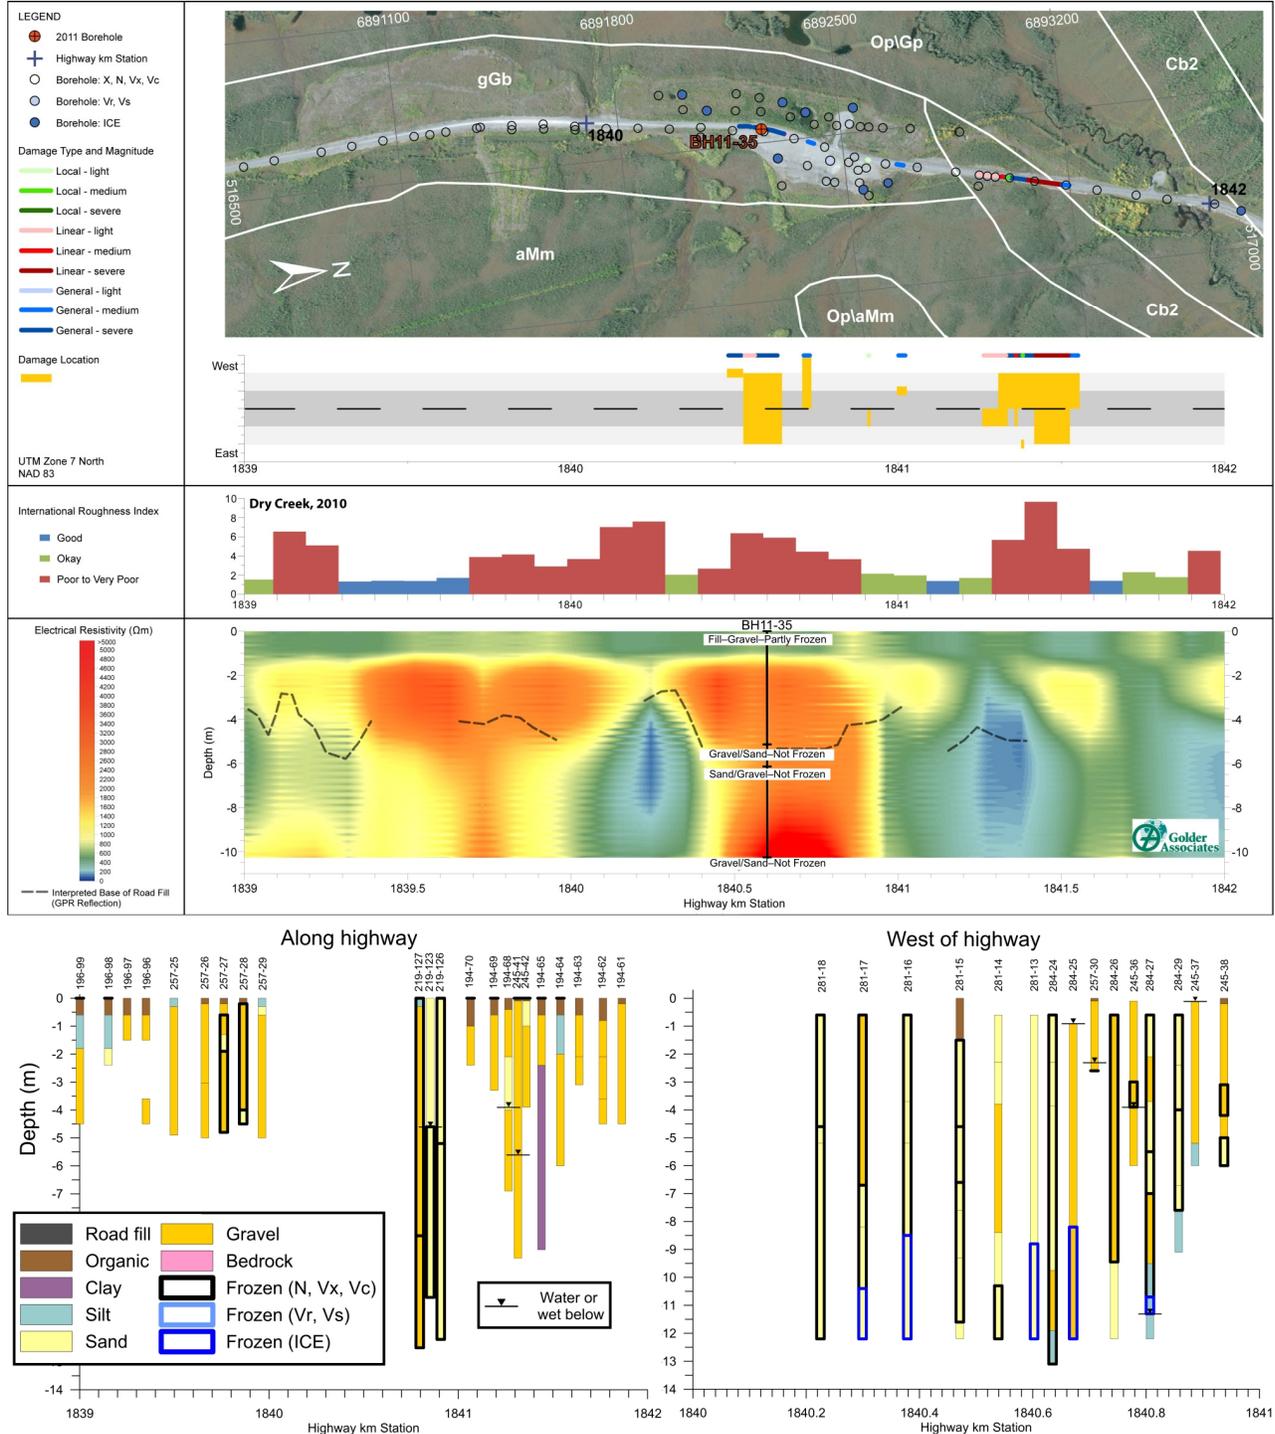
Figure 5. Dry Creek section: surficial geology (Lipovsky and Bond, 2014), damage observations, IRI measurements, geophysical survey results (Hammond, 2013), geotechnical borehole record (Lister, 2011) and sediment texture and ground ice data from 1992–1994 (Lipovsky, 2009).

(Figure 5). The general cryostratigraphy for the glaciofluvial deposit is characterized by relatively ice-poor sands and gravels underlain by deep-seated ground ice below about 6–7 m (boreholes 281-17 to 284-25). Given the low potential for ice segregation in sand and gravel, it is postulated that the ground ice described in the geotechnical boreholes for the Dry Creek section represents relic massive ice buried under glaciofluvial deposits.

Observed highway damage includes all forms of settlement characterized mostly as moderate to severe. Local and linear settlements predominately occur west of the highway, extending from the embankment to the adjacent highway lanes. Again, observed damage coincides with poor and very poor IRI measurements, but there are many poor IRI measurements that have no apparent associated damage.

Observed road damage near 1840.6 and 1841.4 km is associated largely with unfrozen sand and gravel (glaciofluvial) with limited potential for segregation ice. However, there is a distinct cluster of ICE and other ground-ice observations located near the road. There is apparent correspondence between ice occurrence, observed damage and poor IRI measurements near 1840.6 km. Degradation of deep ice may explain the observed highway damage and the absence of thermokarst directly adjacent to the road.

Borehole observations of ICE are perhaps deeper than the reliable depth of investigation of the CR survey. However, there is a clear resistive anomaly ($>4000 \Omega\text{m}$) at 1840.5 km starting around 8 m depth underneath the already resistive sands and gravels ($2000\text{--}4000 \Omega\text{m}$). This is likely the signature of massive ice, but it does not appear to be encountered by BH11-35.

In contrast, there are no observations of ICE along the road near the damage location of 1841.4 km. This zone is associated with a conductive anomaly ($<400 \Omega\text{m}$) that occurs near borehole observations of unfrozen clay. The anomaly appears to continue into the highway embankment. Such an observation would be consistent with increased moisture content or active groundwater within the embankment and natural ground. Heat advection, thaw settlement of any partially frozen clay, mechanical erosion and seasonal freeze/thaw would all contribute to damage of the highway surface for this zone.

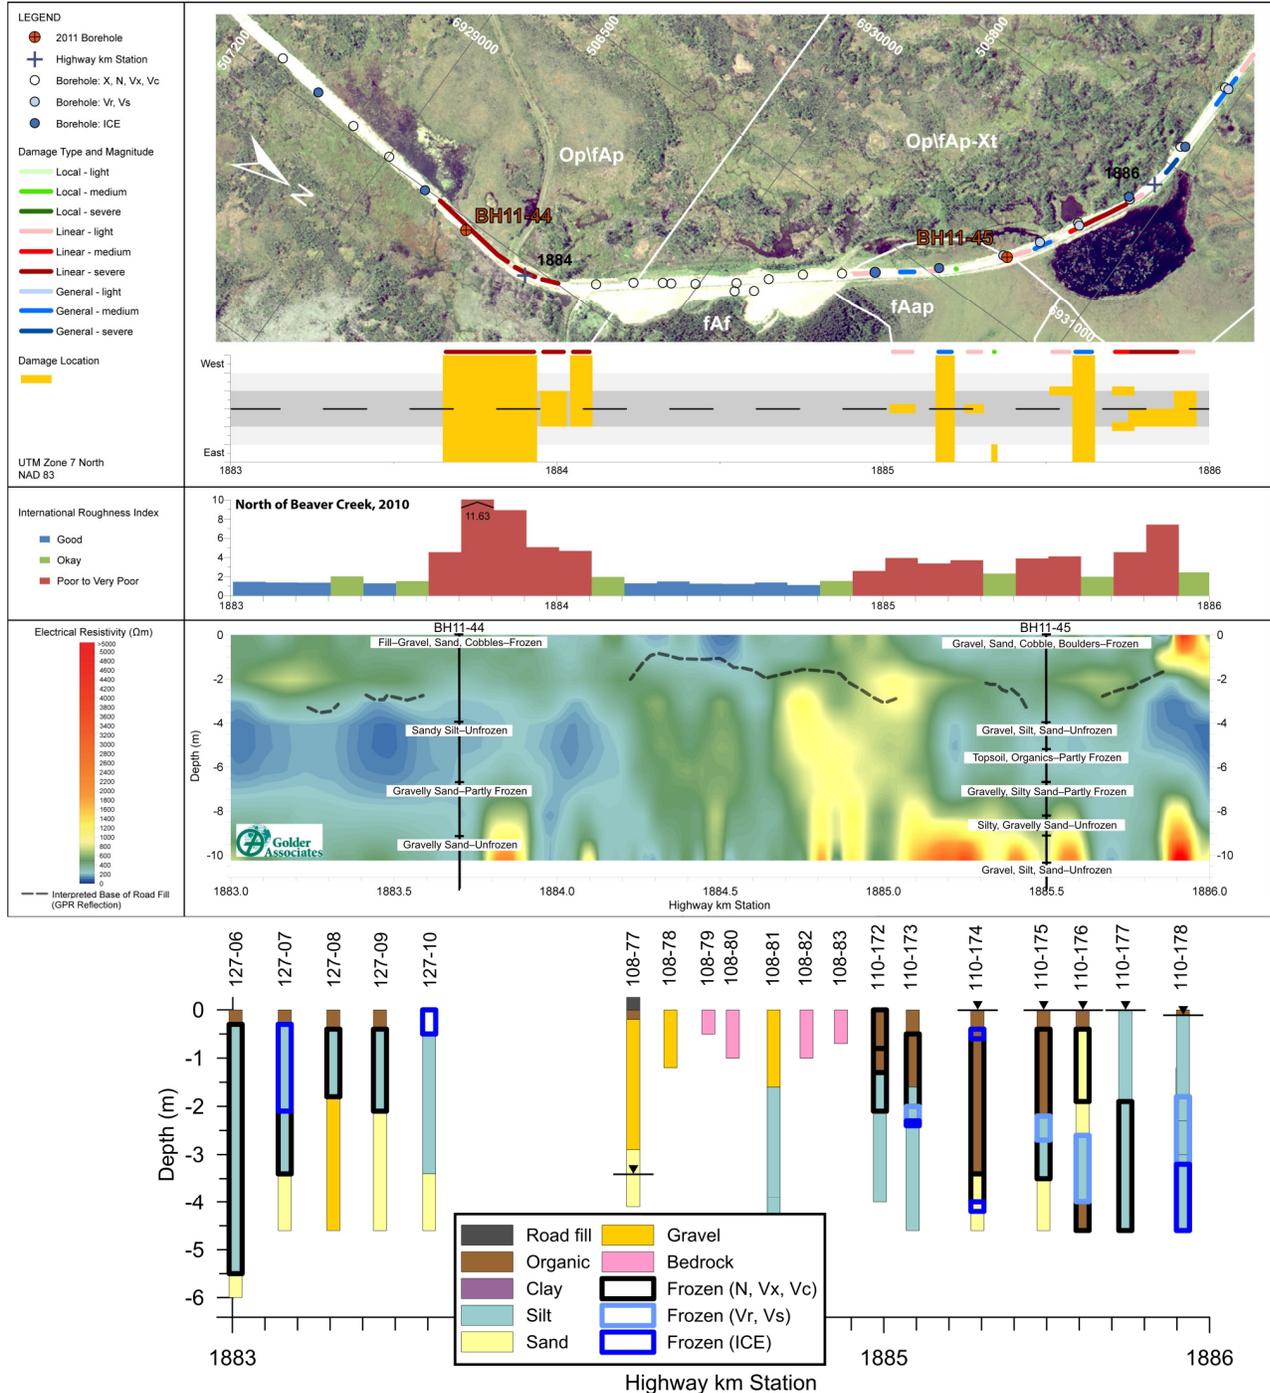
The Beaver Creek section extends from km 1882.6–1898.1 (Figure 1). From km 1883–1886, organic surficial material overlies fluvial sediments and thermokarst features appear across portions of the organic units (Figure 6). Sediment texture is variable; observations of ground ice are prevalent and confined largely to silt. There are some observations of thick frozen organic material that will be highly susceptible to thaw settlement. This section of highway is oriented perpendicular to the direction of surface hydrological flow. Poorly-drained terrain surrounds the highway from 1884–1886 km and surface hydrology or shallow groundwater may play an important role in highway performance.

This part of the Beaver Creek section appears to have a strong relationship between observed damage, poor IRI measurements, and the occurrence of ground ice (boreholes 110-172 to 110-178). However, there is no obvious consistent electrical resistivity anomaly that coincides with the zones of damage. Both sections of elevated IRI measurements near BH11-44 and BH11-45 seem to exhibit reduced resistivity of the embankment material, and high attenuation of the GPR signal is observed near BH11-45 (Hammond, 2013) consistent with increased unfrozen water content or shallow groundwater. These conductive embankment sections occur over silt and organics with ground ice as observed in BH11-44 and BH11-45. It is inferred that the combination of a conductive embankment over conductive frozen silts represents a resistivity anomaly indicative of shallow groundwater-related settlement.

In contrast, the highest observed embankment conductivity is from 1884.1–1884.8 km, but is over borehole observations of bedrock and gravel and coincides with stable good IRI measurements. The resistivity signature of bedrock is not readily apparent, but is interpreted as the moderately resistive anomaly ($1200 \Omega\text{m}$) from 1884.7–1885.1 km below 1–2 m depth. The weakly resistive anomaly ($800 \Omega\text{m}$) from 1884.2–1884.6 km below 2 m depth is interpreted as predominantly gravel. Therefore, a conductive embankment signature alone is not necessarily indicative of settlement.

Figure 6. North of Beaver Creek section: surficial geology (Lipovsky and Bond, 2014), damage observations, IRI measurements, geophysical survey results (Hammond, 2013), geotechnical borehole records (Lister, 2011) and sediment texture and ground ice data from 1990–1991 (Lipovsky, 2009).
