Final Basic Assessment Report for the proposed development of the Hlomendlini Sports Facility in Mandeni, KwaZulu Natal

Report Number 559426

February 2022

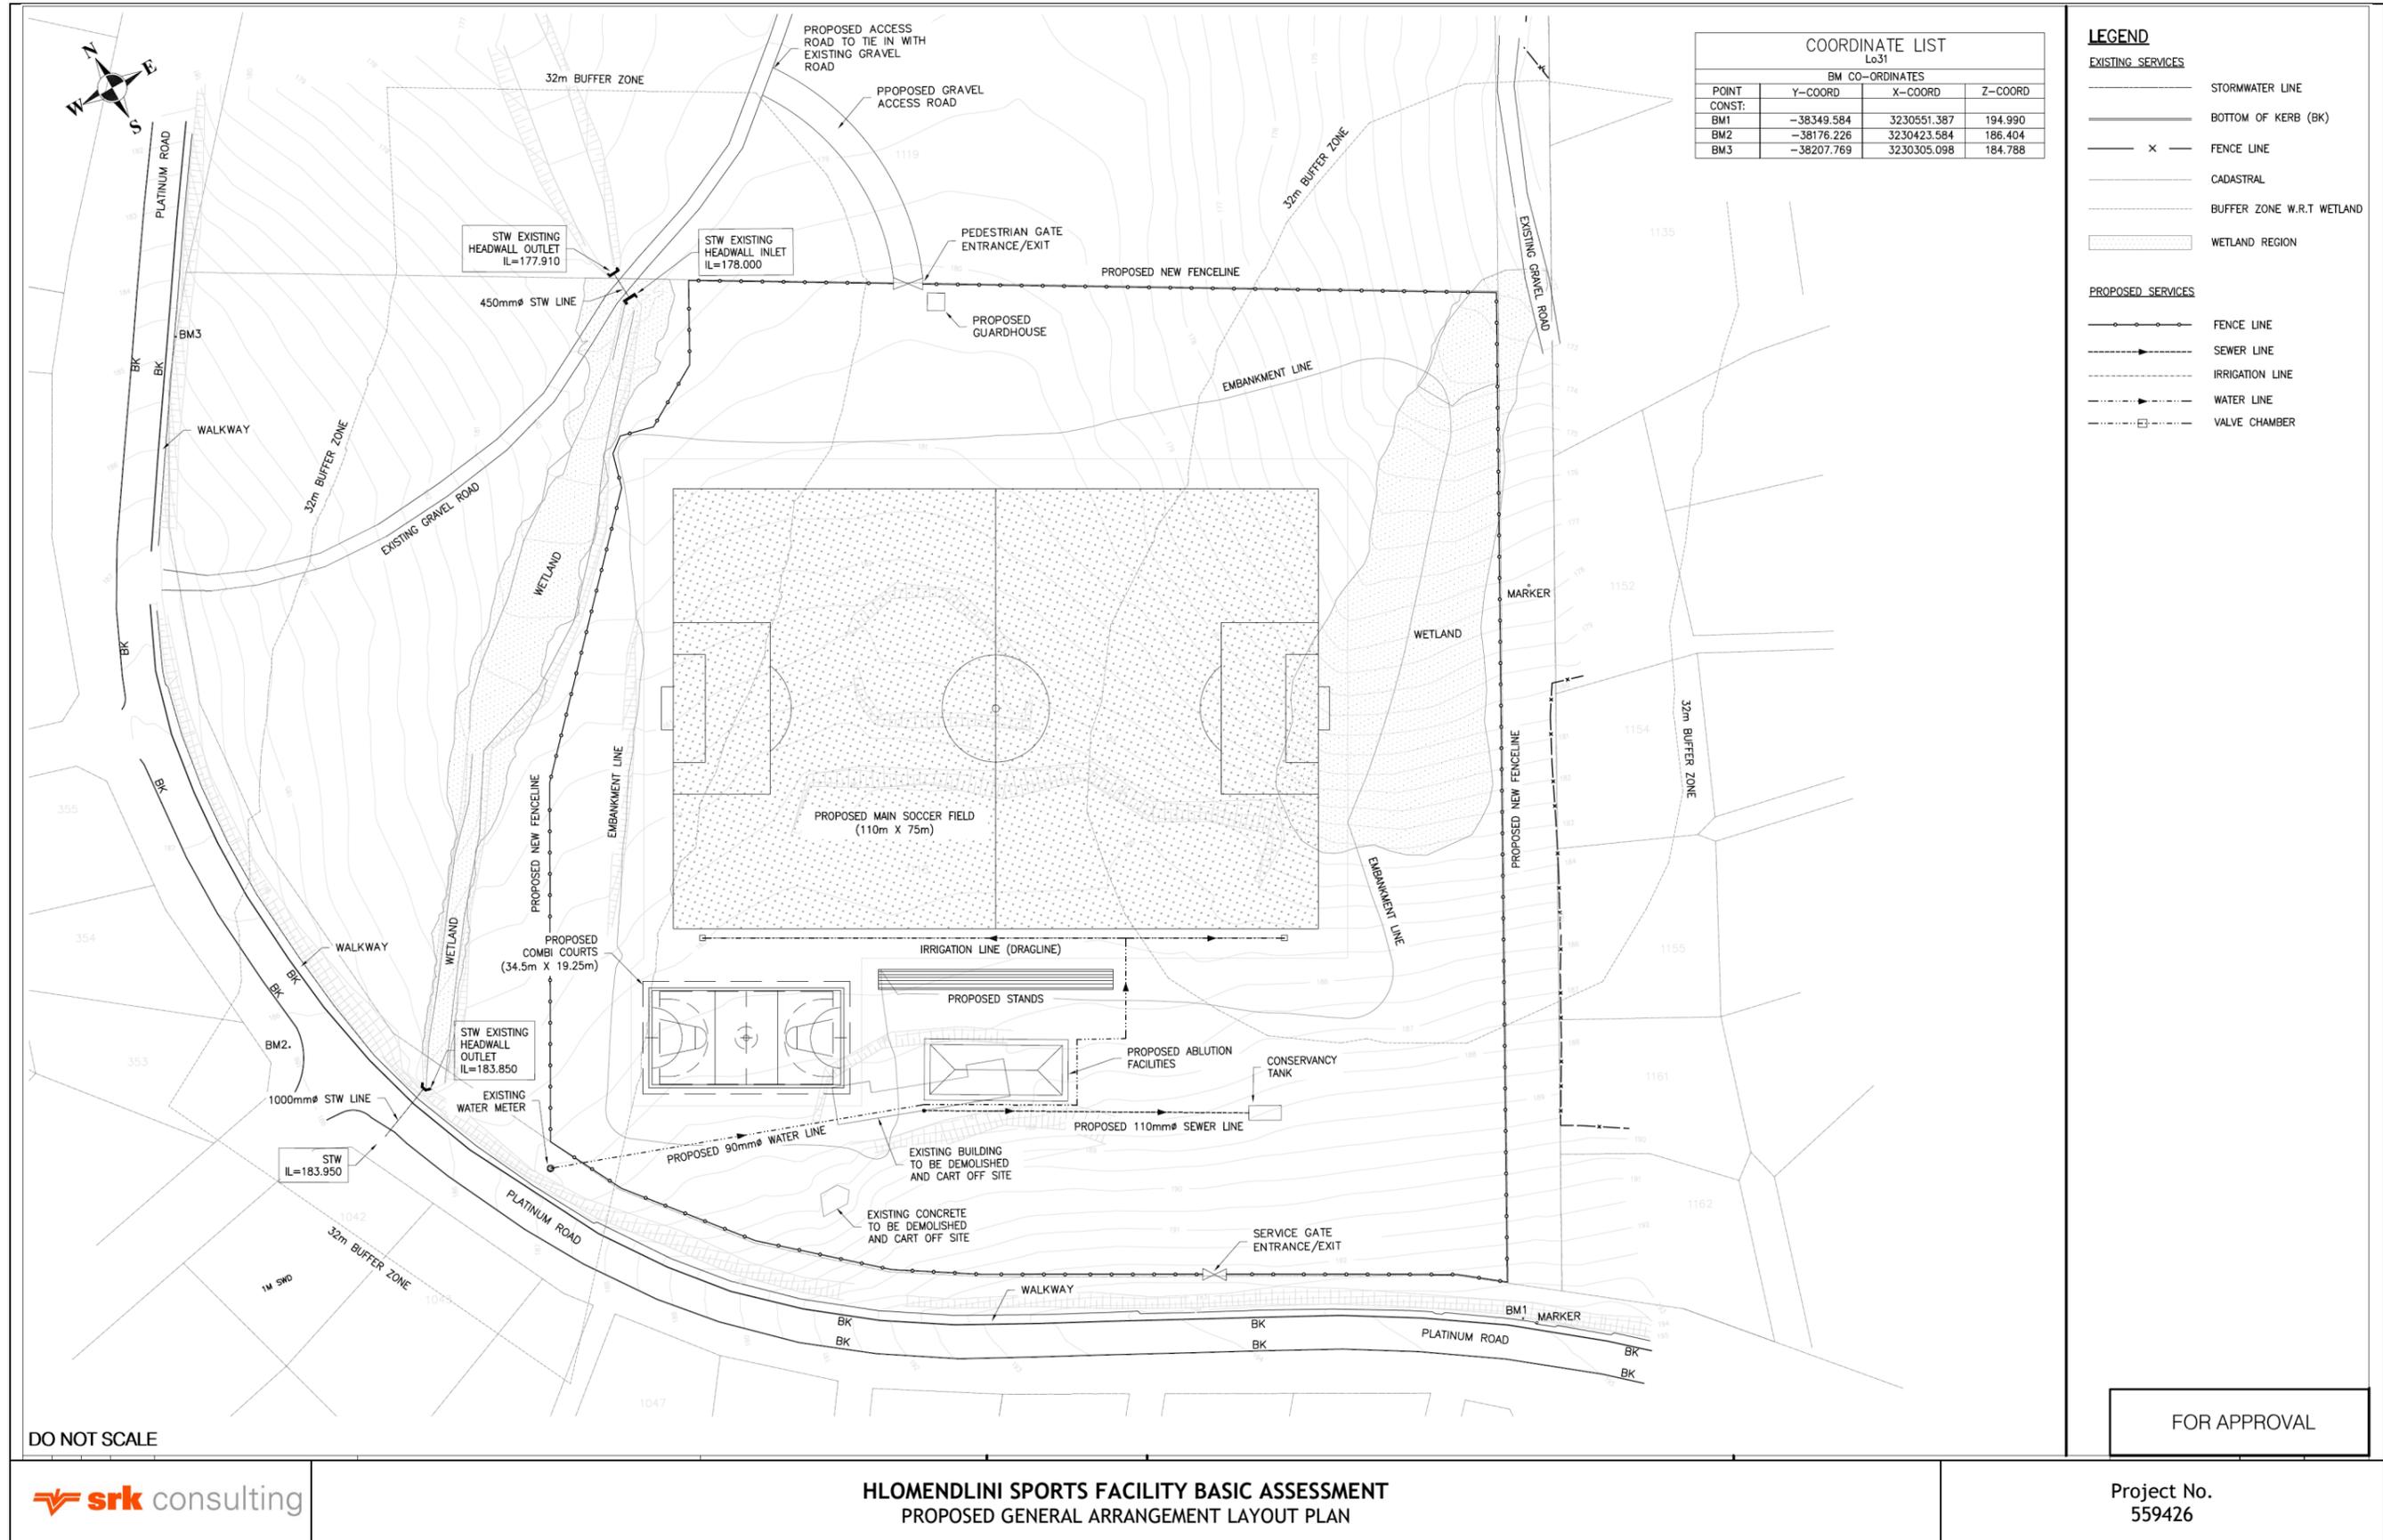
Figure 1-1: Proposed general arrangement layout plan for the preferred alternative

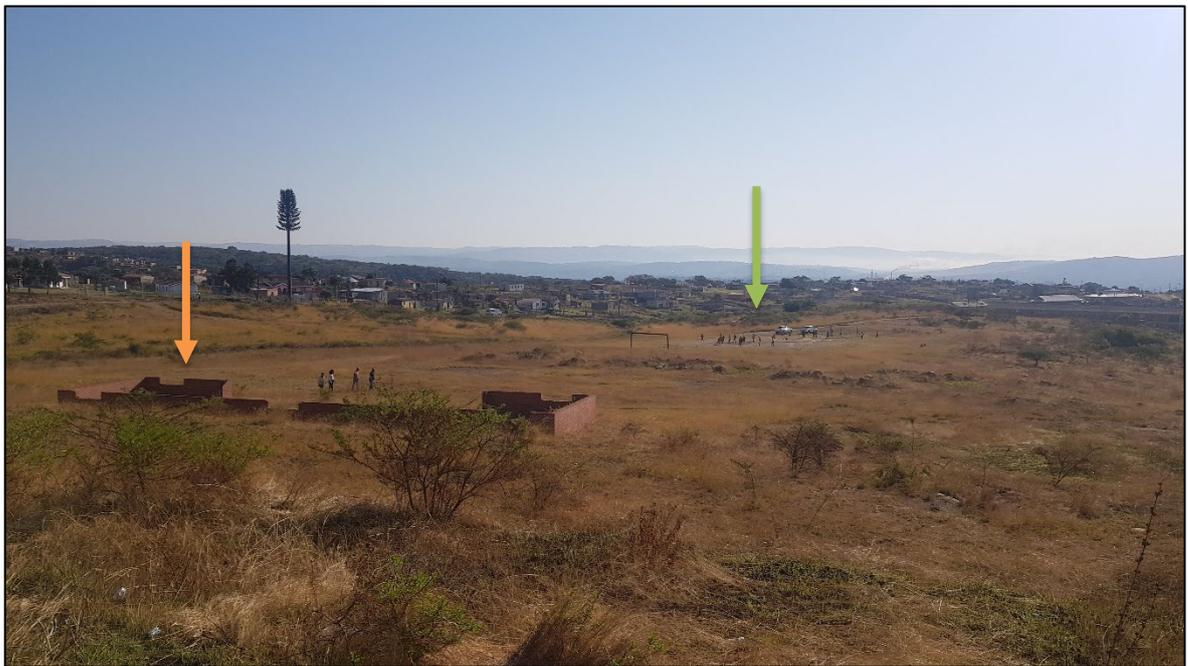
Plate 4-1: Photograph along the southern boundary of the site, looking north-west showing the partially built structure in the foreground (orange arrow) and the local community utilising the site as a soccer field in the background (green arrow) (June 2020)

The CVB wetland has been impacted by various anthropogenic activities in the surrounding catchment, including the surrounding housing development (Plate 4-1) and associated road infrastructure that have altered the pattern, flow and timing of stormwater in the surrounding landscape. This has resulted in increased flood peaks in the CVB wetland, significantly impacting the hydrology. Consequently, runoff from the adjacent residential areas and roads has potentially augmented the surface water input into this system such that the system receives increased volumes of water, leading to the development of prominent wetness indicators and hydrophilic plants. Infilling and modifications to the active channel, particularly from the road and culvert crossing within the wetland (Plate 4-2), further impact the hydrological and geomorphological integrity of the system. The CVB wetland is invaded by Alien and Invasive Plant (AIP) species, contributing to the overall disturbance to the system. Based on the above, the Present Ecological State (PES) of the CVB is therefore Category E (Seriously Modified).

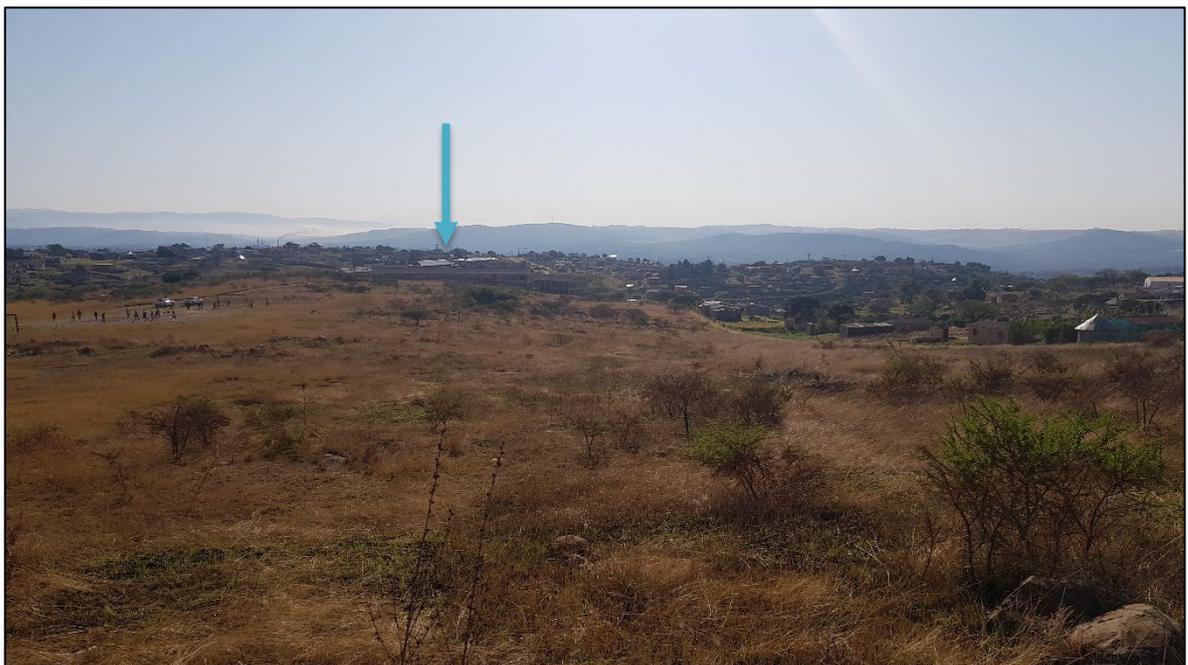
Plate 4-2: Photograph along the southern boundary of the site, looking north-east showing the type of vegetation found across the site, the school in the background (blue arrow) (June 2020)

The site lies approximately 125m from a Critical Biodiversity Area (CBA). Refer to Plate 4-1, Plate 4-2 and Plate 4-3.

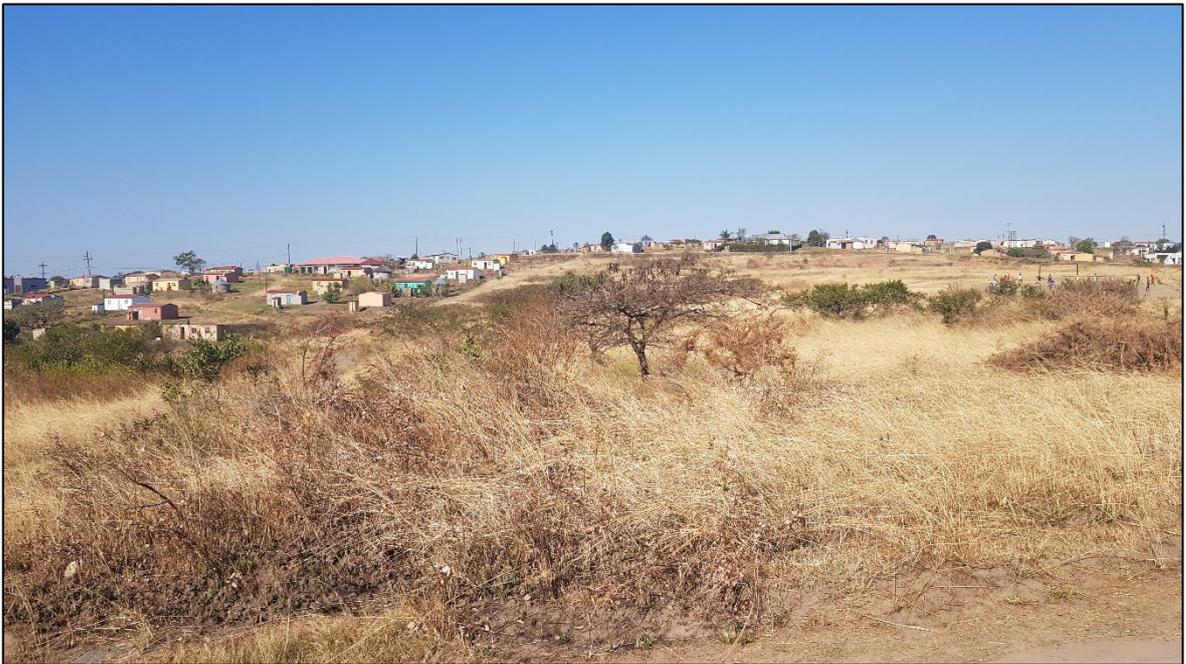
Plate 4-3: Photograph along the northern boundary of the site, looking south/south-west (June 2020)

The valley head seep wetland (Plate 4-3) is within the eastern portion of the site, of which the western portion of this wetland will be traversed by the proposed project.

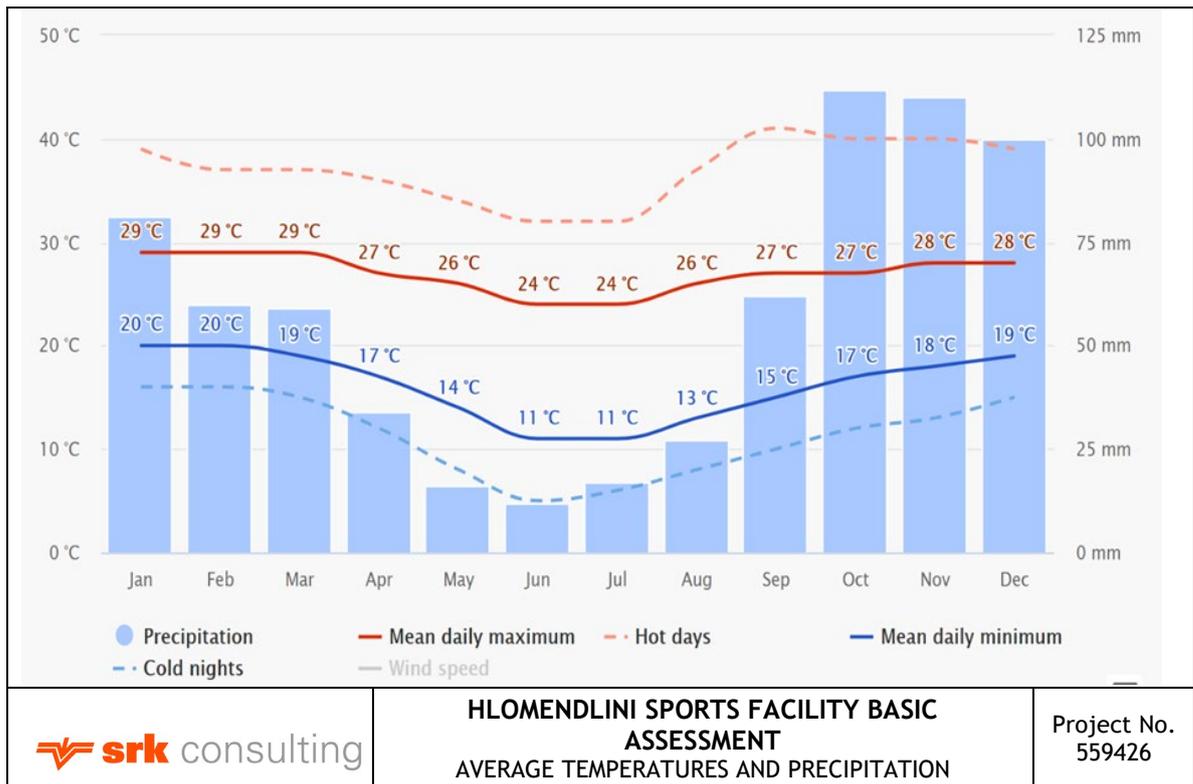
Figure 4-2: Average temperatures and precipitation for Mandeni, KwaZulu-Natal (www.meteoblue.com)

Figure 4-2 shows the mean monthly minimum and maximum temperatures as well as the mean monthly average precipitation. It should be noted however, that the values shown are based on 30 years of hourly weather model simulations and the simulated weather data have a spatial resolution of approximately 30km.

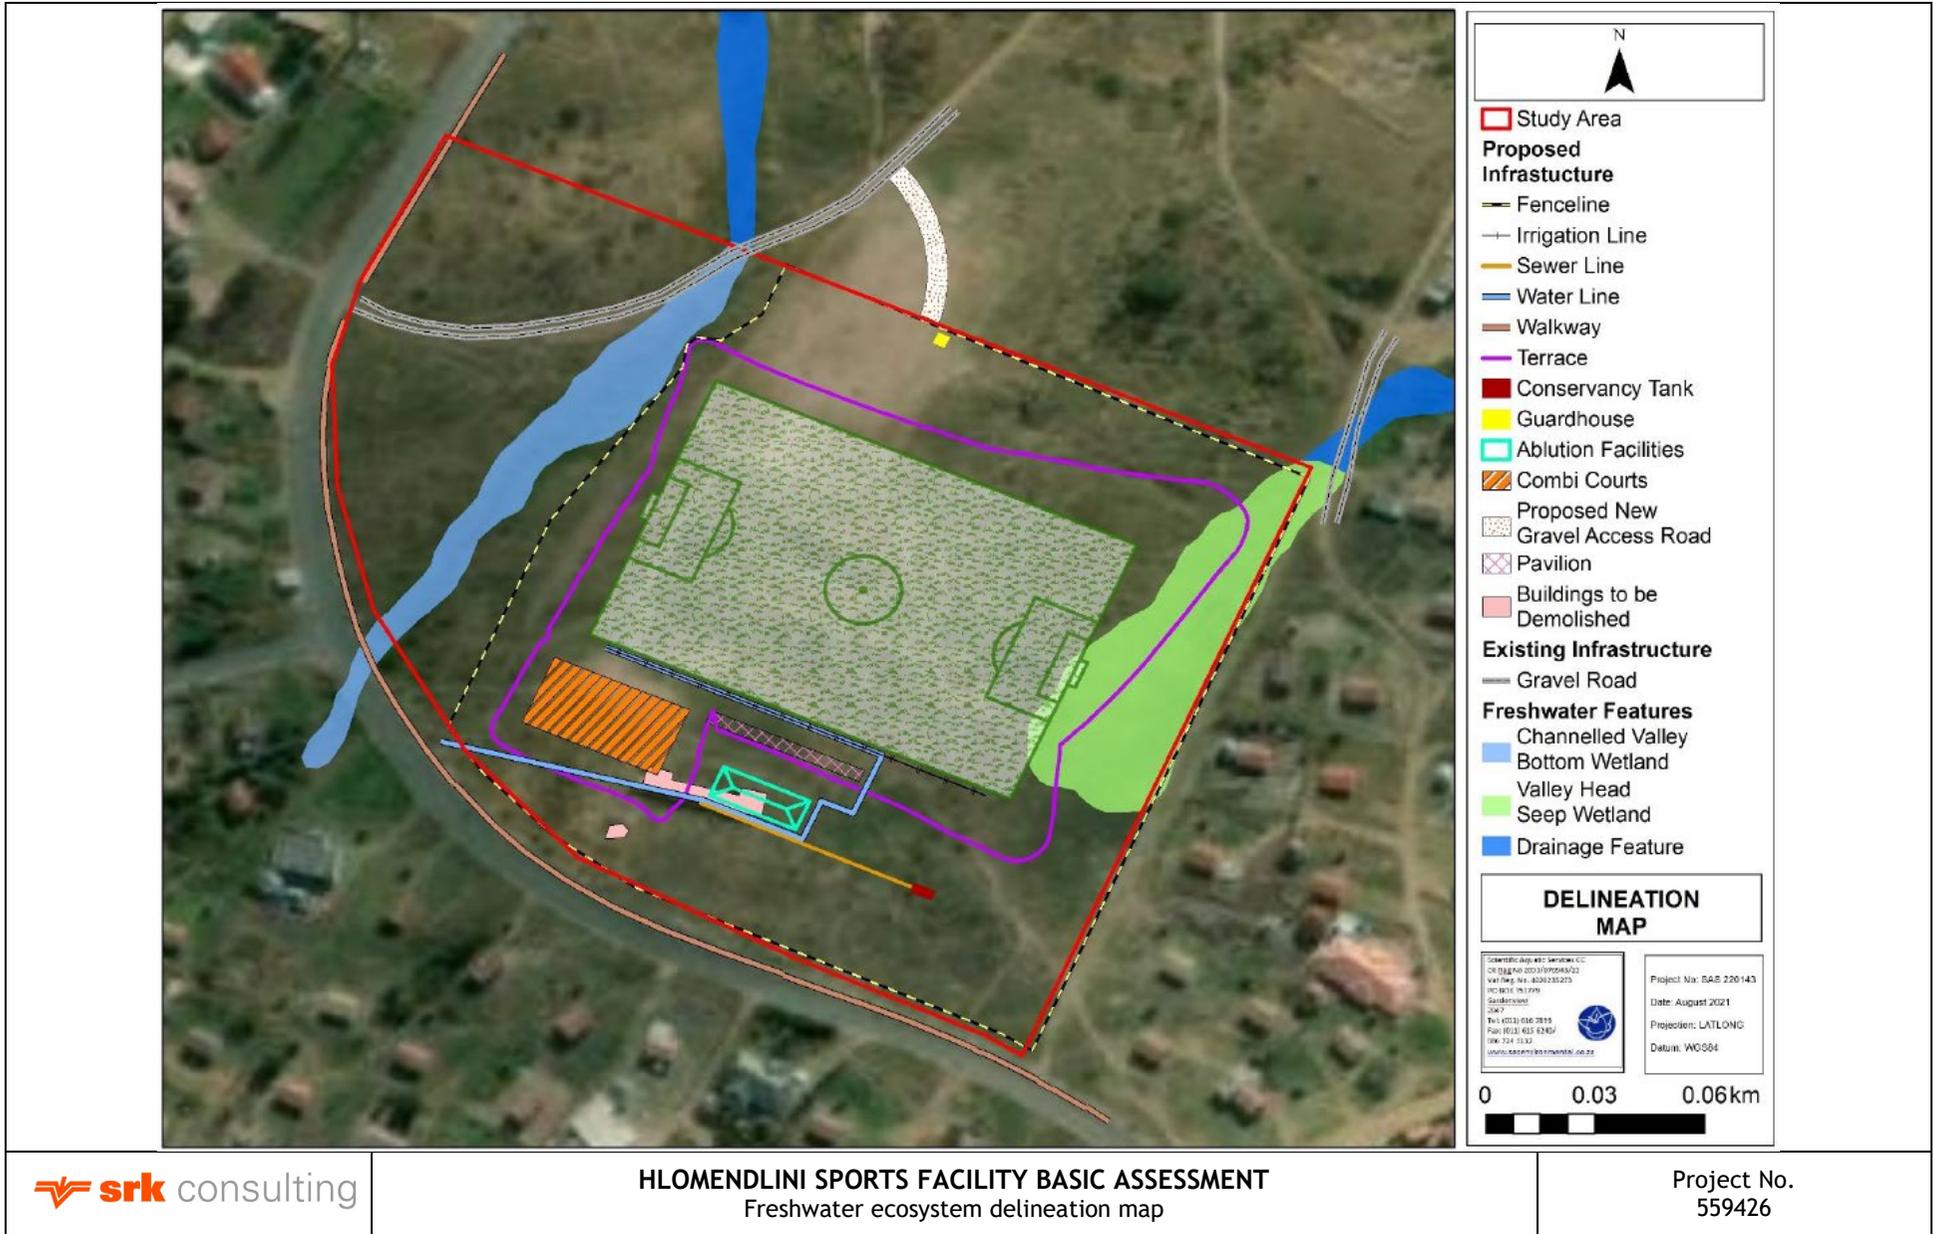
Figure 4-3: Wetland delineation in the study area in relation to the proposed development (Source: SAS/SRK 230321, March 2021)

Two wetlands have been identified and delineated within the boundaries of the site, a modified channelled valley bottom (CVB) wetland and a valley head seep wetland (Figure 4-3). Both systems are connected to drainage features that were identified in the larger investigation area.

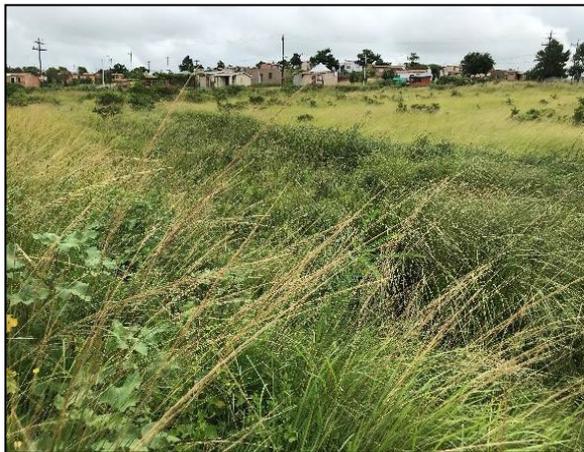
Plate 4-4: CVB wetland receives additional water input from the surrounding housing development

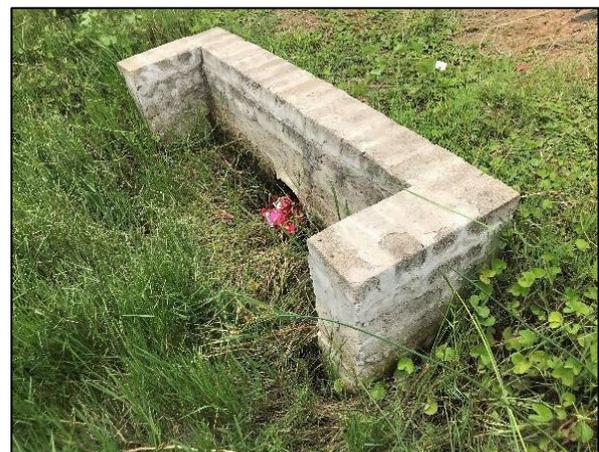
Plate 4-5: Existing culvert crossing within the CVB wetland confining flow

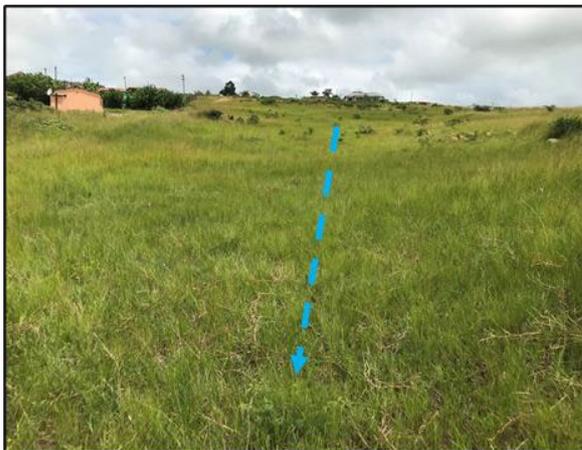
Plate 4-6: Overview of the valley head seep wetland within the surrounding landscape

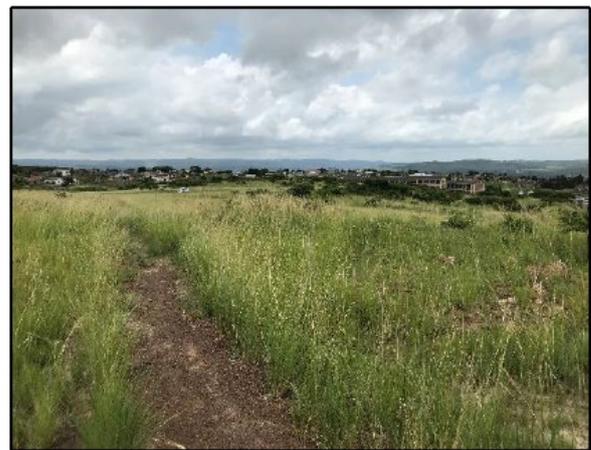
Plate 4-7: Signs of sediment deposition noted within the valley head seep wetland

- **Geomorphology and sediment balance:** The geomorphology of the valley head seep wetland can be considered moderately modified due to increased sediment loads as a result of run-off from the gravel roads resulting in sediment deposition to the wetland. No significant erosion was noted within the wetland due to the surface roughness provided by the vegetation present in the valley head seep wetland.

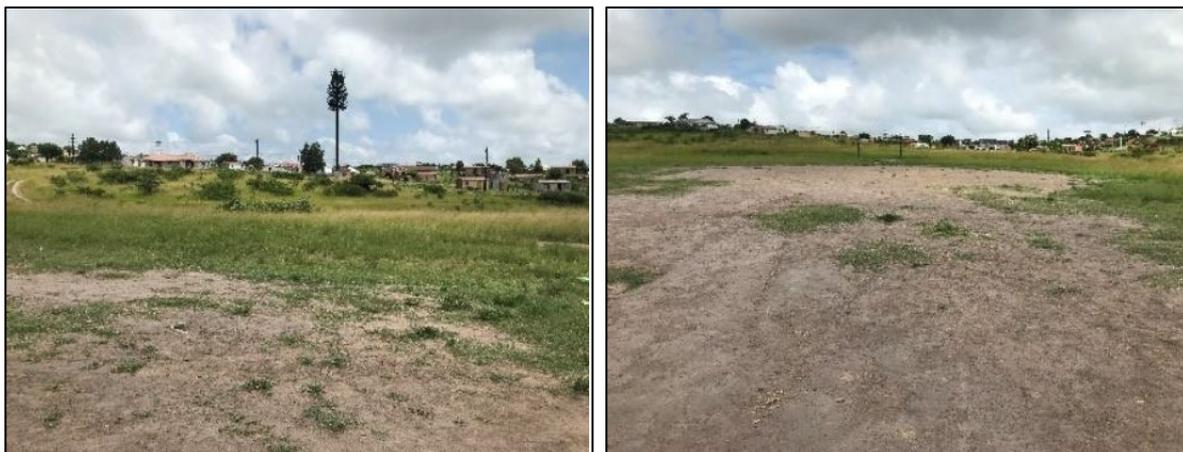
Plate 4-8: Representative images of the remaining grassland areas of the site, including the informal recreational soccer field

The remaining open grassland area within the site (Plate 4-8) has been disturbed as a result of various historic and current land use activities. Most notably, the remaining grassland areas of the site are used by the local community members for recreational (sport) activities as well as the grazing of cattle. Plant species observed in the remaining grassland areas include herbaceous species such as *Cynodon dactylon*, *Eragrostis* spp, *Melinis repens*, *Urochloa* sp and *Digitaria eriantha*. Woody species observed close to the roadside include *Vachellia karoo*, *Chamaecrista comosa*, *Dichrostachys cinerea* and *Vachellia* spp. Whilst some of these species are known from the vegetation type, they are also known to be common and widespread species that occur in areas where ecological integrity has been compromised.

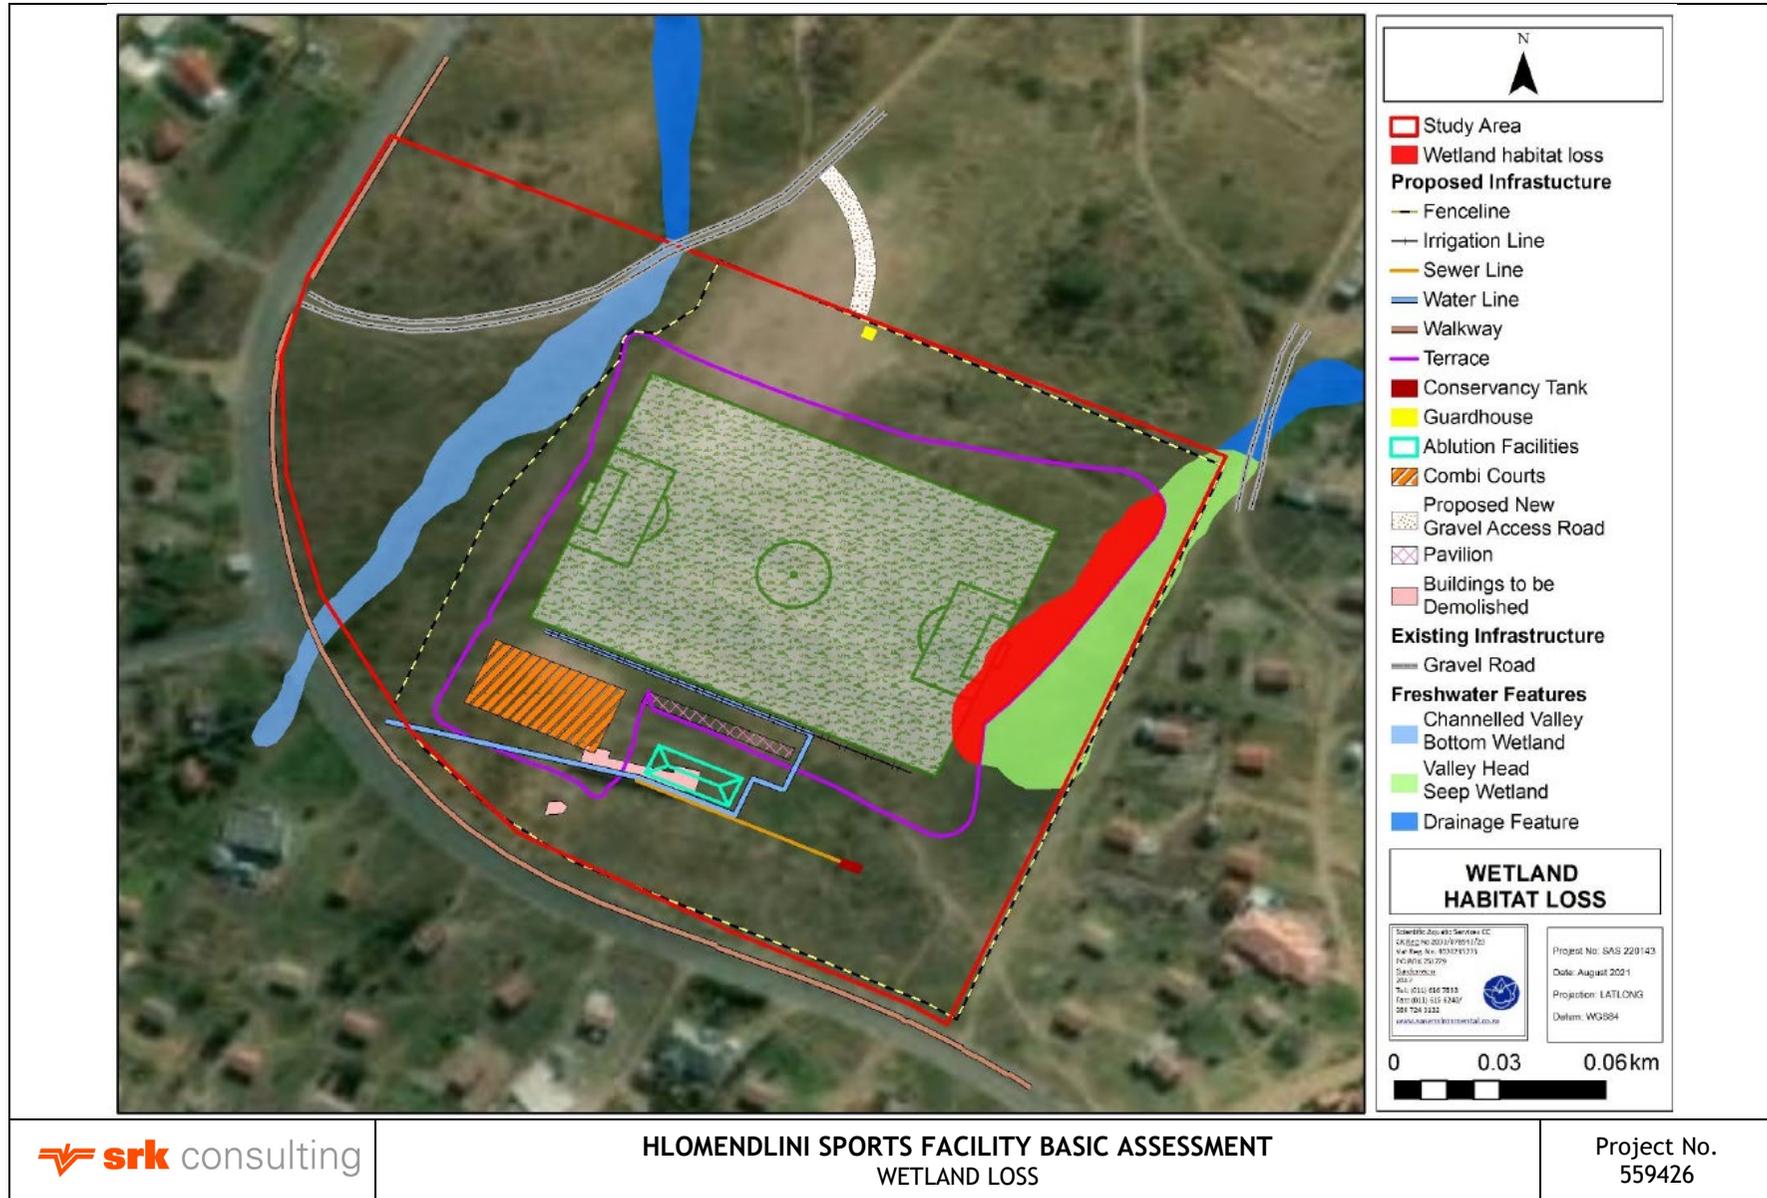
Figure 10-1: Map depicting the wetland habitat loss associated with the proposed main soccer field and terrace within the western extent of the valley head seep wetland

Based on the findings of the wetland assessment and the results of the risk assessment, it is the opinion of the freshwater ecologist that the proposed project poses a Moderate risk to the integrity of the wetlands within the study area, predominantly due to the infilling of the valley head seep wetland associated with the proposed main soccer field and terrace to create a flat platform for the proposed project. This activity will result in habitat fragmentation and the loss of 0.089 ha of wetland habitat in the valley head seep wetland (refer to Figure 10-1).

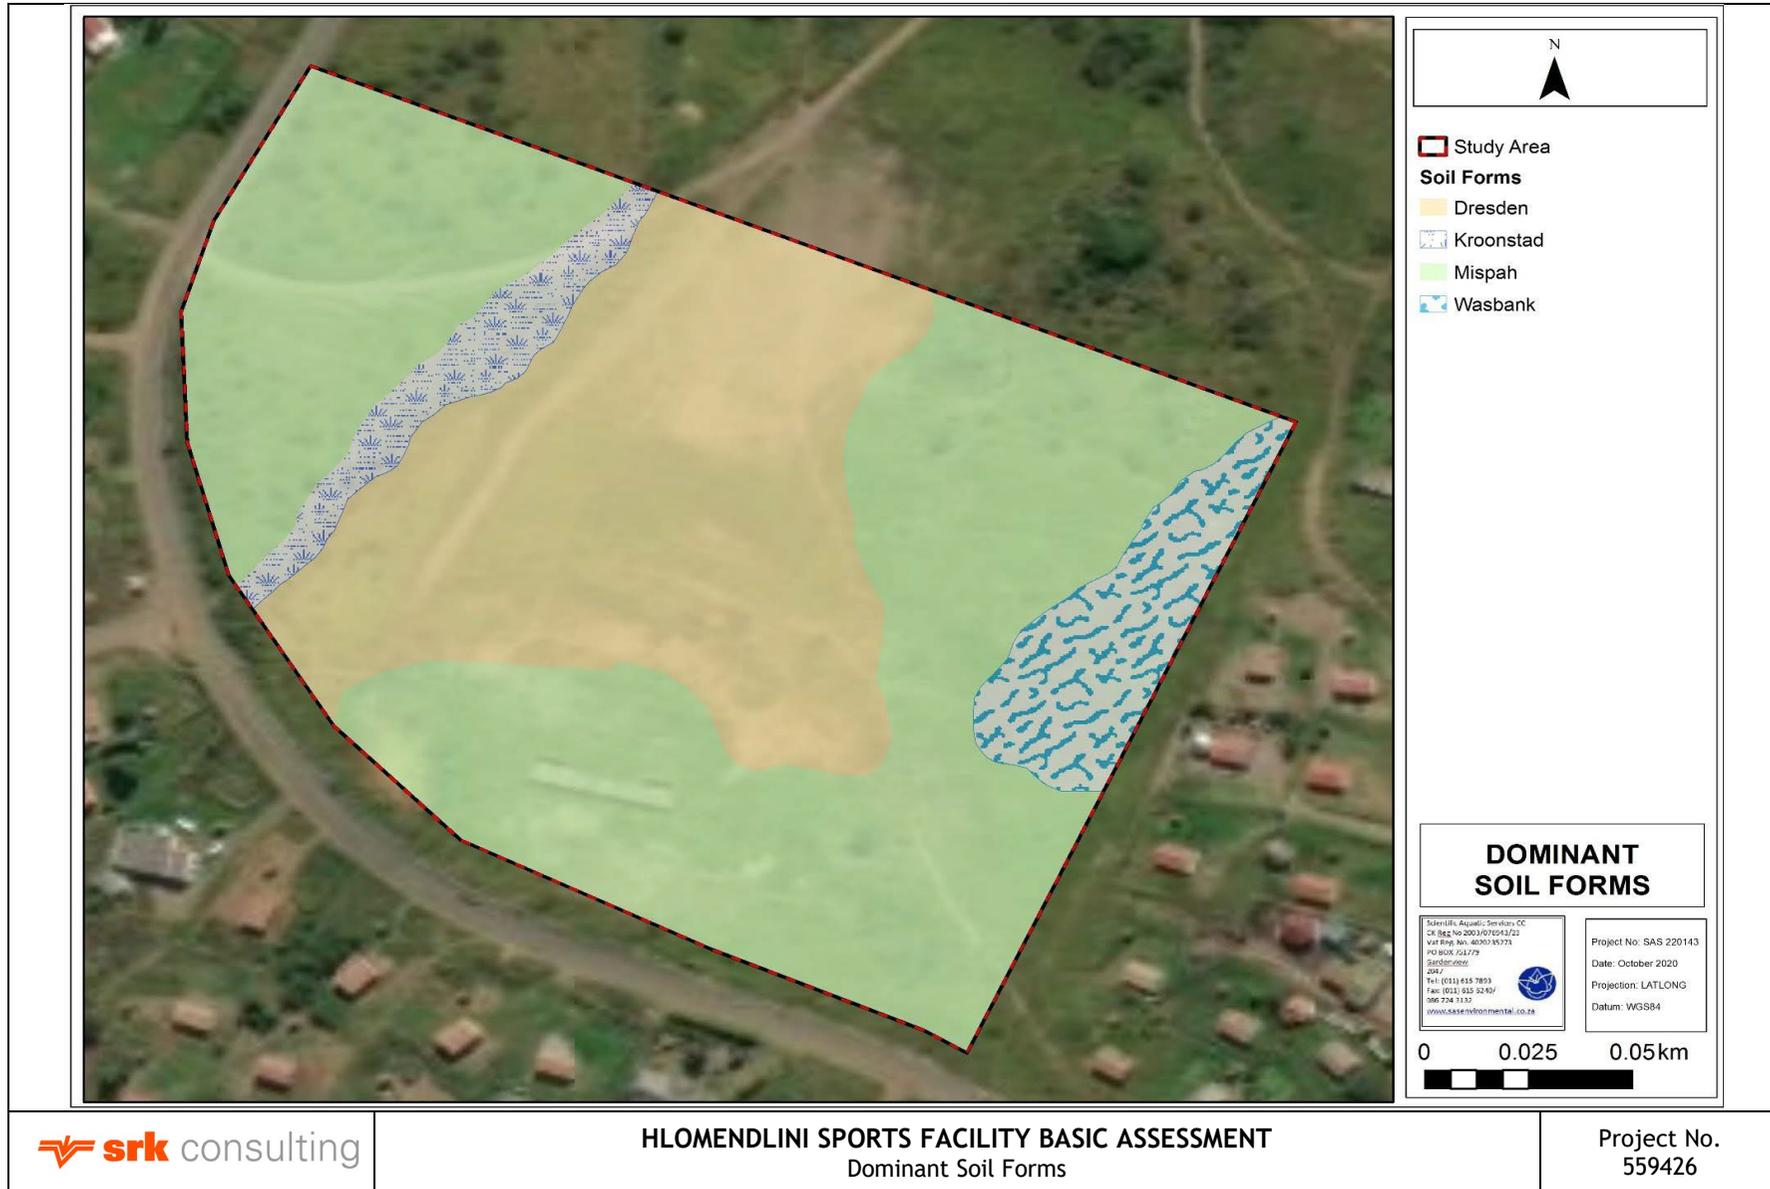
Figure 10-2: Dominant soil forms associated with the study area (Source: SAS/SRK 230321, March 2021)

The soils within the associated valley bottom and valley head seep wetlands can be best classified as Kroonstad and Wasbank soil forms. The dominant soil forms and hydro pedological soil responses associated with the study area are depicted in Figure 10-1 and 10-2 respectively.

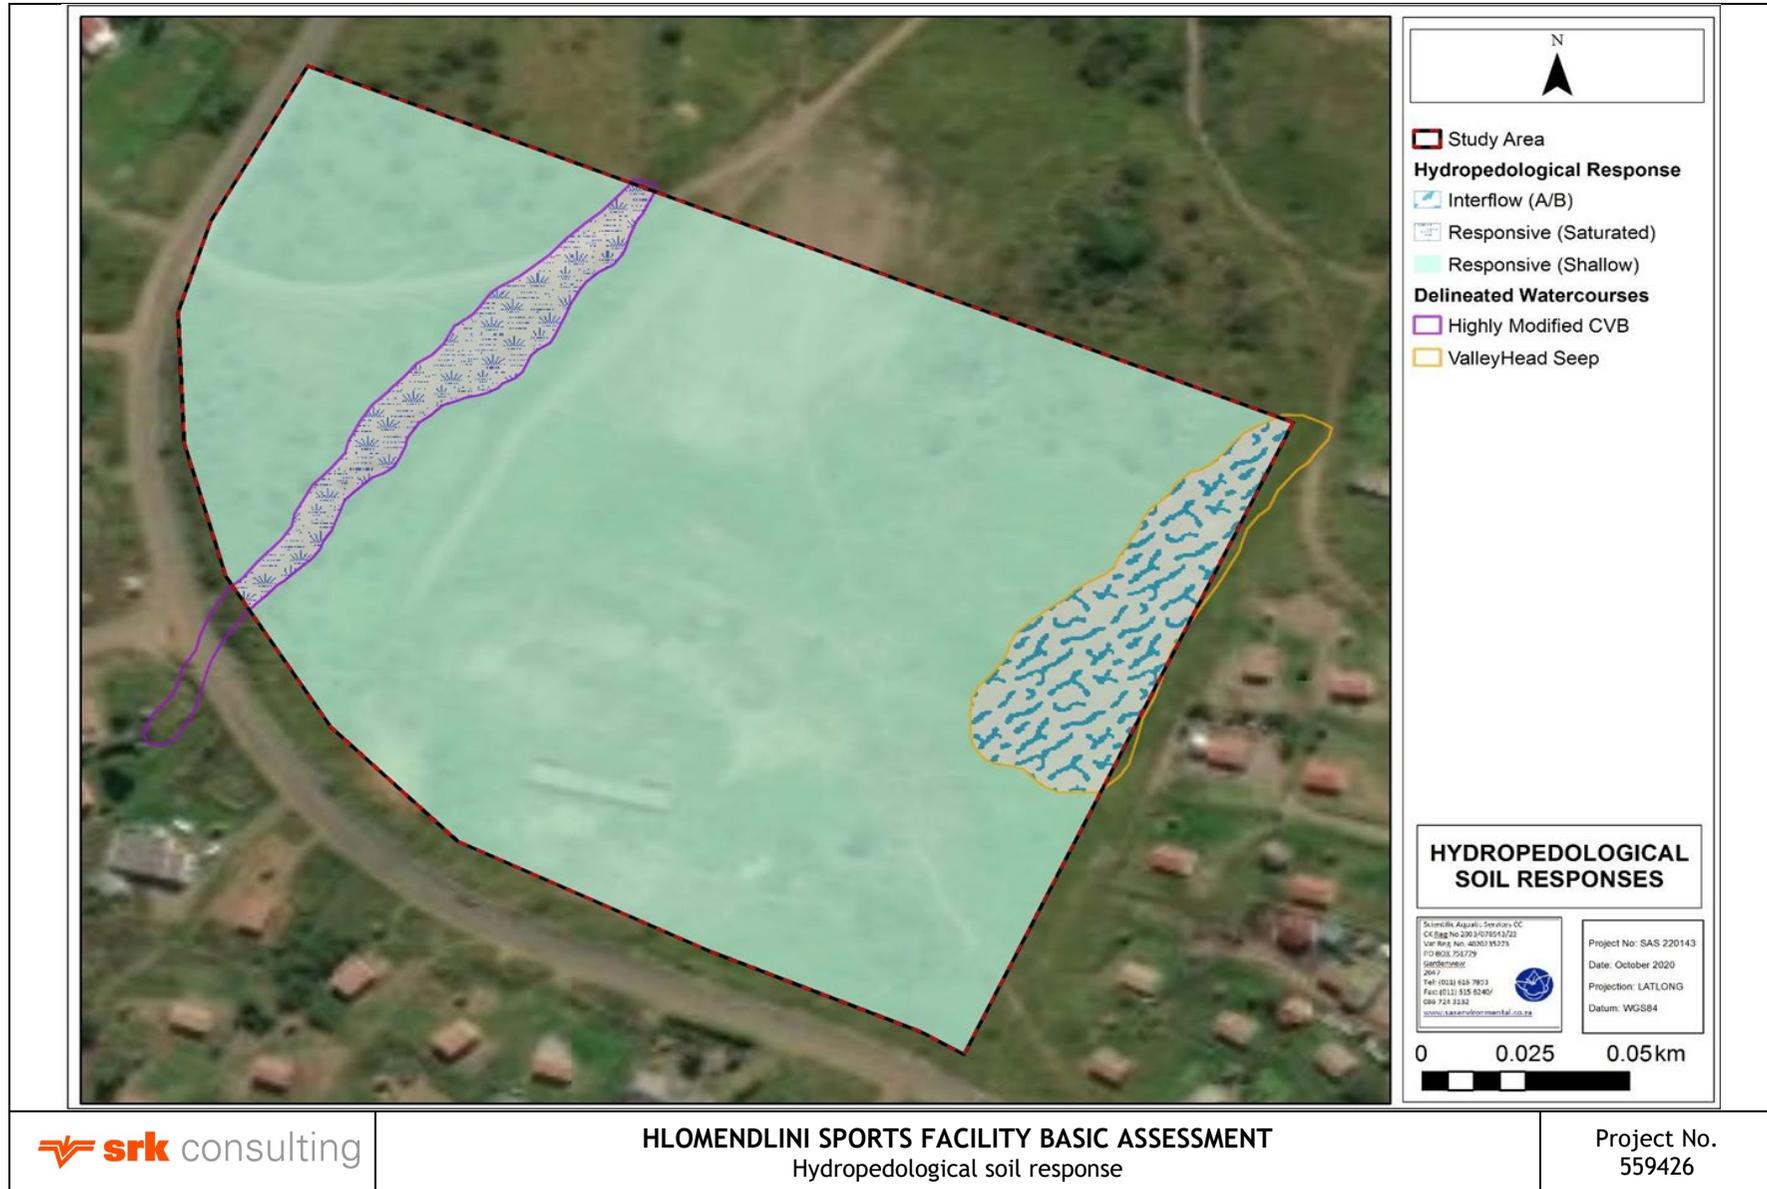
Figure 10-3: Hydropedological soil response (Source: SAS/SRK 230321, March 2021)

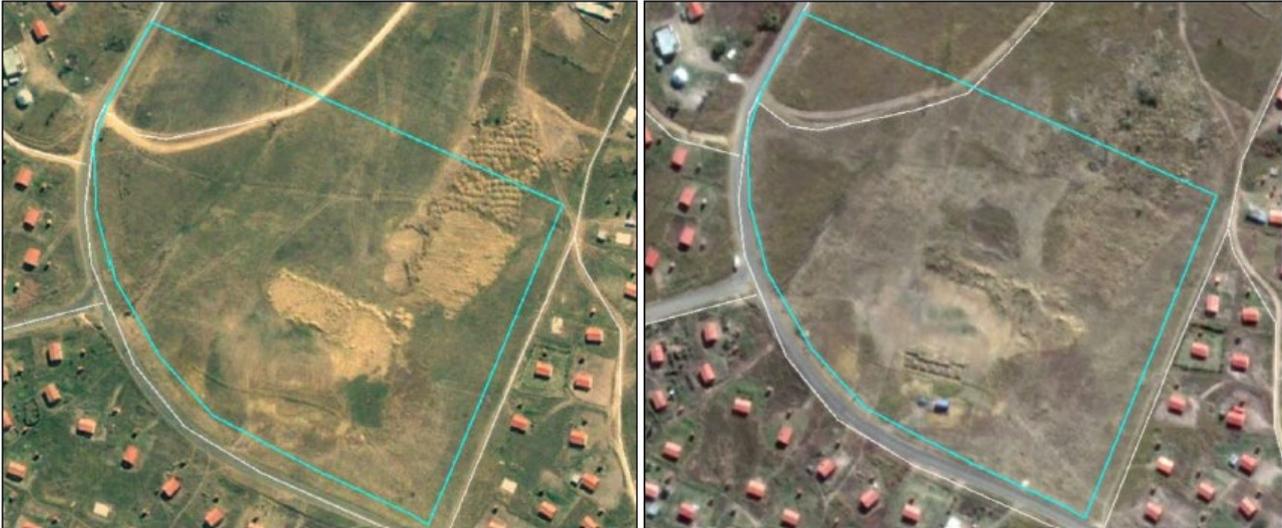
Plate 10-1: Satellite imagery from 2009 (left) and 2011 (right) indicate that portions of the site have been historically disturbed as a result of earth moving and/or dumping activities

Satellite imagery from 2009 and 2011 (Plate 10-1) shows that large portions of the site have previously been disturbed as a result of earth moving and dumping activities. In addition, it appears that the site was, at this point, devoid of any tree species, typical of the vegetation type which is characterised by grassed hills and woody ravines / drainage lines. Natural fire occurrences and potential harvesting of firewood likely excluded the occurrence of woody species from the study area at this point in time.

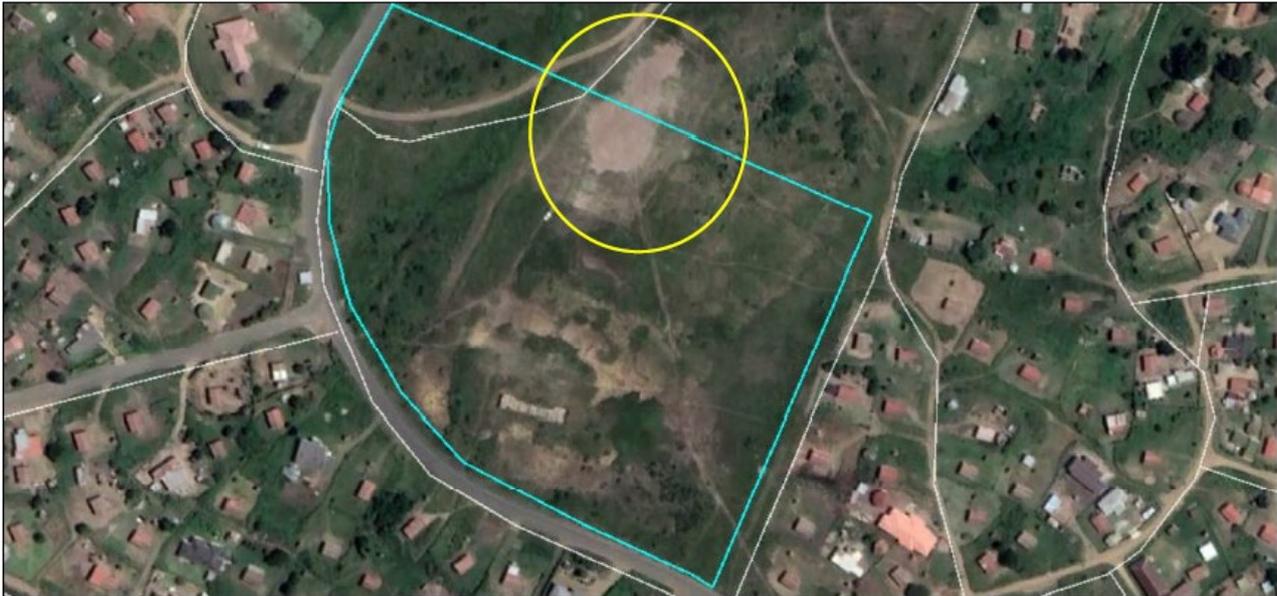
Plate 10-2: Satellite imagery from 2021 indicating the current informal soccer field in north of the site (yellow circle) as well as disturbed and bare patches still evident in the southern half of the site

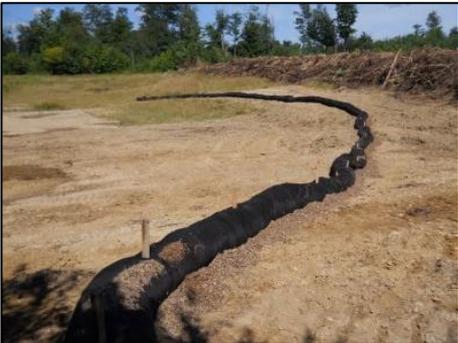
<p>Plate 13-1: Example of the installation of geotextile sediment traps to be used during the construction phase, to limit additional sediment from entering the downstream portion of the wetlands</p> <ul style="list-style-type: none"> Concrete and cement-related mortars can be toxic to aquatic life. Proper handling and disposal should minimize or eliminate discharges into freshwater ecosystems. High alkalinity associated with cement, which can dramatically affect and contaminate both soil and ground water. The following recommendations must be adhered to: <ul style="list-style-type: none"> Fresh concrete and cement mortar should not be mixed within 10 m of the identified wetlands. Mixing of cement may be done within the construction camp, may not be mixed on bare soil, and must be within a lined, bound or banded portable mixer. Consideration must be taken to use ready mix concrete. No mixed concrete shall be deposited directly onto the ground whilst it awaits placing. A batter board or other suitable platform/mixing tray is to be provided onto which any mixed concrete can be deposited whilst it awaits placing. Cement bags must be disposed of in the demarcated hazardous waste receptacles and the used bags must be suitably disposed of. Spilled or excess concrete must be disposed of at a suitable landfill site. Only indigenous vegetation species may be used as part of the landscaping of the development, and invasive plant species should be eradicated.

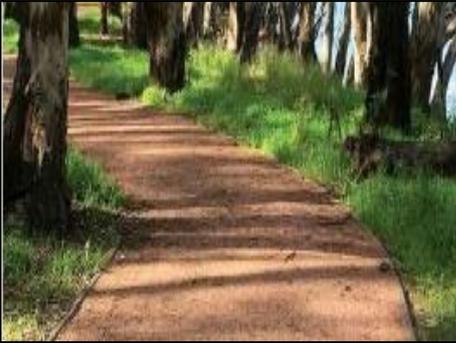
<p>Plate 13-2: Example of compacted soil walkway</p>								
	Extent	Intensity	Duration	Consequence	Probability	Significance	Status	Confidence
With mitigation	Regional	Medium	Medium-term	Medium	Probable	Medium	- ve	High
	2	2	2	6

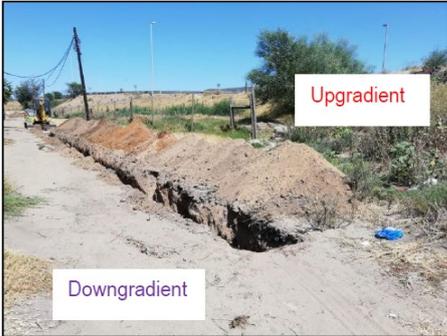
<p>Plate 13-3: An example of a trench being excavated, and the removed soil stockpiled along the trench</p>

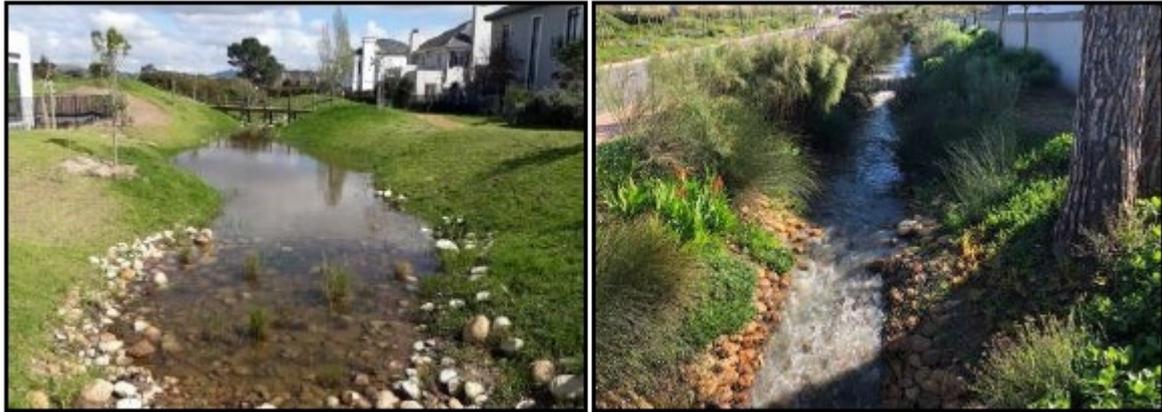
Plate 13-4: Examples of open swales, considered to be SuDs utilised for conveyance of stormwater

- It is further recommended that the developer create a constructed wetland/retention pond for the stormwater to enter so that it is not released directly into the wetlands. This will be a proactive approach to limit contaminated water entering the wetlands.
- Energy dissipating structures should be installed at the stormwater outlets to prevent erosion and scouring of the wetlands where the stormwater will be discharged into.
- At the drop of stormwater outlets, rocks must be placed, and vegetation established to bind the soil of the bed, and to prevent erosion. This will also diffuse flow and lower the velocity of water entering the wetlands.
- Litter traps should be installed at all the inspection chambers to prevent any litter from entering into the freshwater ecosystems.
