# Recent experiences with ground retaining systems in Buenos Aires, Argentina

Alejo O. Sfriso<sup>(1)</sup>

<sup>(1)</sup> SRK Consulting, Buenos Aires, Argentina <asfriso@srk.com,ar>

**ABSTRACT.** This paper presents a summary of the current construction procedures for urban excavations in Buenos Aires, Argentina. The geotechnical conditions are briefly described, and a few case histories are reported. These case histories include large excavations supported with post-tensioned anchors, excavations supported with piles, and diaphragm walls. Finally, the current engineering procedures are discussed and some recommendations for the advancement of the engineering of excavations is proposed.

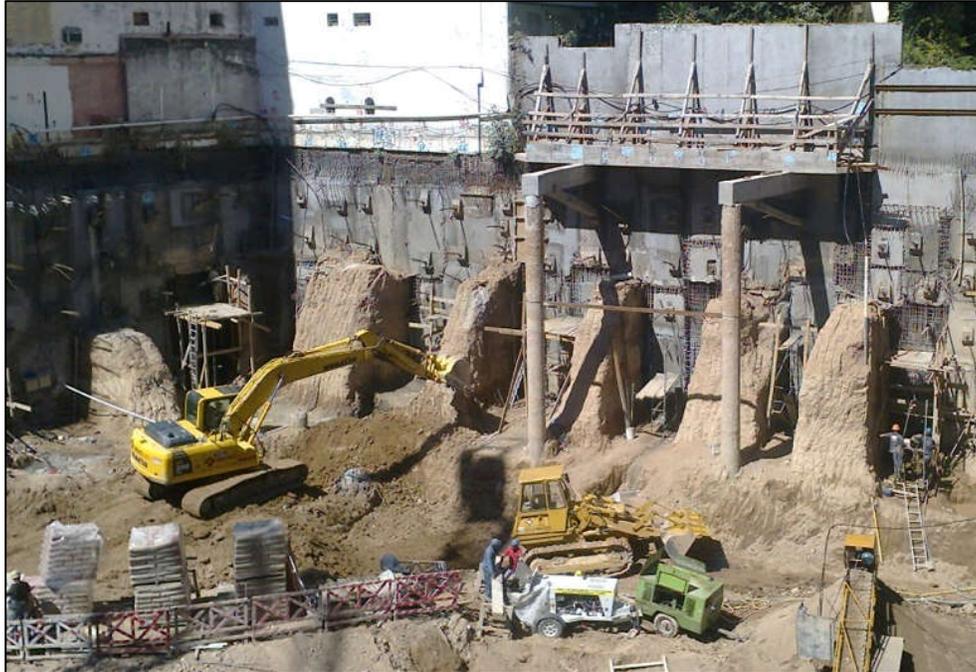
The requirement of no excavation wider than 2.0 m be unsupported is almost 50 years old. The interpretation of this requirement evolved gradually in the period into a very popular procedure for advancing excavations that is readily apparent in Figure 5. The real-world version shown in Figure 6 also shows a magnificent opportunity for improving our construction procedures as well.

Figure 6. Typical construction procedures for large excavations in Buenos Aires. Real world.

There is actually no need for using the cumbersome sequence shown in Figure 5. A sequential excavation, customary in other parts of the world, can be easily adopted in Buenos Aires. The author participated in a few cases where a sequential excavation was adopted, avoiding the use of those soil buttresses shown in Figure 6 and that bring the feel and like of the middle ages to 21<sup>st</sup> century construction sites.

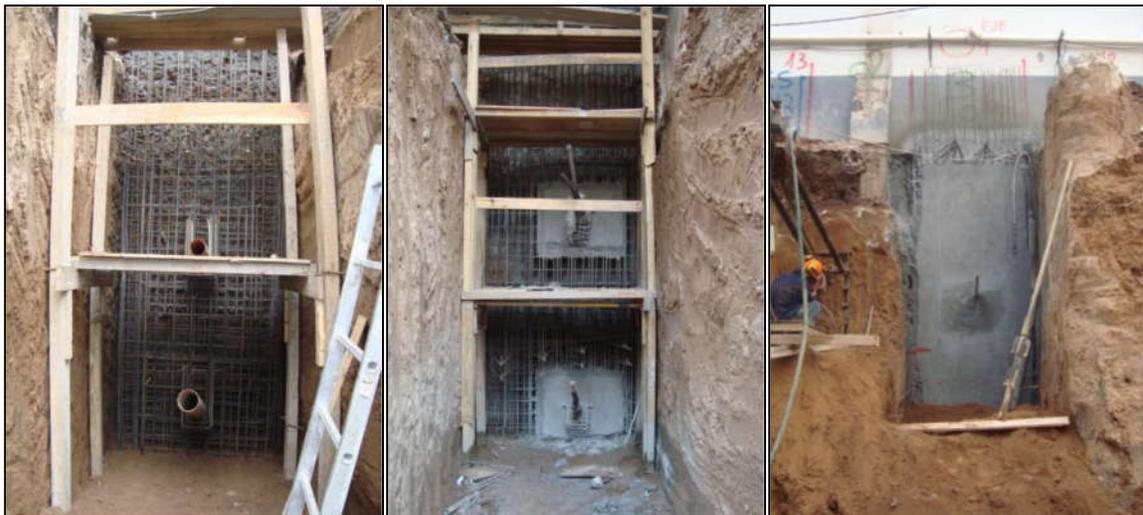
The construction employed was (Figure 7): i) excavation in limited spans; ii) installing of the anchors; iii) casting of the anchor plates; iv) post-tensioning of anchors; v) casting of the final wall; vi) repeat in remaining spans and levels.

Figure 7. Construction sequence of the anchor plates as part of the final wall (Laríá 2015).

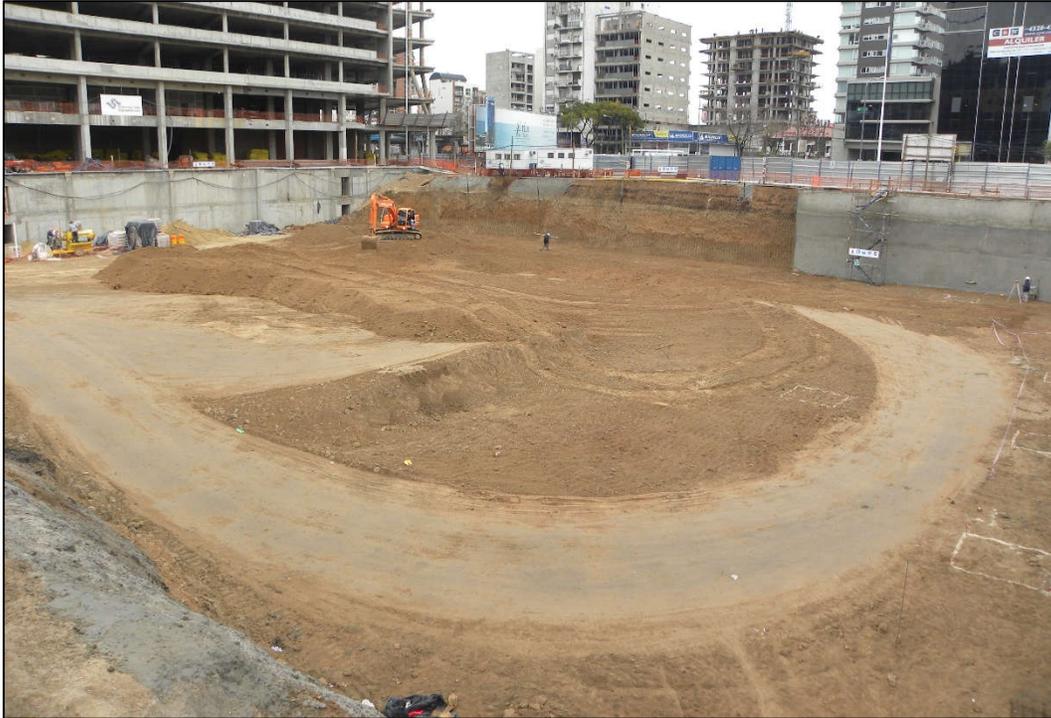
One such case is the “Al Río” project in Rosario, an excavation 9.6 m deep and about 10.000 m<sup>2</sup> in area, supported by passive ground anchors and shotcrete and excavated in long -but shallow- spans. Figure 14 shows an overall view of the excavation, while Figure 15 shows one of the spans, waiting to be covered by shotcrete.

Figure 14. Overall view of the excavation of the Al Río project in Rosario, Argentina. Note the wall supported with shotcrete and ground anchors, and the buttressed portion to be excavated.

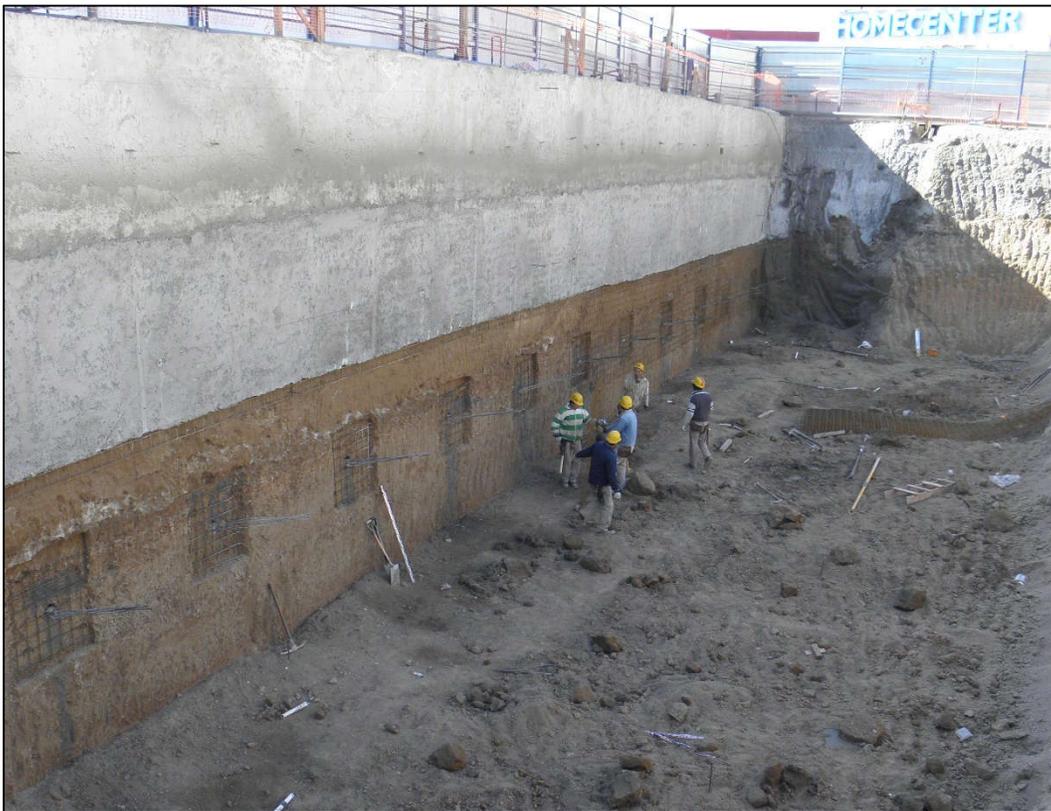
Figure 15. Detail of one excavation stage. Note the carving and mesh reinforcement for the anchor plates, and the ground surface waiting for the shotcrete to be placed.
