**WETLAND DELINEATION IN THE RUSTENBURG
PLATINUM MINE PROJECT AREA AND A HIGH
LEVEL ASSESSMENT OF SELECTED RIVER
CROSSINGS, NORTH-WEST PROVINCE**

SRK Consulting (Pty) Ltd

May 2015

Prepared by:	Scientific Aquatic Services
Report author:	M. Aphane
Report Reviewer	S. van Staden (Pri. Sci. Nat)
Report Reference:	SAS 215053
Date:	May 2015

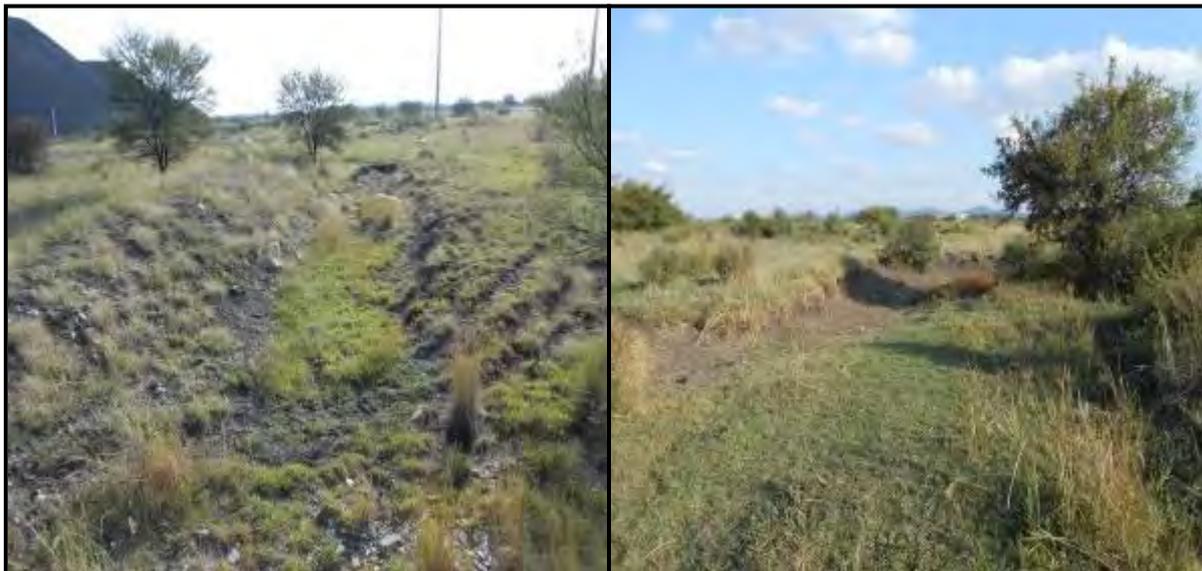
The WET-IHI calculations for the Brakspruit indicates that the system has been moderately/largely modified, and that loss and change of natural habitat and biota have occurred, but the basic ecosystem functions are still predominantly unchanged. The feature has been disturbed by erosion which has occurred as a result of increased water input as well as heavy grazing and trampling by livestock. These activities have resulted in the moderate modification of the geomorphology of the feature. Furthermore alien vegetation invasion has occurred especially along these structures since the soil profile has been altered. The constructions of road crossings and pipelines along this system has resulted in a large modification of the hydrology of the system. Stockpiling in mining areas might lead to sediment deposition within systems if located within 100m of the floodline, and as a result water quality might be altered. However, no soil dumping or stockpiling was evident within the feature. The figures below represent the disturbance observed within the system.

Figure 9: Representative photographs of erosion disturbances within the Brakspruit system.

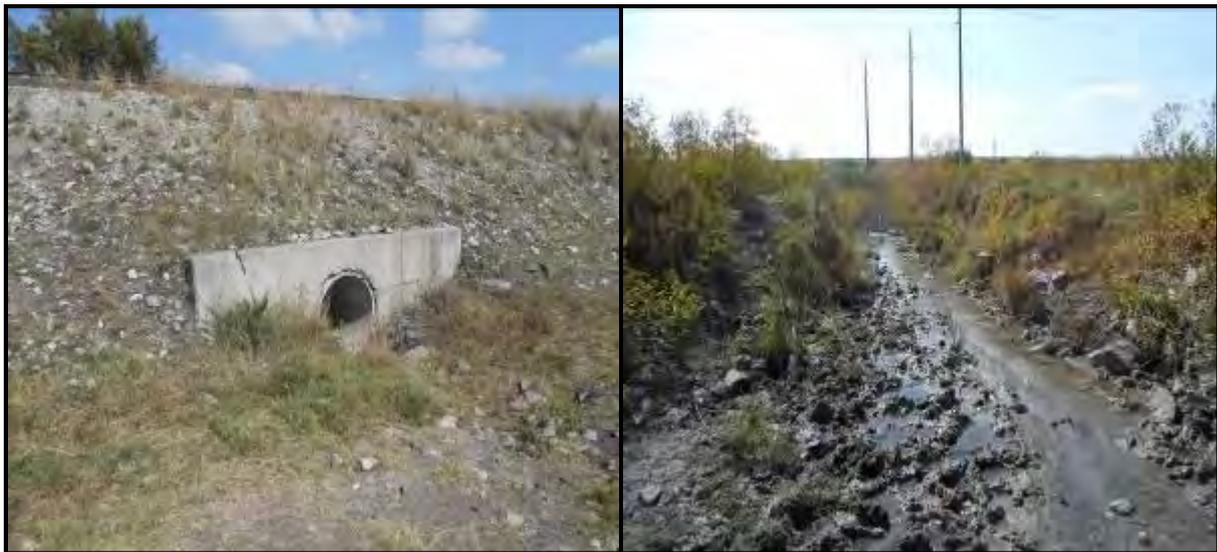
The feature obtained an average percentage that places the feature within category D which implies that the feature has been largely modified, and large loss of natural habitat, biota and basic ecosystem functions has occurred: 20-40% seriously modified. Most of the vegetation within this feature has been cleared during the construction of a railway crossing and development of a road that traverses the feature below the railway crossing. As a result the area has been largely eroded and alien species such as *Flaveria bidentis* have invaded. This species was identified along the edges of the feature and has led to the destabilization of soils within the feature. Due to the road there is increased water input within feature as well

as sediment deposition which moderately altered the geomorphology of the area. The figure below represents the Hoedspruit system.

Figure 10: Representative photographs of the Hoedspruit system.

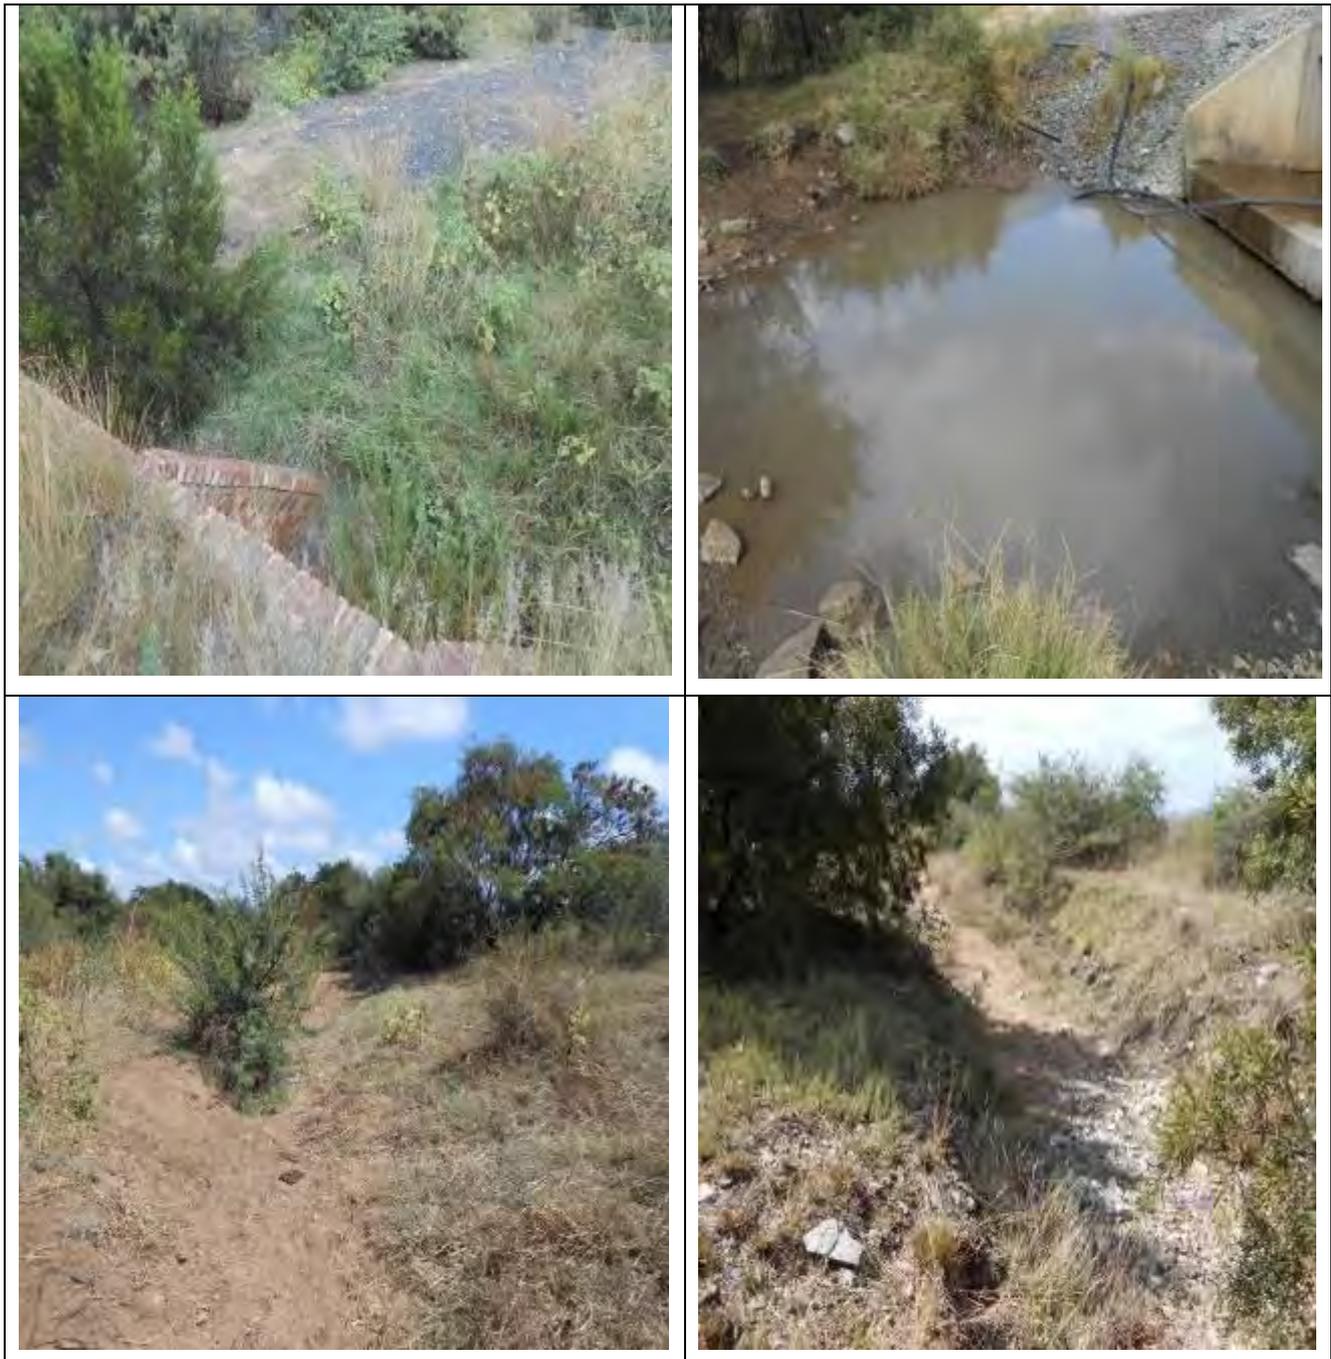
The hydrology of the system has been moderately modified by the construction of the bridges/road crossings which increases the width and in some portions the depth of the channel. There were water abstraction activities observed on site which might be used by the community for crop irrigation. This activity contributes to the modification of the hydrology of the system. Potential influences on water quality are sedimentation and runoff from the neighbouring communities as well as waste dumping. Furthermore, livestock grazing and trampling as well as increased runoff have resulted in the formation of erosion gullies within the system. The vegetation component of the system has been moderately disturbed, by the construction of the bridges as well as the effects of erosion. Alien vegetation such as *Xanthium strumarium*, *Asclepias fruticosa* and *Tagetes minuta* were observed on site. Due to the presence of the culverts and road crossings as well as sediment deposition, the geomorphology of the system has been moderately modified. The figure below represents the disturbances within the Wildebeesfontein system.

Figure 11: Representative photographs of the Wildebeesfonteinspruit (South of Khuseleka 2).

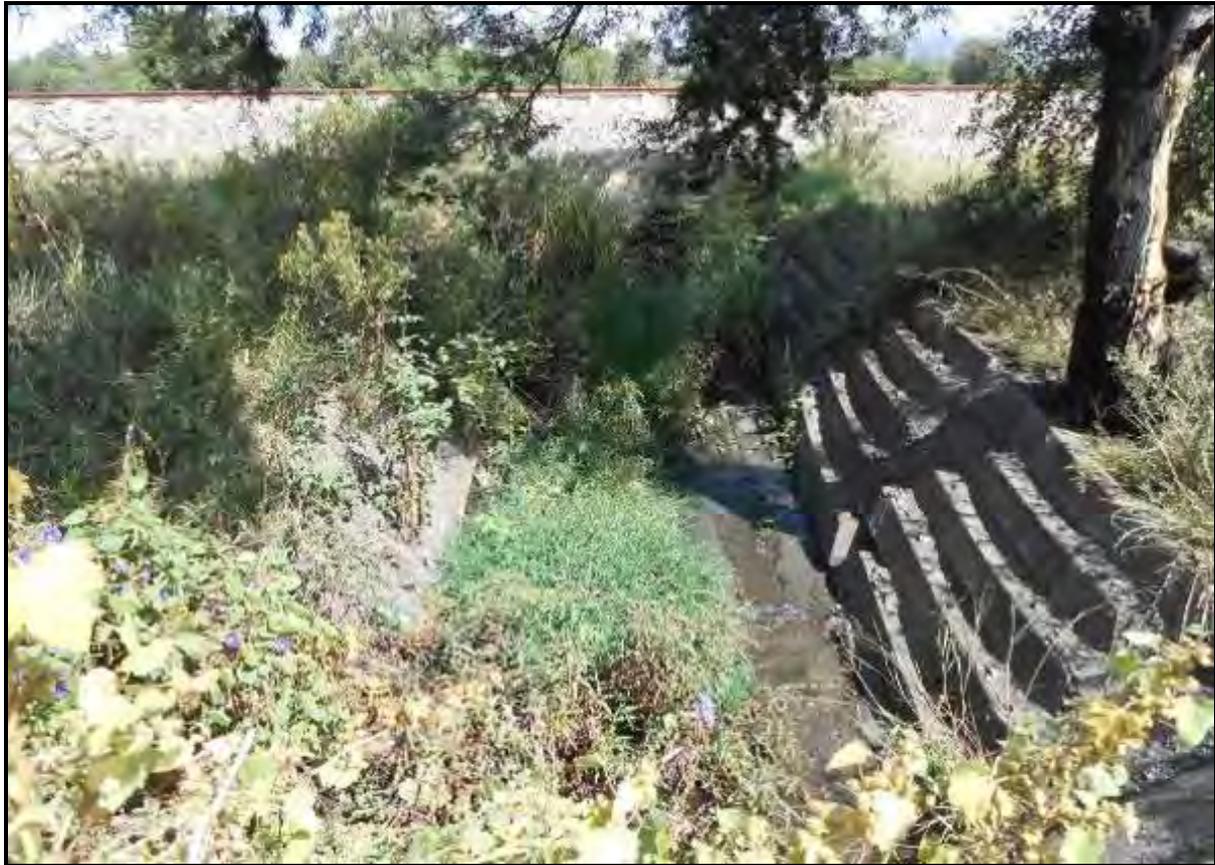
The feature (where Site 33 and Site 34 are located) consists of an artificial canal, created to convey water from the open flooded pit into the nearby watercourse, and it was mainly encroached and dominated by alien vegetation such as *Melia azedarach*, *Datura stramonium*, *Ipomoea purpurea*, and *Flaveria bidentis*. There were soil stockpiling observed adjacent to the upper portions of the feature which deposits sediment into the feature and also reduces the quality of water passing through the channel. Since this feature was

artificially constructed it did not indicate any wetland characteristics and cannot be considered to be a natural watercourse. The figure below represent the artificial channel that forms part of the system.

Figure 12: Representative photograph of the Wildebeesfonteinspruit (North-west of Khuseleka 1)

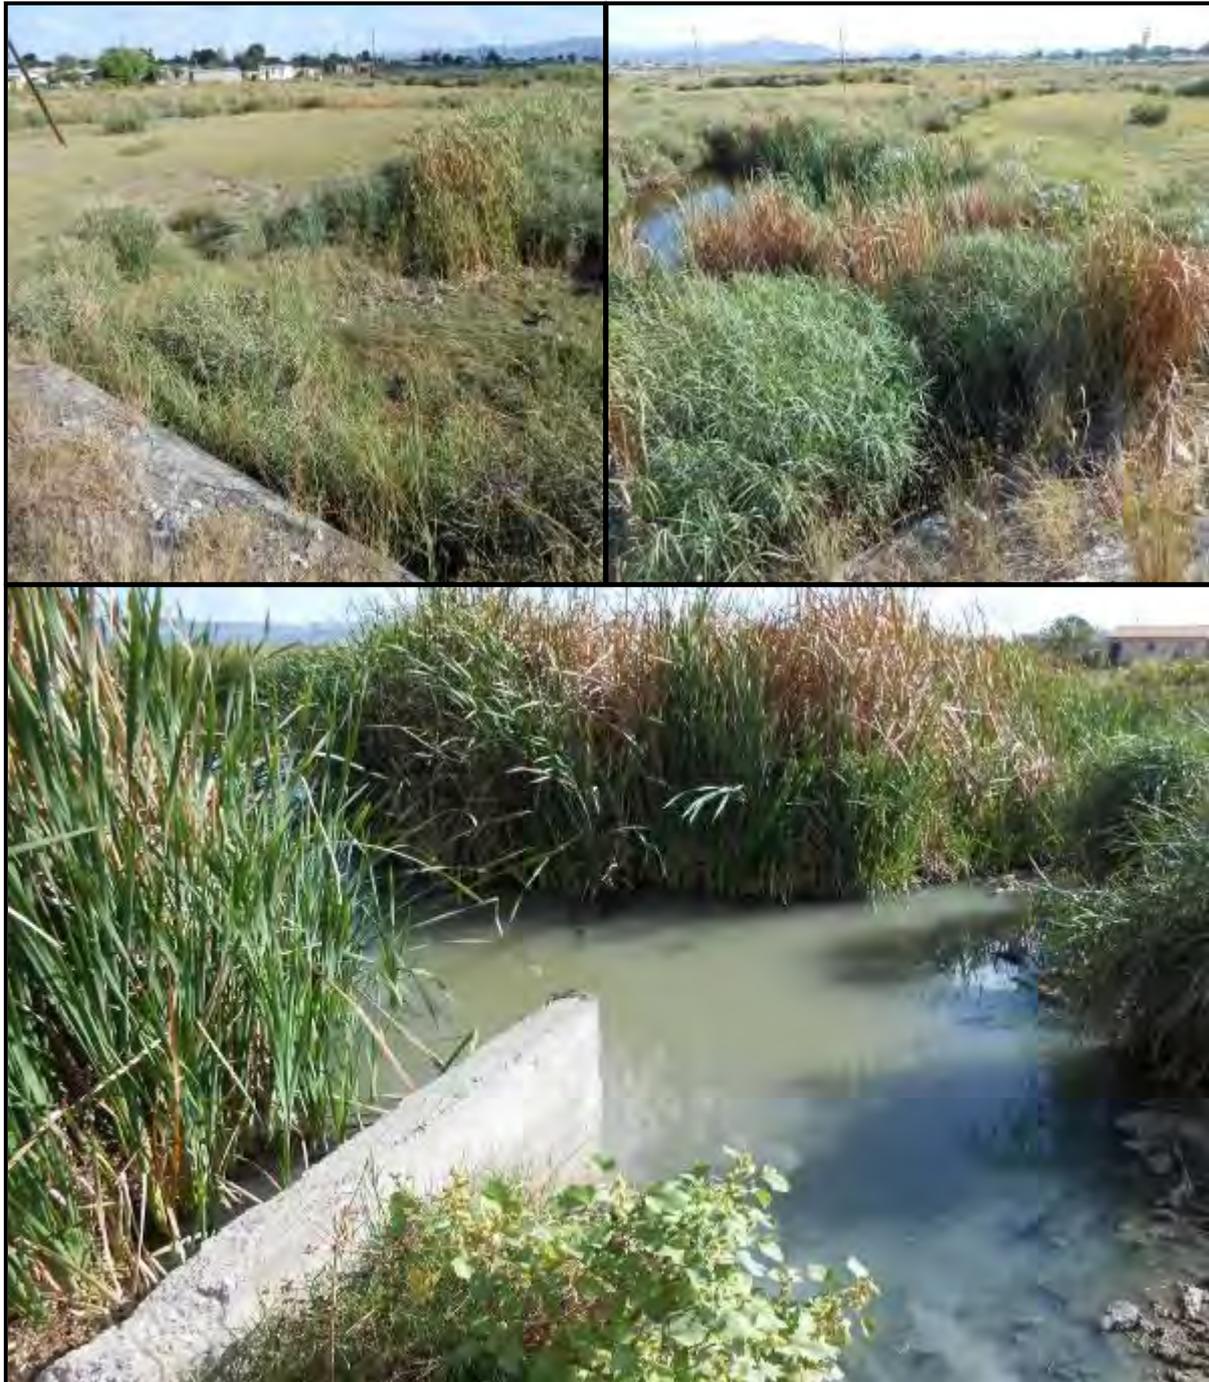
The system obtained an average score that places the system within category B/C. the entire system appears to be in good condition, apart from the presence of structures such as roads and culverts. The vegetation component of this feature was in a largely natural condition with only a few eroded areas along the road crossings. The water quality was largely modified by potential sources such as sedimentation and runoff from the neighbouring communities as well as deposition of untreated sewage effluent from leaking pipes in the upstream areas of the system. The hydrology of the feature is moderately modified by increased water input within the feature as a result of hardened surfaces within the catchment. Increased runoff from the tarred road has led to increased water input, whereas dirt roads traversing the feature have increased the availability of sediment, thus modifying the geomorphology of the feature. The figure below represents the vegetation and sewage effluent that is being discharged within the system.

Figure 13: Representative photographs of the Wildebeesfonteinspruit.

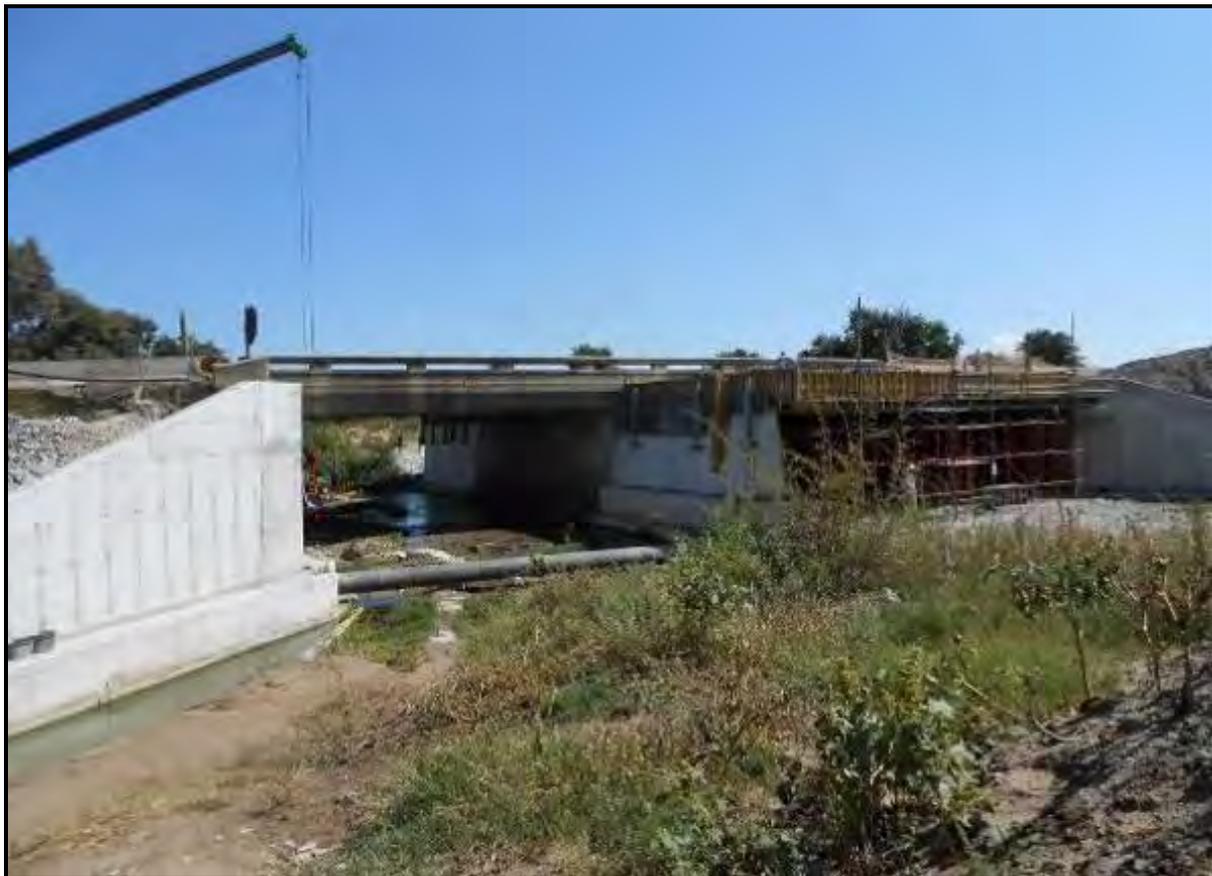
The feature obtained an average score that places the feature within category D which implies that the feature has been largely modified, and large loss of natural habitat, biota and basic ecosystem functions has occurred. The loss of natural habitat, biota and basic ecosystem functions is extensive, and this is mainly due to the road bridge construction activities that are currently taking place within the feature. The system experienced low flow at the time of the assessment therefore there was limited disturbance on stream flow. The

feature has been subjected to vegetation clearing and as a result, alien vegetation species have established. The geomorphology of the feature has been largely modified by the excavations as well as sediment deposition and infilling from the construction. The catchment area will have increased water input as a result of runoff from the road and paved surfaces. Since the feature is hydrologically linked to an upstream dam, in which sewage effluent is being discharged, the water quality of the feature was largely modified and falls within category D. Potential influences on water quality are sedimentation and runoff from the neighbouring communities. The figure below represent the construction activities that are currently taking place within the system.

Figure 14: Representative photograph of the construction activities within the Dorpspruit

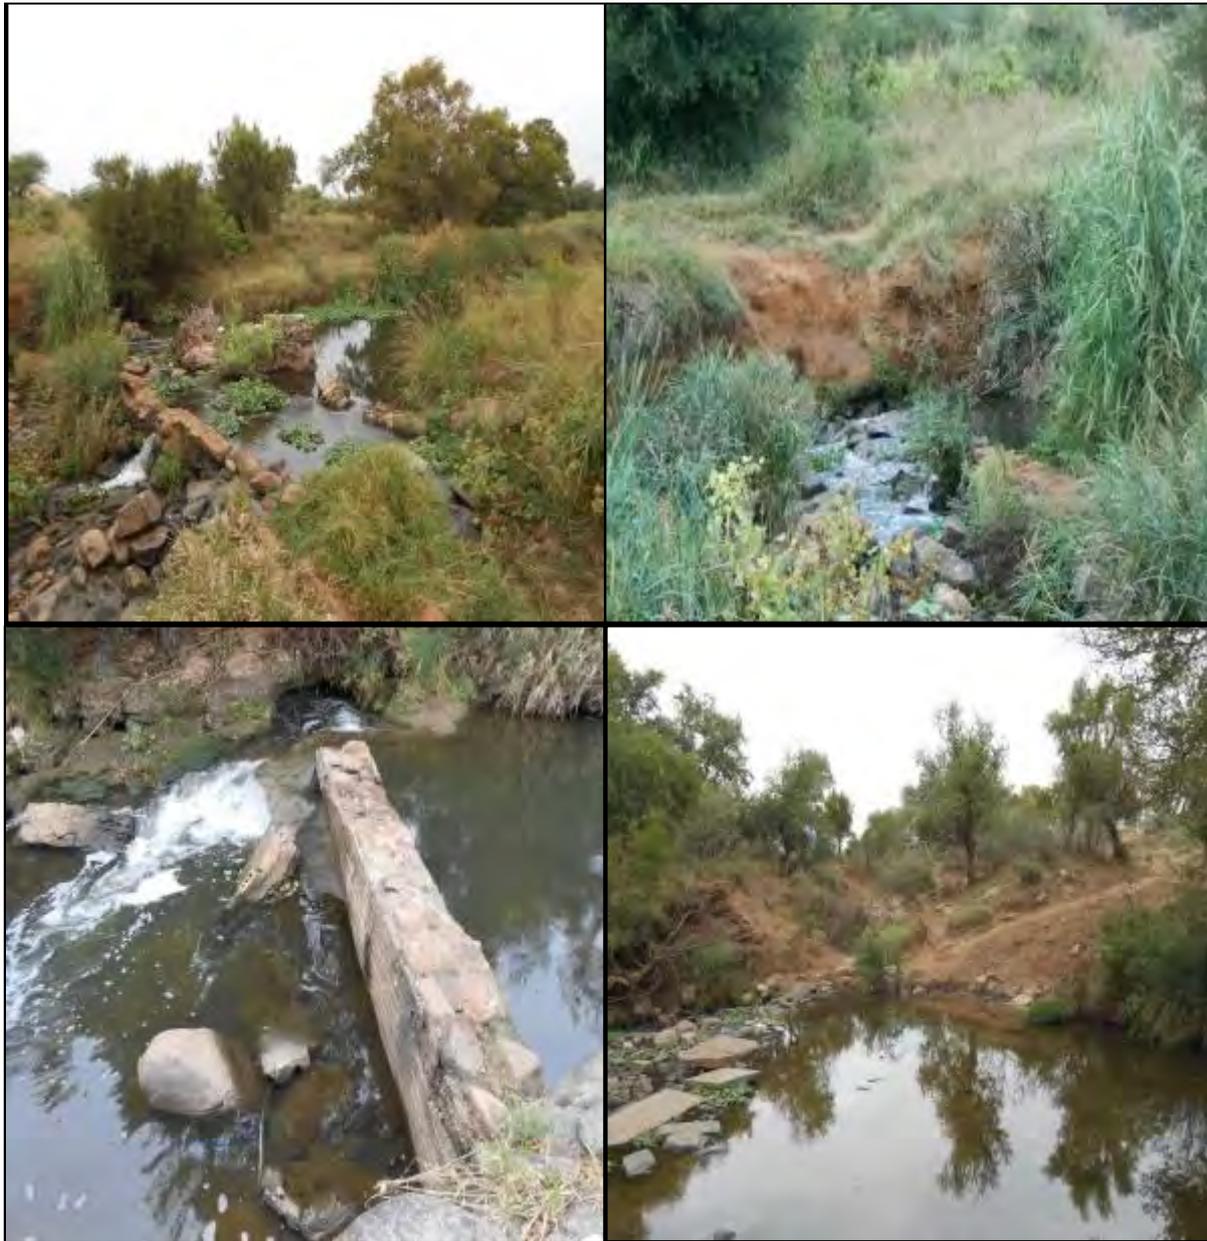
The system has been largely modified by the collapsing of a road crossing and a weir at Site 32e and Site 32f as observed during the site visit. This activity has led to the formation of erosion gullies and sedimentation within the system and increased channel depth and width. As a result, the geomorphology of the system has been seriously modified.

The hydrology of the system has been largely modified and this has resulted in the alteration of water flow patterns. Furthermore, the collapsed structures will eventually cause migration

barriers for aquatic species. Due to erosion, vegetation has been modified especially along the river banks and where the crossings/roads occur along the river. Alien vegetation species have established including *Eichhornia crassipes*. This plant can block sunlight from reaching native aquatic plants, and removes oxygen from the water eventually killing aquatic species. The water quality within the system has been modified, and potential influences on water quality are sedimentation and runoff from the neighbouring communities.

Figure 15: Dorpspruit East of Khuseleka 1 and West of Paardekraal Return Water Dam (RWD)

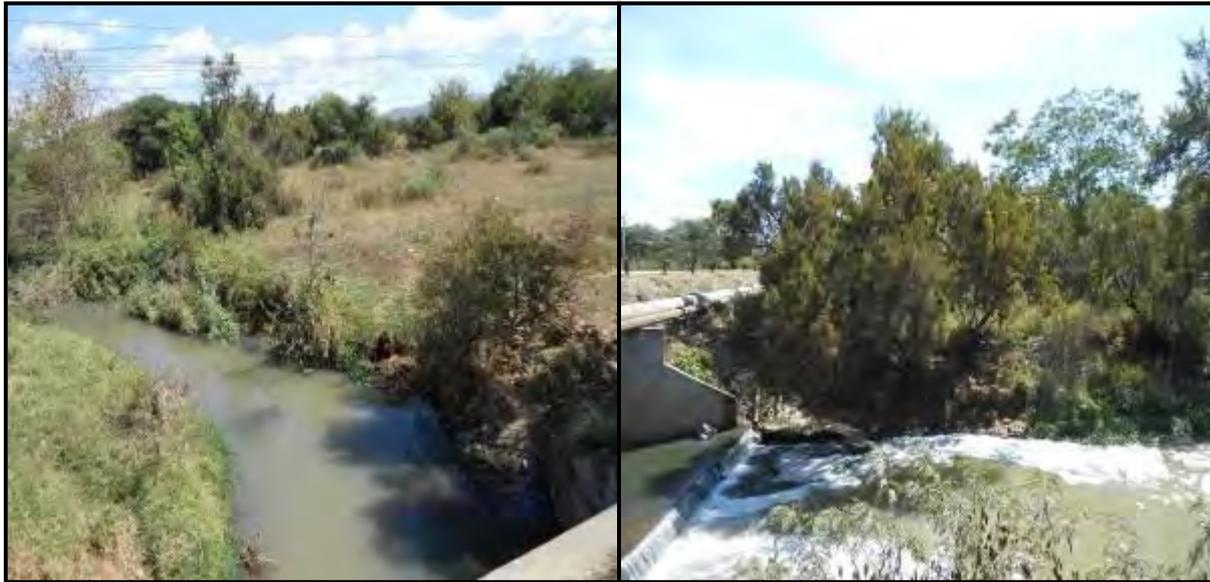
Figure 17: A weir and road crossing as modifications to the hydrology of the stream.

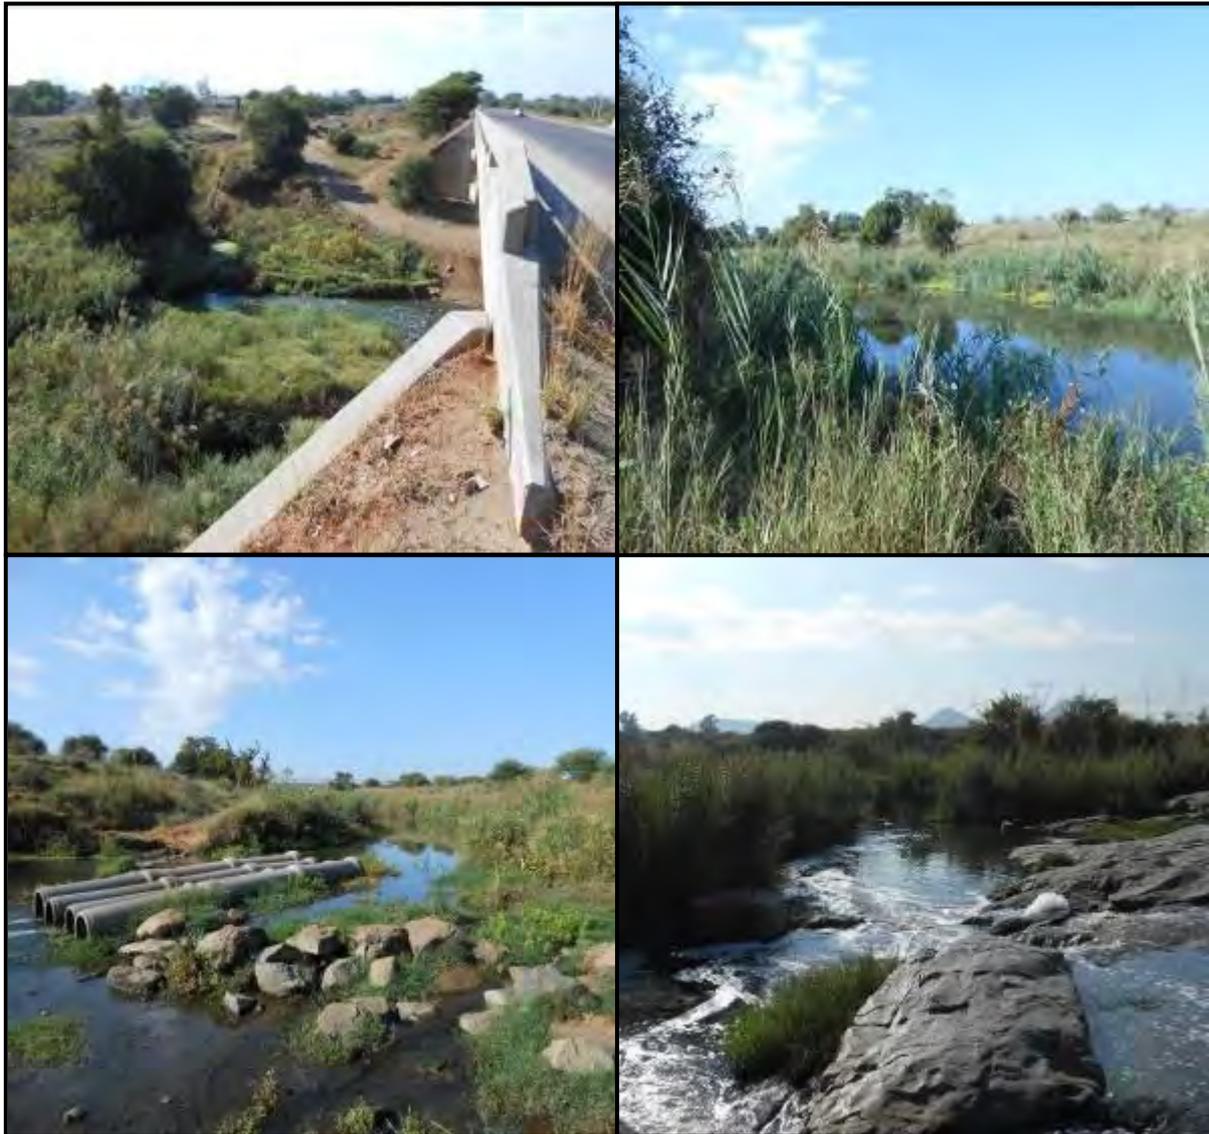
The river obtained an overall score that indicates that the feature falls within the PES Category C (moderately modified), this implies that there has been loss and change of natural habitat and biota, but the basic ecosystem functions are still predominantly unchanged. A few structures such as road bridge crossings and pipelines have resulted in the moderate modification of the feature. Algal proliferation has been observed in a few areas which implies that the water has an overabundance of nutrients such as nitrate and phosphate. Soil stockpiling along with construction rubble as well as litter were observed adjacent to **Site 28** where there is a road crossing. It is anticipated that during heavy rainfall, runoff from the stockpiling area will result in erosion as well as sediment deposition within the feature, which would potentially alter the water quality. In the upper portions of the system the water quality seemed to be moderately modified as opposed to the largely modified portions upstream (Site 28). The hydrology as well as morphology of the feature has also been moderately modified by the presence of the pipes and roads. In some cases these pipes cause a migration barrier and traps debris since they are placed within the river bed and not elevated on plinths. In addition, the water flow pattern changes due to the presence of these pipes, thus resulting in erosion of the river banks. Vegetation removal has occurred in the vicinity of the road crossings, and although alien species were observed on site, indigenous vegetation still occurs in some areas where anthropogenic activity has been less. The figures below represent the Hex River.

Figure 18: Representation of the Hex River.

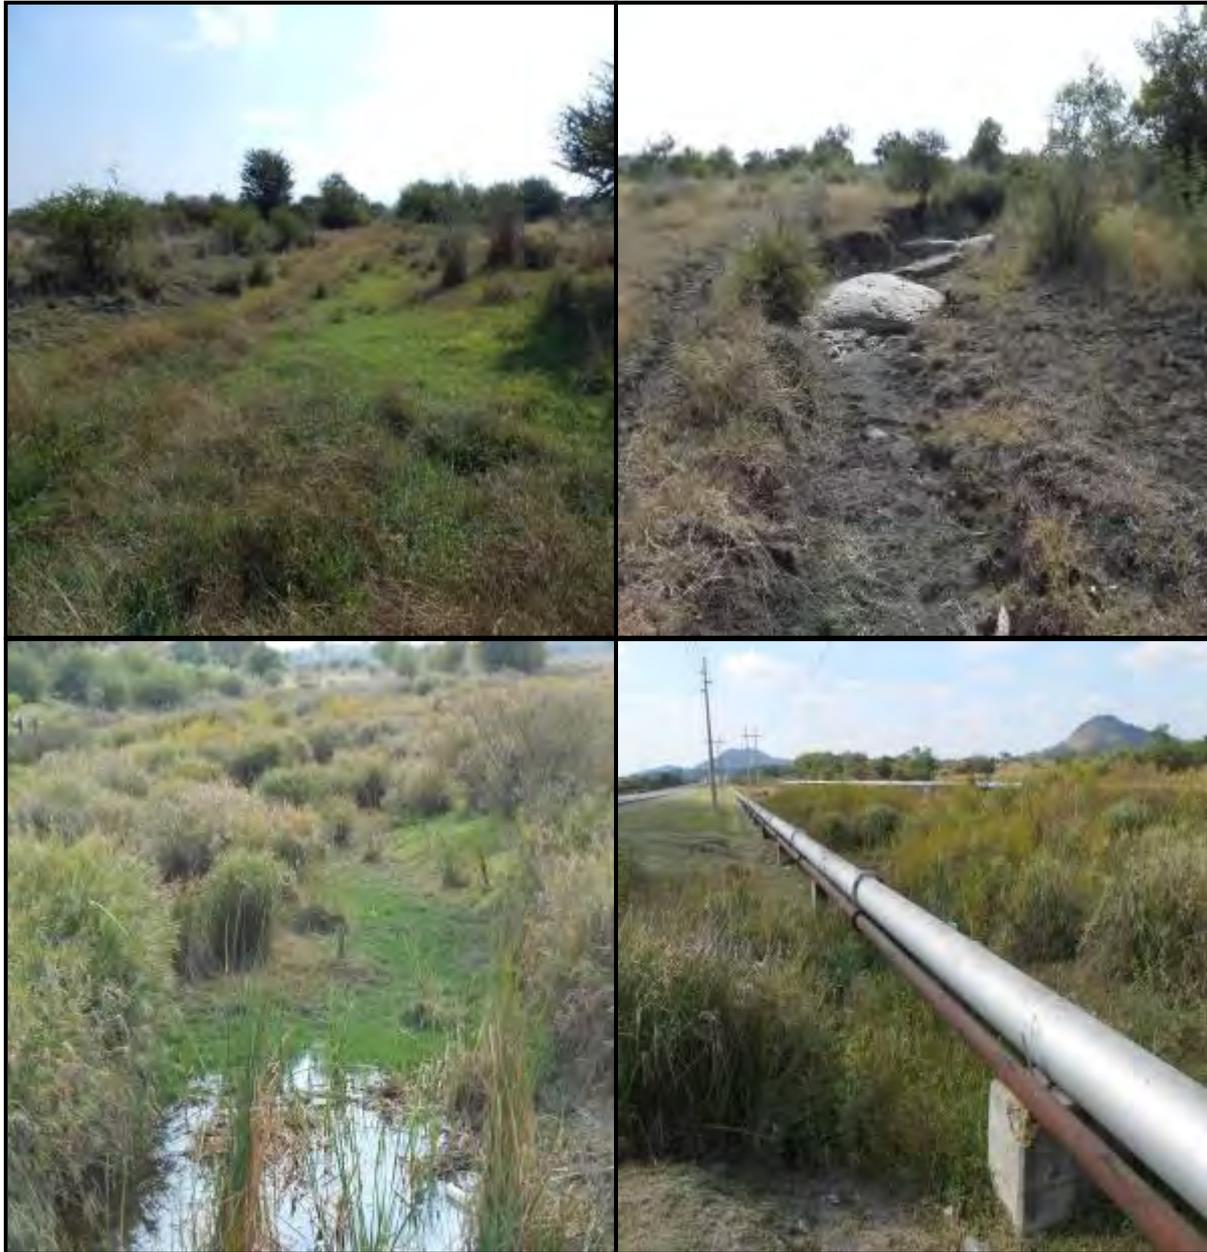
The river obtained an overall score that indicates that the feature falls within the PES Category C (moderately modified), this implies that there has been loss and change of natural habitat and biota, but the basic ecosystem functions are still predominantly unchanged. The hydrology of the feature has been moderately modified by the construction of road crossings/bridges as well as surface hardening within the catchment which causes increased water input within the feature. Furthermore, canals have been created to decrease water retention on the floodplain surface, however, flow capture and removal is ineffective. Mowing along the edges of the road and pipeline as observed at Site 3 has led to the modification of the vegetation structure of the system. In some portions, indigenous

vegetation still persists although alien species proliferation has occurred and was observed throughout the system; *Flaveria bidentis* was the dominant species. Erosion observed was mainly within community areas, and is attributed to cattle trampling and grazing. In addition, waste dumping was observed beneath the road crossings, which alters water quality of the system.

Figure 21: Photographs representing Klipfonteinspruit.

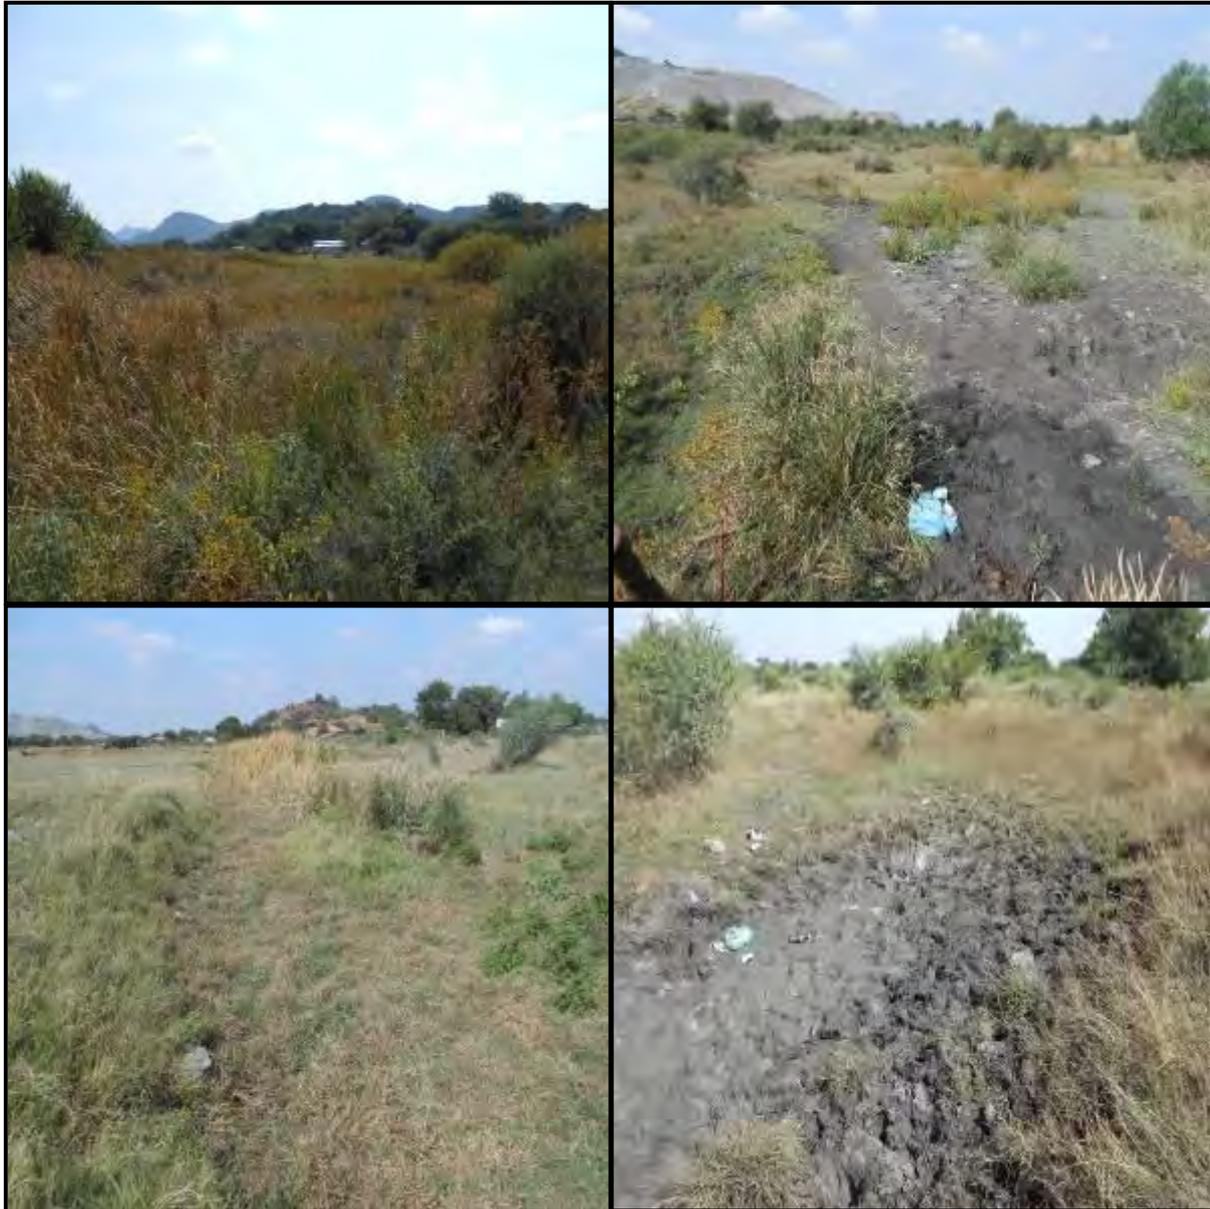
unchanged. The feature is located in an urbanised area, and due to hardened surfaces, there is increased water input into the feature. Vegetation clearing within the catchment and around the feature decreases surface roughness, which leads to an increased erosion risk to the feature. Extensive livestock grazing and trampling has also contributed to erosion within the feature and this has led to alien invasion as presented in the figures below.

Figure 22: Alien invasion and erosion within Paardekraalspruit.

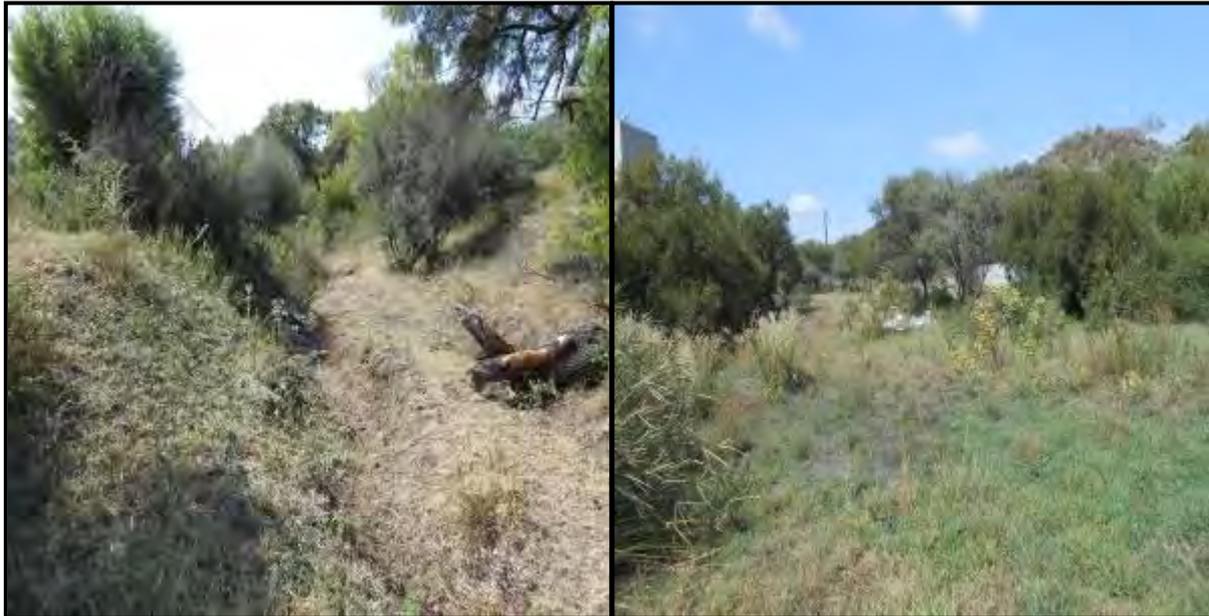
The river obtained an overall score that indicates that the feature falls within the PES Category C (moderately modified). The feature seems to be in moderate condition apart from the waste and debris accumulation below the bridge which obstructs water flow. Vegetation has been disturbed along the road crossing, with clearings and alien invasion

visible. However, the vegetation cover within the feature was moderately low, which plays a significant role in protecting the area against erosion. Due to the feature being located in an urbanised location, it will definitely receive increased runoff and will be affected by altered runoff peaks during heavy rainfall events. Waste dumping observed in the lower portions of the feature, is likely to modify the water quality within this feature. In addition, runoff from the mining area and sediment deposition will further deteriorate the water quality. The figure below represents the Paardekraalspruit system.

Figure 23: Representation of Paardekraalspruit.

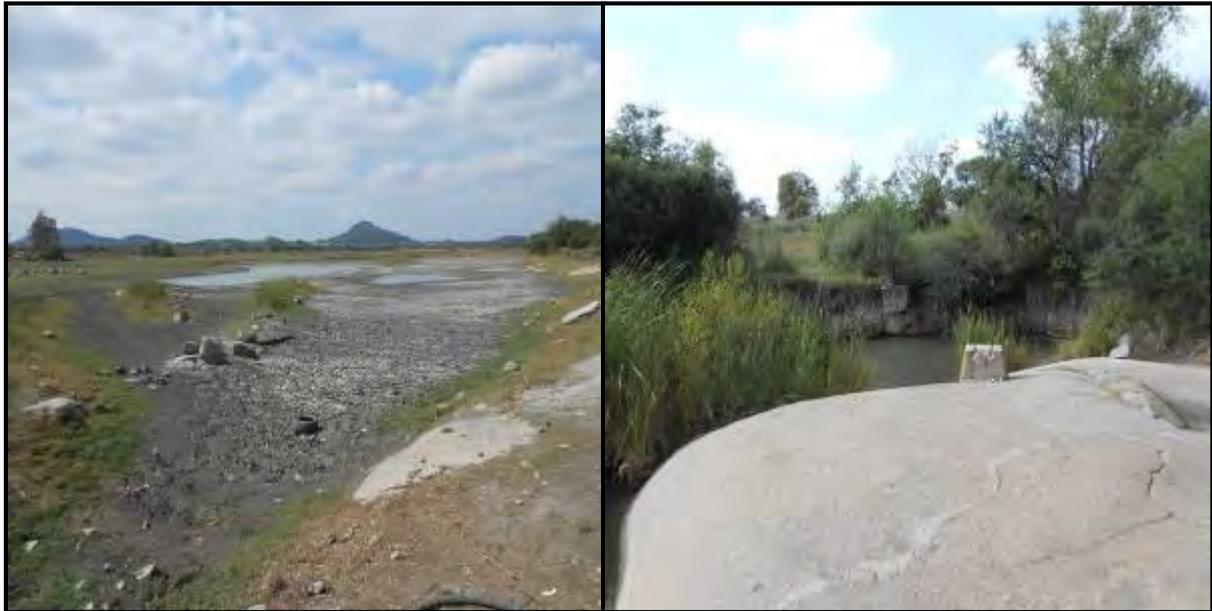
The river obtained an overall score that indicates that the feature falls within the PES Category C/D (moderately to largely modified), this implies that there has been loss and change of natural habitat and biota, but the basic ecosystem functions are still predominantly unchanged. The feature has been modified by the presence of road crossings/culverts as a result, runoff from the road increases water input within the feature. The dam upstream captures sediment before it enters the stream, hence there was less sediment deposition observed. The vegetation has been disturbed by the invasion of alien species which seems to inhibit natural vegetation especially along the culvert.

Figure 26: Representation of Klipfonteinspruit.

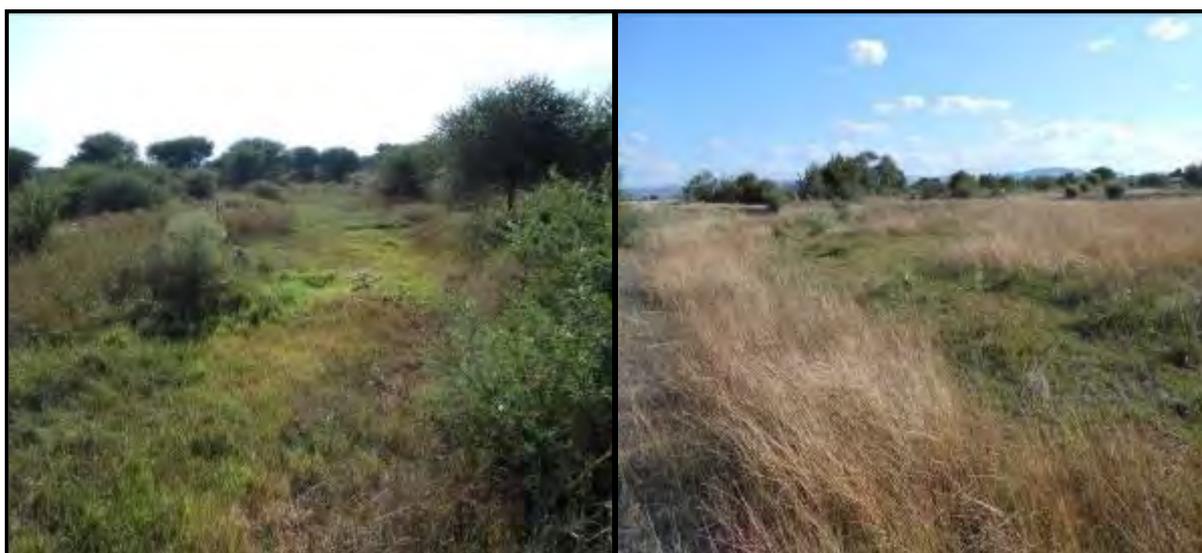
The features obtained an average score that falls within category A/B which implies that the features are largely natural with few modifications. The hydrology of the drainage lines has been slightly modified by the increased water input as a result of runoff from surface hardening within the catchment. In addition vegetation has been slightly modified by livestock grazing as well as minor invasion of alien species such as *Xanthium strumarium* and *Flaveria bidentis*. The geomorphology of the feature was natural but modified by livestock trampling to a limited extent.

Figure 28: Representation of the drainage lines.

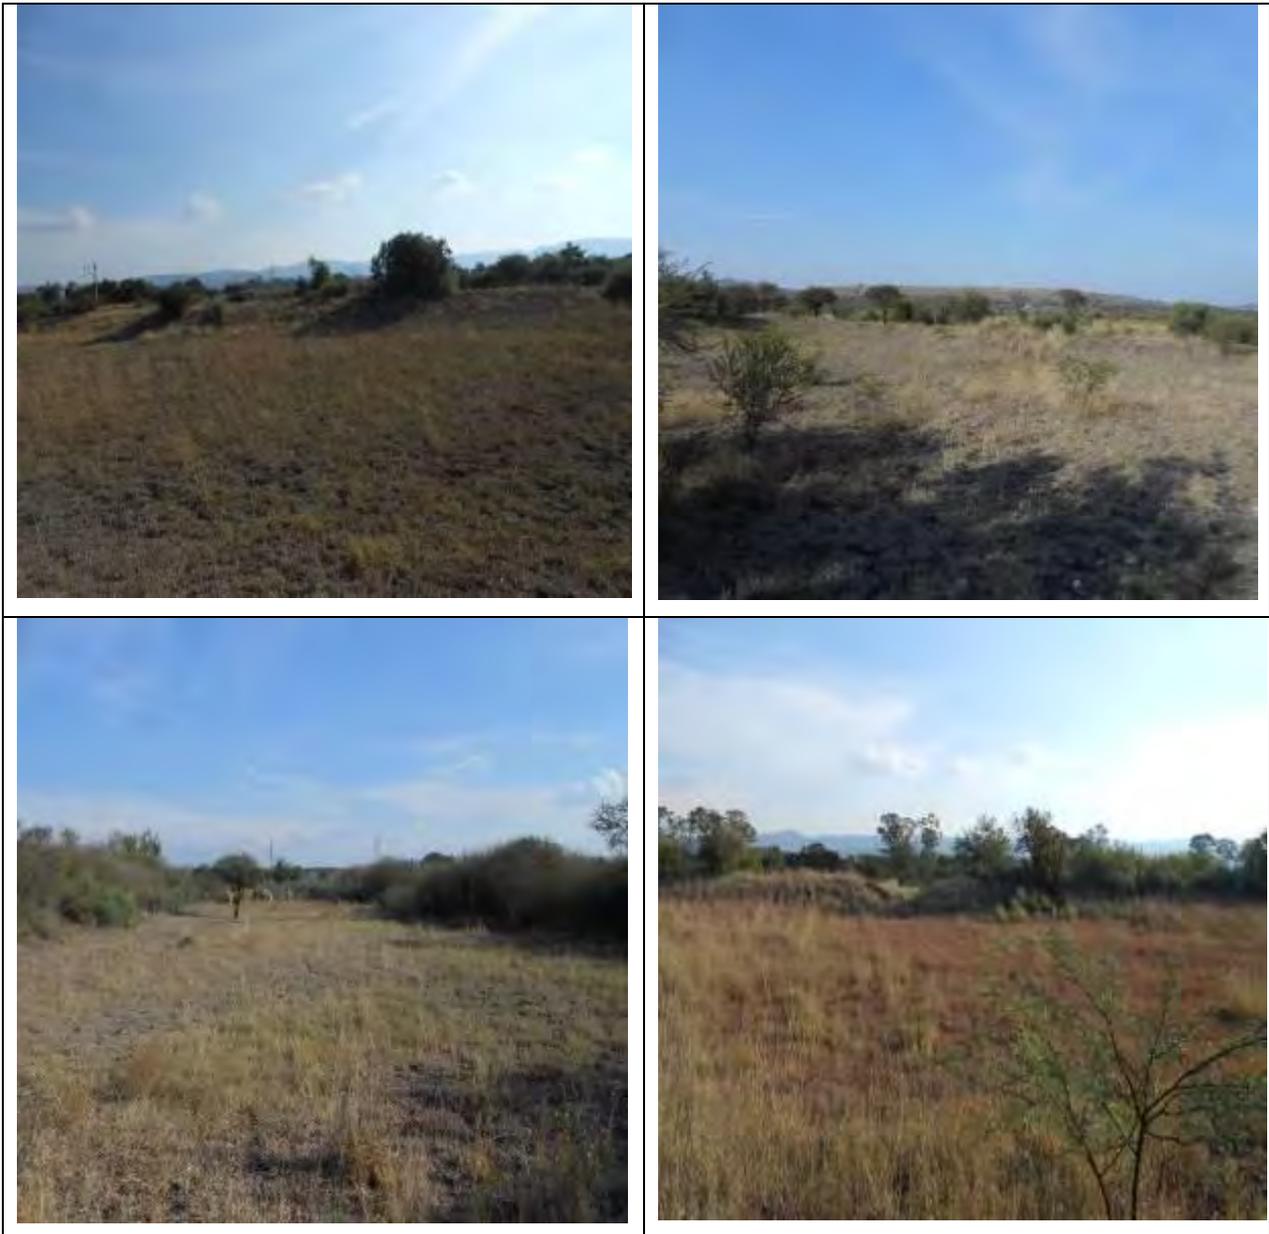
The dams were in a good state at the time of the assessment and were not affected by the current disturbances within the catchment. This may be due to their hydrological isolation from other wetland/riparian features. The hydrology of the features was largely natural with a few modifications. In addition, the geomorphology was slightly modified by compaction as a result of livestock trampling and grazing. The vegetation cover was moderately modified and this is mainly due to livestock grazing.

Figure 29: Representation of the dams observed during site visit.

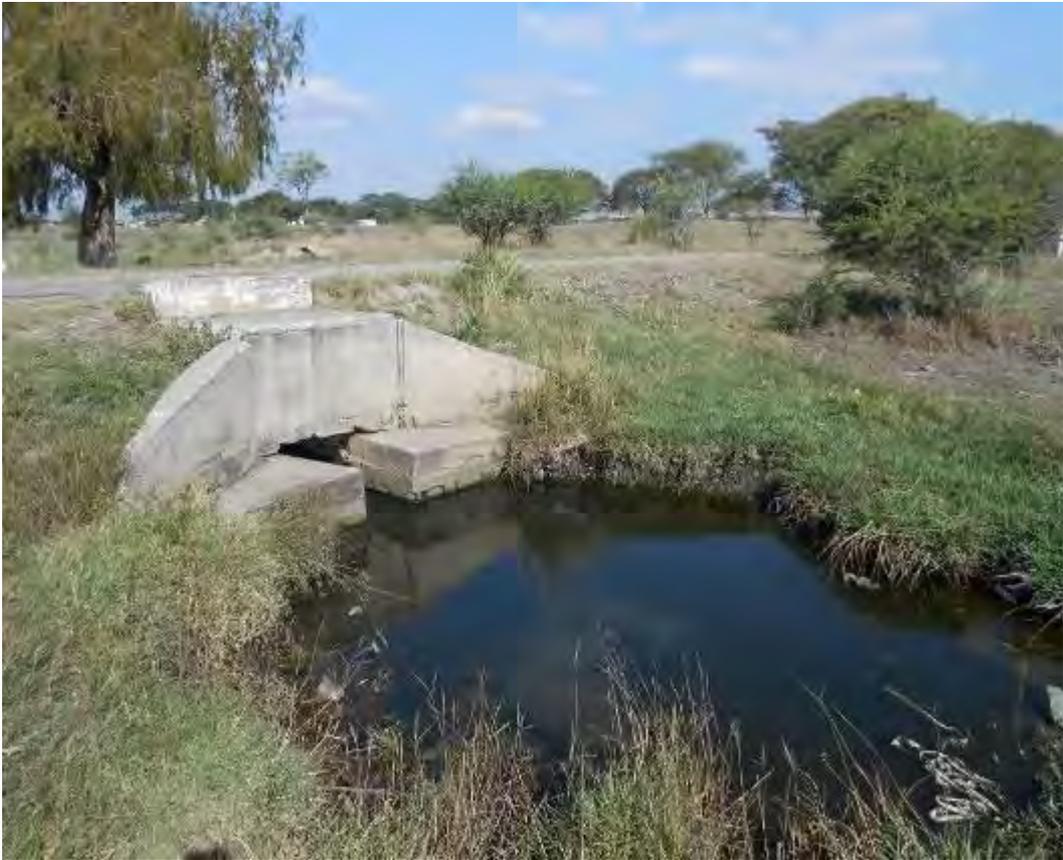
Site number: 01	Coordinates: 25°41'50.69"S 27°22'39.13"E
Crossing Type: Culvert/Road	
Site Photo:

Present Ecological State	D
Wetland type	River
Riparian and in Stream Habitat	<i>Acacia</i> spp. dominated bushveld vegetation; alien vegetation component high. Instream ecology: the wetland was moderately channelled upstream and diffuse downstream.
Vegetation	<i>Cynodon dactylon</i> dominated the wetland; alien vegetation was observed but only for a limited extent.
System Modifiers	Littering, cemented artificial channel, culvert altering waterflow .due to runoff from the road, erosion was observed in the area just adjacent to the culvert and the road.
Potential impacts of water use on environment	The bridge will not significantly negatively impact on any water users.
Socio-economic impacts of water use	The bridge will not significantly negatively impact on any water users.
Socio-economic advantages of water use	The bridge plays an important role in providing connectivity in the area thereby allowing economic activity in the area

Potential impacts of water use on water resource	The culvert is constructed in a way that it constricts water flow especially in the immediate area of the culvert.
Summary of proposed impact on water use will have on other users	The bridge will not impact significantly on other water users.
Mitigation and Rehabilitation plan	Invasive vegetation control. Litter control and removal, erosion monitoring.
