**WETLAND DELINEATION IN THE RUSTENBURG
PLATINUM MINE PROJECT AREA AND A HIGH
LEVEL ASSESSMENT OF SELECTED RIVER
CROSSINGS, NORTH-WEST PROVINCE**

SRK Consulting (Pty) Ltd

May 2015

Prepared by:	Scientific Aquatic Services
Report author:	M. Aphane
Report Reviewer	S. van Staden (Pri. Sci. Nat)
Report Reference:	SAS 215053
Date:	May 2015

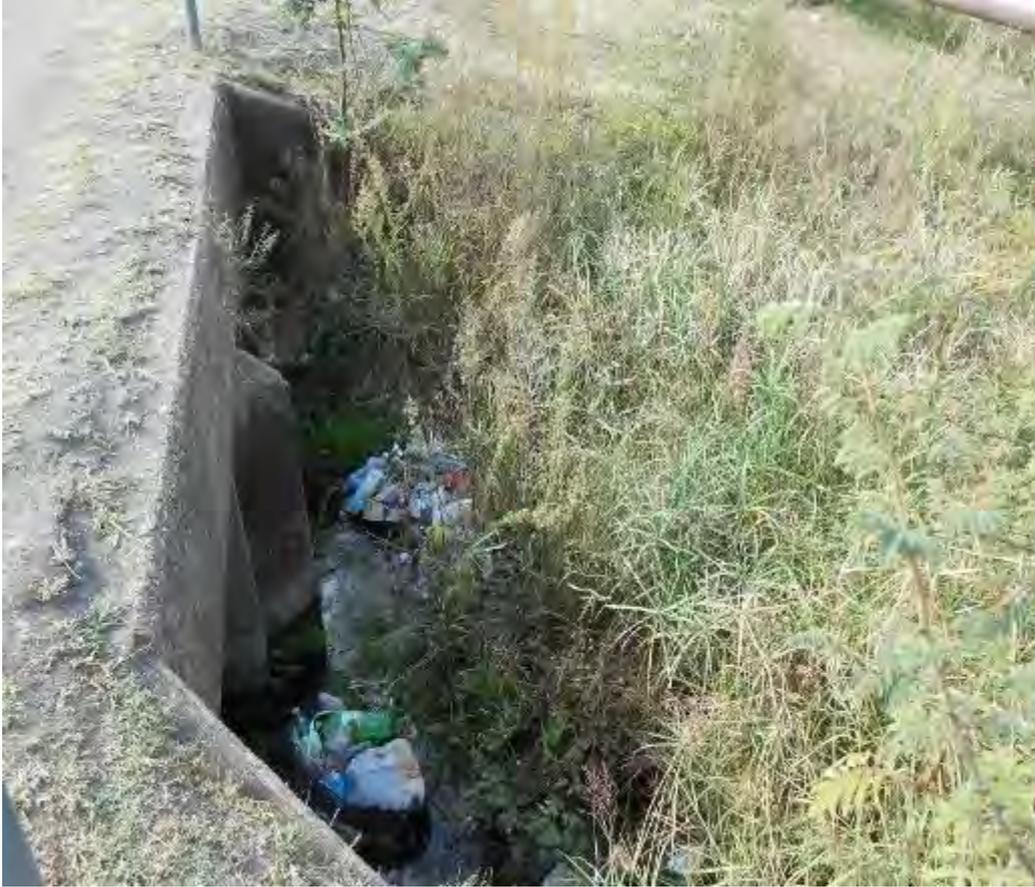
Site number: 03	Coordinates: 25°41'40.69"S 27°22'05.90"E
Crossing Type: Road crossing	
Site Photo:

Present Ecological State	C
Wetland type	River
Morphology	Relatively shallow channel, well vegetated.
Riparian and in Stream Habitat	Instream ecology: dominated by <i>Cyperus sexangularis</i>
Vegetation	The stream is dominated by <i>Sexangularis</i> and <i>Flaveria bidentis</i> .
System Modifiers	Mowing. Waste dumping. Erosion along the culvert.
Potential impacts of water use on environment	The road crossing will not significantly negatively impact on the receiving environment; provided it is adequately maintained.
Socio-economic impacts of water use	The road crossing will not significantly negatively impact on any water users.
Socio-economic advantages of water use	The road crossing will not significantly negatively impact on any water users.
Potential impacts of water use on water resource	The road crossing will lead to increased water input within the river.

Summary of proposed impact on water use will have on other users	The road crossing will not impact significantly on other water users.
Mitigation and Rehabilitation plan	Clean up litter. Minimize the extent of vegetation clearing (curb side maintenance/grass mowing) next to the road to reduce runoff. Monitor erosion. Clear vegetation within the stream to promote clear stream flow.

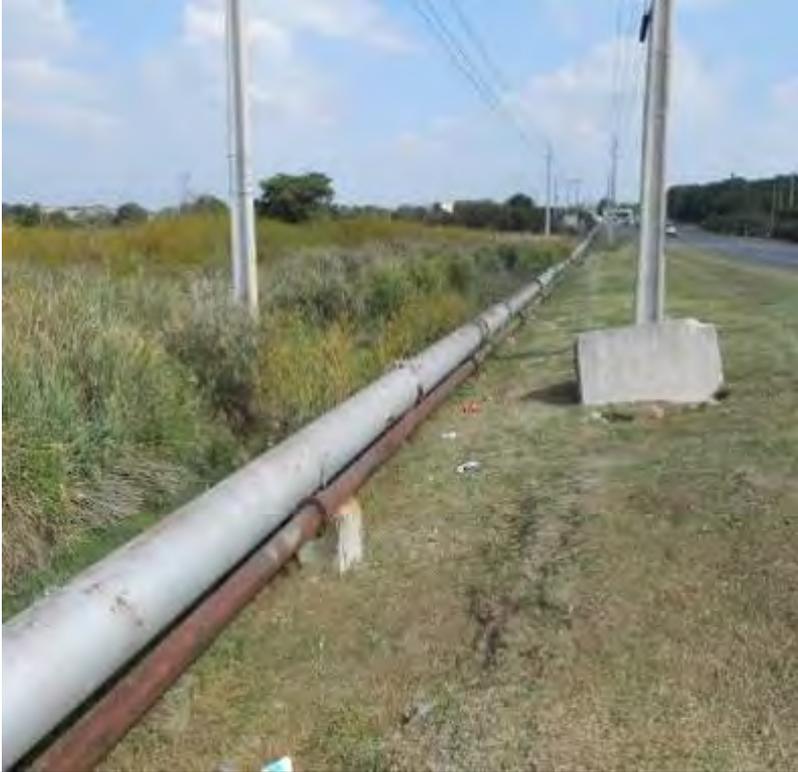
Site number: 3a	Coordinates: 25°41'41.32"S 27°22'06.46"E
Crossing Type: Pipeline	
Site Photo:

Present Ecological State	C
Wetland type	River
Morphology	Wide, relatively shallow channel.
Riparian and in Stream Habitat	Instream ecology: dominated by <i>Cyperus sexangularis</i>
Vegetation	The stream is dominated by <i>Sexangularis</i> and <i>Flaveria bidentis</i> .
System Modifiers	Mowing.
Potential impacts of water use on environment	The pipeline will not significantly negatively impact on the receiving environment; provided it is adequately maintained and there are no leaks detected during monitoring.
Socio-economic impacts of water use	The pipeline will not significantly negatively impact on any water users.
Socio-economic advantages of water use	The sewer line is necessary for the safe disposal of sewage.
Potential impacts of water use on water resource	The support structures within the channel will result in some but not major alterations to streamflow patterns; however these are not deemed to have a significant impact on downstream resources.

Summary of proposed impact on water use will have on other users	The pipeline crossing will not impact significantly on other water users.
Mitigation and Rehabilitation plan	Minimize the extent of vegetation clearing (curb side maintenance/grass mowing) next to the road to reduce runoff.

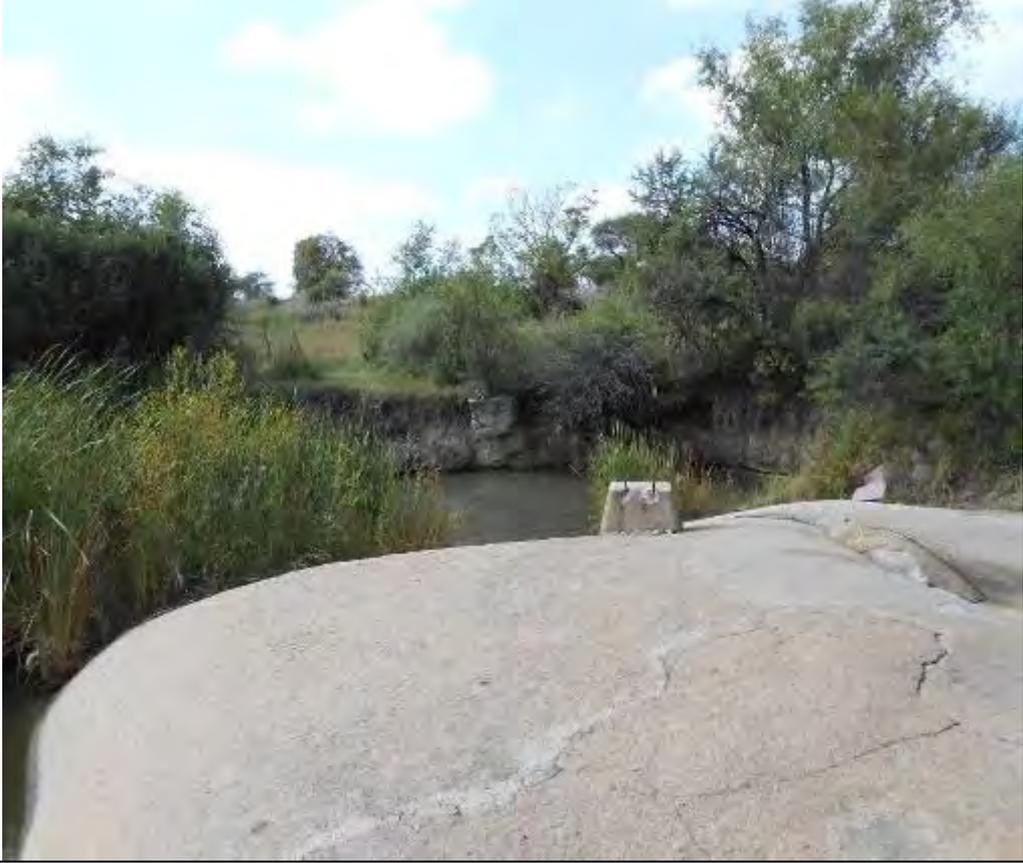
Site number: 3c	Coordinates: 25°41'33.32"S 27°21'23.65"E
Crossing Type: Culvert	
Site Photo:

Present Ecological State	C
Wetland type	River
Morphology	Wide, deeply incised channel.
Riparian and in Stream Habitat	<i>Acacia</i> spp. dominated bushveld vegetation. Instream ecology: lowered water level during assessment, exposed bedrock.
Vegetation	<i>Typha capensis</i> , dominated and alien species such <i>Asparagus larycinus</i> and <i>Conyza bonariensis</i> were observed.
System Modifiers	Encroachment.
Potential impacts of water use on environment	The culvert has been broken or removed on purpose since there is no obstruction of waterflow.
Socio-economic impacts of water use	The culvert will not significantly negatively impact on any water users.
Socio-economic advantages of water use	The culvert will not significantly negatively impact on any water users
Potential impacts of water use on water resource	The culvert will not significantly negatively impact on the water resource.

Summary of proposed impact on water use will have on other users	The culvert will not impact significantly on other water users.
Mitigation and Rehabilitation plan	Control alien vegetation.

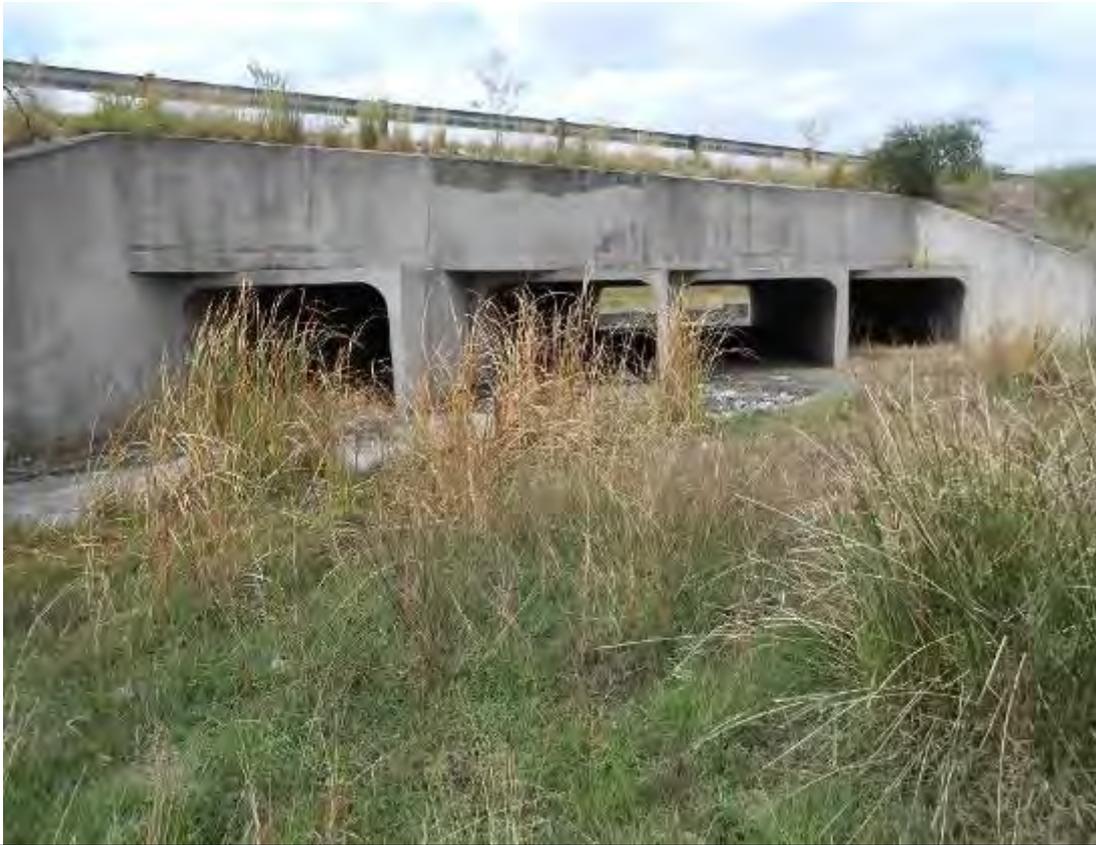
Site number: 4/4a	Coordinates: 25°41'26.54"S 27°21'10.01"E
Crossing Type: Road crossing	
Site Photo:

Present Ecological State	C
Wetland type	River
Morphology	Wide, relatively shallow channel. Dry river bed.
Riparian and in Stream Habitat	Instream ecology: riverbed dry at the time of the study.
Vegetation	<i>Typha capensis</i> and <i>Cyperus sexangularis</i> dominated. Alien species such as <i>Tagetes minuta</i> and <i>Bidens pilosa</i> were observed on site.
System Modifiers	Culvert. Increased runoff from road.
Potential impacts of water use on environment	The road crossing will not significantly negatively impact on any water users.
Socio-economic impacts of water use	The road crossing will not significantly negatively impact on any water users.
Socio-economic advantages of water use	The road crossing plays an important role in providing connectivity in the area thereby allowing economic activity in the area

Potential impacts of water use on water resource	The road crossing is well constructed and berms are constructed to prevent erosion.
Summary of proposed impact on water use will have on other users	The road crossing will not impact significantly on other water users.
Mitigation and Rehabilitation plan	Control alien vegetation

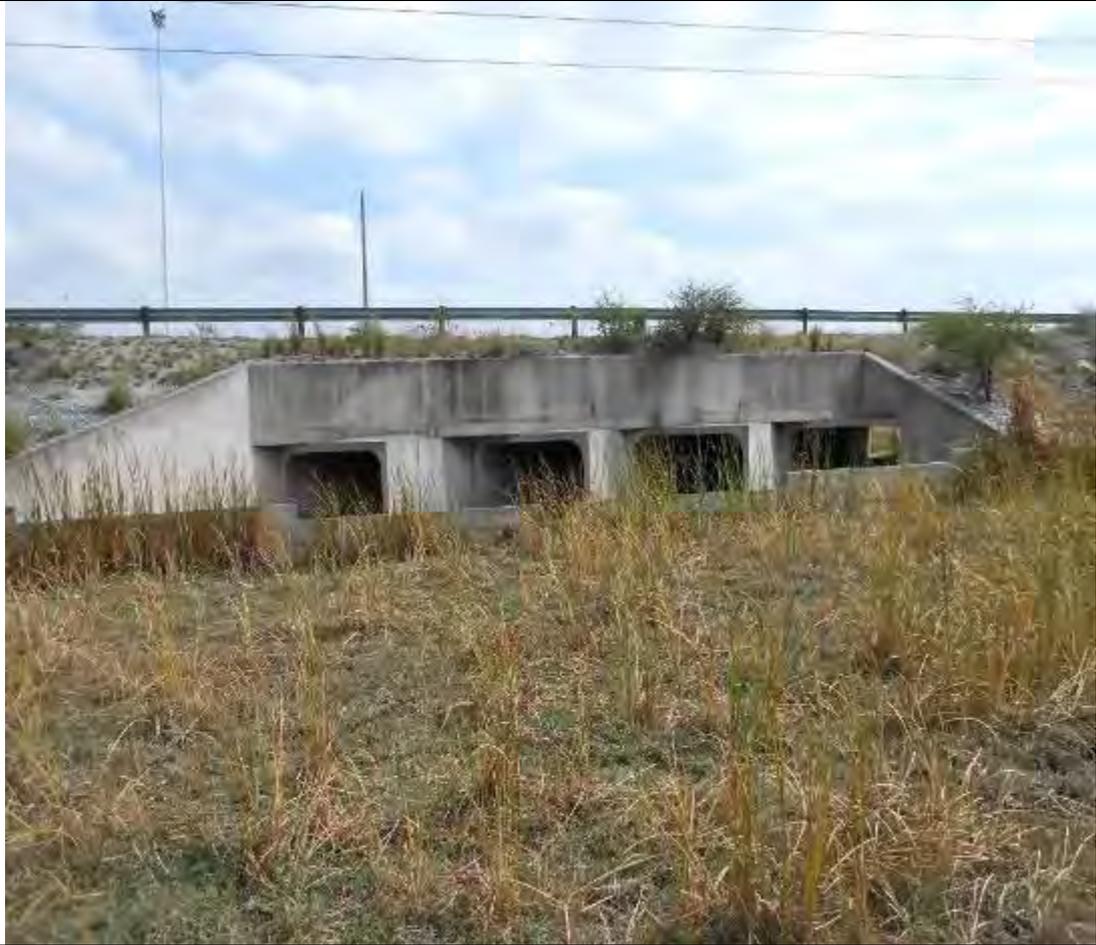
Site number: 05	Coordinates: 25°41'26.59"S 27°21'11.30"E
Crossing Type: Road crossing

Present Ecological State	C
Wetland type	River
Morphology	Wide, relatively shallow channel. Dry river bed.
Riparian and in Stream Habitat	Instream ecology: riverbed dry at the time of the study.
Vegetation	<i>Typha capensis</i> dominated.
System Modifiers	Culvert. Increased runoff from road. Stock piling
Potential impacts of water use on environment	The road crossing will not significantly negatively impact on any water users.
Socio-economic impacts of water use	The road crossing will not significantly negatively impact on any water users.
Socio-economic advantages of water use	The road crossing plays an important role in providing connectivity in the area thereby allowing economic activity in the area
Potential impacts of water use on water resource	The road crossing is well constructed. However stock piling adjacent the stream will result in sediment deposition.

Summary of proposed impact on water use will have on other users	The road crossing will not impact significantly on other water users.
Mitigation and Rehabilitation plan	Control alien vegetation. Remove stock piled adjacent the feature to avoid sediment deposition and further erosion of the area.

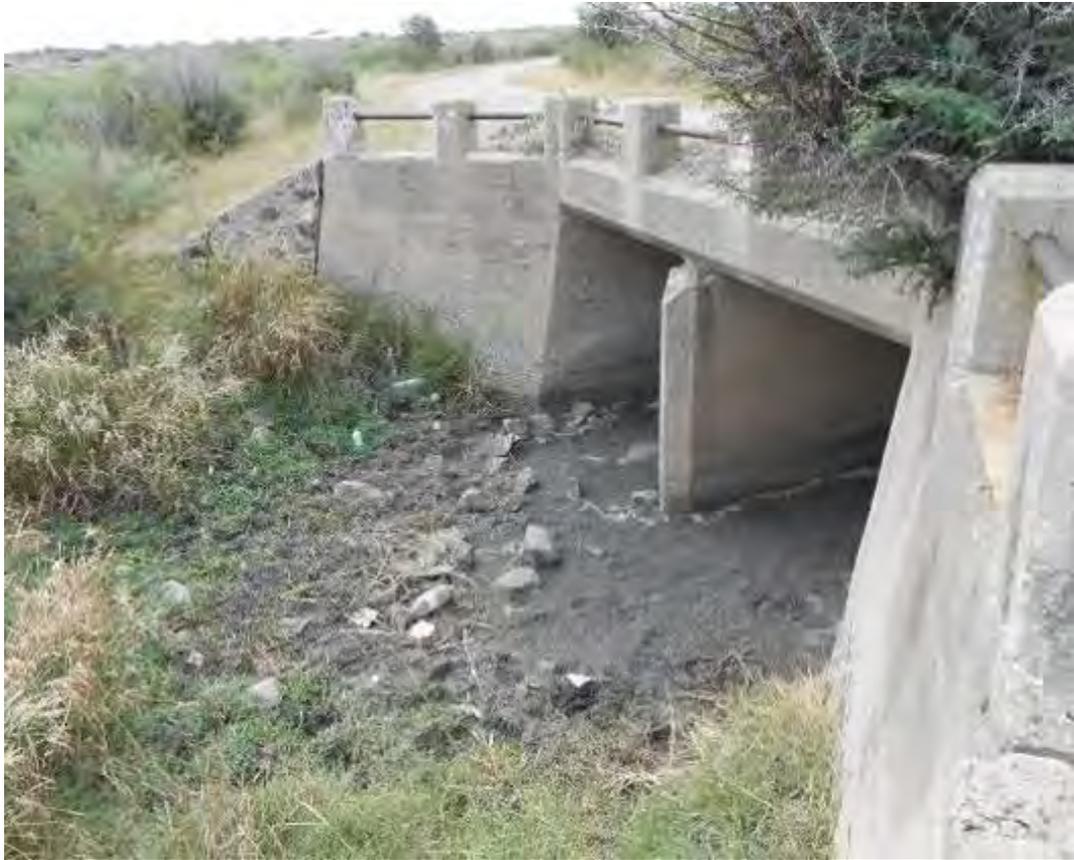
Site number: 06	Coordinates: 25°40'52.34"S 27°20'25.70"E
Crossing Type: Road crossing	
Site Photo:

Present Ecological State	C
Wetland type	River
Morphology	Wide, shallow banks. Dry river bed.
Riparian and in Stream Habitat	Riparian vegetation dominated by <i>Asparagus laricinus</i> and <i>Acacia</i> spp. In-stream ecology: riverbed dry at the time of the study.
Vegetation	<i>Hyperhenia hirta</i> , <i>Eragrostis curvula</i> , and <i>Cyperus sexangularis</i> dominated.
System Modifiers	In-stream flow altered moderately due to infrastructure (old bridge) within macro-channel. Some alien vegetation present. Trampling by livestock resulting in erosion and sedimentation.
Potential impacts of water use on environment	The bridge will not significantly negatively impact on any water users.
Socio-economic impacts of water use	The bridge will not significantly negatively impact on any water users.
Socio-economic advantages of water use	The bridge plays an important role in providing connectivity in the area thereby allowing economic activity in the area

Potential impacts of water use on water resource	The bridge is likely to have moderately altered streamflow patterns.
Summary of proposed impact on water use will have on other users	The bridge does not impact significantly on other water users.
Mitigation and Rehabilitation plan	Monitor erosion, alien vegetation control programme.

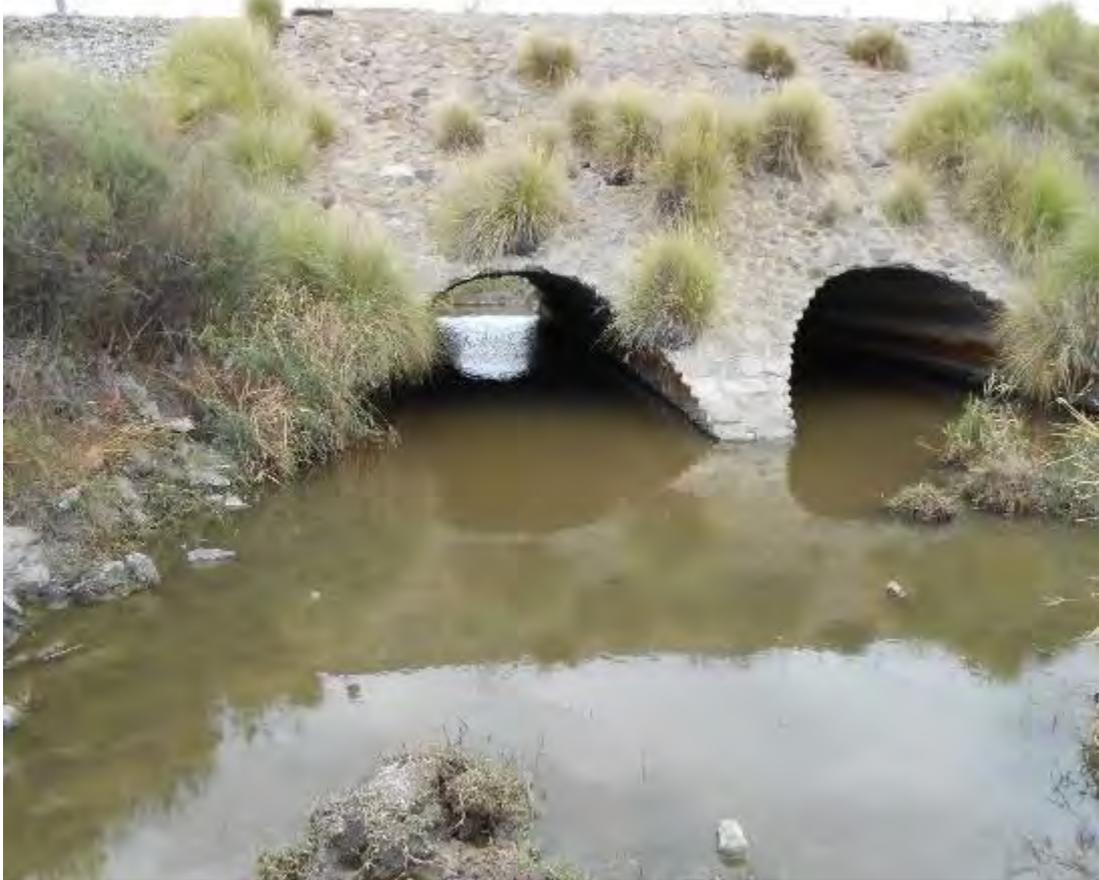
Site number: 07	Coordinates: 25°40'45.84"S 27°20'01.63"E
Crossing Type: Railway/Culvert	
Site Photo:

Present Ecological State	C
Wetland type	River
Morphology	Trampling by livestock and resulting erosion.
Riparian and in Stream Habitat	<i>Cyperus sexangularis</i> dominated.
Vegetation	<i>Asclepias fruiticosa</i> , <i>Xanthium strumarium</i> , <i>Asparagus larinicus</i> , <i>Flaveria bidentis</i> , <i>Conyza bonariensis</i> , <i>Cyperus sexangularis</i>
System Modifiers	Trampling and overgrazing by livestock.
Potential impacts of water use on environment	The culvert has changed the geomorphology as well as vegetation on site.
Socio-economic impacts of water use	The culvert will not significantly impact negatively on any water users.
Socio-economic advantages of water use	The bridge plays an important role in providing connectivity in the area thereby allowing economic activity in the area.
Potential impacts of water use on water resource	The culvert has altered water flow patterns line on the water resource.

Summary of proposed impact on water use will have on other users	The culvert will not significantly impact negatively on any water users.
Mitigation and Rehabilitation plan	Erosion monitoring and control

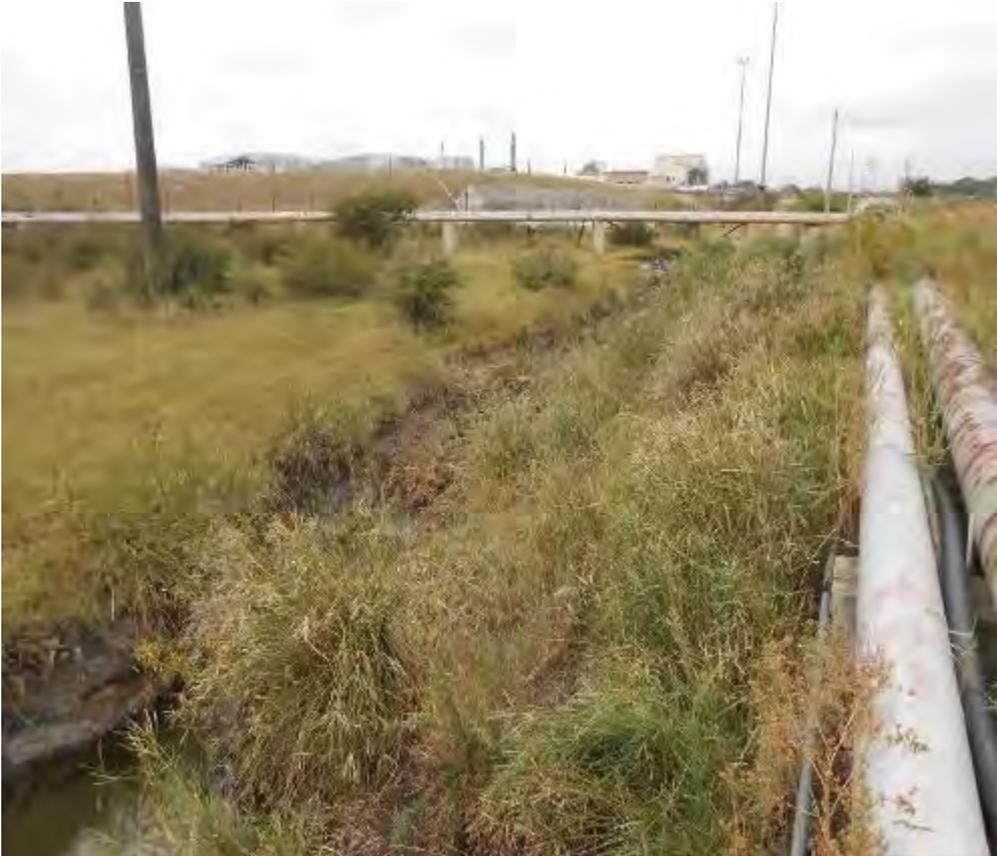
Site number: 8a	Coordinates: 25°40'43.43"S 27°19'36.40"E
Crossing Type: Pipeline	
Site Photo:

Present Ecological State	D
Wetland type	River
Morphology	Narrow, ephemeral channel.
Riparian and in Stream Habitat	Riparian habitat dominated by pioneer graminoid species. Instream ecology: riverbed dry at the time of the study; terrestrial plants found in the channel.
Vegetation	<i>Hyparrhenia hirta</i> , <i>Phragmites australis</i> , <i>Flaveria bidentis</i> , <i>Coenzyza bonariensis</i> , <i>Cynodon dactylon</i> , <i>Sesbania sesban</i>
System Modifiers	Erosion. Grazing and trampling by livestock has altered the vegetation. Sediment deposition. Berm not functioning well.
Potential impacts of water use on environment	The pipeline will not significantly negatively impact on any water users.
Socio-economic impacts of water use	The pipeline will not significantly negatively impact on any water users.

Socio-economic advantages of water use	The pipeline will not significantly negatively impact on any water users.
Potential impacts of water use on water resource	The pipeline will not significantly negatively impact on any water users.
Summary of proposed impact on water use will have on other users	The road crossing will not impact significantly on other water users.
Mitigation and Rehabilitation plan	Invasive vegetation control. Fix berm where the other canal enters the stream. Monitor erosion.

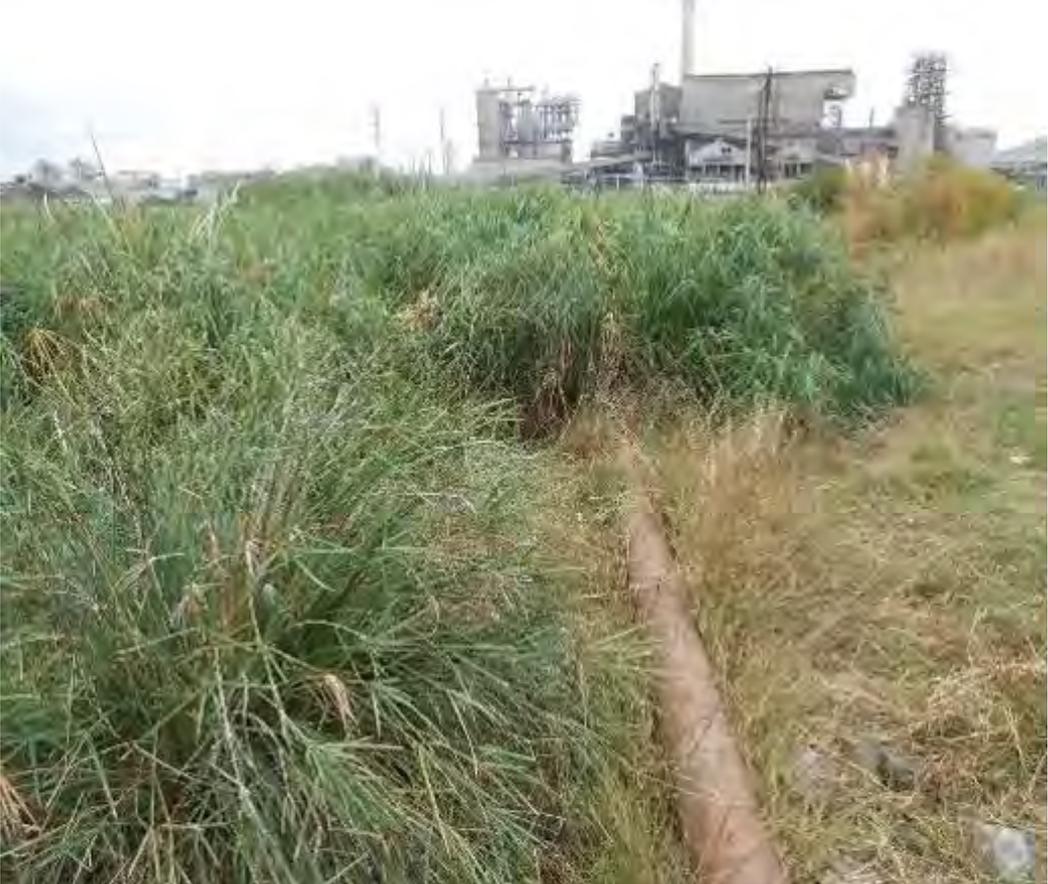
Site number: 8b	Coordinates: 25°40'42.44"S 27°19'27.71"E
Crossing Type: Pipeline	
Site Photo:

Present Ecological State	C
Wetland type	River
Morphology	Fairly vegetated area.
Riparian and in Stream Habitat	Not applicable.
Vegetation	<i>Cyperus sexangularis</i> , <i>Cynodon dactylon</i> , <i>Sesbania sesban</i>
System Modifiers	Leaking pipes, trampling.
Potential impacts of water use on environment	The pipeline crossing might alter water flow patterns since it is not elevated and it lies on the ground.
Socio-economic impacts of water use	The pipeline will not significantly negatively impact on any water users.
Socio-economic advantages of water use	The pipeline will not significantly negatively impact on any water users.
Potential impacts of water use on water resource	Due to the inherent erodability of the soils in the area, the pipeline might trap sediment during rainfall events. The pipe will not cause a migration barrier since this is not a crossing with flow.

Summary of proposed impact on water use will have on other users	The pipeline will not impact significantly on other water users.
Mitigation and Rehabilitation plan	Monitor erosion and pipe leakages.

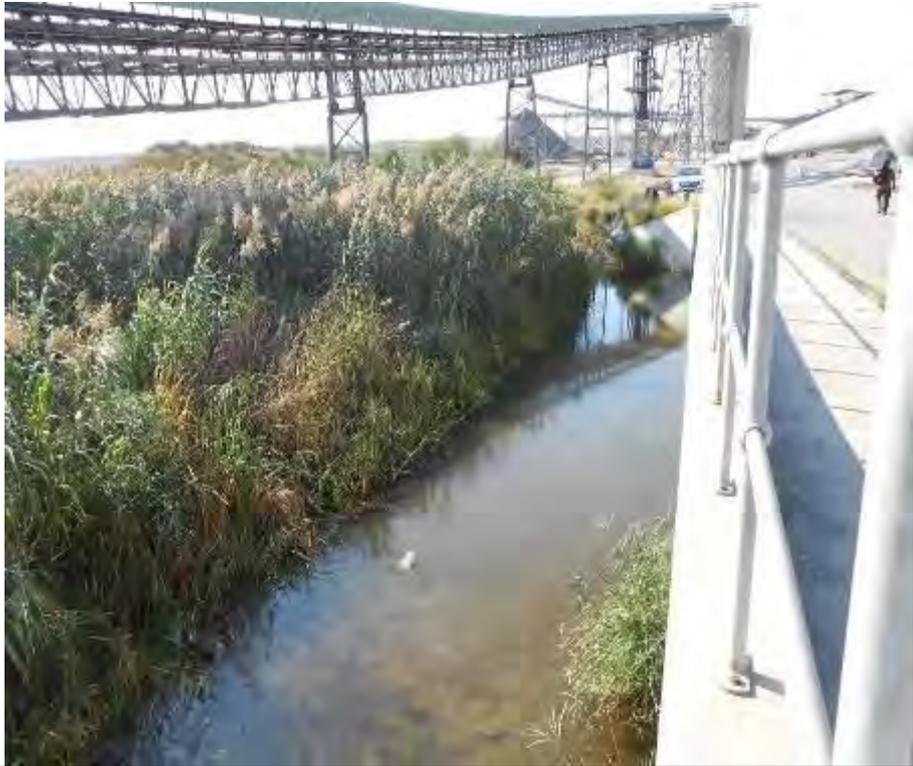
Site number: 09	Coordinates: 25°40'31.53"S 27°18'46.76"E
Crossing Type: Pipeline & conveyer belt	
Site Photo:

Present Ecological State	C
Wetland type	River
Morphology	Moderately incised channel.
Riparian and in Stream Habitat	Inundation below the bridge. Well vegetated in-stream habitat.
Vegetation	<i>Sporobolus pyramidalis</i> , <i>Cynodon dactylon</i> , <i>Phragmites australis</i> , <i>Melinis repens</i>
System Modifiers	Erosion along culvert due to grazing and trampling
Potential impacts of water use on environment	The conveyor line crossing will not significantly negatively impact on any water users, provided it is well maintained.
Socio-economic impacts of water use	The conveyor line crossing will not significantly negatively impact on any water users, however, the bridge will alter water flow patterns.
Socio-economic advantages of water use	The conveyor line as well as the road/bridge crossing is essential for continued mining operations, thus continuing economic development in the area.

Potential impacts of water use on water resource	The conveyor line crossing plinths do not pose any significant risk to the resource. Due to inherent erodability of the soils, bank incision during high-flow events and sedimentation of downstream resources is anticipated; however this is not as a direct consequence of the support structures.
Summary of proposed impact on water use will have on other users	The conveyor line crossing will not impact significantly on other water users.
Mitigation and Rehabilitation plan	Control erosion if possible (The activity may be out of RPM control as the feature is used by livestock for regular watering and crossing point)

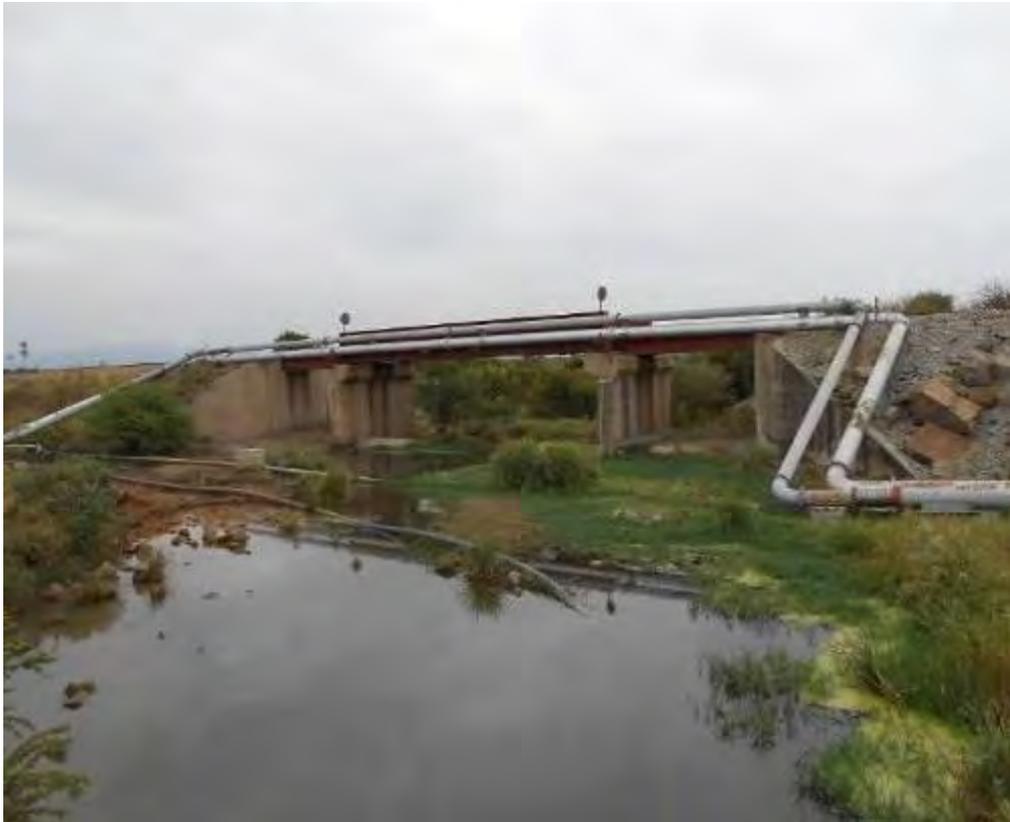
Site number: 11/a/b	Coordinates: 25°39'28.41"S 27°17'47.97"E
Crossing Type: Railway/Weir/Pipeline	
Site Photo:

Present Ecological State	D
Wetland type	River
Morphology	Shallow, wide channel.
Riparian and in Stream Habitat	Predominantly terrestrial, alien floral species.
Vegetation	<i>Cyperus sexangularis</i> , <i>Tagetes minuta</i> , <i>Melinis repens</i> , <i>Hyparrhenia hirta</i> , <i>Brachiaria brizantha</i> , <i>Rhus lancea</i> , <i>Typha capensis</i> , <i>Phragmites australis</i> , <i>Aloe spp.</i> , <i>Asparagus laricinus</i> , <i>Coenyzia bonariensis</i> , <i>Asclepias fruticosa</i> , <i>Eragrostis curvula</i>
System Modifiers	Erosion. Livestock grazing and trampling. Leaking pipes. Weir altering water flow patterns
Potential impacts of water use on environment	The weir and the culvert will alter water flow pattern. However the railway line and the pipeline will not significantly negatively impact on any water users.

Socio-economic impacts of water use	The structures will not significantly negatively impact on any water users.
Socio-economic advantages of water use	The railway line is utilised for the mining operations.
Potential impacts of water use on water resource	Alteration to streamflow patterns during flow periods is anticipated due to the presence of the culvert and the weir.
Summary of proposed impact on water use will have on other users	The railway crossing will not impact significantly on other water users, in addition, the pipeline will not have any significant impact provided it is well maintained.
Mitigation and Rehabilitation plan	Monitor erosion. Monitor pipes for leaks. Insert erosion control berms.

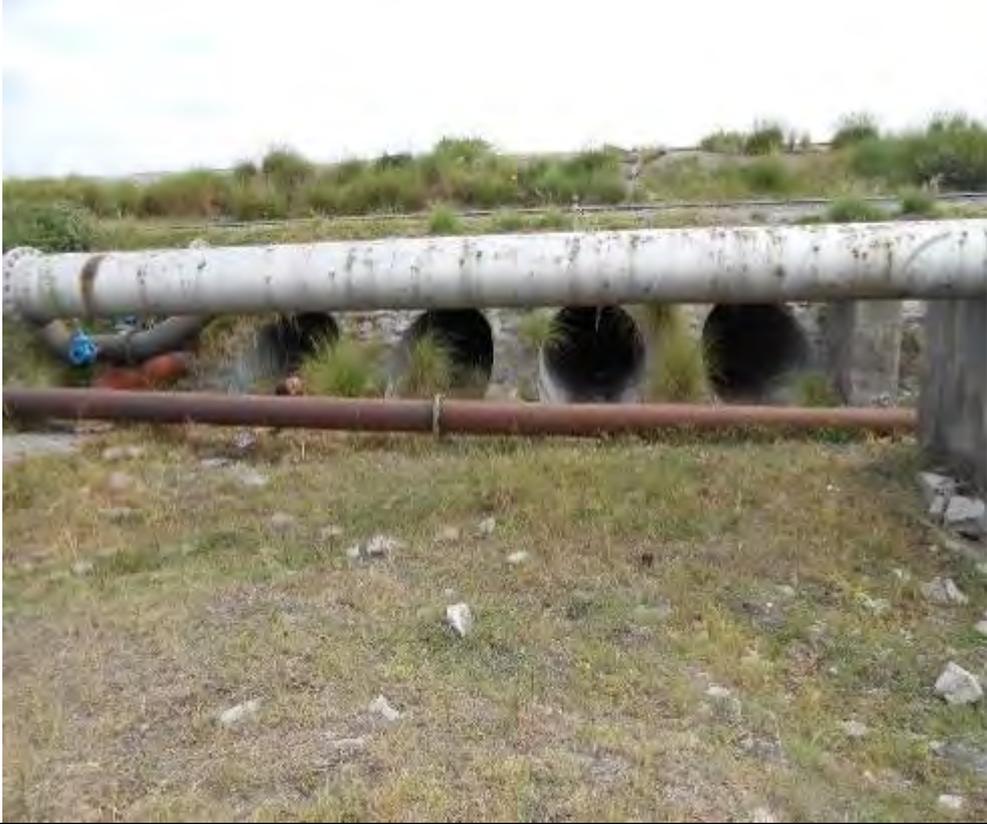
Site number: 12/12a	Coordinates: 25°39'56.50"S 27°20'07.59"E
Crossing Type: Road crossing culvert & pipeline	
Site Photo:

Present Ecological State	C
Wetland type	River
Morphology	Wide, relatively shallow channel. Dry river bed.
Riparian and in Stream Habitat	<i>Dichrostachys</i> spp. dominated bushveld vegetation. Instream ecology: riverbed dry at the time of the study.
Vegetation	<i>Cyperus sexangularis</i> , <i>Hyparrhenia hirta</i> , <i>Acacia</i> spp, <i>Coenyzia bonariensis</i> , <i>Cynodon dactylon</i> , <i>Verbena bonariensis</i> , <i>Setaria sphacelata</i> , <i>Helichrysum</i> spp, <i>Typha capensis</i>
System Modifiers	Livestock grazing. Erosion.
Potential impacts of water use on environment	The road crossing will not significantly negatively impact on the receiving environment.
Socio-economic impacts of water use	The road crossing will not significantly negatively impact on any water users.

Socio-economic advantages of water use	The pipeline will not significantly negatively impact on the receiving environment provide it is well maintained
Potential impacts of water use on water resource	The road crossing as well as the pipeline plinths within the channel will result in some alterations to streamflow patterns during flow periods; however these are not deemed to have a significant impact on downstream resources.
Summary of proposed impact on water use will have on other users	The pipeline will not impact significantly on other water users.
Mitigation and Rehabilitation plan	Monitor erosion.

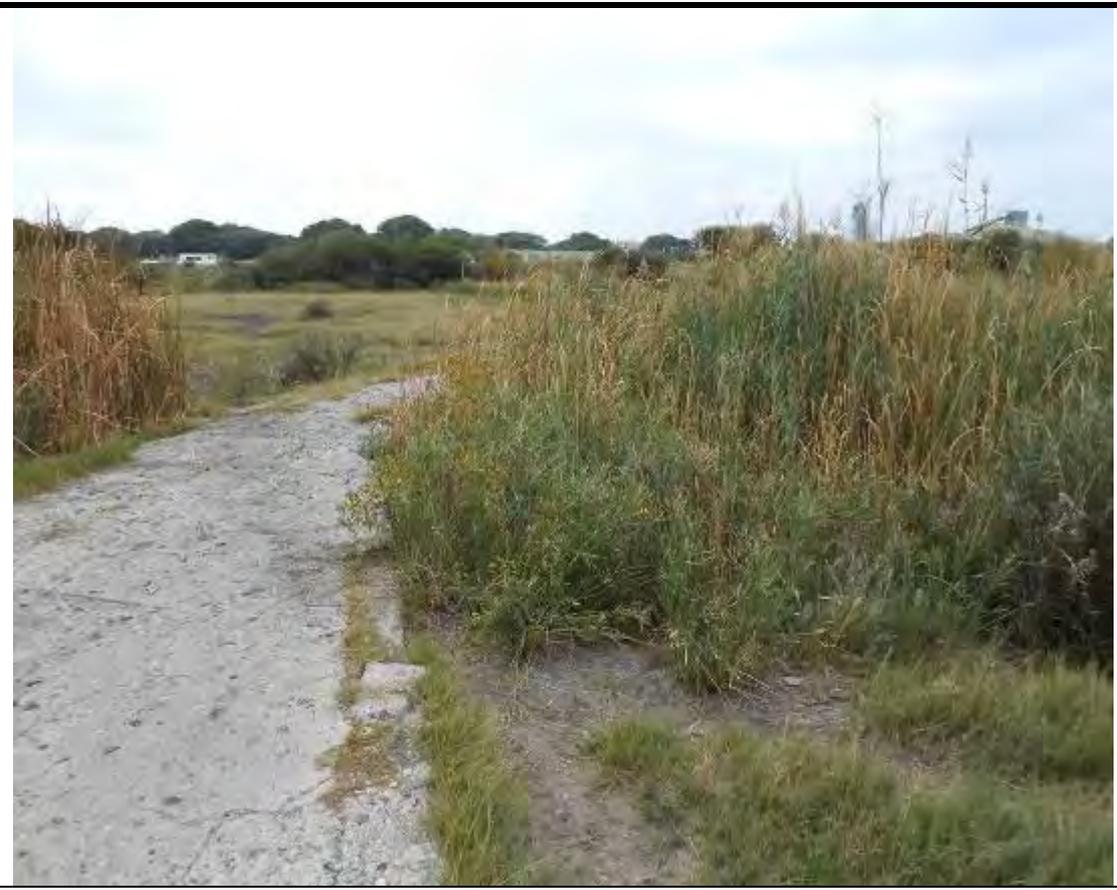
Site number: 12b	Coordinates: 25°39'30.67"S 27°19'16.36"E
Crossing Type: Road crossing

Present Ecological State	C
Wetland type	River
Morphology	Wide, relatively shallow channel, mixture of alluvial sand and bedrock. Dry river bed.
Riparian and in Stream Habitat	<i>Dichrostachys</i> spp. dominated bushveld vegetation. Instream ecology: riverbed dry at the time of the study.
Vegetation	<i>Phragmites australis</i> , <i>Cynodon dactylon</i> , <i>Conyza bonariensis</i> , <i>Panicum maxima</i> , <i>Cyperus sexangularis</i> , <i>Flaveria bidentis</i> , <i>Typha capensis</i> .
System Modifiers	Road traversing feature. Livestock grazing and trampling. Erosion.
Potential impacts of water use on environment	The road crossing will not significantly negatively impact on the receiving environment.
Socio-economic impacts of water use	The road crossing will not significantly negatively impact on any water users.

Socio-economic advantages of water use	The road crossing is necessary to connect the mining area to the neighbouring community.
Potential impacts of water use on water resource	The road crossing will not significantly negatively impact on any water users.
Summary of proposed impact on water use will have on other users	The road crossing will not impact significantly on other water users.
Mitigation and Rehabilitation plan	Monitor erosion. And control alien vegetation.

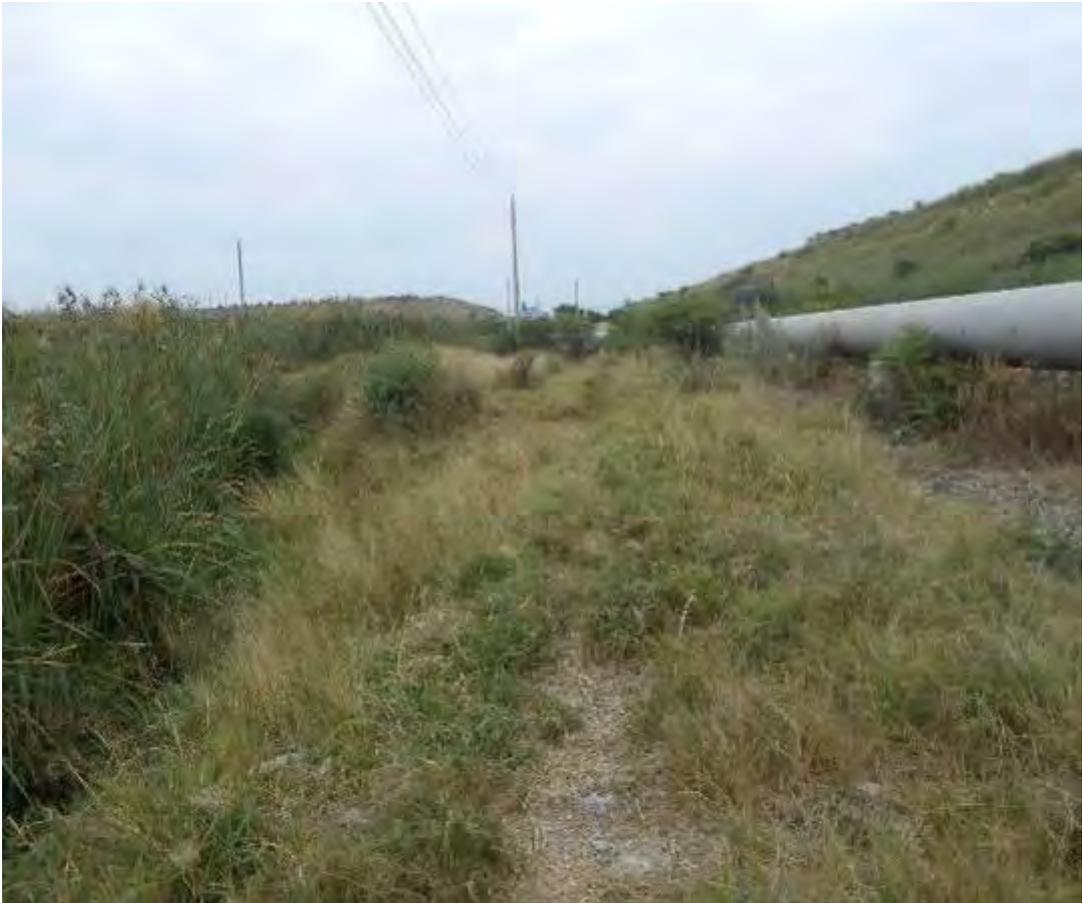
Site number: 12c	Coordinates: 25°39'30.67"S 27°19'16.36"E
Crossing Type: Pipeline	
Site Photo:

Present Ecological State	C
Wetland type	River
Morphology	Wide, relatively shallow channel. Dry river bed.
Riparian and in Stream Habitat	Instream ecology: riverbed dry at the time of the study.
Vegetation	<i>Phragmites australis</i> , <i>Cyperus sexangularis</i> , <i>Cynodon dactylon</i> , <i>typha capensis</i> , <i>Acacia</i> spp.
System Modifiers	Erosion and alien invasion along the pipeline.
Potential impacts of water use on environment	The pipeline will not significantly negatively impact on the receiving environment; provided it is adequately maintained.
Socio-economic impacts of water use	The pipeline will not significantly negatively impact on any water users.
Socio-economic advantages of water use	The pipeline will not significantly negatively impact on any water users.
Potential impacts of water use on water resource	The plinths within the channel will result in some alterations to streamflow patterns during flow periods; however these are not deemed to have a significant impact on downstream resources.

Summary of proposed impact on water use will have on other users	The pipeline crossing will not impact significantly on other water users.
Mitigation and Rehabilitation plan	Monitor erosion. Control alien vegetation

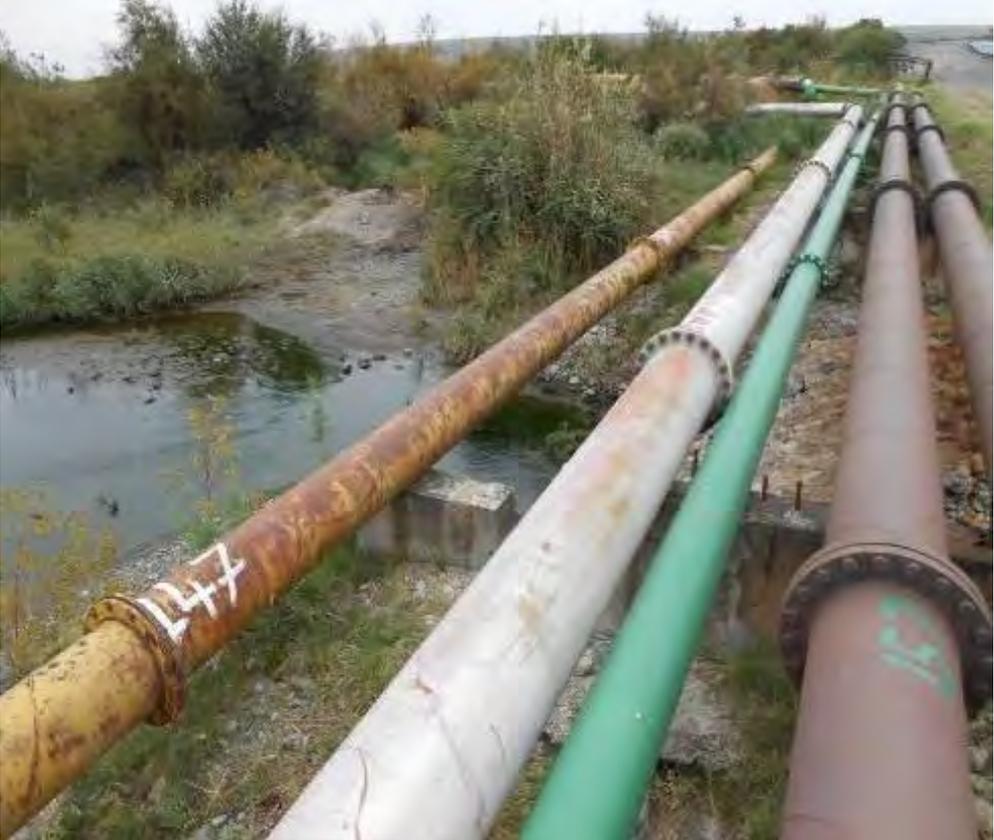
Site number: 13/13a	Coordinates: 25°39'30.18"S 27°19'15.73"E
Crossing Type: Culvert and pipeline	
Site Photo:

Present Ecological State	D
Wetland type	River
Morphology	Wide, relatively shallow channel, mixture of alluvial sand and bedrock. Dry river bed.
Riparian and in Stream Habitat	<i>Acacia</i> spp. dominated bushveld vegetation. Instream ecology: flowing water
Vegetation	<i>Phragmites australis</i> , <i>Cyperus sexangularis</i> , <i>Asparagus larinus</i> , <i>Conyza bonariensis</i> , <i>Tagetes minuta</i> , <i>Melinis repens</i> , <i>Eragrostis curvula</i> , <i>Panicum maxima</i>
System Modifiers	Sedimentation. Erosion. Alien invasion.
Potential impacts of water use on environment	The pipeline will not significantly negatively impact on the receiving environment; provided it is adequately maintained.
Socio-economic impacts of water use	The pipeline will not significantly negatively impact on any water users.

Socio-economic advantages of water use	The pipeline is necessary for the safe disposal of sewage.
Potential impacts of water use on water resource	The plinths within the channel will result in some alterations to streamflow patterns during flow periods. The culvert is very narrow and low and will cause a constriction on water flow.
Summary of proposed impact on water use will have on other users	The pipeline will not impact significantly on other water users.
Mitigation and Rehabilitation plan	Monitor pipes for leakage. Control alien vegetation. redesign and reconstruct the culvert

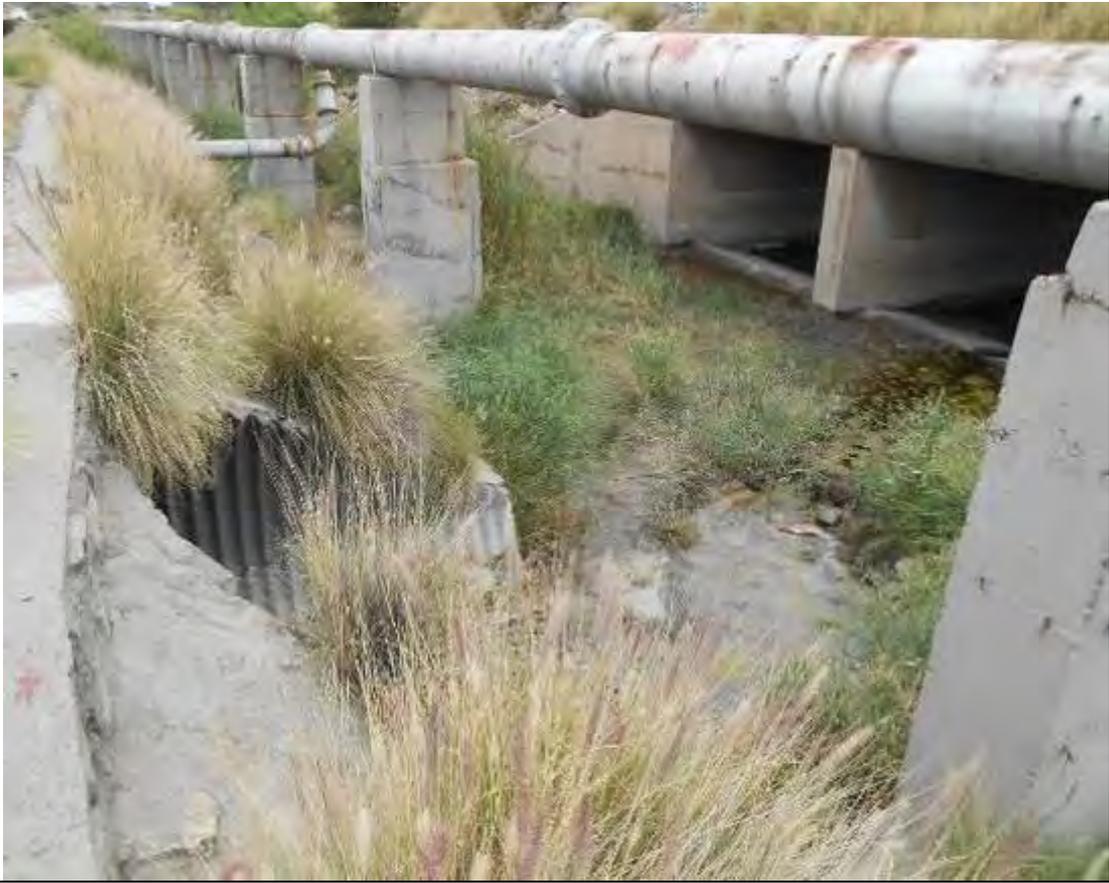
Site number: 14/a/weir	Coordinates: 25°39'03.71"S 27°18'45.09"E
Crossing Type: Culvert & pipeline & weir	
Site Photo:

Present Ecological State	C
Wetland type	River
Morphology	Wide, relatively shallow channel.
Riparian and in Stream Habitat	Instream ecology: there is water within the channel.
Vegetation	<i>Cyperus sexangularis</i> , <i>Melinis repens</i> , <i>Typha capensis</i> , <i>Phragmites australis</i> , <i>Acacia</i> spp., <i>Cynodon dactylon</i> .
System Modifiers	Culvert. Erosion. Cattle trampling. Increased water input due to runoff from road.
Potential impacts of water use on environment	The pipeline crossing will not significantly negatively impact on the receiving environment; provided it is adequately maintained. The culvert and the weir will alter water flow patterns.
Socio-economic impacts of water use	The pipeline and culvert will not significantly negatively impact on any water users.

Socio-economic advantages of water use	The pipeline and culvert will not significantly negatively impact on any water users.
Potential impacts of water use on water resource	The plinths within the channel will result in some alterations to streamflow patterns during flow periods; however these are not deemed to have a significant impact on downstream resources.
Summary of proposed impact on water use will have on other users	The structures will not impact significantly on other water users.
Mitigation and Rehabilitation plan	Monitoring of erosion. Monitor pipes for leaks

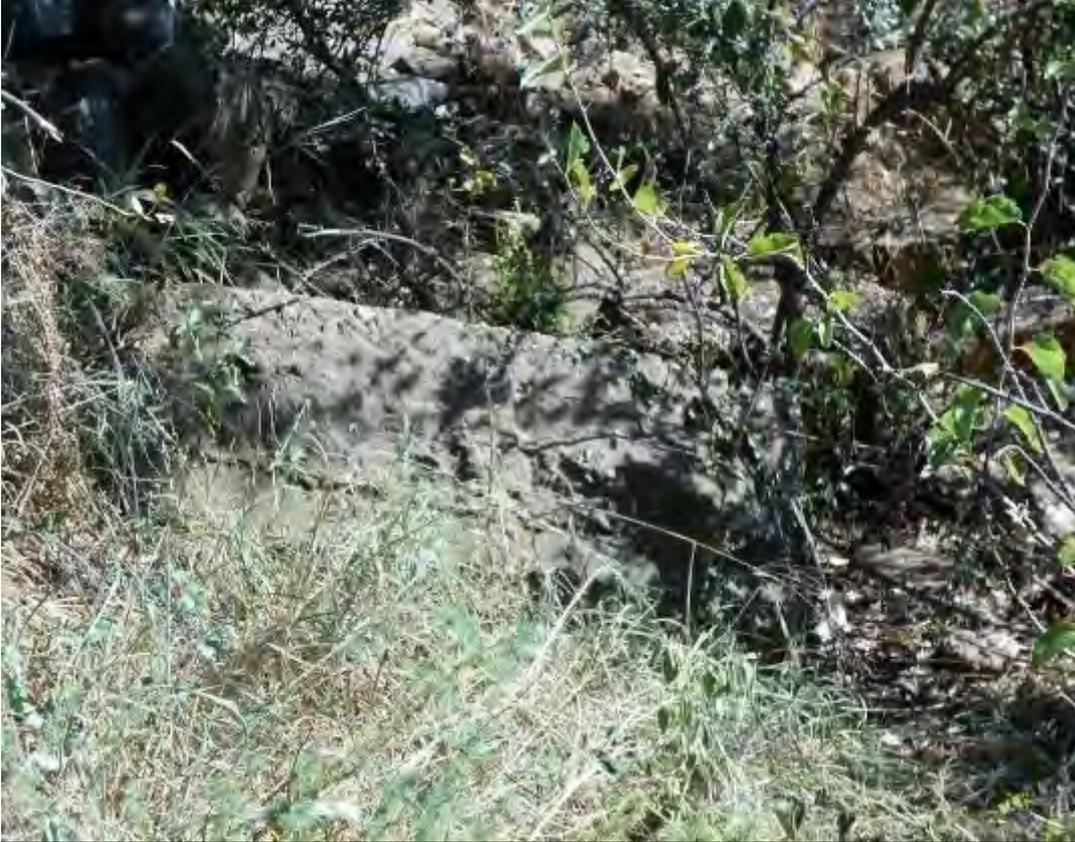
Site number: 14b/c	Coordinates: 25°38'0.36"S 27°17'39.04"E
Crossing Type: Road crossing	
Site Photo:

Present Ecological State	C
Wetland type	River
Morphology	Wide, relatively shallow channel, mixture of alluvial sand and bedrock. Dry river bed.
Riparian and in Stream Habitat	<i>Dichrostachys</i> spp. dominated bushveld vegetation. Instream ecology: riverbed dry at the time of the study.
Vegetation	<i>Cyperus sexangularis</i> , <i>Melinis repens</i> , <i>Typha capensis</i> , <i>Phragmites australis</i> , <i>Acacia</i> spp. <i>Cynodon dactylon</i> .
System Modifiers	Culvert. Erosion. Cattle trampling. Increased water input due to runoff from road.
Potential impacts of water use on environment	The sewer line crossing will not significantly negatively impact on the receiving environment; provided it is adequately maintained.
Socio-economic impacts of water use	The sewer line crossing will not significantly negatively impact on any water users.

Socio-economic advantages of water use	The sewer line is necessary for the safe disposal of sewage.
Potential impacts of water use on water resource	The support structures within the channel will result in some alterations to streamflow patterns during flow periods; however these are not deemed to have a significant impact on downstream resources.
Summary of proposed impact on water use will have on other users	The sewer line crossing will not impact significantly on other water users.
Mitigation and Rehabilitation plan	Monitoring of erosion. Monitor pipes for leaks
