**WETLAND DELINEATION IN THE RUSTENBURG
PLATINUM MINE PROJECT AREA AND A HIGH
LEVEL ASSESSMENT OF SELECTED RIVER
CROSSINGS, NORTH-WEST PROVINCE**

SRK Consulting (Pty) Ltd

May 2015

Prepared by:	Scientific Aquatic Services
Report author:	M. Aphane
Report Reviewer	S. van Staden (Pri. Sci. Nat)
Report Reference:	SAS 215053
Date:	May 2015

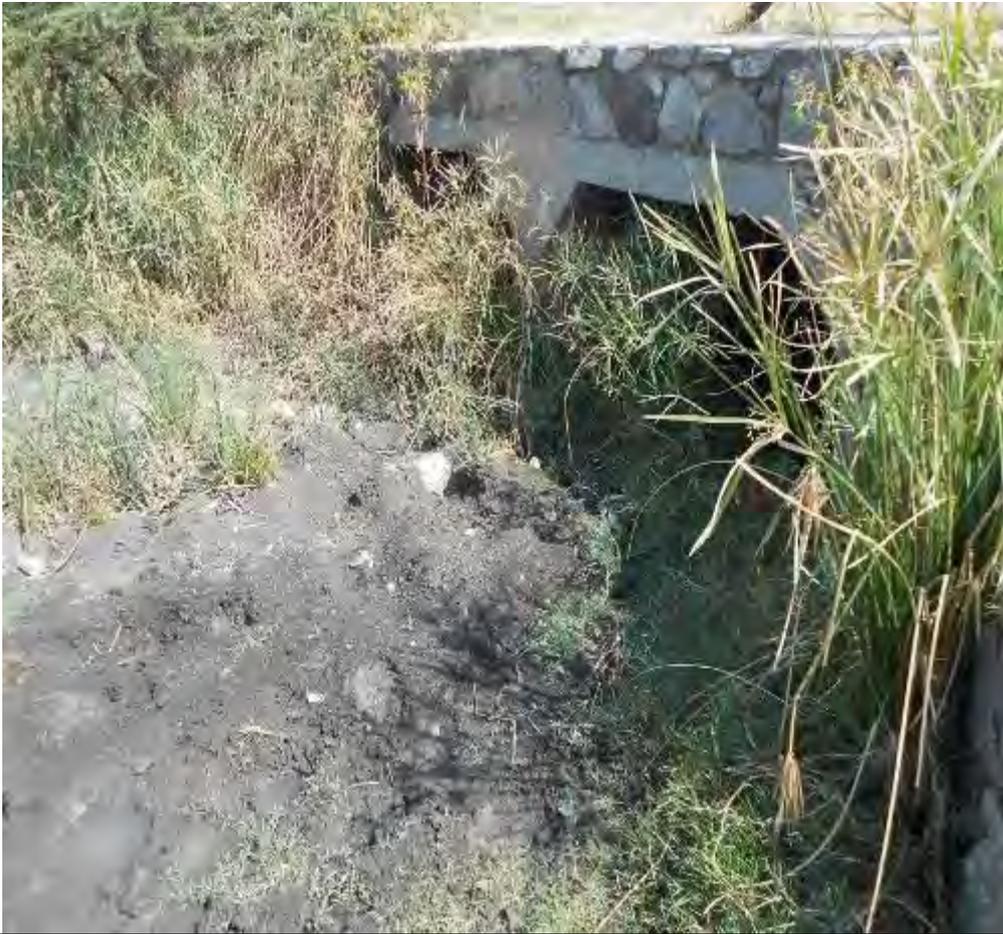
Site number: 15	Coordinates: 25°39'09.61"S 27°22'09.61"E
Crossing Type: Road culvert	
Site Photo:

Present Ecological State	C
Wetland type	River
Morphology	Narrow shallow channel. Dry river bed.
Riparian and in Stream Habitat	Instream ecology: riverbed dry at the time of the study.
Vegetation	<i>Typha capensis</i> , <i>Flaveria bidentis</i> , <i>Cyperus sexangularis</i> , <i>Brachiarai brizantha</i> , <i>Cynodon dactylon</i> , <i>Xanthium strumarium</i> , <i>Heteropogon contortus</i> , <i>Bidens pilosa</i>
System Modifiers	Increased runoff from the road. Cattle trampling and grazing.
Potential impacts of water use on environment	The culvert/road crossing will not significantly negatively impact on the receiving environment.
Socio-economic impacts of water use	The culvert/road crossing will not significantly negatively impact on any water users.
Socio-economic advantages of water use	The culvert/road crossing plays an important role in providing connectivity in the area thereby allowing economic activity in the area

Potential impacts of water use on water resource	The culvert will result in some alterations to streamflow patterns during flow periods.
Summary of proposed impact on water use will have on other users	The culvert/road crossing will not impact significantly on other water users.
Mitigation and Rehabilitation plan	Monitor erosion and control alien vegetation

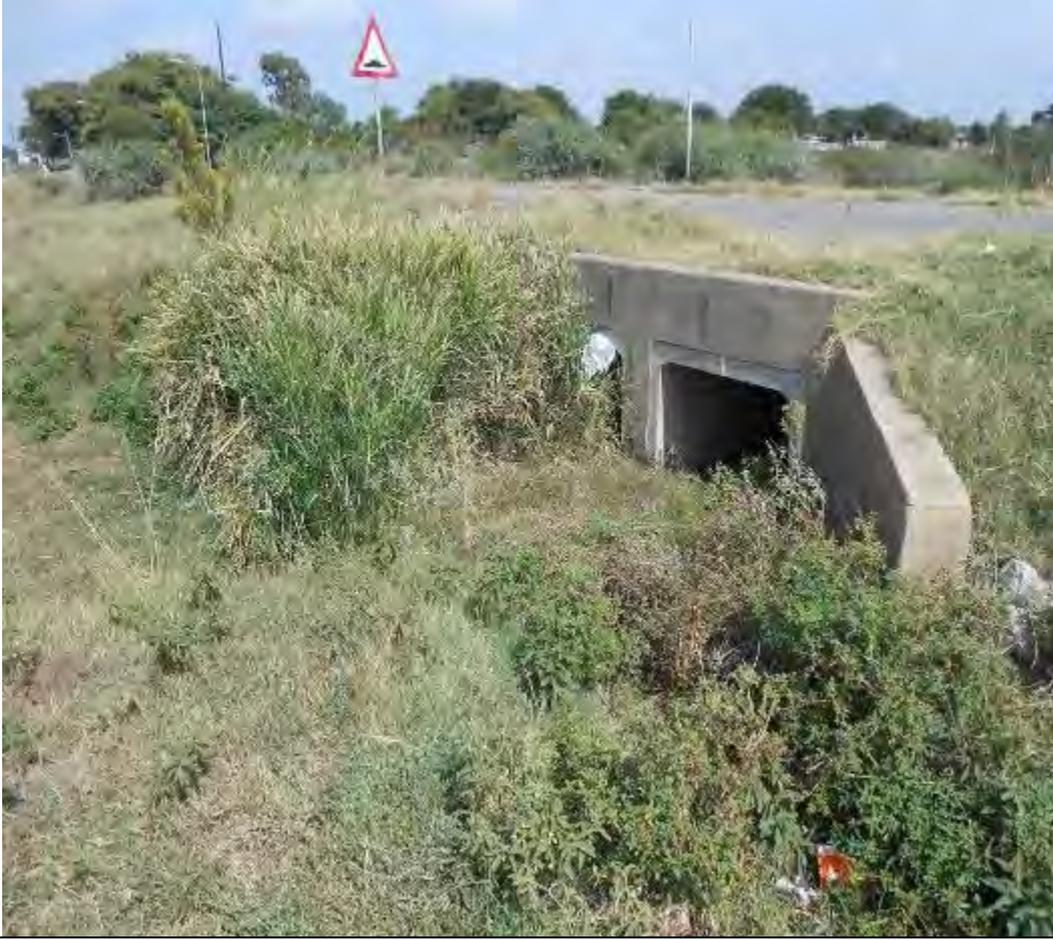
Site number: 16	Coordinates: 25°39'09.61"S 27°22'09.61"E
Crossing Type: Road crossing	
Site Photo:

Present Ecological State	C
Wetland type	River
Morphology	Shallow channel. Dry river bed.
Riparian and in Stream Habitat	Well vegetated. Instream ecology: riverbed dry at the time of the study.
Vegetation	<i>Chloris gayana</i> , <i>Cyperus sexangularis</i> , <i>Flaveria bidentis</i> , <i>Heteropogon contortus</i> , <i>Asclepias fruticosa</i> , <i>Opuntia ficus-indica</i> .
System Modifiers	Littering. Alien species invasion.
Potential impacts of water use on environment	The road crossing will not significantly negatively impact on the receiving environment: provided it is adequately maintained.
Socio-economic impacts of water use	The road crossing will not significantly negatively impact on any water users.
Socio-economic advantages of water use	The road crossing plays an important role in providing connectivity in the area thereby allowing economic activity in the area

Potential impacts of water use on water resource	The culvert will result in some alterations to water flow patterns during flow periods; however these are not deemed to have a significant impact on downstream resources.
Summary of proposed impact on water use will have on other users	The road crossing will not impact significantly on other water users.
Mitigation and Rehabilitation plan	Clean up litter. Control alien species

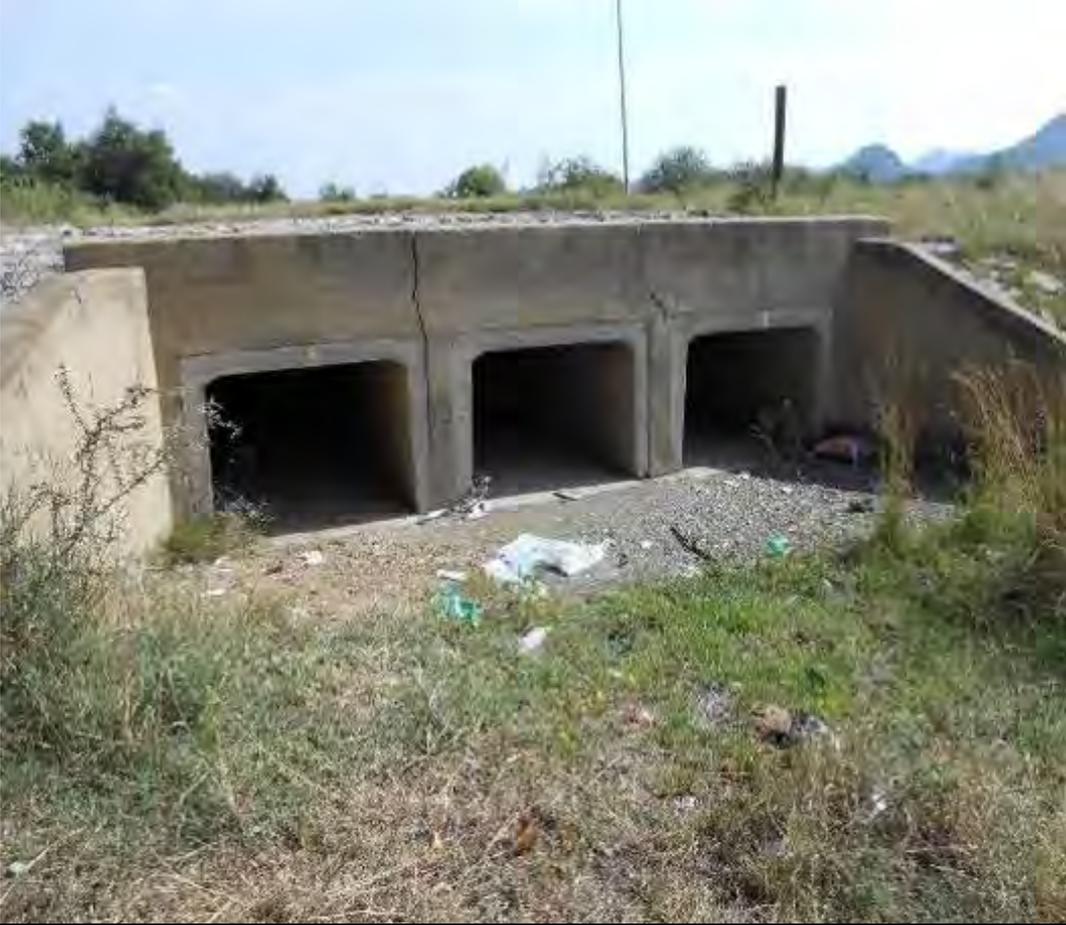
Site number: 17	Coordinates: 25°39'06.22"S 27°22'11.14"E
Crossing Type: road crossing	
Site Photo:

Present Ecological State	C
Wetland type	River
Morphology	Shallow channel. Dry river bed.
Riparian and in Stream Habitat	<i>Acacia</i> spp. dominated bushveld vegetation. Instream ecology: riverbed dry at the time of the study.
Vegetation	<i>Heteropogon contortus</i> , <i>Aslepias fruiticosa</i> , <i>Hyparrhenia hirta</i> , <i>Cynodon dactylon</i>
System Modifiers	Exposed pipe just beneath the culvert. Livestock grazing and trampling.
Potential impacts of water use on environment	The road crossing will not significantly negatively impact on the receiving environment.
Socio-economic impacts of water use	The road crossing will not significantly negatively impact on any water users.
Socio-economic advantages of water use	The road crossing plays an important role in providing connectivity in the area thereby allowing economic activity in the area.

Potential impacts of water use on water resource	The road crossing will result in some alterations to water flow patterns during flow periods; however these are not deemed to have a significant impact on downstream resources.
Summary of proposed impact on water use will have on other users	The road crossing will not impact significantly on other water users.
Mitigation and Rehabilitation plan	Monitor the area for erosion.

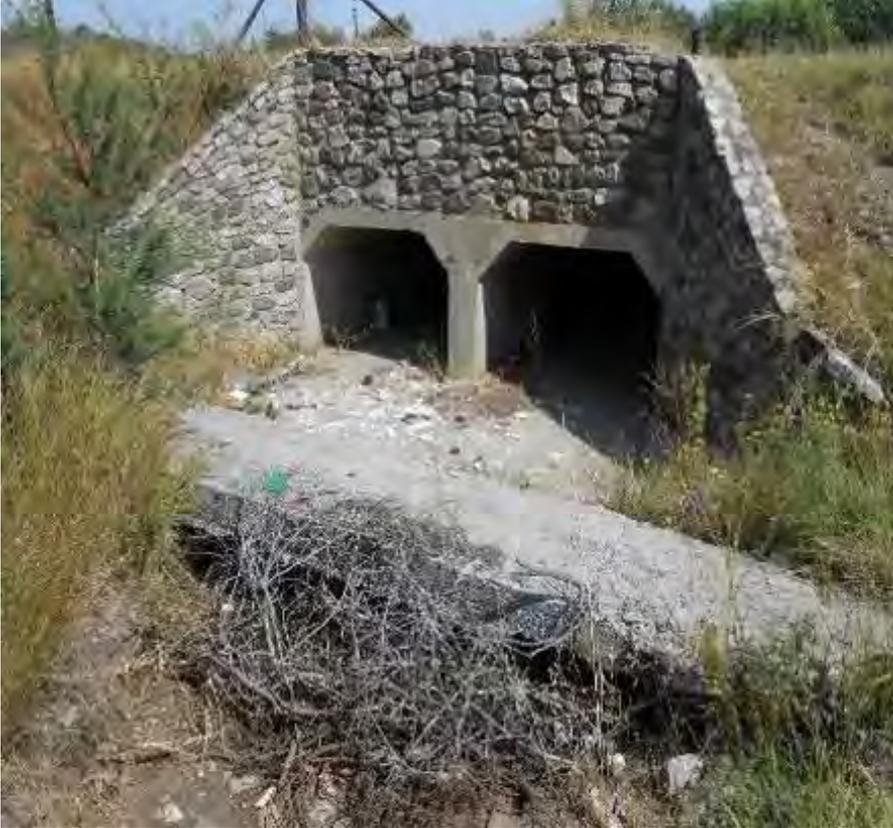
Site number: 18	Coordinates: 25°39'03.03"S 27°22'30.54"E
Crossing Type: Road culvert	
Site Photo:

Present Ecological State	C
Wetland type	River
Morphology	Wide, relatively shallow channel, mixture of alluvial sand and bedrock. Dry river bed.
Riparian and in Stream Habitat	<i>Rhus lancea</i> and <i>Acacia</i> spp. dominated bushveld vegetation. Instream ecology: riverbed dry at the time of the study.
Vegetation	<i>Datura stramonium</i> , <i>Persicaria lapathifolia</i> , <i>Conyza bonariensis</i> , <i>tithonia rotundifolia</i> , <i>Eragrostis curvula</i> , <i>Rhus lancea</i> , <i>Sporobolus pyramidalis</i> , <i>Tagetes minuta</i> , <i>Verbena bonariensis</i> , <i>Acacia</i> spp.
System Modifiers	Increased runoff from the road. Debris blocking water flow and causing a migration barrier. Erosion and river bed scouring. Waste dumping.
Potential impacts of water use on environment	The road culvert crossing will not significantly negatively impact on the receiving environment.

Socio-economic impacts of water use	The road culvert crossing will not significantly negatively impact on any water users.
Socio-economic advantages of water use	The road culvert plays an important role in providing connectivity in the area thereby allowing economic activity in the area
Potential impacts of water use on water resource	The road culvert crossing will result in some alterations to water flow patterns during flow periods. In addition, the eroded culvert will cause a migration barrier during high flow periods.
Summary of proposed impact on water use will have on other users	The road culvert crossing will not impact significantly on other water users.
Mitigation and Rehabilitation plan	Remove waste. Remove a concrete slab that forms a weir as it traps debris and blocks water flow. Remove waste. Monitor erosion.

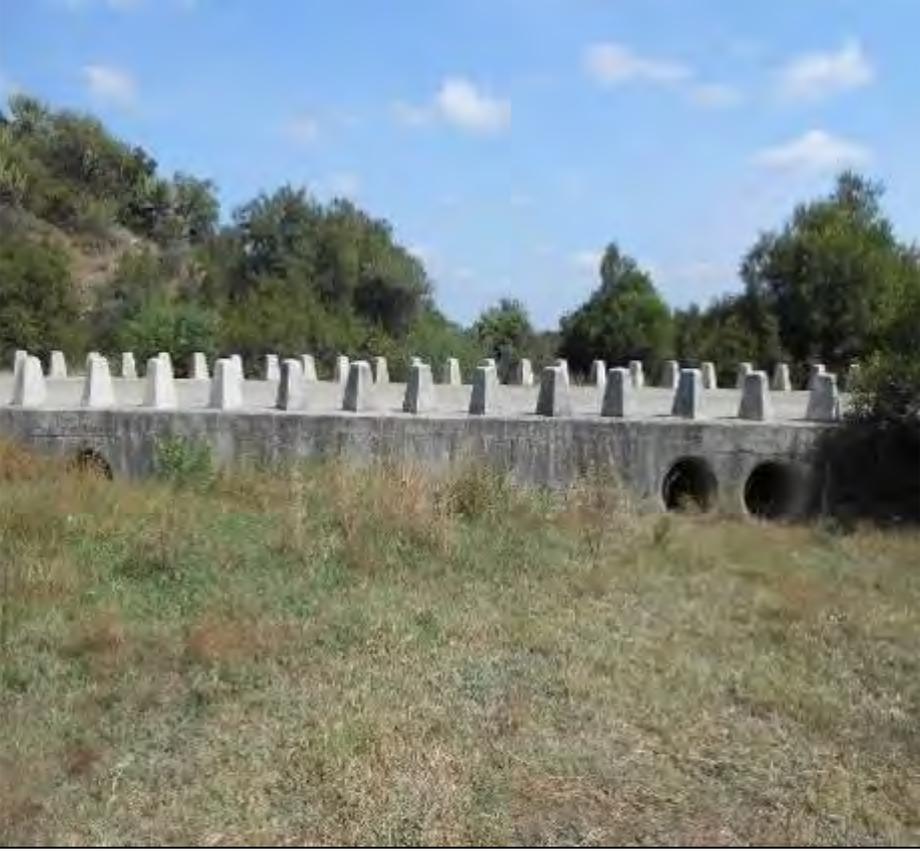
Site number: 19	Coordinates: 25°39'00.83"S 27°22'42.64"E
Crossing Type: Road culvert	
Site Photo:

Present Ecological State	C
Wetland type	River
Morphology	Wide, relatively shallow channel, mixture of alluvial sand and bedrock. Dry river bed.
Riparian and in Stream Habitat	<i>Rhus lancea</i> and <i>Acacia</i> spp. dominated bushveld vegetation. Instream ecology: riverbed dry at the time of the study.
Vegetation	<i>Cyperus sexangularis</i> , <i>Asclepias fruiticosa</i> , <i>Sporobolus africanus</i>
System Modifiers	Increased runoff from the road. Littering. Stockpiling. Erosion.
Potential impacts of water use on environment	The road culvert crossing will not significantly negatively impact on the receiving environment.
Socio-economic impacts of water use	The road culvert crossing will not significantly negatively impact on any water users.
Socio-economic advantages of water use	The road culvert plays an important role in providing connectivity in the area thereby allowing economic activity in the area

Potential impacts of water use on water resource	The road culvert crossing will result in some alterations to water flow patterns during flow periods, and increase water input within the water resource.
Summary of proposed impact on water use will have on other users	The road culvert crossing will not impact significantly on other water users.
Mitigation and Rehabilitation plan	Clean up litter. Remove piled soil to prevent sedimentation. Monitor erosion

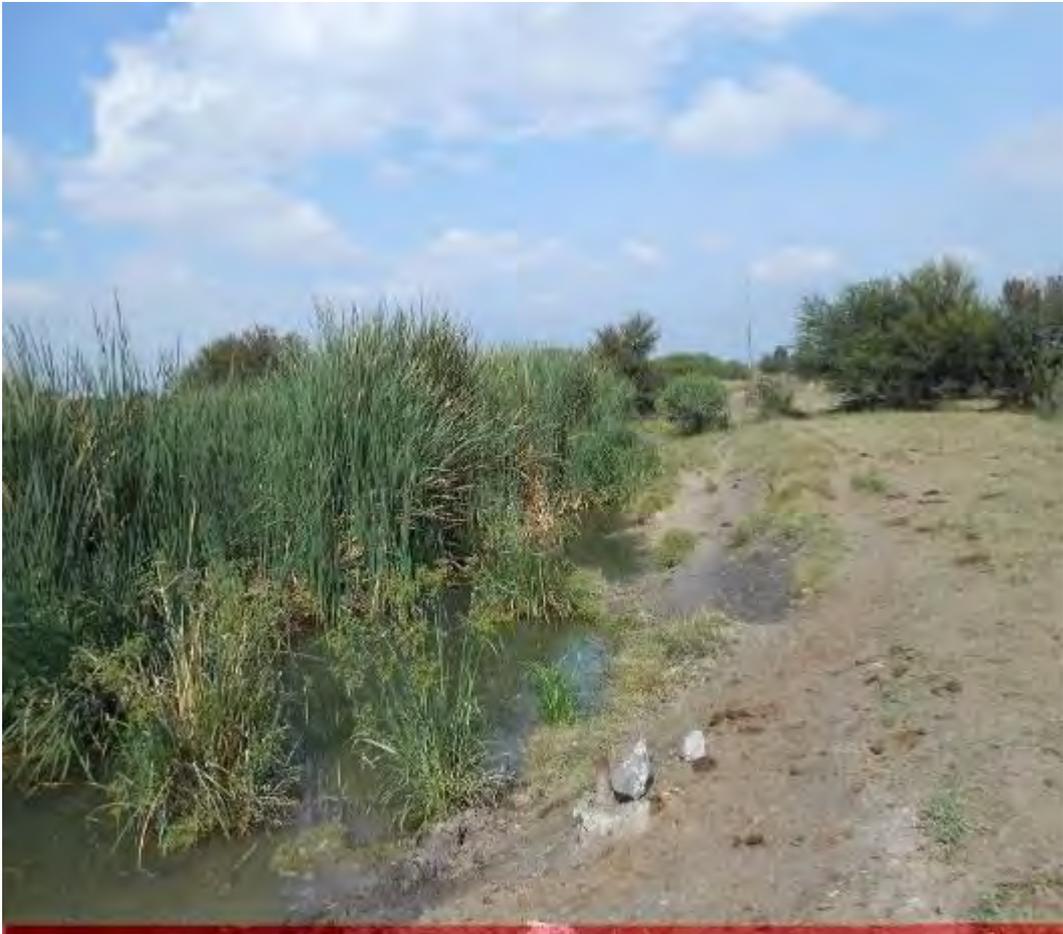
Site number: 19a	Coordinates: 25°38'21.79"S 27°20'53.49"E
Crossing Type: road crossing	
Site Photo:

Present Ecological State	C
Wetland type	Pan
Morphology	Wide, relatively shallow channel, mixture of alluvial sand and bedrock. Dry river bed.
Riparian and in Stream Habitat	<i>Acacia</i> spp. dominated bushveld vegetation. Instream ecology: riverbed dry at the time of the study.
Vegetation	<i>Heteropogon contortus</i> , <i>Typha capensis</i> , <i>Melinis repens</i> , <i>Persicaria lapathifolia</i> , <i>Themeda triandra</i> , <i>Setaria sphacelata</i> , <i>Tagetes minuta</i>
System Modifiers	Erosion. Livestock grazing and trampling.
Potential impacts of water use on environment	The road crossing is not well constructed and since it is a dirt road there will be sediment deposition during rainfall events.
Socio-economic impacts of water use	The road crossing will not significantly negatively impact on any water users.

Socio-economic advantages of water use	The road crossing will not negatively impact on water users.
Potential impacts of water use on water resource	There will be increase sediment deposition within the water resource since the road is a dirt road.
Summary of proposed impact on water use will have on other users	The road will not impact significantly on other water users.
Mitigation and Rehabilitation plan	Monitor the area for erosion.

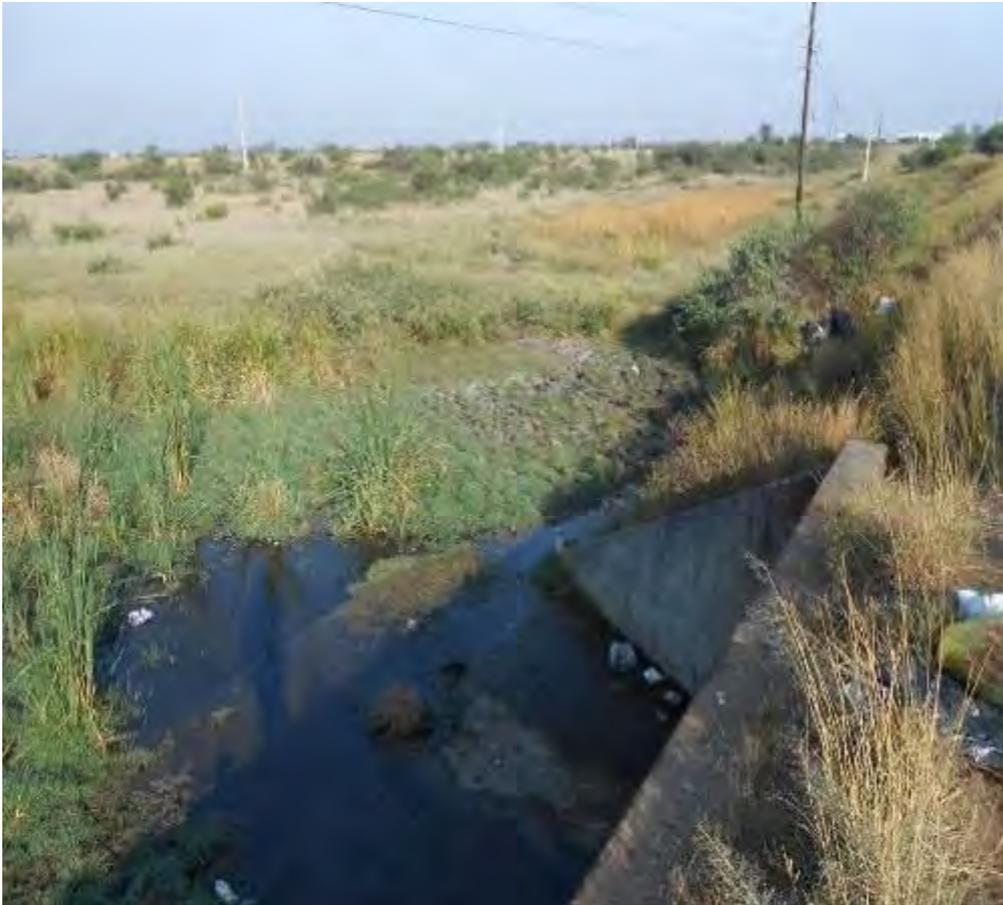
Site number: 21	Coordinates: 25°36'35.53"S 27°18'21.15"E
Crossing Type: Culvert road	
Site Photo:

Present Ecological State	C
Wetland type	River
Morphology	Wide, moderately diffuse channel, inundation below the culvert
Riparian and in Stream Habitat	The stream channel was well vegetated
Vegetation	<i>Heteropogon contortus</i> , <i>Cyperus sexangularis</i> , <i>Typha capensis</i> , <i>Eragrostis curvula</i> , <i>Melinis repens</i> , <i>Xanthium strumarium</i> , <i>Conyza bonariensis</i> , <i>Asclepias fruiticosa</i>
System Modifiers	Livestock grazing and trampling. Littering
Potential impacts of water use on environment	The road crossing will not significantly negatively impact on the environment.
Socio-economic impacts of water use	The road crossing will not significantly negatively impact on any water users.
Socio-economic advantages of water use	The road crossing plays an important role in providing connectivity in the area, particularly to the local community, thereby allowing economic activity in the area.

Potential impacts of water use on water resource	The culvert will result in some alterations to streamflow patterns during flow periods; however these are not deemed to have a significant impact on downstream resources.
Summary of proposed impact on water use will have on other users	The road crossing will not impact significantly on other water users.
Mitigation and Rehabilitation plan	Monitor the area for erosion. Control alien invasion.

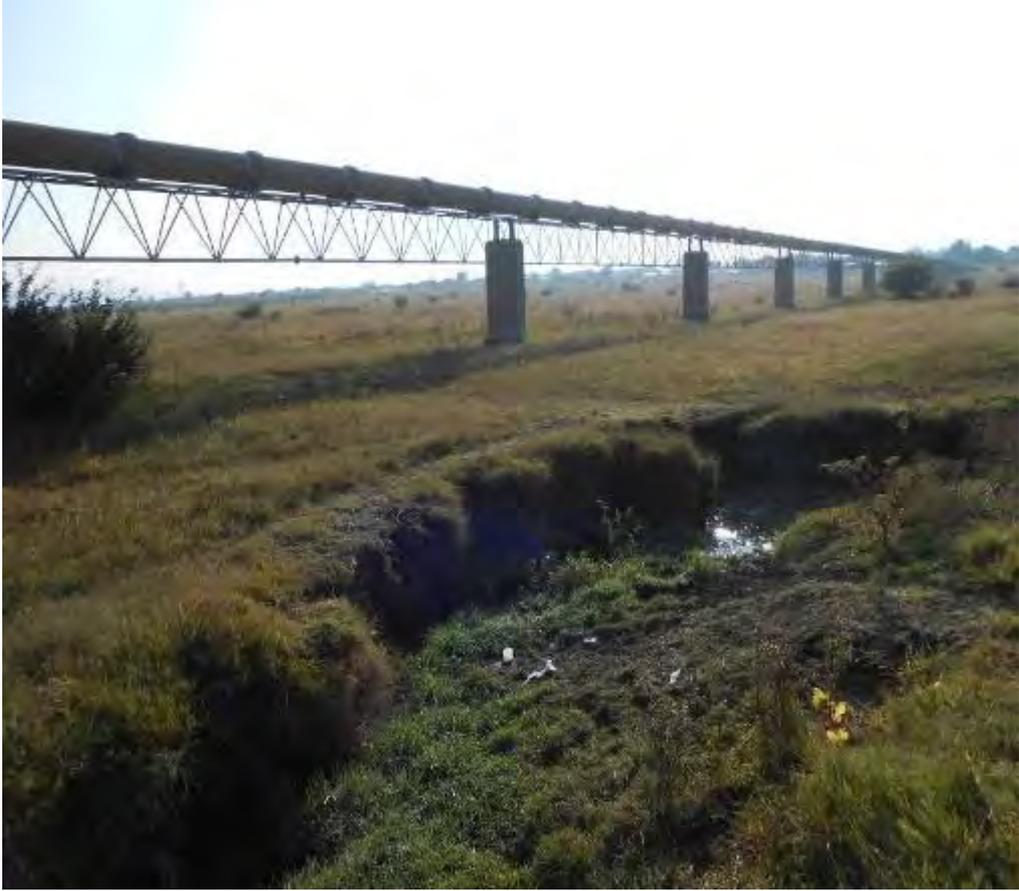
Site number: 21a/b	Coordinates: 25°36'05.18"S 27°18'10.04"E
Crossing Type: Pipeline	
Site Photo:

Present Ecological State	B
Wetland type	River
Morphology	Narrow moderately incised, shallow channel.
Riparian and in Stream Habitat	<i>Acacia karoo</i> dominated bushveld vegetation.
Vegetation	<i>Setaria sphacelata</i> , <i>Flaveria bidentis</i> , <i>Typha capensis</i> , <i>Conyza bonariensis</i> , <i>Cyperus sexangularis</i>
System Modifiers	Livestock grazing
Potential impacts of water use on environment	The pipeline will not significantly negatively impact on the receiving environment; provided it is adequately maintained.
Socio-economic impacts of water use	The pipeline will not significantly negatively impact on any water users.
Socio-economic advantages of water use	The pipeline will not significantly negatively impact on any water users
Potential impacts of water use on water resource	The support structures within the channel will result in some alterations to streamflow patterns during flow periods; however these are not deemed to have a significant impact on downstream resources.

Summary of proposed impact on water use will have on other users	The pipeline will not impact significantly on other water users.
Mitigation and Rehabilitation plan	Monitor pipes for leaks

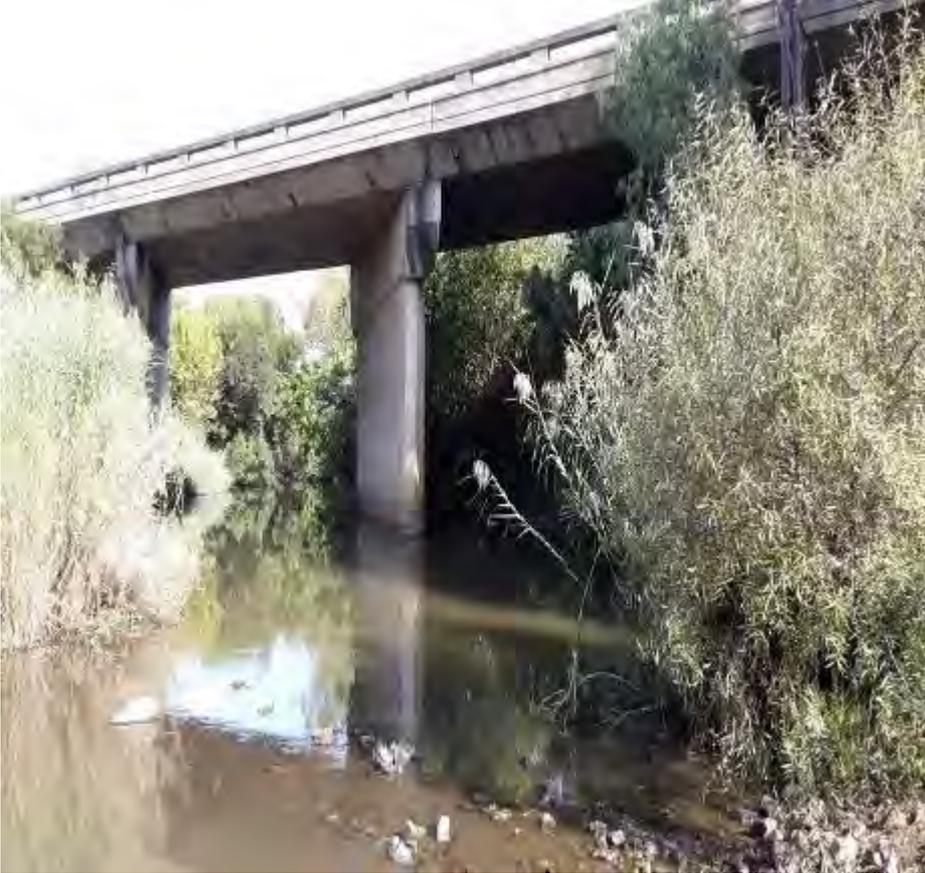
Site number: Site 22 and Site 23	Coordinates: 25°40'34.99"S 27°16'40.43"E
Crossing Type: Road crossing	
Site Photo:

Present Ecological State	B
Wetland type	River
Morphology	Wide, relatively shallow channel, inundation below bridge.
Riparian and in Stream Habitat	<i>Melia azedarach</i> in the terrestrial area. Inundation below bridge.
Vegetation	<i>Phragmites australis</i> , <i>Cyperus sexangularis</i> , <i>Asparagus larinicus</i> , <i>Xanthium strumarium</i> , <i>Rhus lancea</i> ,
System Modifiers	Water abstraction. Vegetation clearing. Erosion. Runoff from the road. Livestock grazing.
Potential impacts of water use on environment	The road crossing will not significantly negatively impact on the environment.
Socio-economic impacts of water use	The road crossing will not significantly negatively impact on any water users.
Socio-economic advantages of water use	The road crossing plays an important role in providing connectivity in the area, particularly to the local community, thereby allowing economic activity in the area.

Potential impacts of water use on water resource	The support structures within the channel will result in some alterations to streamflow patterns during flow periods; however these are not deemed to have a significant impact on downstream resources.
Summary of proposed impact on water use will have on other users	The road crossing will not impact significantly on other water users.
Mitigation and Rehabilitation plan	Re-vegetate where necessary. Monitor erosion.

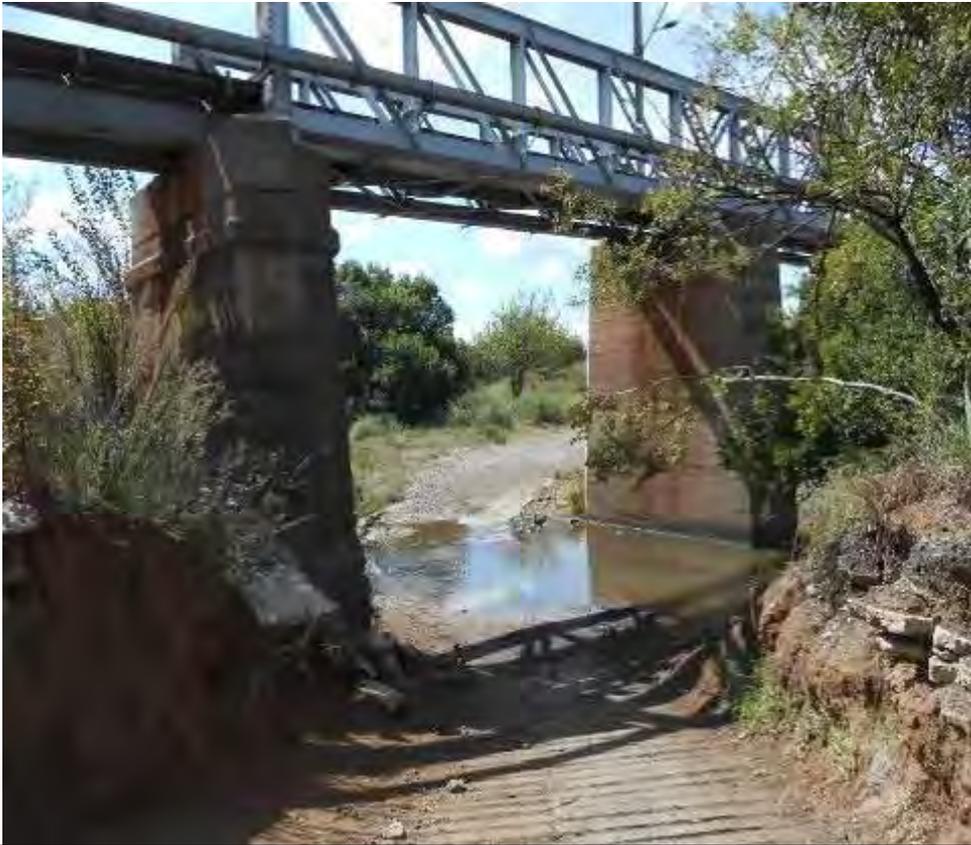
Site number: Site 24	Coordinates: 25°40'05.75"S 27°16'40.08"E
Crossing Type: Railway/Culvert	
Site Photo:

Present Ecological State	C
Wetland type	River
Morphology	Wide, relatively shallow channel. Paved road below the railway crossing reducing infiltration.
Riparian and in Stream Habitat	Inundation below crossing
Vegetation	<i>Rhus lancea</i> , <i>Persicaria lapathifolia</i> , <i>Panicum maxima</i> , <i>Morus alba</i> , <i>Cyperus sexangularis</i> , <i>Phragmites australis</i> , <i>Themeda triandra</i>
System Modifiers	Road beneath the railway traversing the river. Erosion. Cattle trampling and grazing. Leaking pipes.
Potential impacts of water use on environment	The railway crossing will not significantly negatively impact on the environment.
Socio-economic impacts of water use	The railway crossing will not significantly negatively impact on any water users.
Socio-economic advantages of water use	The railway crossing is necessary for transporting mining goods.

Potential impacts of water use on water resource	The support structures within the channel will result in some alterations to streamflow patterns during flow periods; however these are not deemed to have a significant impact on downstream resources.
Summary of proposed impact on water use will have on other users	The railway crossing will not impact significantly on other water users.
Mitigation and Rehabilitation plan	Control alien vegetation. Monitor erosion. Monitor leaking pipes. Re-vegetate the banks.

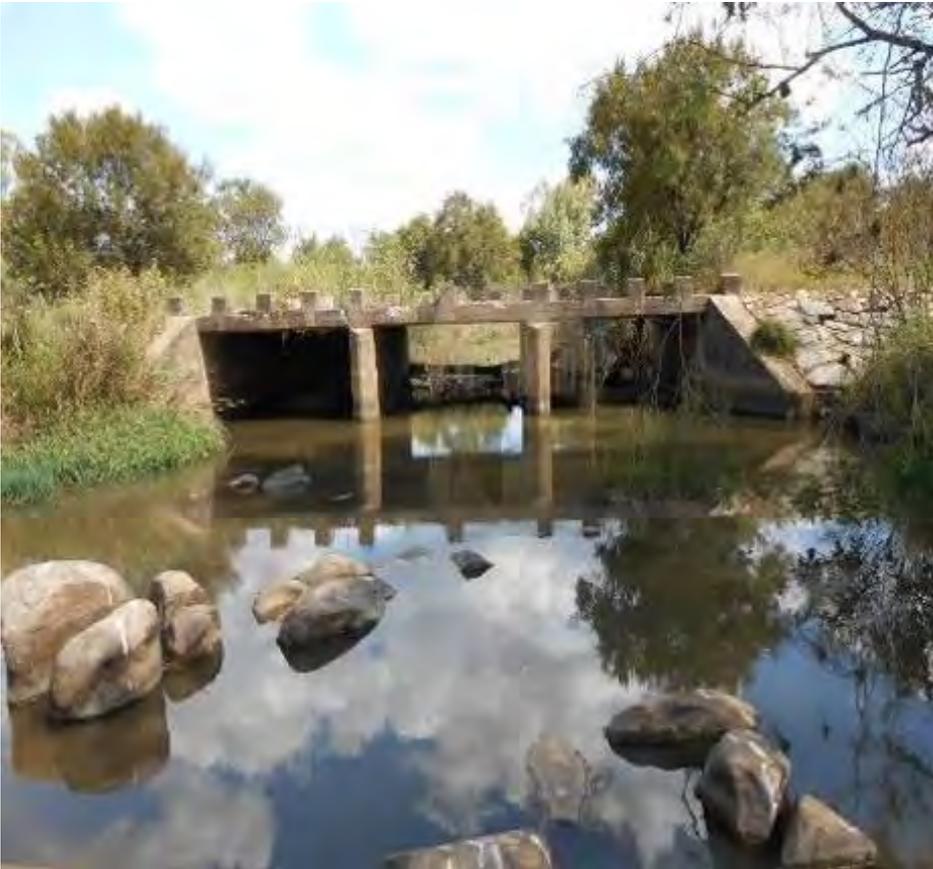
Site number: Site 24a/24b	Coordinates: 25°39'55.43"S 27°16'46.30"E
Crossing Type: Bridge/road crossing	
Site Photo:

Present Ecological State	D
Wetland type	River
Morphology	Wide, relatively shallow channel, mixture of alluvial sand and bedrock. Dry river bed.
Riparian and in Stream Habitat	<i>Dichrostachys</i> spp. dominated bushveld vegetation. Instream ecology: riverbed dry at the time of the study.
Vegetation	
System Modifiers	Weir. Debris within the stream. Cattle trampling and grazing. Water abstraction. Alien vegetation.
Potential impacts of water use on environment	The sewer line crossing will not significantly negatively impact on the receiving environment; provided it is adequately maintained.
Socio-economic impacts of water use	The sewer line crossing will not significantly negatively impact on any water users.
Socio-economic advantages of water use	The sewer line is necessary for the safe disposal of sewage.

Potential impacts of water use on water resource	The support structures within the channel will result in some alterations to streamflow patterns during flow periods; however these are not deemed to have a significant impact on downstream resources.
Summary of proposed impact on water use will have on other users	The sewer line crossing will not impact significantly on other water users.
Mitigation and Rehabilitation plan	Remove debris. Monitor erosion. Control alien vegetation.

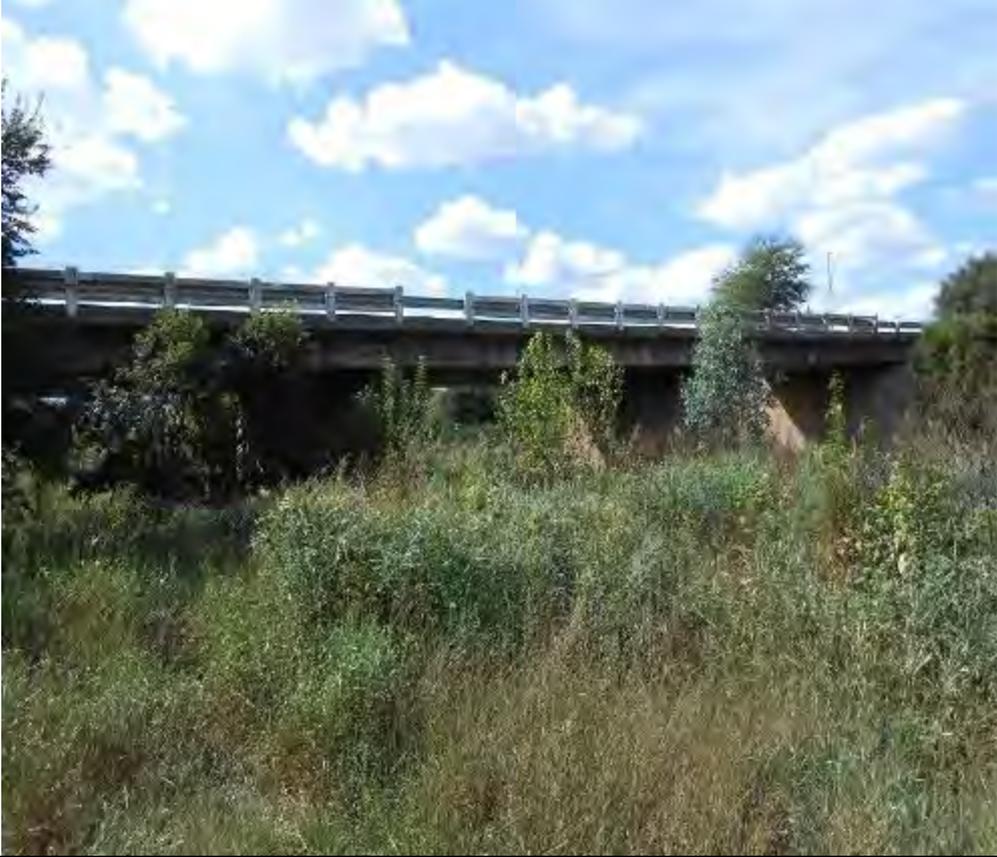
Site number: Site 25	Coordinates: 25°39'53.01"S 27°16'46.74"E
Crossing Type: Road crossing	
Site Photo:

Present Ecological State	C
Wetland type	River
Morphology	Wide, shallow channel.
Riparian and in Stream Habitat	<i>Dichrostachys</i> spp. dominated bushveld vegetation. Instream ecology: riverbed dry at the time of the study.
Vegetation	<i>Lantana camara</i> , <i>Cyperus sexangularis</i> , <i>Tagetes minuta</i>
System Modifiers	Encroachment.
Potential impacts of water use on environment	The road crossing will not significantly negatively impact on the environment.
Socio-economic impacts of water use	The road crossing will not significantly negatively impact on the on any water users.
Socio-economic advantages of water use	The road crossing plays an important role in providing connectivity in the area, particularly to the local community, thereby allowing economic activity in the area.
Potential impacts of water use on water resource	The support structures within the channel will result in some alterations to streamflow patterns during flow periods; however these are not deemed to have a significant impact on downstream resources.

Summary of proposed impact on water use will have on other users	The road crossing will not impact significantly on other water users.
Mitigation and Rehabilitation plan	Control alien vegetation.

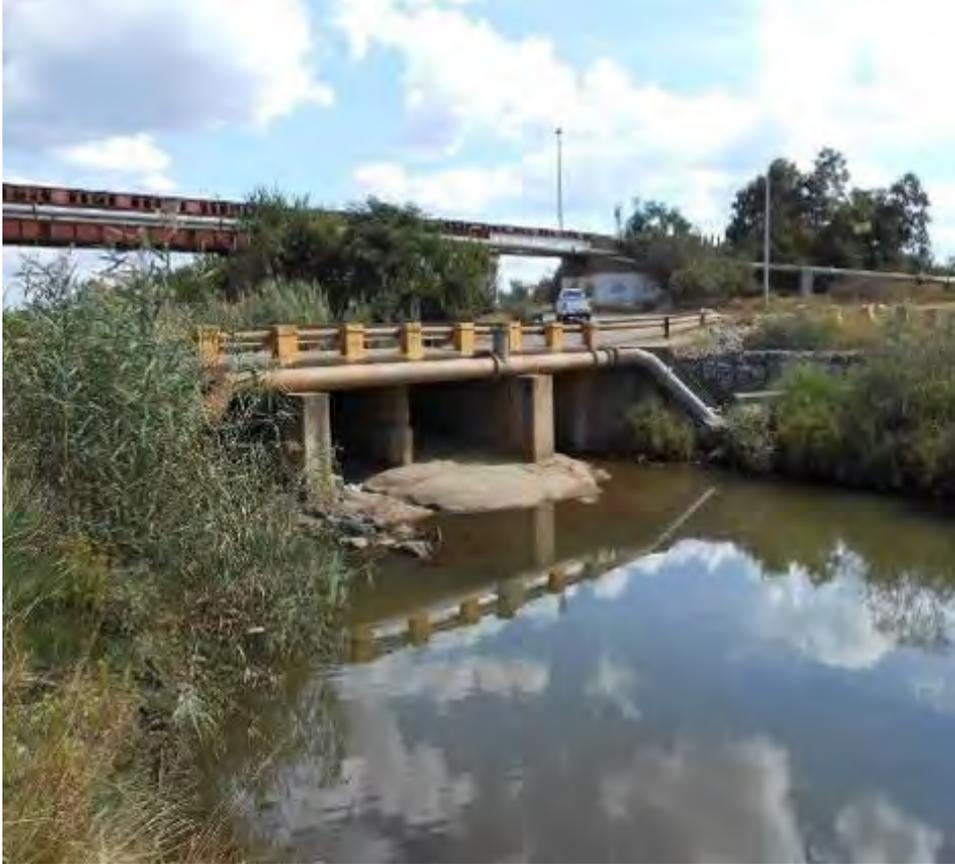
Site number: Site 26/26weir	Coordinates: 25°39'24.47"S 27°17'14.53"E
Crossing Type: Road crossing + weir	
Site Photo:

Present Ecological State	C
Wetland type	River
Morphology	Wide, relatively shallow channel, mixture of alluvial sand and bedrock. Dry river bed.
Riparian and in Stream Habitat	<i>Acacia</i> spp. dominated bushveld vegetation. Instream ecology: inundation underneath the bridge.
Vegetation	<i>Tagetes minuta</i> , <i>Cyperus sexangularis</i> , <i>Phragmites australis</i> , <i>Flaveria bidentis</i>
System Modifiers	Rock dumping. Leaking pipes. Alien vegetation.
Potential impacts of water use on environment	The road crossing will not significantly negatively impact on the environment.
Socio-economic impacts of water use	The road crossing will not significantly negatively impact on any water users.
Socio-economic advantages of water use	The road crossing plays an important role in providing connectivity in the area, particularly to the local community, thereby allowing economic activity in the area.

Potential impacts of water use on water resource	The weir and support structures within the channel will result in some alterations to streamflow patterns during flow periods; however these are not deemed to have a significant impact on downstream resources.
Summary of proposed impact on water use will have on other users	The road crossing will not impact significantly on other water users.
Mitigation and Rehabilitation plan	Control alien vegetation. Monitor pipes for leakages.

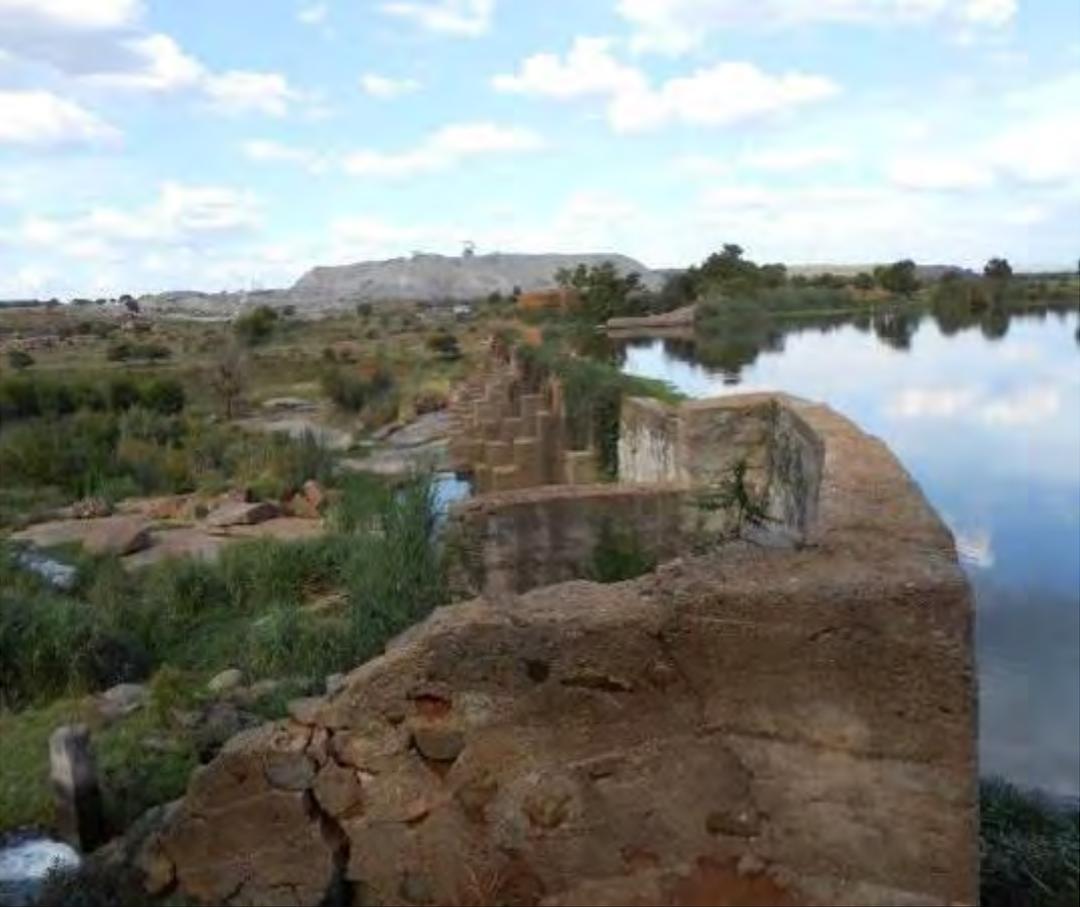
Site number: Site 26a	Coordinates: 25°38'57.41"S 27°17'22.82"E
Crossing Type: Dam crossing	
Site Photo:

Present Ecological State	C
Wetland type	River
Morphology	Wide, relatively shallow channel, inundation behind the dam wall. Flowing water. Exposed bed rock within the stream channel.
Riparian and in Stream Habitat	Exposed bedrock within the stream channel
Vegetation	<i>Typha capensis</i> , <i>Rhus lancea</i> , <i>Cyperus sexangularis</i>
System Modifiers	Weir. Waste dumping. Alien vegetation.
Potential impacts of water use on environment	The dam will not significantly negatively impact on the environment.
Socio-economic impacts of water use	The dam will capture flow during low flow periods, leading to less water flowing to downstream areas.
Socio-economic advantages of water use	N/A.
Potential impacts of water use on water resource	The support structures within the channel will result in some alterations to streamflow patterns during flow periods.

Summary of proposed impact on water use will have on other users	The dam will capture flow during low flow periods, resulting in less water flowing to downstream areas.
Mitigation and Rehabilitation plan	Clean up litter. Control alien vegetation.

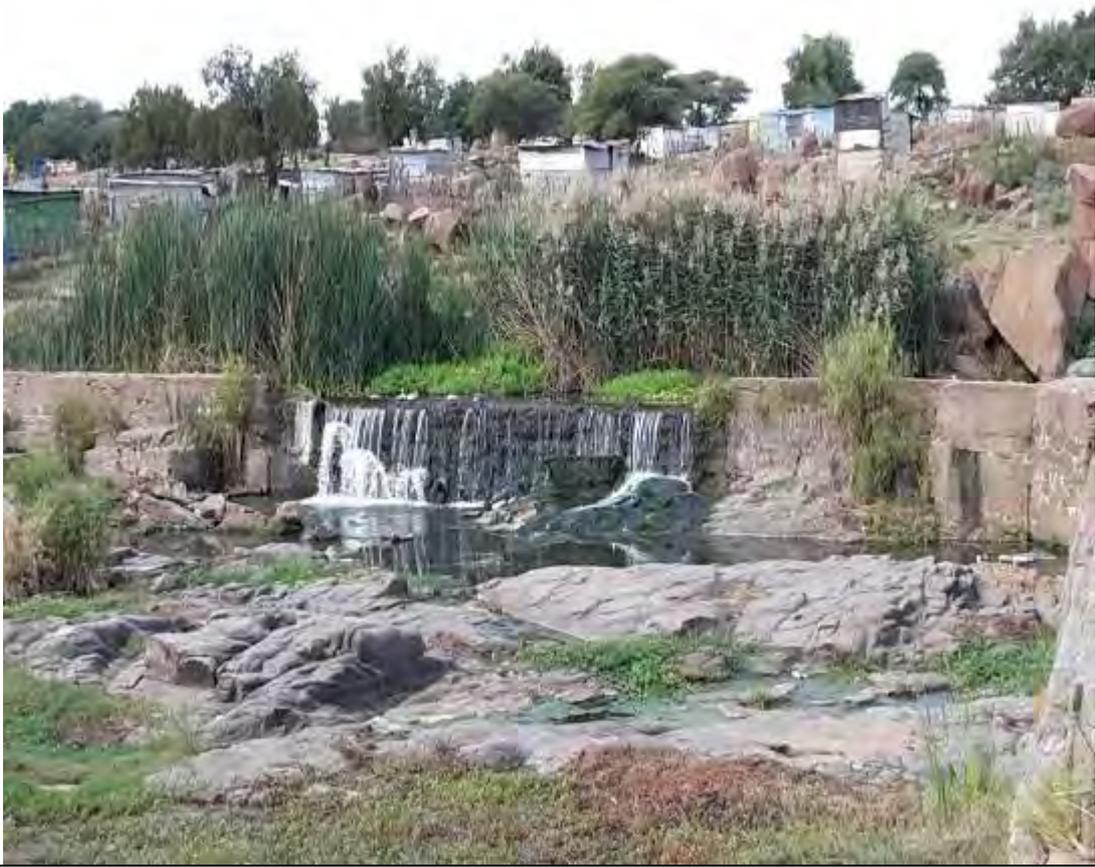
Site number: Site 26b	Coordinates: 25°38'52.20"S 27°17'29.00"E
Crossing Type: Weir	
Site Photo:

Present Ecological State	D
Wetland type	River
Morphology	Wide, relatively shallow channel, mixture of alluvial sand and bedrock. Dry river bed.
Riparian and in Stream Habitat	Exposed bedrock within the stream channel
Vegetation	<i>Persicaria lapathifolia</i> , <i>Cyperus sexangularis</i> , <i>Phragmites australis</i> , <i>Melinis repens</i>
System Modifiers	Weir. Change in water quality due to use for laundry purposes. Alien vegetation.
Potential impacts of water use on environment	The weir will not significantly negatively impact on the environment.
Socio-economic impacts of water use	The weir will not significantly negatively impact on any water users.
Socio-economic advantages of water use	N/A.
Potential impacts of water use on water resource	The weir result in some alterations to streamflow patterns during flow periods; however these are not deemed to have a significant impact on downstream resources.

Summary of proposed impact on water use will have on other users	The weir will not impact significantly on other water users.
Mitigation and Rehabilitation plan	Monitor water quality. Control alien vegetation.

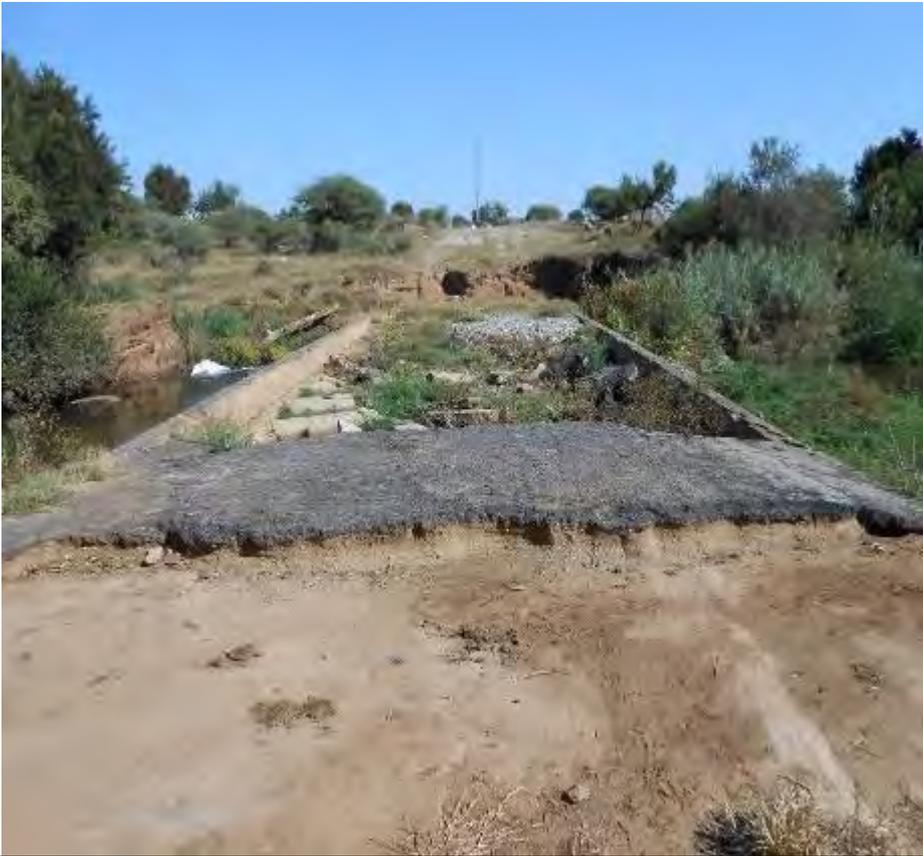
Site number: Site 27	Coordinates: 25°37'18.86"S 27°17'22.07"E
Crossing Type: Road crossing	
Site Photo:

Present Ecological State	E
Wetland type	River
Morphology	Wide, relatively shallow channel, mixture of alluvial sand and bedrock. Dry river bed.
Riparian and in Stream Habitat	<i>Eucalyptus</i> spp on the terrestrial area. <i>Eichhornia crassipes</i>
Vegetation	<i>Rhus lancea</i> , <i>Sesbania sesban</i> , <i>Chloris gayana</i> , <i>Tagetes minuta</i> , <i>Phragmites australis</i> , <i>Eichhornia crassipes</i>
System Modifiers	Collapsed road causing flow diversion which further erodes the banks and creates gullies. Algae proliferation. Sewage effluent. Cattle trampling and grazing.
Potential impacts of water use on environment	The road crossing will result in bank erosion, thus depositing sediment within the stream channel.
Socio-economic impacts of water use	The road crossing will not significantly negatively impact on any water users.

Socio-economic advantages of water use	The collapsed road causes water flow obstruction
Potential impacts of water use on water resource	Alterations to streamflow patterns during flow periods; however these are not deemed to have a significant impact on downstream resources.
Summary of proposed impact on water use will have on other users	Causes migration barrier.
Mitigation and Rehabilitation plan	If the crossing is no longer required remove the structure and rehabilitate the area to minimize erosion. Control alien vegetation. Monitor erosion. Re-vegetate the banks.

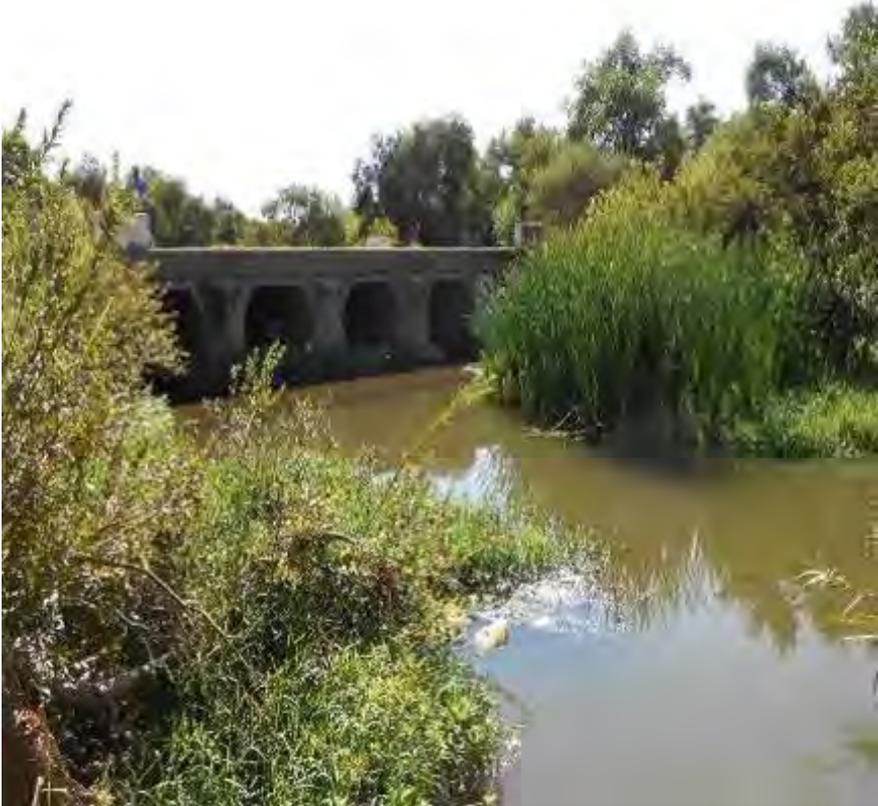
Site number: Site 27a	Coordinates: 25°37'59.54"S 27°17'24.99"E
Crossing Type: Culvert road crossing	
Site Photo:

Present Ecological State	E
Wetland type	River
Morphology	Wide, relatively shallow channel, mixture of alluvial sand and bedrock. Dry river bed.
Riparian and in Stream Habitat	<i>Acacia</i> spp. And asparagus laricinus dominated bushveld vegetation. Inundation below bridge.
Vegetation	<i>Phragmites australis</i> , <i>Typha capensis</i> , <i>Flaveria bidentis</i> , <i>Morus alba</i> , <i>Sesbania sesban</i> , <i>Eucalyptus</i> spp.
System Modifiers	Erosion. Altered water quality due to usage for laundry washing purposes.
Potential impacts of water use on environment	The road crossing will not significantly negatively impact on the environment.
Socio-economic impacts of water use	The road crossing will not significantly negatively impact on any water users.
Socio-economic advantages of water use	The road crossing plays an important role in providing connectivity in the area, particularly to the local community, thereby allowing economic activity in the area.

Potential impacts of water use on water resource	The culvert within the channel will result in some alterations to streamflow patterns during flow periods; however these are not deemed to have a significant impact on downstream resources.
Summary of proposed impact on water use will have on other users	The road crossing will not impact significantly on other water users.
Mitigation and Rehabilitation plan	Control alien vegetation. Monitor erosion.
