**WETLAND DELINEATION IN THE RUSTENBURG
PLATINUM MINE PROJECT AREA AND A HIGH
LEVEL ASSESSMENT OF SELECTED RIVER
CROSSINGS, NORTH-WEST PROVINCE**

SRK Consulting (Pty) Ltd

May 2015

Prepared by:	Scientific Aquatic Services
Report author:	M. Aphane
Report Reviewer	S. van Staden (Pri. Sci. Nat)
Report Reference:	SAS 215053
Date:	May 2015

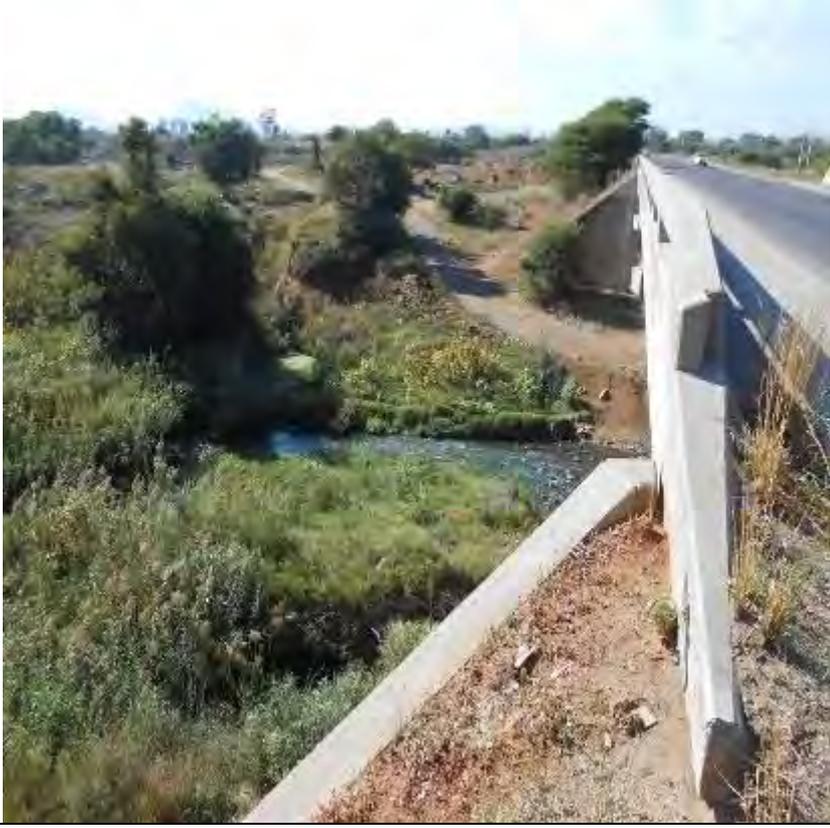
Site number: Site 28	Coordinates: 25°36'29.48"S 27°17'18.84"E
Crossing Type: Road crossing	
Site Photo:

Present Ecological State	C
Wetland type	River
Morphology	Wide, relatively shallow channel flowing water within the channel
Riparian and in Stream Habitat	<i>Acacia</i> spp. dominated bushveld vegetation. Instream ecology: <i>Phragmites australis</i> dominating instream habitat
Vegetation	<i>Phragmites australis</i> , <i>Cynodon dactylon</i> , <i>Cyperus sexangularis</i> , <i>Asclepius fruiticosa</i>
System Modifiers	Soil dumping adjacent to feature. Erosion below bridge. Waste dumping. Leaking drain next to the river. Grazing.
Potential impacts of water use on environment	The road crossing will not significantly negatively impact on the environment
Socio-economic impacts of water use	The road crossing will not significantly negatively impact on any water users.
Socio-economic advantages of water use	The road crossing plays an important role in providing connectivity in the area, particularly to the local community, thereby allowing economic activity in the area.

Potential impacts of water use on water resource	The culverts within the channel will result in some alterations to streamflow patterns during flow periods; however these are not deemed to have a significant impact on downstream resources.
Summary of proposed impact on water use will have on other users	The road crossing will not impact significantly on other water users.
Mitigation and Rehabilitation plan	Monitor erosion below the bridge. Clean up litter. Remove soil piles to prevent sedimentation. Monitor drain leakage to prevent contamination of water.

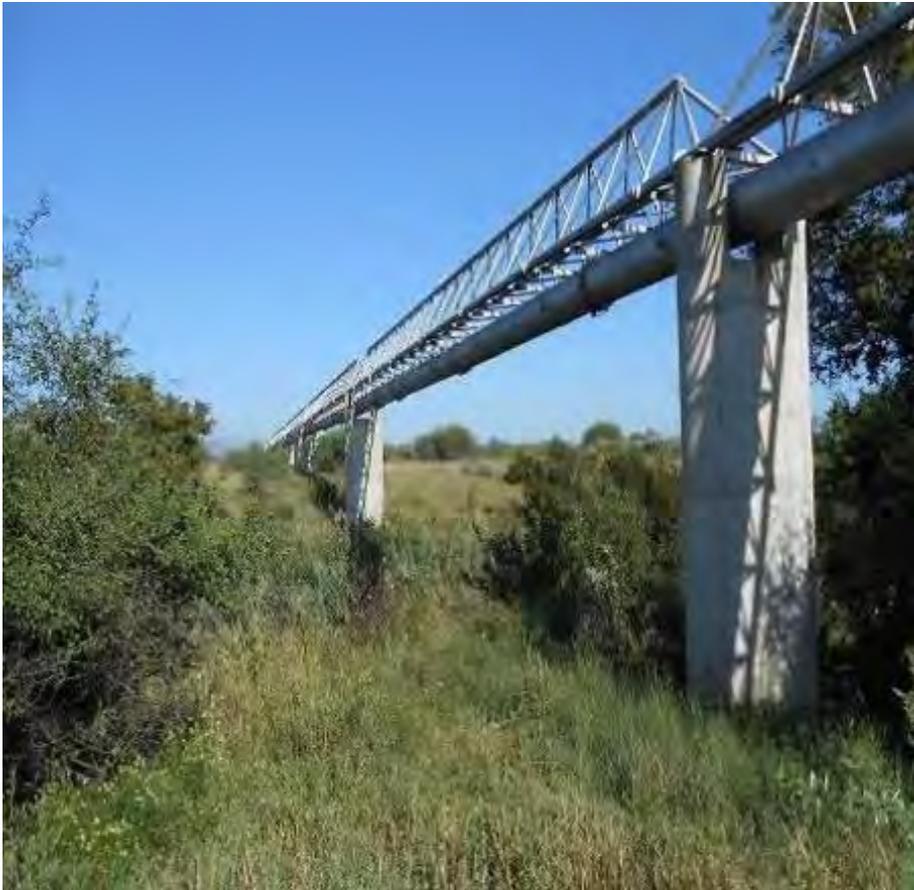
Site number: Site 28a	Coordinates: 25°36'01.36"S 27°17'37.67"E
Crossing Type: Pipeline crossing	
Site Photo:

Present Ecological State	C
Wetland type	River
Morphology	Wide, relatively deep channel.
Riparian and in Stream Habitat	<i>Rhus lancea</i> and <i>Acacia</i> spp. dominated bushveld vegetation. Instream ecology: Water within the channel
Vegetation	<i>Flaveria bidentis</i> , <i>Cyperus sexangularis</i> , <i>Cynodon dactylon</i>
System Modifiers	Water contamination. Algae proliferation.
Potential impacts of water use on environment	The pipeline crossing will not significantly negatively impact on the receiving environment; provided it is adequately maintained.
Socio-economic impacts of water use	The pipeline crossing will not significantly negatively impact on any water users.
Socio-economic advantages of water use	The pipeline is necessary for the safe disposal of sewage.
Potential impacts of water use on water resource	The support structures within the channel will result in some alterations to streamflow patterns during flow periods; however these are not deemed to have a significant impact on downstream resources.

Summary of proposed impact on water use will have on other users	The pipeline crossing will not impact significantly on other water users.
Mitigation and Rehabilitation plan	Monitor water quality

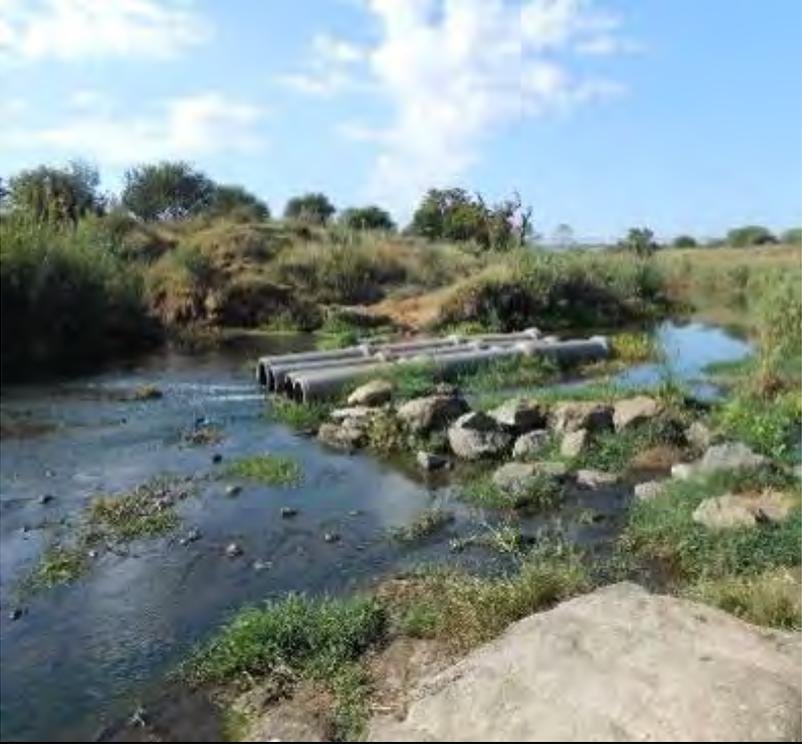
Site number: Site 28b	Coordinates: 25°35'55.85"S 27°17'33.01"E
Crossing Type: Battery of pipes which possibly formed part of a historical road crossing	
Site Photo:

Present Ecological State	C
Wetland type	River
Morphology	Wide, relatively shallow channel, mixture of alluvial sand and bedrock. Flowing water
Riparian and in Stream Habitat	<i>Acacia</i> spp dominated bushveld vegetation.
Vegetation	<i>Conyza bonariensis</i> , <i>Cyperus sexangularis</i> , <i>Phragmites australis</i>
System Modifiers	Erosion. Algae proliferation. Exposed pipes.
Potential impacts of water use on environment	The pipeline crossing will not significantly negatively impact on the environment.
Socio-economic impacts of water use	The pipeline crossing will not significantly negatively impact on any water users.
Socio-economic advantages of water use	N/A
Potential impacts of water use on water resource	The pipes within the channel will result in some alterations to streamflow patterns during flow periods; however these are not deemed to have a significant impact on downstream resources.

Summary of proposed impact on water use will have on other users	The pipeline crossing will not impact significantly on other water users.
Mitigation and Rehabilitation plan	Monitor erosion. Construct a proper crossing and/or make sure the pipes are underground to allow proper flow of water. If crossing is no longer required remove pipes from the watercourse. If crossing is required, construct a proper crossing to enable proper flow of water and movement of biota.

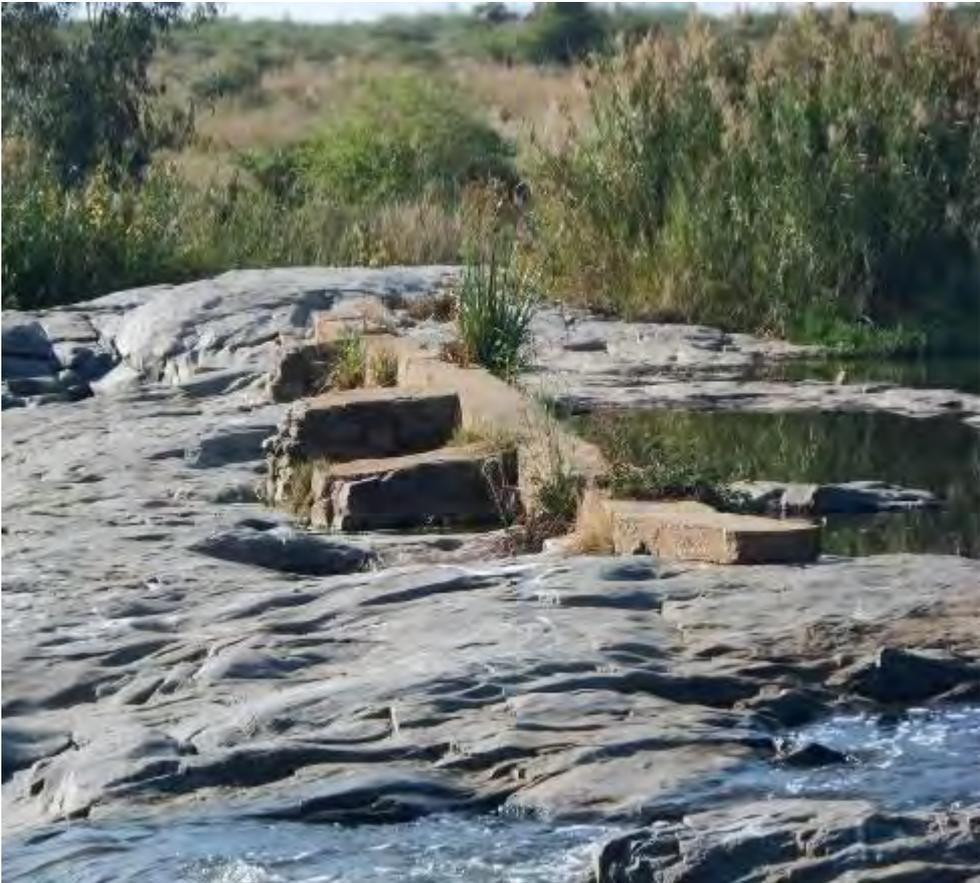
Site number: Site 28c	Coordinates: 25°35'31.42"S 27°17'55.09"E
Crossing Type: Weir crossing	
Site Photo:

Present Ecological State	C
Wetland type	River
Morphology	Wide, relatively shallow channel, exposed bedrock.
Riparian and in Stream Habitat	<i>Eucalyptus</i> spp. dominated bushveld vegetation. Instream ecology: Exposed bedrock.
Vegetation	<i>Phragmites australis</i> , <i>Cyperus sexangularis</i>
System Modifiers	Broken weir. Alien vegetation.
Potential impacts of water use on environment	The weir will not significantly negatively impact on the environment.
Socio-economic impacts of water use	The weir will not significantly negatively impact on any water users.
Socio-economic advantages of water use	The weir will not significantly negative impact on any water users
Potential impacts of water use on water resource	The weir will result in some alterations to streamflow patterns during flow periods; however these are not deemed to have a significant impact on downstream resources.

Summary of proposed impact on water use will have on other users	The weir will not impact significantly on other water users.
Mitigation and Rehabilitation plan	Control alien vegetation.

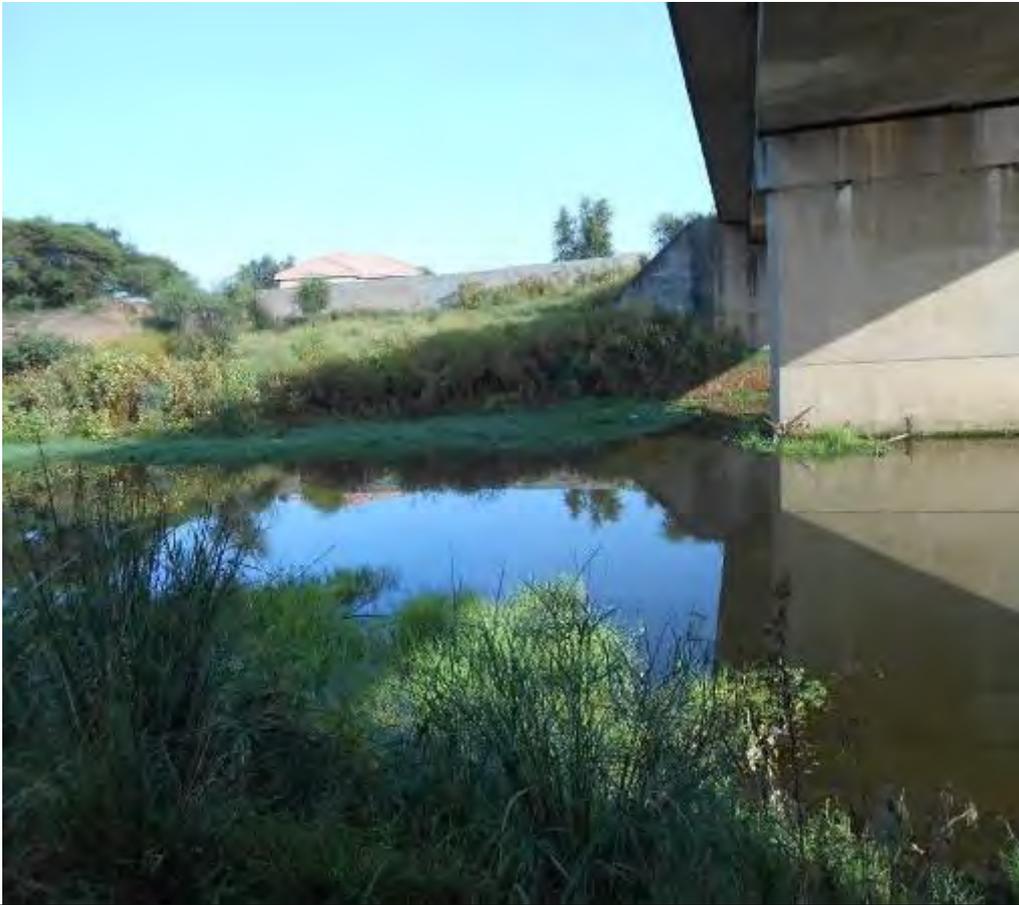
Site number: Site 29	Coordinates: 25°35'07.16"S 27°18'16.92"E
Crossing Type: Road crossing	
Site Photo:

Present Ecological State	C
Wetland type	River
Morphology	Wide, relatively shallow channel, inundation below bridge
Riparian and in Stream Habitat	<i>Acacia</i> spp. dominated bushveld vegetation. Instream ecology: Inundation below dam.
Vegetation	<i>Themeda triandra</i> , <i>Cyperus sexangularis</i> , <i>Phragmites australis</i> , <i>Typha capensis</i>
System Modifiers	Trampling. Erosion. Waste dumping.
Potential impacts of water use on environment	The road crossing will not significantly negatively impact on the environment.
Socio-economic impacts of water use	The road crossing will not significantly negatively impact on any water users.
Socio-economic advantages of water use	The road crossing plays an important role in providing connectivity in the area, particularly to the local community, thereby allowing economic activity in the area.

Potential impacts of water use on water resource	The support structures within the channel will result in some alterations to streamflow patterns during flow periods; however these are not deemed to have a significant impact on downstream resources.
Summary of proposed impact on water use will have on other users	The road crossing will not impact significantly on other water users.
Mitigation and Rehabilitation plan	Control alien vegetation along river banks. Re-vegetate eroded banks.

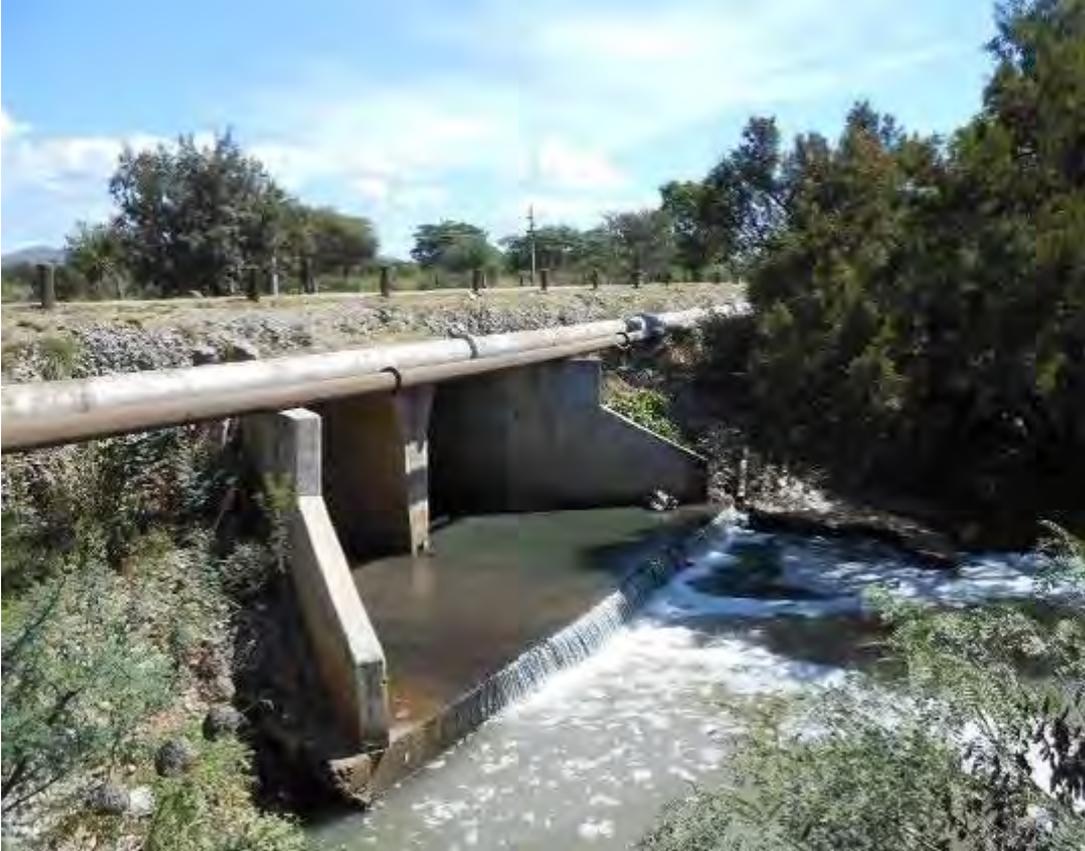
Site number: Site 30	Coordinates: 25°38'50.46"S 27°15'12.10"E
Crossing Type: Road/weir crossing	
Site Photo:

Present Ecological State	C
Wetland type	River
Morphology	Wide, relatively shallow channel.
Riparian and in Stream Habitat	<i>Rhus lancea</i> dominated bushveld vegetation. Instream ecology: flowing water
Vegetation	<i>Tagetes minuta</i> , <i>Datura stramonium</i> , <i>Cynodon dactylon</i> , <i>Coenzya bonariensis</i>
System Modifiers	Erosion. Waste dumping. Sewage effluent. Road construction.
Potential impacts of water use on environment	The road/weir crossing will not significantly negatively impact on the environment.
Socio-economic impacts of water use	The road/weir crossing will not significantly negatively impact on any water users.
Socio-economic advantages of water use	The road crossing plays an important role in providing connectivity in the area, particularly to the local community, thereby allowing economic activity in the area.

Potential impacts of water use on water resource	The weir will result in some alterations to streamflow patterns during flow periods; however these are not deemed to have a significant impact on downstream resources.
Summary of proposed impact on water use will have on other users	The road crossing will not impact significantly on other water users.
Mitigation and Rehabilitation plan	Monitor erosion. Monitor water quality.

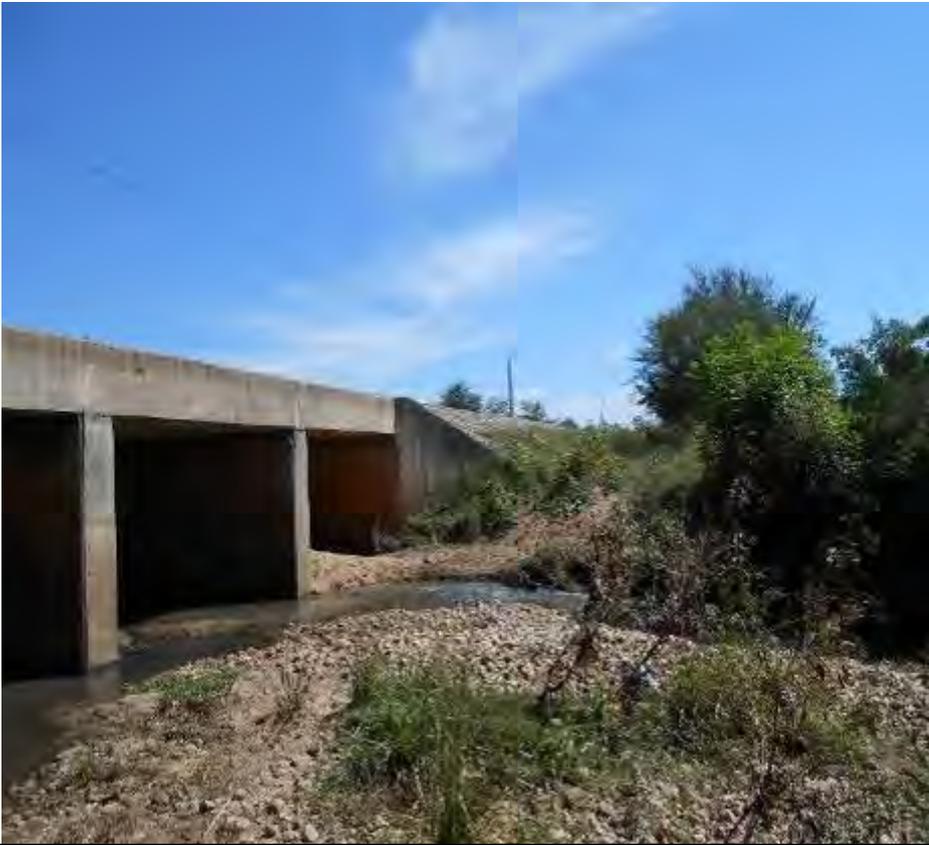
Site number: 31	Coordinates: 25°38'41.89S 27°15'17.04"E
Crossing Type: Railway crossing	
Site Photo:

Present Ecological State	D
Wetland type	River
Morphology	Wide, relatively shallow channel, high sediment load along the culvert
Riparian and in Stream Habitat	<i>Acacia karroo</i> dominate the bushveld vegetation.
Vegetation	<i>Morus alba</i> , <i>Melia azedarach</i> , <i>Tagetes minuta</i> , <i>Rhus lancea</i>
System Modifiers	Sediment and debris deposition causing streamflow diversion and aquatic migratory barrier. Erosion below the bridge and banks. Algae proliferation.
Potential impacts of water use on environment	The road crossing will not significantly negatively impact on the environment.
Socio-economic impacts of water use	The road crossing will not significantly negatively impact on any water users.
Socio-economic advantages of water use	The road crossing plays an important role in providing connectivity in the area, particularly to the local community, thereby allowing economic activity in the area.

Potential impacts of water use on water resource	The support structures within the channel will result in some alterations to streamflow patterns during flow periods; however these are not deemed to have a significant impact on downstream resources.
Summary of proposed impact on water use will have on other users	The road crossing will not impact significantly on other water users.
Mitigation and Rehabilitation plan	Remove debris within the stream. Control erosion by putting berms on the banks below bridge. Desilt the feature.

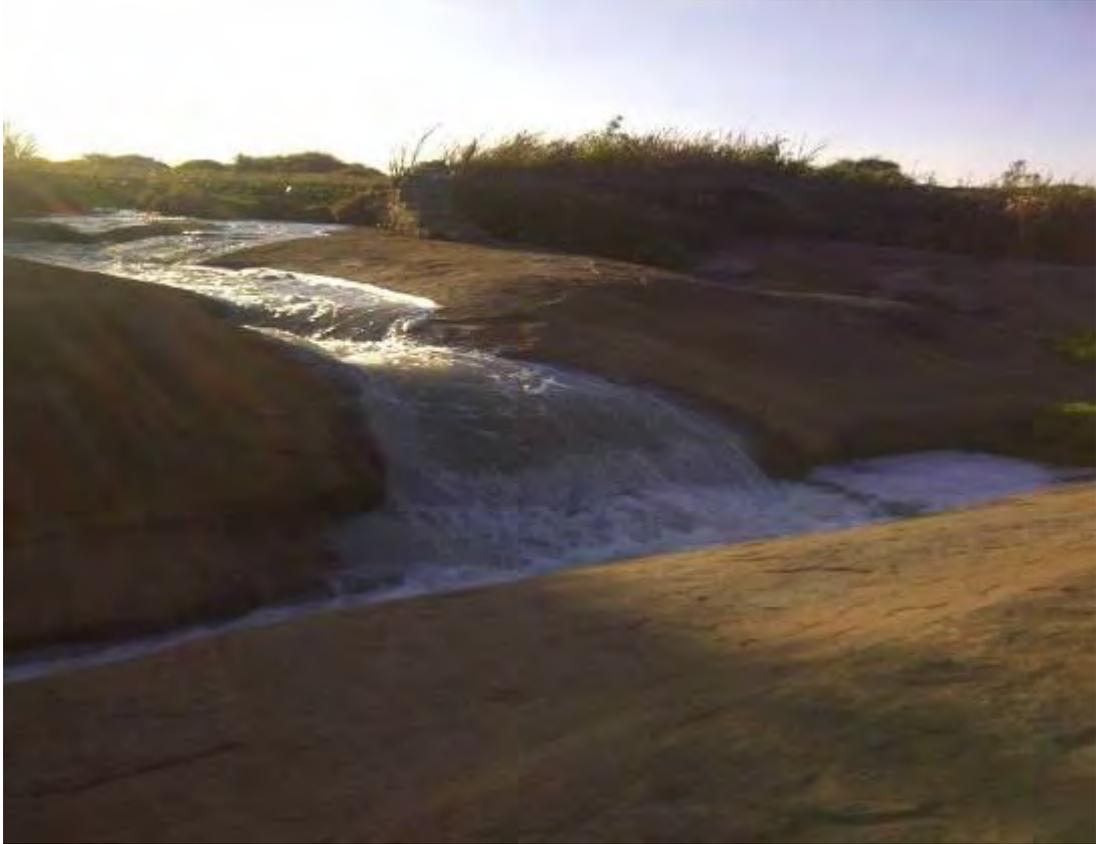
Site number: 31a	Coordinates: 25°37'55.64S 27°15'39.41"E
Crossing Type: Weir	
Site Photo:

Present Ecological State	C
Wetland type	River
Morphology	Exposed bedrock
Riparian and in Stream Habitat	Exposed bedrock
Vegetation	<i>Eichhornia crassipes</i> , <i>Typha capensis</i> , <i>Tagetes minuta</i>
System Modifiers	Sewage effluent.
Potential impacts of water use on environment	The weir crossing will not significantly negatively impact on the environment.
Socio-economic impacts of water use	The weir will not significantly negatively impact on any water users.
Socio-economic advantages of water use	N/A
Potential impacts of water use on water resource	The weir will result in some alterations to streamflow patterns during flow periods; however these are not deemed to have a significant impact on downstream resources.
Summary of proposed impact on water use will have on other users	The weir crossing will not impact significantly on other water users.

Mitigation and Rehabilitation plan	Monitor water quality and implement measures to prevent sewage effluent from entering the system.

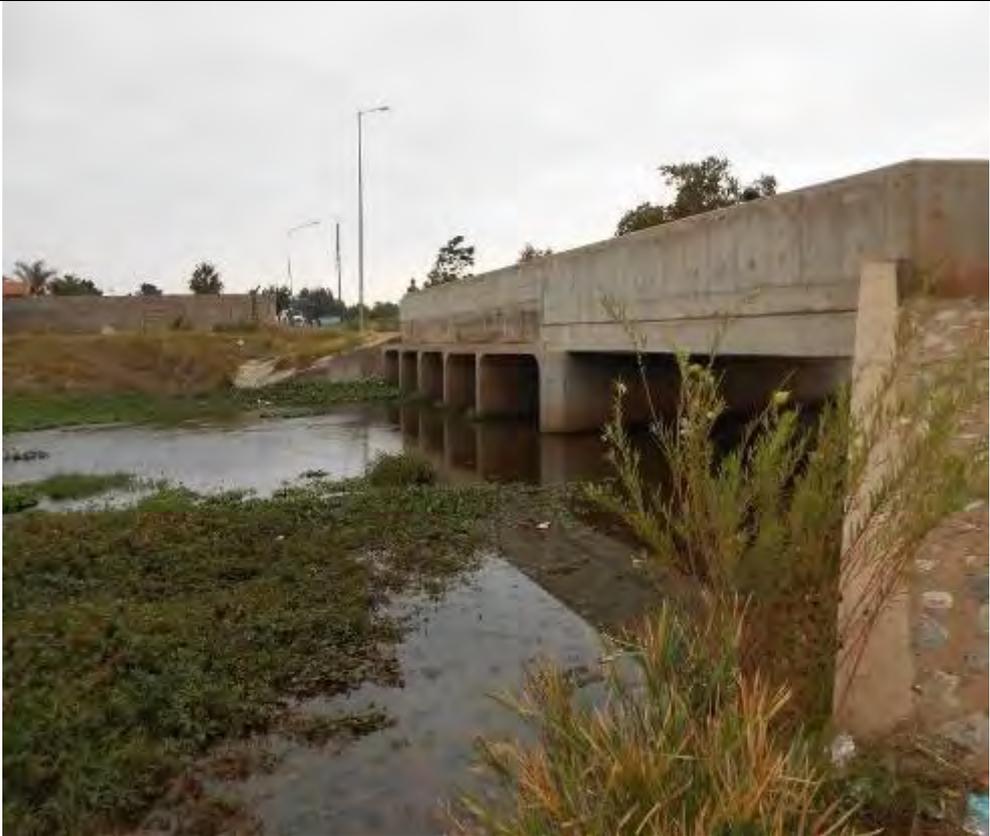
Site number: 32c	Coordinates: 25°37'39.14"S 27°16'24.15"E
Crossing Type: Road crossing

Present Ecological State	C
Wetland type	River
Morphology	Wide, very shallow channel
Riparian and in Stream Habitat	<i>Acacia</i> spp. dominated bushveld vegetation. Instream ecology: <i>Echhornia crassipes</i>
Vegetation	<i>Tagetes minuta</i> , <i>Asclepias fruiticosa</i> , <i>Typha capensis</i> , <i>Conyza bonariensis</i> , <i>Cyperus sexangularis</i> , <i>Persicaria lapathifolia</i> , <i>Datura stramonium</i> , <i>Asclepias fruiticosa</i> , <i>Sesbania sesban</i> , <i>Sporobolus pyramidalis</i> , <i>Verbena bonariensis</i> , <i>Bidens pilosa</i>
System Modifiers	Waste dumping. Increased water input from the road. Livestock grazing.
Potential impacts of water use on environment	The road crossing will not significantly negatively impact on the environment.
Socio-economic impacts of water use	The road crossing will not significantly negatively impact on any water users.

Socio-economic advantages of water use	The road crossing plays an important role in providing connectivity in the area, particularly to the local community, thereby allowing economic activity in the area.
Potential impacts of water use on water resource	The support structures within the channel will result in some alterations to streamflow patterns during flow periods; however these are not deemed to have a significant impact on downstream resources.
Summary of proposed impact on water use will have on other users	The road crossing will not impact significantly on other water users.
Mitigation and Rehabilitation plan	Monitor water quality. Control alien vegetation. Clean up litter

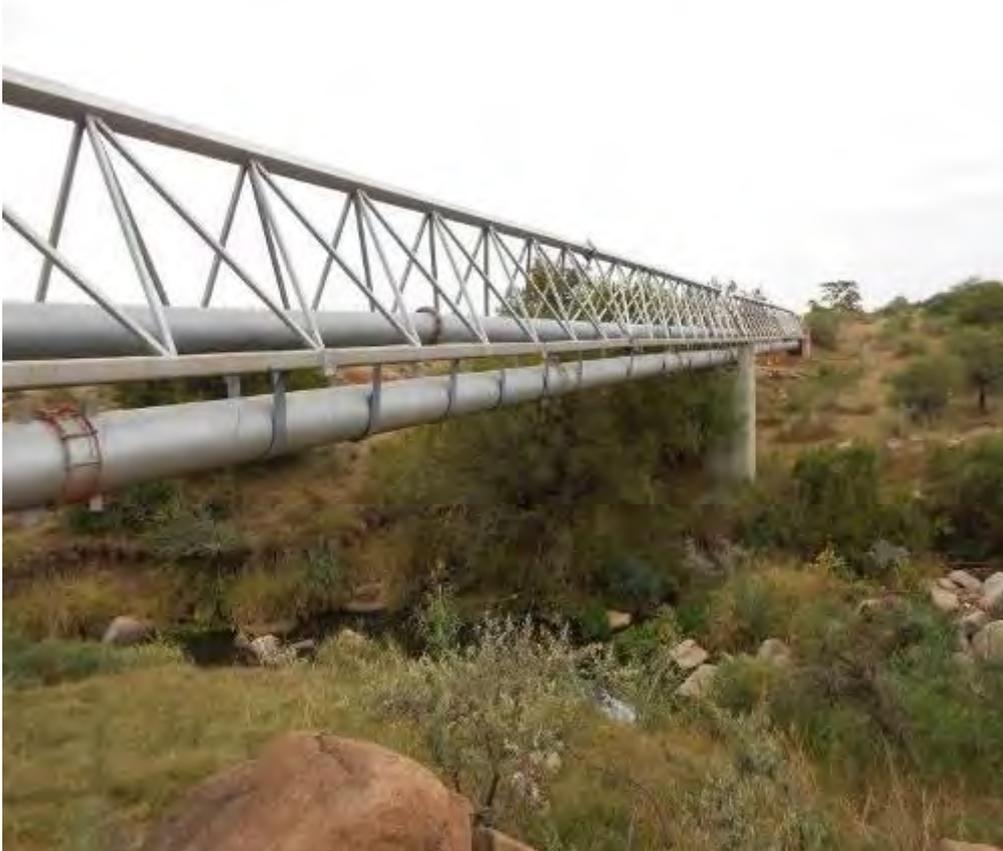
Site number: 32d	Coordinates: 25°36'28.67"S 27°13'12.66"E
Crossing Type: Pipeline	
Site Photo:

Present Ecological State	C
Wetland type	River
Morphology	Wide, relatively shallow, incised channel.
Riparian and in Stream Habitat	<i>Acacia karroo</i> . Dominated bushveld vegetation. Instream ecology: flowing water.
Vegetation	<i>Cynodon dactylon</i> , <i>Lantana camara</i> , <i>Asclepias fruticosa</i> , <i>Phragmites australis</i> , <i>Senecio cinerascens</i>
System Modifiers	Sedimentation. Erosion. Encroachment
Potential impacts of water use on environment	The pipeline crossing will not significantly negatively impact on the receiving environment; provided it is adequately maintained.
Socio-economic impacts of water use	The pipeline crossing will not significantly negatively impact on any water users.
Socio-economic advantages of water use	N/A
Potential impacts of water use on water resource	The support structures within the channel will result in some alterations to streamflow patterns during flow periods; however these are not deemed to have a significant impact on downstream resources.

Summary of proposed impact on water use will have on other users	The pipeline crossing will not impact significantly on other water users.
Mitigation and Rehabilitation plan	Monitor erosion. Control alien vegetation.

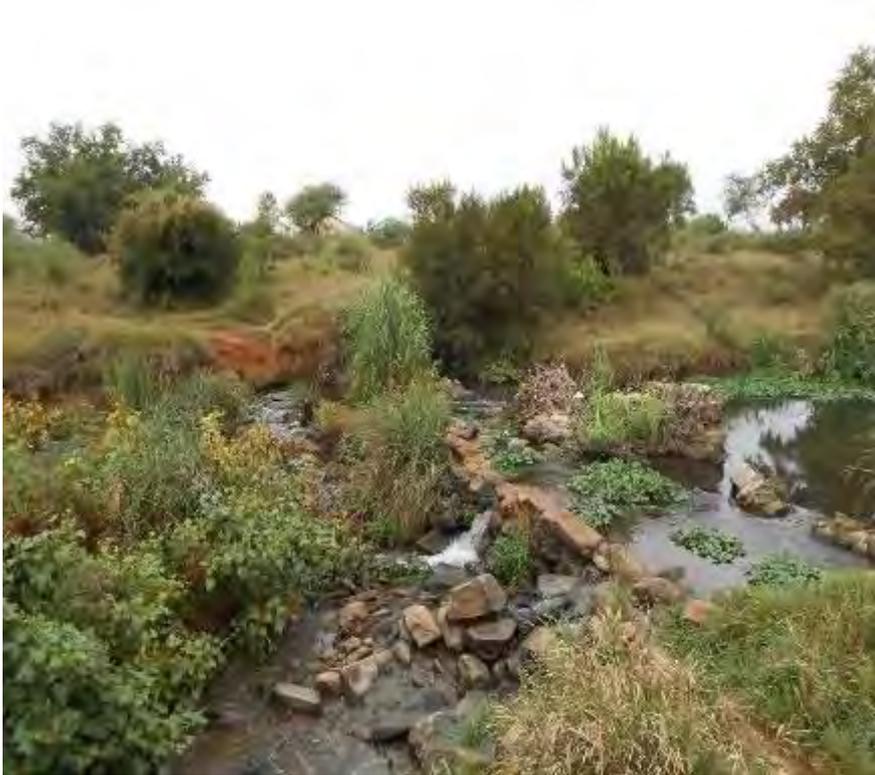
Site number: 32e	Coordinates: 25°37'31.96"S 27°17'02.40"E
Crossing Type: Road crossing	
Site Photo:

Present Ecological State	C
Wetland type	River
Morphology	Wide, relatively shallow incised channel.
Riparian and in Stream Habitat	<i>Rhus lancea</i> dominated bushveld vegetation. Instream ecology: Flowing water with vegetation such as <i>Cyperus sexangularis</i> in stream
Vegetation	<i>Asclepias fruiticosa</i> , <i>Typha capensis</i> , <i>Conyza bonariensis</i> , <i>Cyperus sexangularis</i> , <i>Persicaria lapathifolia</i> , <i>Asclepias fruiticosa</i> , <i>Sporobolus pyramidalis</i> , <i>Eichhornia crassipes</i> , <i>Xanthium strumarium</i> , <i>Phragmites australis</i> , <i>Asparagus laricus</i> , <i>Conyza bonariensis</i> , <i>Cynodon dactylon</i> , <i>Parthenium hysterophorus</i>
System Modifiers	Erosion. Broken informal small weir.
Potential impacts of water use on environment	The road crossing will not significantly will further increase erosion along the banks.

Socio-economic impacts of water use	The road crossing will not significantly negatively impact on any water users.
Socio-economic advantages of water use	The road no longer serves its purpose of connectivity within the area.
Potential impacts of water use on water resource	The collapsed road will result in some alterations to streamflow patterns during flow periods; however these are not deemed to have a significant impact on downstream resources.
Summary of proposed impact on water use will have on other users	The road crossing will not impact significantly on other water users.
Mitigation and Rehabilitation plan	If the road is no longer required, remove collapsed structure. Insert berms to control erosion.

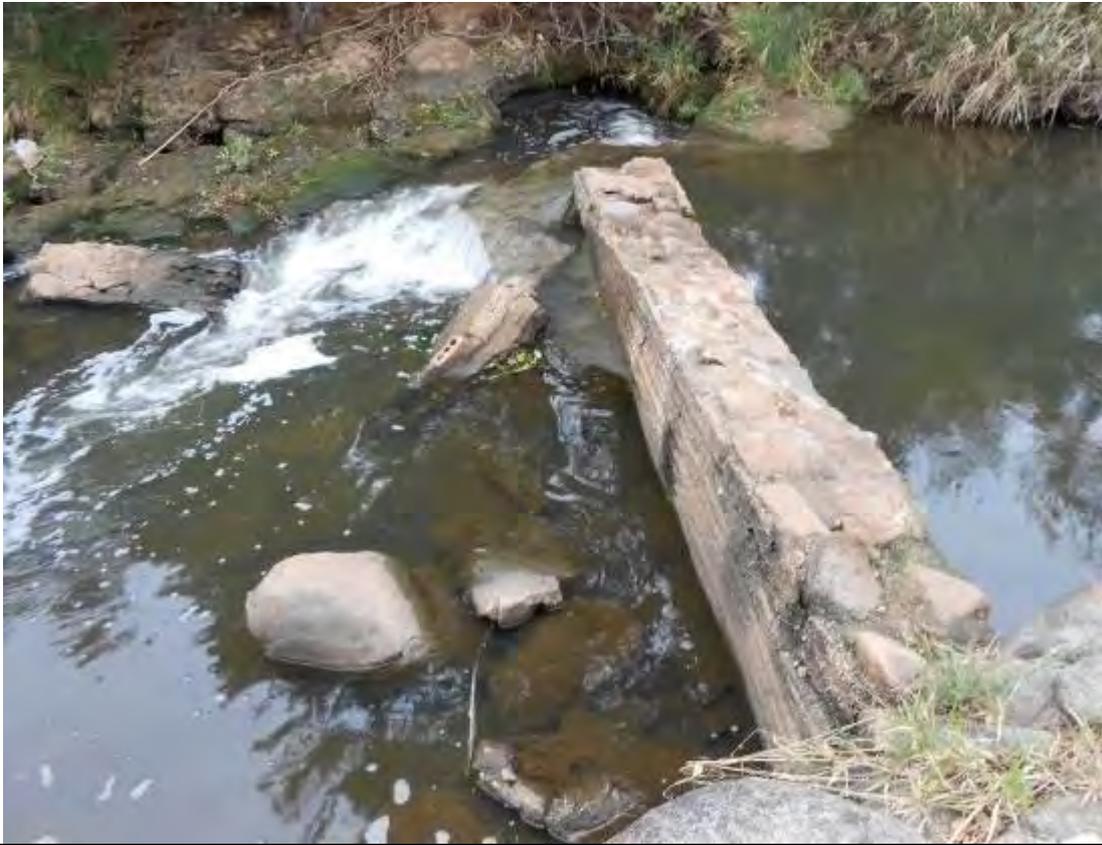
Site number: 32f	Coordinates: 25°37'31.44"S 27°17'07.71"E
Crossing Type: Road crossing	
Site Photo:

Present Ecological State	C
Wetland type	River
Morphology	Wide, relatively shallow channel, exposed rocks along the banks due to erosion.
Riparian and in Stream Habitat	Instream ecology: flowing water
Vegetation	<i>Cyperus sexangularis</i> , <i>Sporobolus pyramidalis</i> , <i>Xanthium strumarium</i> , <i>Phragmites australis</i> , <i>Asparagus laricinus</i> , <i>Conyza bonariensis</i> , <i>Panicum ecklonii</i> , <i>Rhus lancea</i> , <i>Tagetes minuta</i> , <i>Hyparrhenia hirta</i> .
System Modifiers	Weir altering water flow. Erosion
Potential impacts of water use on environment	The road crossing will not significantly negatively impact on the environment.
Socio-economic impacts of water use	The road crossing will not significantly negatively impact on any water users.
Socio-economic advantages of water use	The road is not efficiently providing connectivity due to the fact that it is very narrow and not well constructed.

Potential impacts of water use on water resource	The road will result in some alterations to streamflow patterns during flow periods; however these are not deemed to have a significant impact on downstream resources.
Summary of proposed impact on water use will have on other users	The road crossing will not impact significantly on other water users.
Mitigation and Rehabilitation plan	Control erosion. Construct a proper bridge crossing or remove the collapsed structure if crossing is no longer needed.

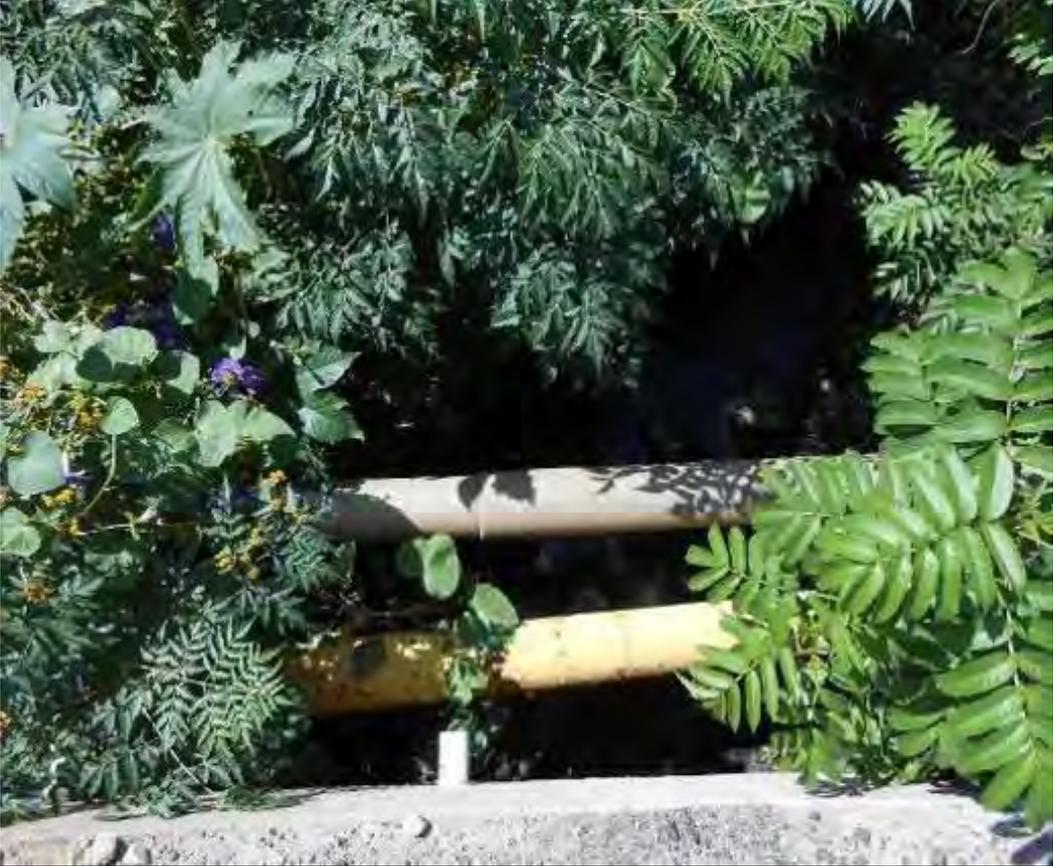
Site number: 33	Coordinates: 25°37'11.05"S 27°13'31.08"E
Crossing Type: Road crossing	
Site Photo:

Present Ecological State	D
Wetland type	Artificial channel
Morphology	Very narrow artificial channel
Riparian and in Stream Habitat	<i>Melia azedarach</i> dominated bushveld vegetation.
Vegetation	<i>Ipomoea purpurea</i> , <i>Asparagus laricinus</i> , <i>Datura stramonium</i> , <i>Typha capensis</i>
System Modifiers	Stockpiling which will result in sediment deposition within the wetland. Cemented channels. Site clearing adjacent feature. Altered water quality. Dense trees obstructing the view. Erosion. Encroachment
Potential impacts of water use on environment	The road crossing will not significantly negatively impact on the environment;
Socio-economic impacts of water use	The road crossing will not significantly negatively impact on any water users.
Socio-economic advantages of water use	The road is not efficiently providing connectivity in the area.

Potential impacts of water use on water resource	The road will result in some alterations to streamflow patterns during flow periods; however these are not deemed to have a significant impact on downstream resources.
Summary of proposed impact on water use will have on other users	The sewer line crossing will not impact significantly on other water users.
Mitigation and Rehabilitation plan	Clean culverts. Cut trees along the banks.

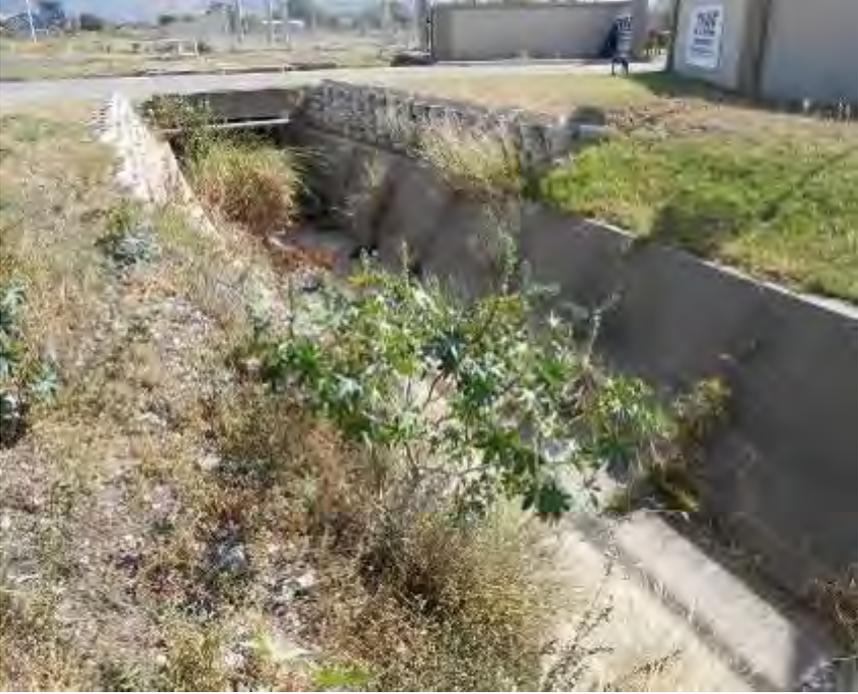
Site number: 33a and 33b	Coordinates: 25°37'33.76"S 27°13'44.07"E
Crossing Type: Road crossing	
Site Photo:

Present Ecological State	C
Wetland type	Artificial channel
Morphology	Relatively narrow artificial channel, no water present at the time of the assessment.
Riparian and in Stream Habitat	Dominated by bushveld grass; alien vegetation component moderate. Instream ecology: Artificial stream dry at the time of the study.
Vegetation	<i>Eragrostis gummiflua</i> , <i>Tagetes minuta</i> , <i>Melinis repens</i> , <i>Bidens pilosa</i> , <i>Asclepias fruiticosa</i> , <i>Acacia karroo</i> , <i>Datura stramonium</i> , <i>Persicaria lapathifolia</i> .
System Modifiers	Increased water input from the road. Alien vegetation. Cemented channel.
Potential impacts of water use on environment	Loss of natural instream habitat.
Socio-economic impacts of water use	The bridge will not significantly negatively impact on any water users.

Socio-economic advantages of water use	The bridge plays an important role in providing connectivity in the area, particularly in the industrial sector, thereby allowing economic activity in the area.
Potential impacts of water use on water resource	The bridge has been well-constructed with little to no incision apparent at the bridge tie-ins. Moderate alteration to streamflow patterns as well as increased water input is anticipated as a result of the artificial nature of the channel, however since the system is ephemeral, no significant impact on downstream resources is anticipated as a result of this.
Summary of proposed impact on water use will have on other users	The bridge will not impact significantly on other water users.
Mitigation and Rehabilitation plan	Monitor the area for structure failure and alien vegetation control.

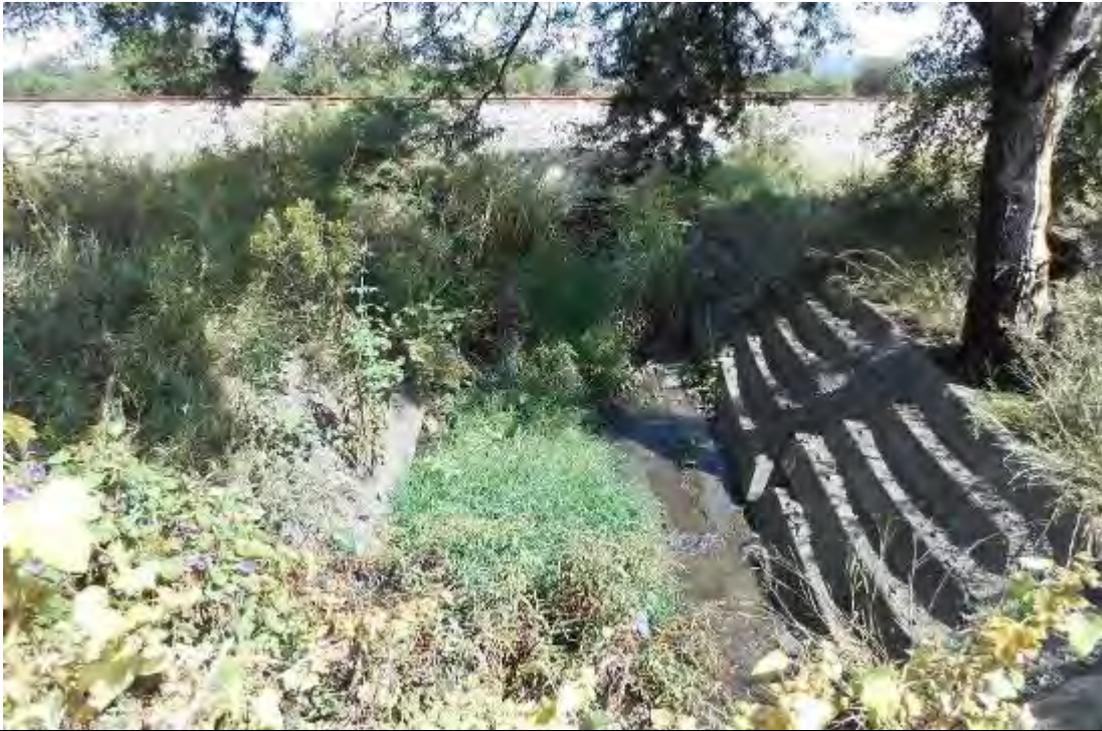
Site number: 34	Coordinates: 24°37'04.04"S 27°13'40.26"E
Crossing Type: Railway line/bridge crossing	
Site Photo:

Present Ecological State	D
Wetland type	Artificial channel
Morphology	Relatively narrow artificial channel. Some water present during the study, unlikely to support any aquatic macro-invertebrates. Overgrown instream vegetation.
Riparian and in Stream Habitat	Dominated by bushveld grasses. Instream ecology: limited flow present at the time of the assessment. Overgrown instream vegetation.
Vegetation	<i>Xanthium strumarium</i> , <i>Acacia karroo</i> , <i>Datura stramonium</i> , <i>Asclepias fruiticosa</i> , <i>Themeda triandra</i> , <i>Persicaria lapathifolia</i> , <i>Ipomoea purpurea</i> , <i>Tagetes minuta</i> , <i>Rhus lancea</i> , <i>Tithonia rotundifolia</i>
System Modifiers	Sedimentation. Erosion. Encroachment.
Potential impacts of water use on environment	Loss of natural instream habitat.

Socio-economic impacts of water use	The railway crossing will not significantly negatively impact on any water users.
Socio-economic advantages of water use	The railway crossing plays an important role in providing connectivity in the area, particularly in the industrial sector, thereby allowing economic activity in the area.
Potential impacts of water use on water resource	The railway crossing has been well-constructed with little to no incision evident. Moderate alteration to streamflow is anticipated as a result of the artificial nature of the channel, however since the system is ephemeral, no significant impact on downstream resources is anticipated as a result of this.
Summary of proposed impact on water use will have on other users	The railway crossing will not impact significantly on other water users.
Mitigation and Rehabilitation plan	Monitoring of erosion. Alien vegetation removal and monitoring within the channel.

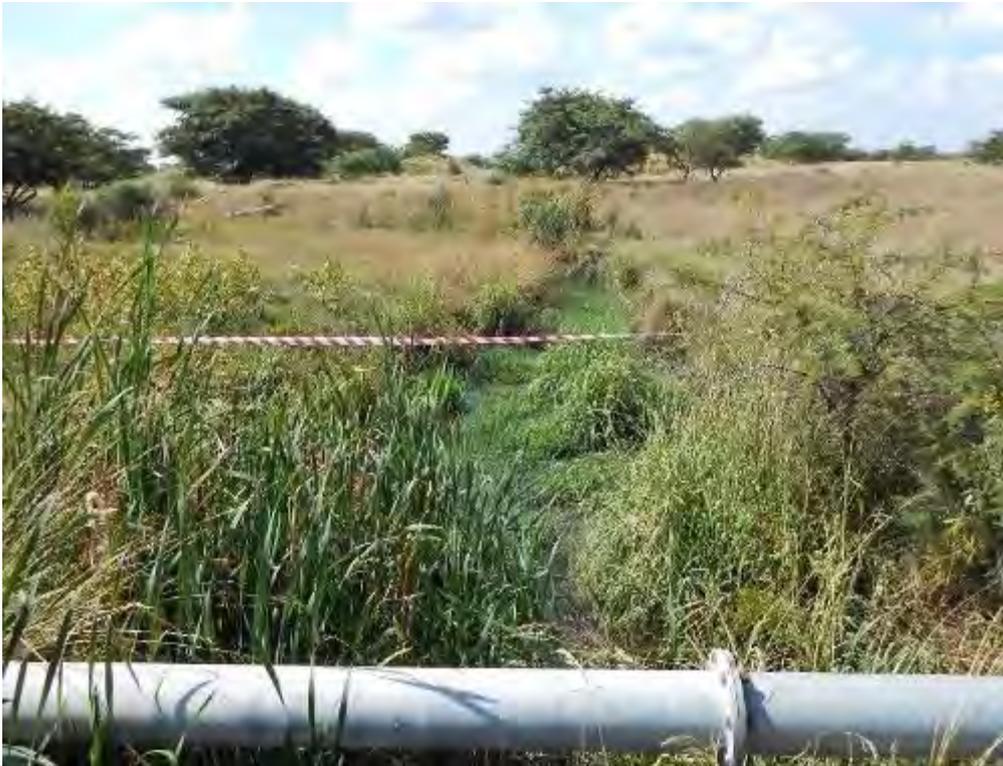
Site number: 34a	Coordinates: 25°37'29.34"S 27°13'54.70"E
Crossing Type: Pipeline	
Site Photo:

Present Ecological State	B
Wetland type	River
Morphology	Relatively narrow, shallow channel, mixture of alluvial sand and mud. Limited flow present at the time of the study.
Riparian and in Stream Habitat	<i>Cymbopogon</i> dominated bushveld vegetation; alien vegetation component moderate. Instream ecology: limited flow present at the time of the assessment, dominated by <i>Typha</i> .
Vegetation	<i>Tagetes minuta</i> , <i>Typha capensis</i> , <i>Cymbopogon validus</i> , <i>Flaveria bidentis</i>
System Modifiers	Invasive alien vegetation.
Potential impacts of water use on environment	Possible flow impedance during high flow periods.
Socio-economic impacts of water use	The pipeline will not significantly negatively impact on any water users.
Socio-economic advantages of water use	The pipeline will not significantly negatively impact on any water users.

Potential impacts of water use on water resource	The support structures within the channel will result in some alterations to streamflow patterns during flow periods; however these are not deemed to have a significant impact on downstream resources.
Summary of proposed impact on water use will have on other users	The pipeline will not impact significantly on other water users.
Mitigation and Rehabilitation plan	Implement alien vegetation control programme. Monitor the pipeline for leaks.

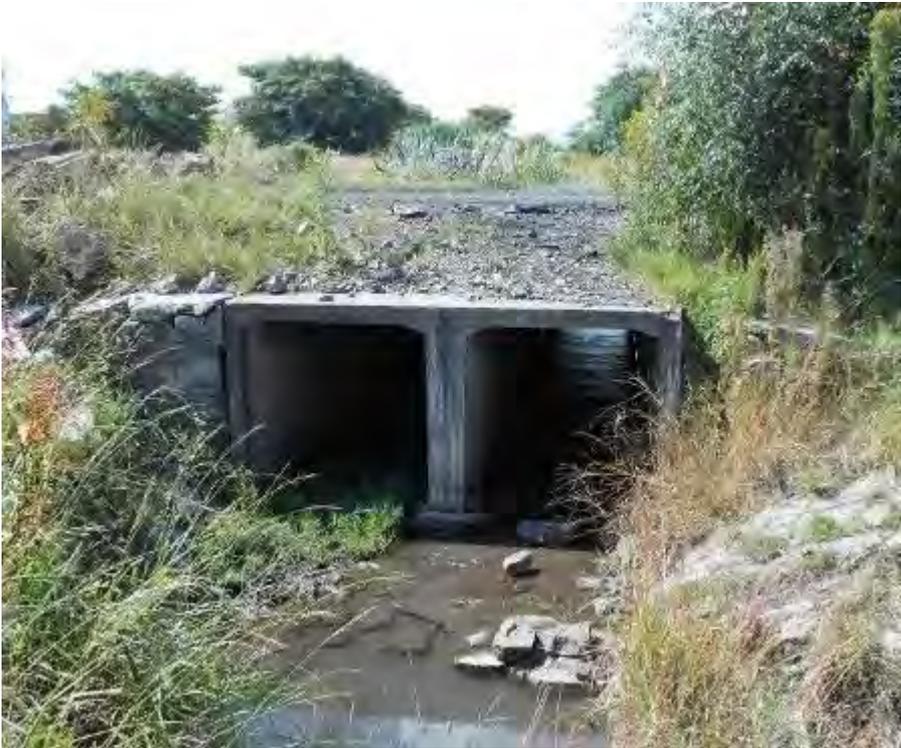
Site number: 34b	Coordinates: 25°37'29.82"S 27°13'54.76"E
Crossing Type: Road crossing/culvert	
Site Photo:

Present Ecological State	C
Wetland type	River
Morphology	Wide, relatively deep channel, mixture of alluvial sand and rocky substrate. Low flow present at the time of the study.
Riparian and in Stream Habitat	Dominated by bushveld grass, alien vegetation component moderate. Instream ecology: low flow present, no instream vegetation present at the time of the study.
Vegetation	<i>Verbena bonariensis</i> , <i>Tagetes minuta</i> , <i>Persicaria lapathifolia</i> , <i>Bidens pilosa</i> , <i>Cynodon dactylon</i> , <i>Datura stramonium</i> ,
System Modifiers	Erosion. Construction. Waste dumping.
Potential impacts of water use on environment	Increased water input from the road. Further erosion and sedimentation of the system.
Socio-economic impacts of water use	The bridge will not significantly negatively impact on any water users.

Socio-economic advantages of water use	The bridge plays an important role in providing connectivity in the area, thereby allowing economic activity in the area
Potential impacts of water use on water resource	Some erosion and incision apparent at the bridge tie-ins. Moderate alteration to streamflow patterns is anticipated as a result of the culvert.
Summary of proposed impact on water use will have on other users	The bridge will not impact significantly on other water users.
Mitigation and Rehabilitation plan	Invasive vegetation control. Erosion monitoring.

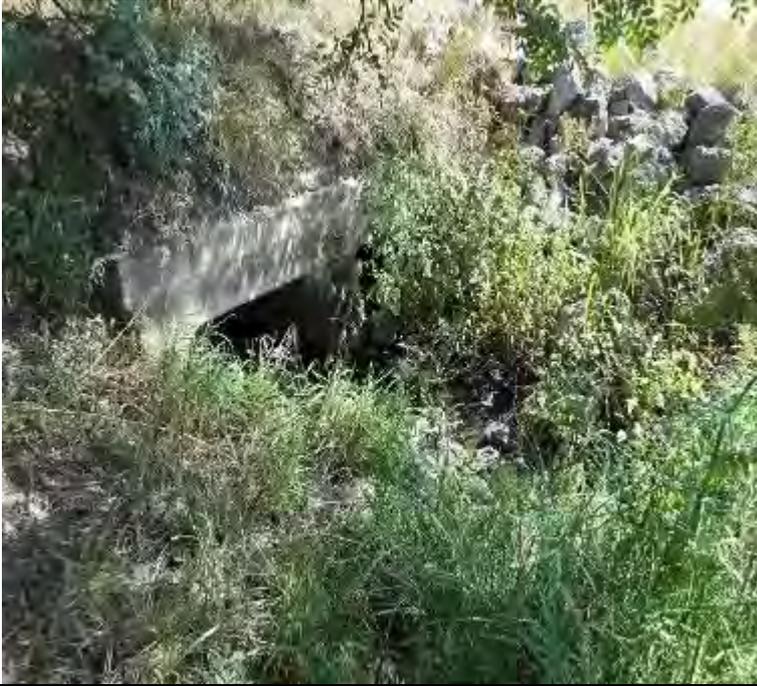
Site number: 34c	Coordinates: 25°37'24.04"S 27°13'59.50"E
Crossing Type: Culvert/Road	
Site Photo:

Present Ecological State	C
Wetland type	River
Morphology	Narrow, relatively shallow channel, with a mixture of alluvial sand. Dry river bed at the time of the assessment.
Riparian and in Stream Habitat	Dominated by bushveld grass; alien vegetation component moderate. Instream ecology: riverbed dry at the time of the study.
Vegetation	<i>Leonotis dysophylla</i> , <i>Tagetes minuta</i> , <i>Asparagus laricinus</i> , <i>circium vulgare</i> , <i>Cyperus sexangularis</i> , <i>Bidens pilosa</i> , <i>Persicaria lapathifolia</i> , <i>Xanthium strumarium</i>
System Modifiers	Erosion. Rock dumping. Alien invasion. Encroachment
Potential impacts of water use on environment	The culvert will not significantly negatively impact on the environment due to the ephemeral nature of the stream.
Socio-economic impacts of water use	The culvert will not significantly negatively impact on any water users.

Socio-economic advantages of water use	The culvert will not significantly negatively impact on any water users, but does not serve as an important socio-economic advantage due to its remote location.
Potential impacts of water use on water resource	The culvert has been well-constructed with little to no incision apparent at the tie-ins. Moderate alteration to streamflow patterns is anticipated as a result of the overgrown instream habitat; however since the system is ephemeral, no significant impact on downstream resources is anticipated as a result of this.
Summary of proposed impact on water use will have on other users	The culvert will not impact significantly on other water users.
Mitigation and Rehabilitation plan	Invasive vegetation control especially within the river channel. Insert proper berms along the culvert, instead of rocks. Erosion monitoring. Remove rocks.
