**WETLAND DELINEATION IN THE RUSTENBURG
PLATINUM MINE PROJECT AREA AND A HIGH
LEVEL ASSESSMENT OF SELECTED RIVER
CROSSINGS, NORTH-WEST PROVINCE**

SRK Consulting (Pty) Ltd

May 2015

Prepared by:	Scientific Aquatic Services
Report author:	M. Aphane
Report Reviewer	S. van Staden (Pri. Sci. Nat)
Report Reference:	SAS 215053
Date:	May 2015

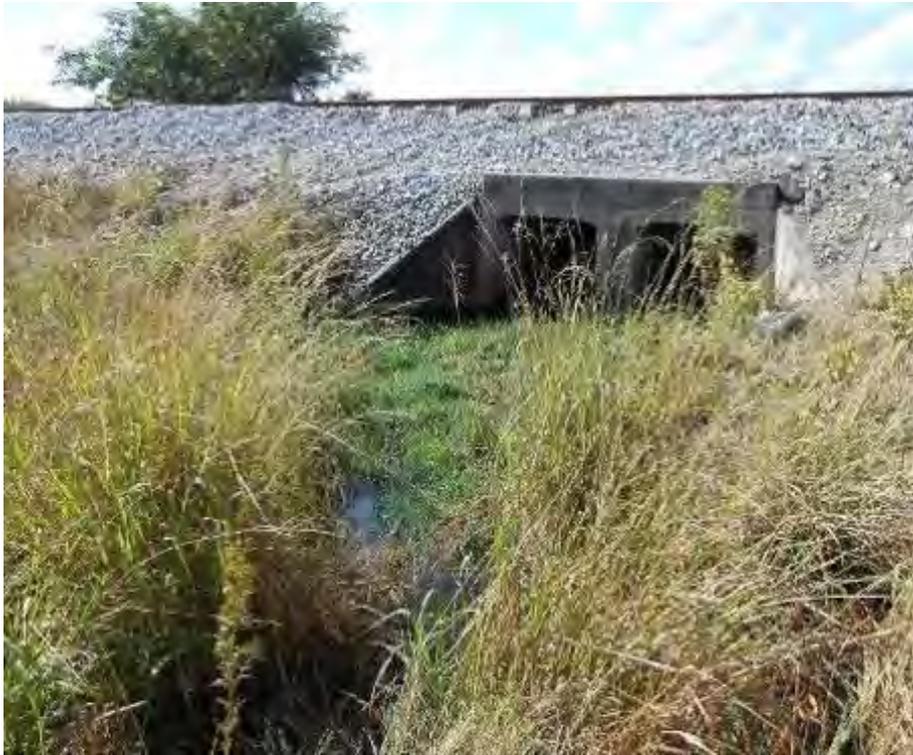
Site number: 34d	Coordinates: 25°37'25.30"S 27°13'58.66"E
Crossing Type: Railway crossing	
Site Photo:

Present Ecological State	C
Wetland type	River
Morphology	Wide, relatively shallow channel, mixture of alluvial sand and mud. Limited water present at the time of the assessment, unlikely to support any aquatic macro-invertebrates..
Riparian and in Stream Habitat	Dominated by bushveld grass; alien vegetation component moderate. Instream ecology: limited water present at the time of the assessment. Instream habitat dominated by terrestrial species.
Vegetation	<i>Leonotis dysophylla</i> , <i>Tagetes minuta</i> , <i>Asparagus laricinus</i> , <i>circium vulgare</i> , <i>Cyperus sexangularis</i> , <i>Bidens pilosa</i> , <i>Persicaria lapathifolia</i>
System Modifiers	Sedimentation. Alien vegetation
Potential impacts of water use on environment	The railway crossing will not significantly negatively impact on the environment due to the ephemeral nature of the stream.

Socio-economic impacts of water use	The railway crossing will not significantly negatively impact on any water users.
Socio-economic advantages of water use	The railway crossing plays an important role in providing connectivity in the area, particularly to the industrial sector, thereby allowing economic activity in the area
Potential impacts of water use on water resource	The railway crossing has been well-constructed with little to no incision apparent at the bridge tie-ins. Moderate alteration to streamflow patterns is anticipated as a result of the culverts; however since the system is ephemeral, no significant impact on downstream resources is anticipated as a result of this.
Summary of proposed impact on water use will have on other users	The railway crossing will not impact significantly on other water users.
Mitigation and Rehabilitation plan	Control alien vegetation

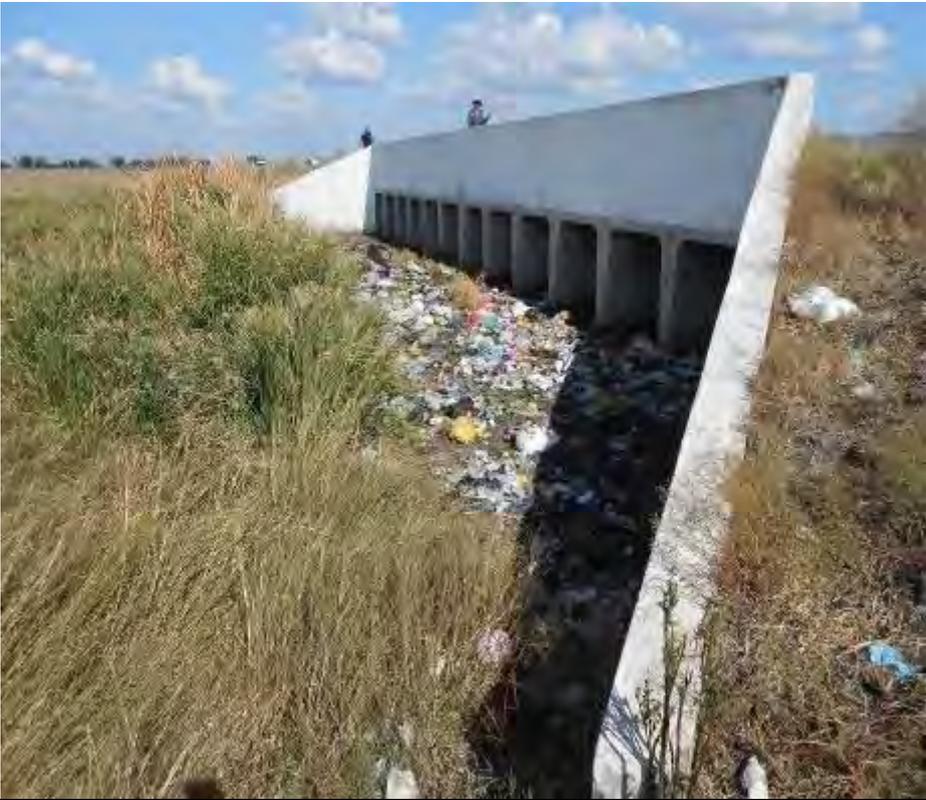
Site number: 34e	Coordinates: 25°36'57.65"S 27°14'30.30"E
Crossing Type: Road crossing	
Site Photo:

Present Ecological State	D
Wetland type	River
Morphology	Wide, relatively shallow channel, mixture of alluvial sand. Dry river bed at the time of the study.
Riparian and in Stream Habitat	Dominated by bushveld vegetation; alien vegetation component moderate. Instream ecology: riverbed dry at the time of the study and dominated by <i>Typha capensis</i> .
Vegetation	<i>Typha capensis</i> , <i>Cyperus sexangularis</i> , <i>Cynodon dactylon</i>
System Modifiers	Increased water input from the road. Dumping of general waste.
Potential impacts of water use on environment	The bridge will not significantly negatively impact on the environment due to the ephemeral nature of the stream.
Socio-economic impacts of water use	The bridge will not significantly negatively impact on any water users.
Socio-economic advantages of water use	The bridge plays an important role in providing connectivity in the area, particularly to the local community, thereby allowing economic activity in the area

Potential impacts of water use on water resource	The bridge has been well-constructed with little to no incision apparent at the bridge tie-ins. Moderate alteration to streamflow patterns is anticipated as a result of the culverts; however since the system is ephemeral, no significant impact on downstream resources is anticipated as a result of this.
Summary of proposed impact on water use will have on other users	The bridge will not impact significantly on other water users.
Mitigation and Rehabilitation plan	Remove general waste from bridge crossing.

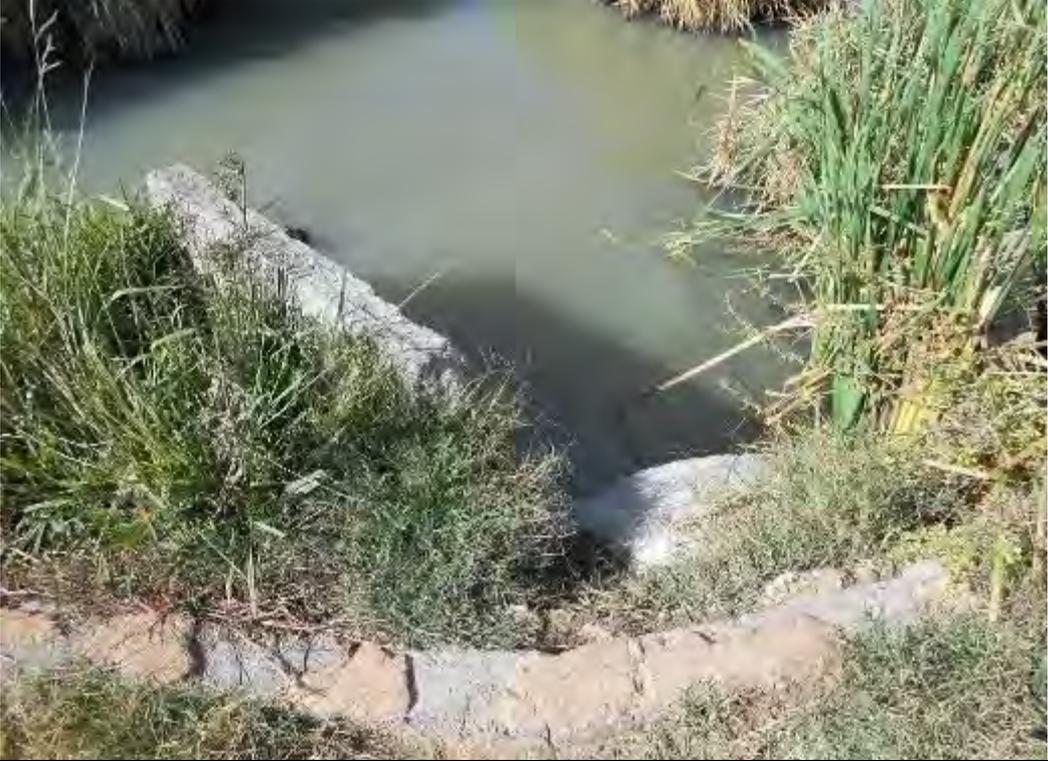
Site number: 34f	Coordinates: 25°36'04.22"S 27°15'20.27"E
Crossing Type: Pipe crossing	
Site Photo:

Present Ecological State	D
Wetland type	River
Morphology	Wide, relatively shallow channel, mixture of alluvial sand. Slow flowing water present at the time of the assessment.
<i>Riparian and in Stream Habitat</i>	Instream ecology: dominated by <i>Typha capensis</i> .
Vegetation	<i>Conyza bonariensis</i> , <i>Cyperus sexangularis</i> , <i>Typha capensis</i> , <i>Bidens pilosa</i> , <i>Urochloa mosambicensis</i> , <i>Tithonia rotundifolia</i>
System Modifiers	Sewage effluent altering water quality. Burst pipe traversing the road and the feature. Trampling, Erosion.
Potential impacts of water use on environment	At the moment sewage is entering the system due to the broken pipe at the time of the assessment. The pipeline crossing will not significantly negatively impact on the receiving environment; provided it is adequately maintained.

Socio-economic impacts of water use	At the moment sewage is entering the system due to the broken pipe at the site. The pipeline crossing will not significantly negatively impact on any water users, provided it is adequately maintained.
Socio-economic advantages of water use	The sewer line is necessary for the safe disposal of sewage.
Potential impacts of water use on water resource	The pipeline crossing has been poorly-constructed with some erosion present at the site. The pipeline present at the site has been damaged, this will alter the flow of the system with increased flow entering the system.
Summary of proposed impact on water use will have on other users	At the moment the pipeline crossing is having a negative impact due to the damaged pipe and sewage entering the system. The crossing will not impact significantly on other water users if it is properly maintained.
Mitigation and Rehabilitation plan	Monitor erosion. Construct a proper road crossing. Install proper sewage pipes.

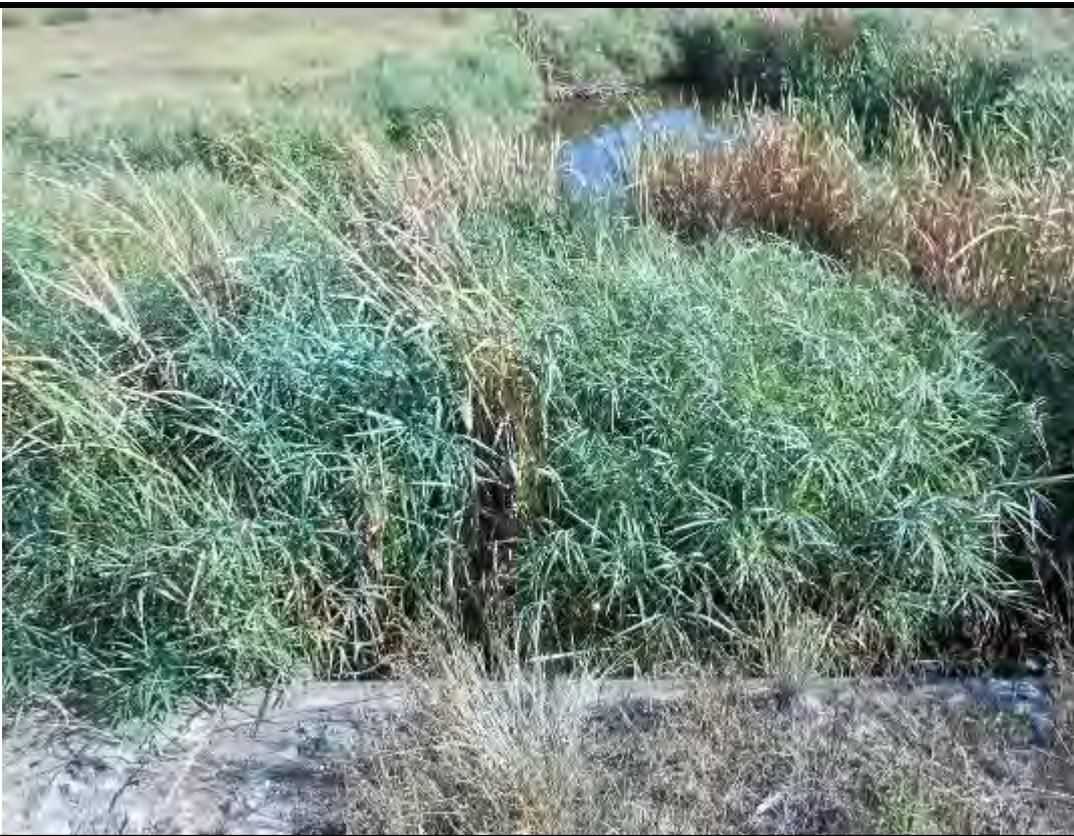
Site number: 34g	Coordinates: 25°56'44.93"S 27°15'41.10"E
Crossing Type: Road crossing

Present Ecological State	C
Wetland type	River
Morphology	Wide, relatively shallow channel. Slow flowing water present at the site.
Riparian and in Stream Habitat	Instream habitat dominated by <i>Cyperus sexangularis</i> and <i>Typha capensis</i> .
Vegetation	<i>Conyza bonariensis</i> , <i>Cyperus sexangularis</i> , <i>Typha capensis</i> , <i>Bidens pilosa</i> , <i>Urochloa mosambicensis</i> , <i>Tithonia rotundifolia</i>
System Modifiers	Sewage effluent. Increased water input from the road. Waste dumping.
Potential impacts of water use on environment	The bridge crossing will not significantly negatively impact on the receiving environment.
Socio-economic impacts of water use	The bridge crossing will not significantly negatively impact on any water users.
Socio-economic advantages of water use	The bridge plays an important role in providing connectivity in the area, particularly to the local community, thereby allowing economic activity in the area

Potential impacts of water use on water resource	The bridge has been well-constructed with little to no incision apparent at the bridge tie-ins. Moderate alteration to streamflow patterns is anticipated as a result of the culverts and overgrown instream vegetation.
Summary of proposed impact on water use will have on other users	The bridge will not impact significantly on other water users.
Mitigation and Rehabilitation plan	Monitoring of erosion.

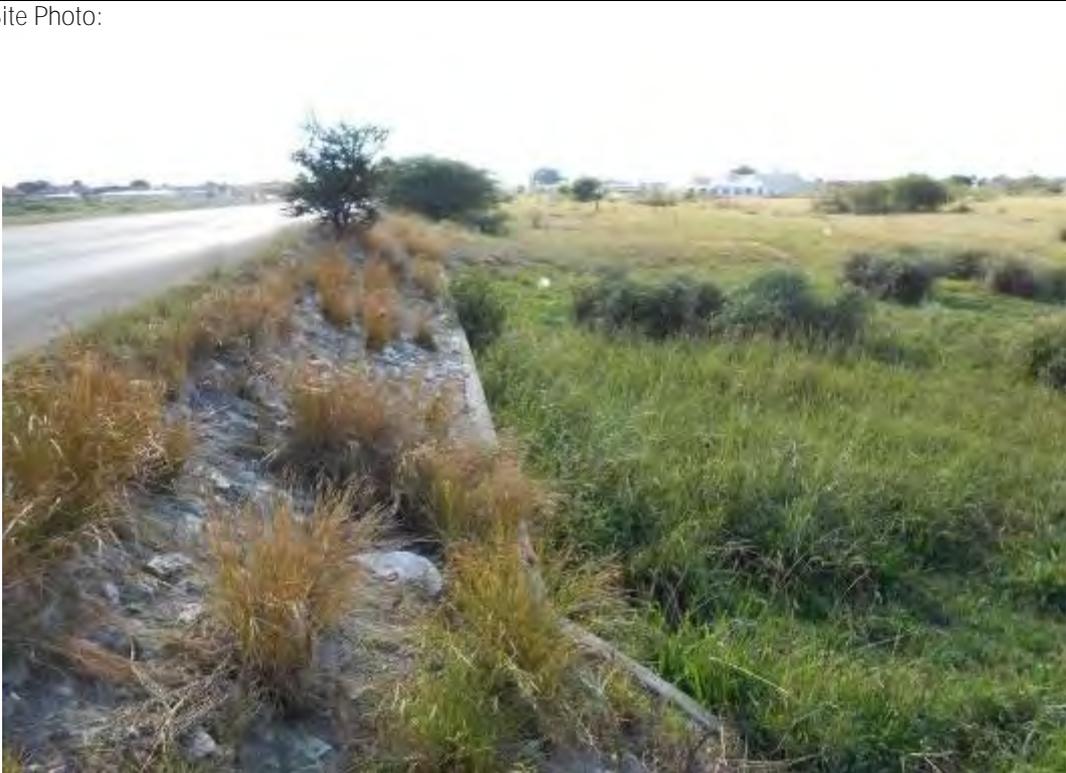
Site number: 34h	Coordinates: 25°35'43.76"S 27°15'40.05"E
Crossing Type: Road crossing culvert	
Site Photo:

Present Ecological State	C
Wetland type	River
Morphology	Wide, relatively shallow channel, mixture of alluvial sand. Dry river bed at the time of the study.
Riparian and in Stream Habitat	Dominated by bushveld vegetation. Instream ecology: riverbed dry at the time of the study and dominated by terrestrial species.
Vegetation	<i>Typha capensis</i> , <i>Cyperus sexangularis</i> , <i>Bidens pilosa</i> , <i>Persicaria lapathifolia</i>
System Modifiers	Increased water input due to the road crossing.
Potential impacts of water use on environment	The bridge crossing will not significantly negatively impact on the receiving environment.
Socio-economic impacts of water use	The bridge crossing will not significantly negatively impact on any water users.
Socio-economic advantages of water use	The bridge plays an important role in providing connectivity in the area, particularly to the local community, thereby allowing economic activity in the area

Potential impacts of water use on water resource	The bridge has been well-constructed with little to no incision apparent at the bridge tie-ins. Moderate alteration to streamflow patterns is anticipated as a result of the culverts and overgrown instream vegetation, however due to the ephemeral nature of the system, limited impact on the downstream users is expected.
Summary of proposed impact on water use will have on other users	The bridge will not impact significantly on other water users.
Mitigation and Rehabilitation plan	Monitoring of erosion.

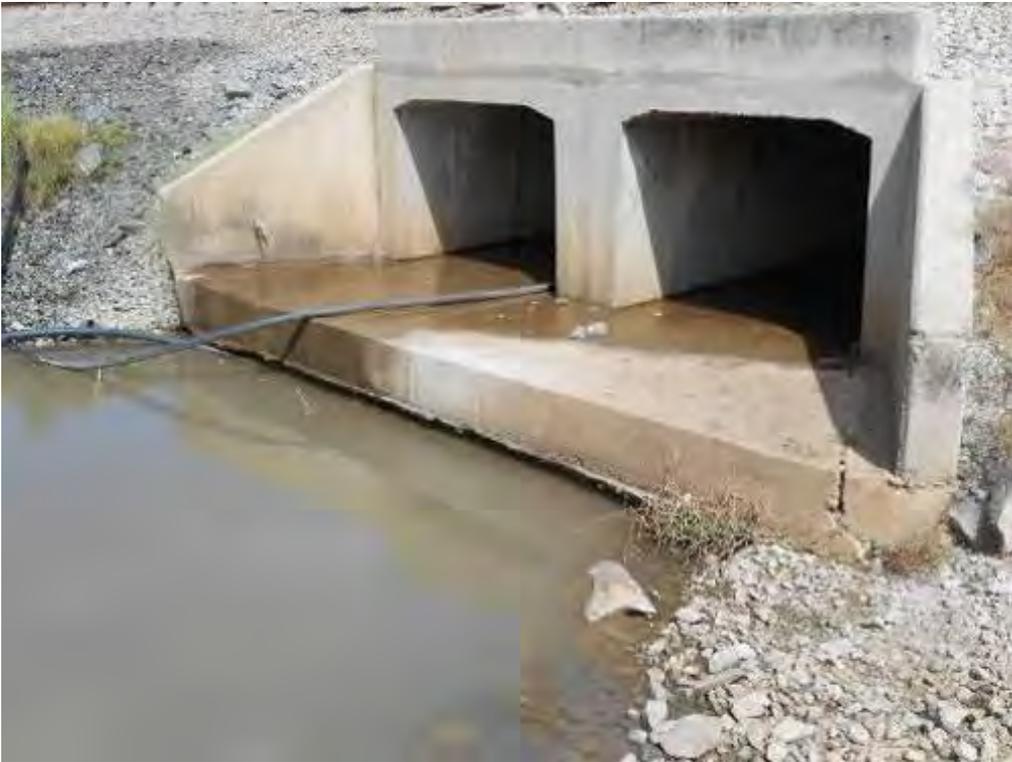
Site number: Site 35	Coordinates: 25°36'35.39"S 27°13'07.44"E
Crossing Type: Culvert/Railway	
Site Photo:

Present Ecological State	C
Wetland type	Non-perennial drainage line
Morphology	Wide, relatively deep channel, mixture of alluvial sand and gravel. Shallow pool present at the time of the assessment, unlikely to support any aquatic macro-invertebrates. .
Riparian and in Stream Habitat	Dominated by bushveld vegetation; alien vegetation component moderate. Instream ecology: shallow pool present at the time of the study with no instream vegetation present.
Vegetation	<i>Setaria sphacelata</i> , <i>Bidens pilosa</i> , <i>Cynodon dactylon</i> , <i>Acacia karroo</i>
System Modifiers	Burst leaking pipes. Erosion. Grazing. Alien invasion.
Potential impacts of water use on environment	Aquatic migratory barrier- during low flow periods.
Socio-economic impacts of water use	The railway culvert will not significantly negatively impact on any water users.

Socio-economic advantages of water use	The railway culvert plays an important role in providing connectivity in the area, particularly to the industrial sector, thereby allowing economic activity in the area
Potential impacts of water use on water resource	The railway culvert has been poorly-constructed with incision and erosion apparent at the bridge tie-ins. Moderate alteration to streamflow patterns is anticipated as a result of the culverts; scouring of the streambed evident.
Summary of proposed impact on water use will have on other users	The railway culvert will not impact significantly on other water users.
Mitigation and Rehabilitation plan	Invasive vegetation control. Erosion monitoring. Monitor pipes for leaks.

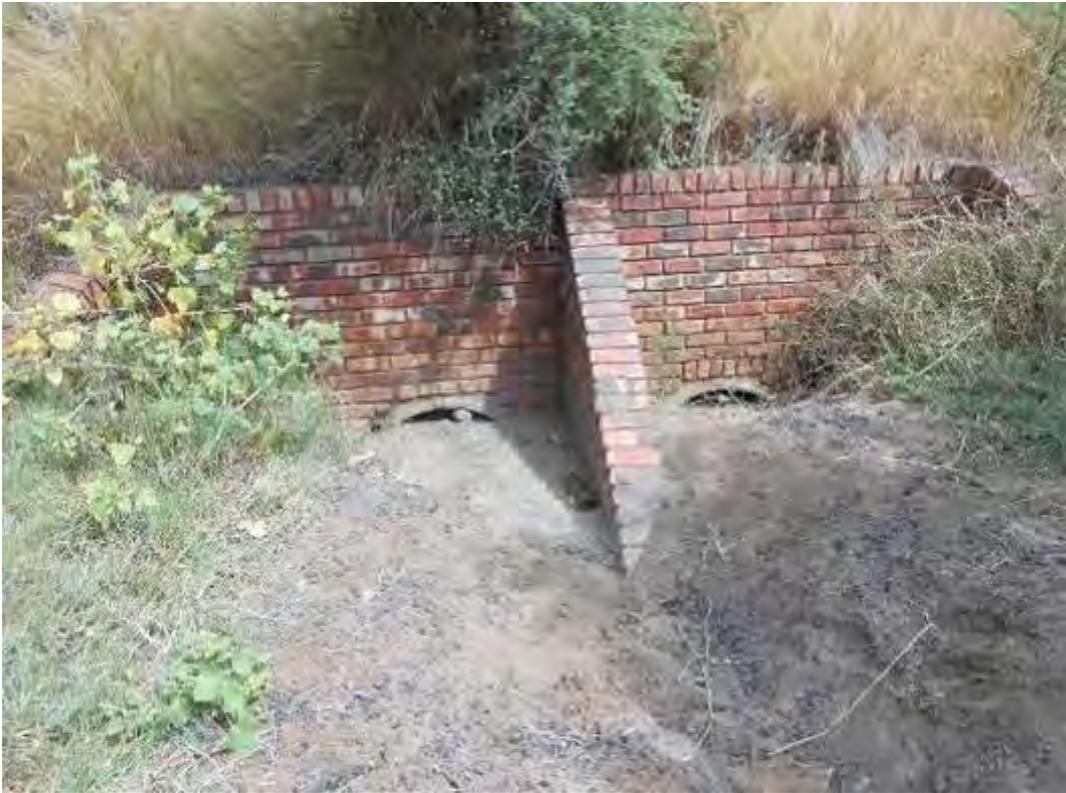
Site number: Site 35a	Coordinates: 25°36'42.81"S 27°13'01.83"E
Crossing Type: Culvert	
Site Photo:

Present Ecological State	E
Wetland type	Non-perennial drainage line
Morphology	Wide, relatively shallow channel, mixture of alluvial sand. Dry stream bed at the time of the assessment.
Riparian and in Stream Habitat	Dominated by bushveld vegetation. Instream ecology: streambed dry at the time of the study. Excessive sedimentation of the system.
Vegetation	<i>Asclepias fruticosa</i> , <i>Xanthium strumarium</i> , <i>Tagetes minuta</i> , <i>Melinis repens</i> , <i>Bidens pilosa</i> , <i>Cynodon dactylon</i>
System Modifiers	Clogged pipes. Erosion. Encroachment. Trampling by livestock, some alteration to streamflow patterns is anticipated due to the support structures placed in the channel.
Potential impacts of water use on environment	Unclog pipes to in order to restore instream flow patterns. The culvert will not significantly negatively impact on the environment, if the culvert is properly maintained.

Socio-economic impacts of water use	The culvert will not significantly negatively impact on any water users.
Socio-economic advantages of water use	The culvert will not significantly negatively impact on any water users.
Potential impacts of water use on water resource	Some streamflow alteration is anticipated high flow periods, however, due to the ephemeral nature of the stream it is unlikely to have a significant impact on downstream resources.
Summary of proposed impact on water use will have on other users	The culvert will not significantly negatively impact on any water users.
Mitigation and Rehabilitation plan	Erosion monitoring, alien vegetation monitoring. Unclog pipes to in order to restore instream flow patterns.

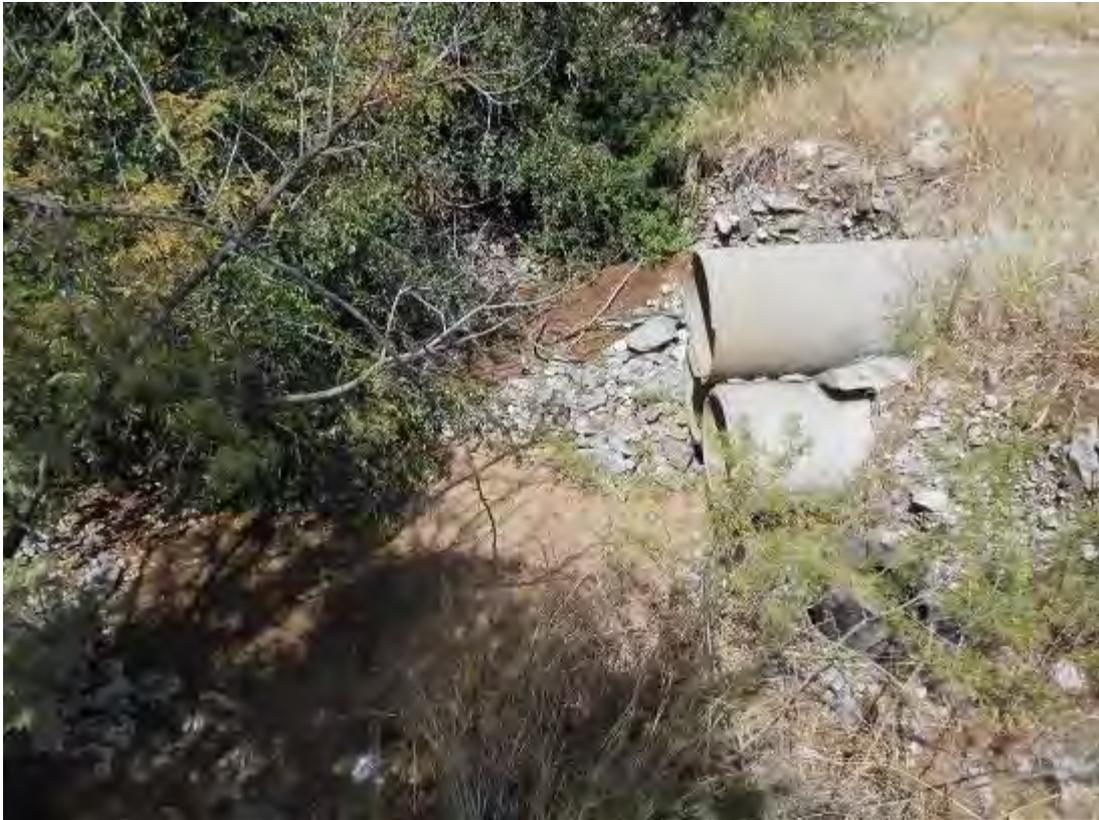
Site number: 35b	Coordinates: 25°36'28.32"S 27°13'13.8"E
Crossing Type: Road crossing/pipeline	
Site Photo:

Present Ecological State	D
Wetland type	Non-perennial drainage line
Morphology	Wide, relatively shallow channel, mixture of alluvial sand and bedrock. Dry riverbed at the time of the study.
Riparian and in Stream Habitat	Dominated by bushveld vegetation. Instream ecology: dry riverbed at the time of the assessment dominated by terrestrial species.
Vegetation	<i>Tagetes minuta</i> , <i>Melinis repens</i> , <i>Hyparrhenia hirta</i> . <i>Rhus lancea</i>
System Modifiers	Erosion. Encroachment
Potential impacts of water use on environment	The crossing will not significantly negatively impact on the environment.
Socio-economic impacts of water use	The culvert will not significantly negatively impact on any water users.
Socio-economic advantages of water use	The culvert plays an important role in providing connectivity in the area, particularly to the industrial sector, thereby allowing economic activity in the area

Potential impacts of water use on water resource	Some streamflow alteration may occur during high flow periods, however due to the ephemeral nature of the stream it is unlikely to have a significant impact on downstream resources.
Summary of proposed impact on water use will have on other users	The culvert will not significantly negatively impact on any water users.
Mitigation and Rehabilitation plan	Erosion monitoring. Alien vegetation monitoring. Build a proper culvert.

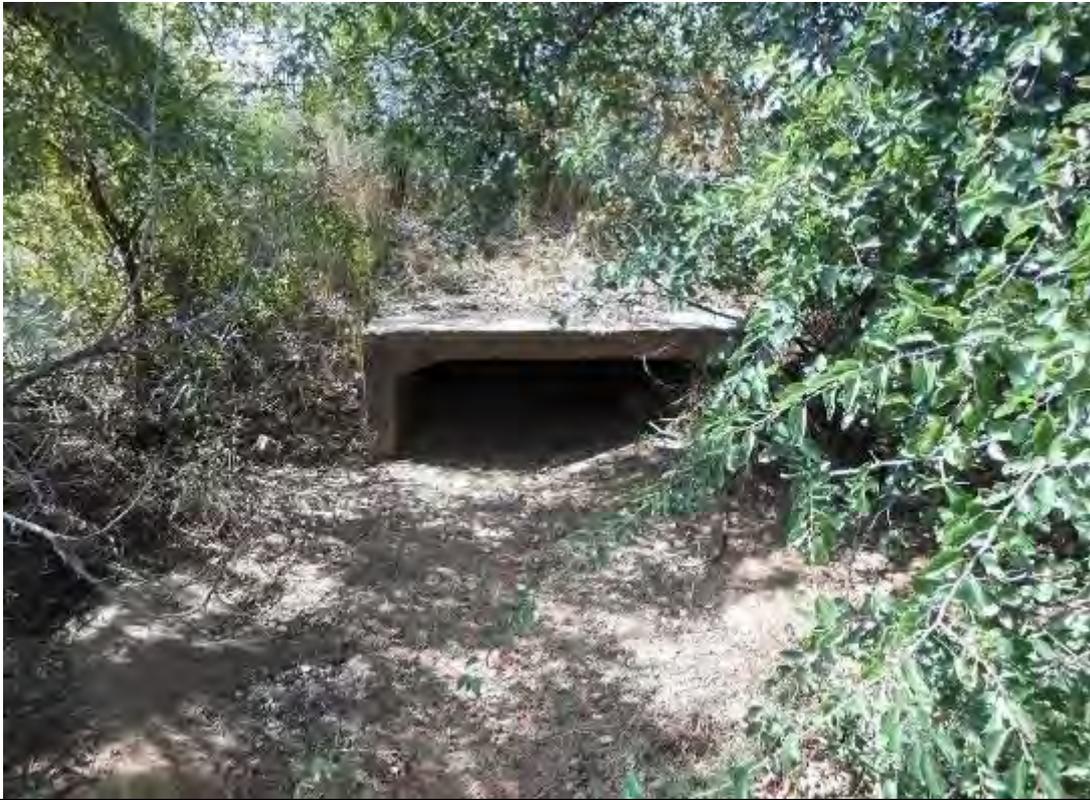
Site number: 36	Coordinates: 25°36'28.67"S 27°13'12.66"E
Crossing Type: Road crossing culvert	
Site Photo:

Present Ecological State	C
Wetland type	Non-perennial drainage line
Morphology	Wide, relatively shallow channel, mixture of alluvial sand. Dry river bed at the time of the assessment.
Riparian and in Stream Habitat	Dominated by bushveld vegetation. Instream ecology: riverbed dry at the time of the study. Excessive sedimentation of the system.
Vegetation	<i>Xanthium strumarium</i> , <i>Acacia karroo</i> , <i>Datura stramonium</i> , <i>Asclepias fruiticosa</i> , <i>Themeda triandra</i>
System Modifiers	Sedimentation. Erosion. Encroachment
Potential impacts of water use on environment	Unclog pipes to in order to restore instream flow patterns. The culvert will not significantly negatively impact on the environment, if the culvert is properly maintained.
Socio-economic impacts of water use	The culvert will not significantly negatively impact on any water users.

Socio-economic advantages of water use	The culvert plays an important role in providing connectivity in the area, particularly to the industrial sector, thereby allowing economic activity in the area.
Potential impacts of water use on water resource	Some streamflow alteration is anticipated high flow periods, however, due to the ephemeral nature of the stream it is unlikely to have a significant impact on downstream resources.
Summary of proposed impact on water use will have on other users	The culvert will not significantly negatively impact on any water users.
Mitigation and Rehabilitation plan	Monitoring of erosion. Alien vegetation monitoring. Unclog sediment from the culvert.

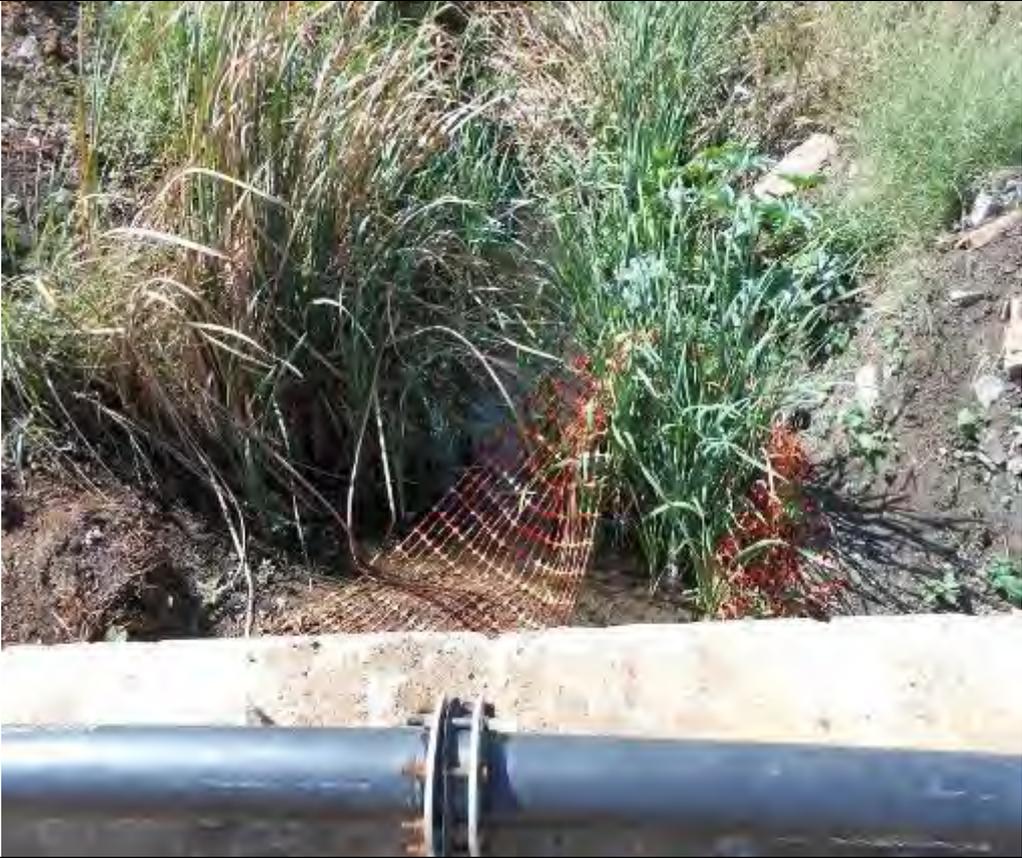
Site number: 36a	Coordinates: 25°37'30.69"S 27°13'48.20"E
Crossing Type: Road crossing

Present Ecological State	D
Wetland type	Non-perennial drainage line
Morphology	Narrow shallow channel
Riparian and in Stream Habitat	Instream ecology: channel vegetated.
Vegetation	<i>Ipomoea bolusiana</i> , <i>Persicaria lapathifolia</i> , <i>Asclepias fruticosa</i> , <i>Bidens pilosa</i> , <i>Cynodon dactylon</i> , <i>Melinis repens</i> , <i>Tagetes minuta</i> , <i>Morus alba</i> , <i>Datura stramonium</i> , <i>Sesbania sesban</i> , <i>Typha capensis</i> .
System Modifiers	Construction, stockpiling, Erosion
Potential impacts of water use on environment	The road crossing will not significantly negatively impact on the environment.
Socio-economic impacts of water use	The road crossing will not significantly negatively impact on any water users.
Socio-economic advantages of water use	The road is mainly used by mining vehicles.

Potential impacts of water use on water resource	The road will result in some alterations to streamflow patterns during flow periods; however these are not deemed to have a significant impact on downstream resources.
Summary of proposed impact on water use will have on other users	The road crossing will not impact significantly on other water users.
Mitigation and Rehabilitation plan	Provide hessian curtains to minimise erosion and sediment deposition.

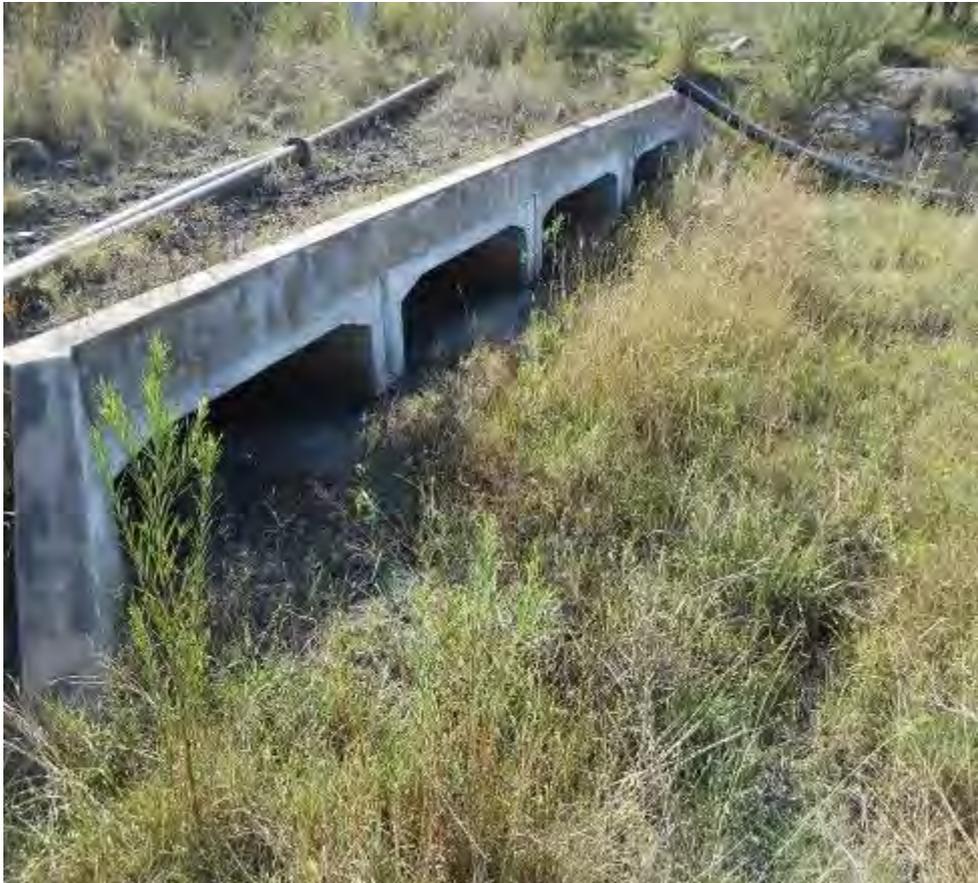
Site number: 37	Coordinates: 25°42'01.90"S 27°24'42.46"E
Crossing Type: Road culvert	
Site Photo:

Present Ecological State	C
Wetland type	River
Morphology	Wide, shallow channel. Dry river bed.
Riparian and in Stream Habitat	Dry at the time of the assessment.
Vegetation	<i>Asclepias fruiticosa</i> , <i>Brachiaria brizantha</i> , <i>Cynodon dactylon</i> , <i>Melinis repens</i> , <i>Tagetes minuta</i> , <i>Acacia karroo</i> , <i>Setaria sphacelata</i> , <i>Hyparrhenia hirta</i> , <i>Helichrysum aureonitens</i> , <i>Cyperus sexangularis</i>
System Modifiers	Grazing and trampling. Erosion. Culvert
Potential impacts of water use on environment	The road culvert will not significantly negatively impact on the environment.
Socio-economic impacts of water use	The road will not significantly negatively impact on any water users.
Socio-economic advantages of water use	The road will not significantly negatively impact on any water users.

Potential impacts of water use on water resource	The road culvert will result in some alterations to streamflow patterns during flow periods; however these are not deemed to have a significant impact on downstream resources.
Summary of proposed impact on water use will have on other users	The road will not impact significantly on other water users.
Mitigation and Rehabilitation plan	Control erosion.

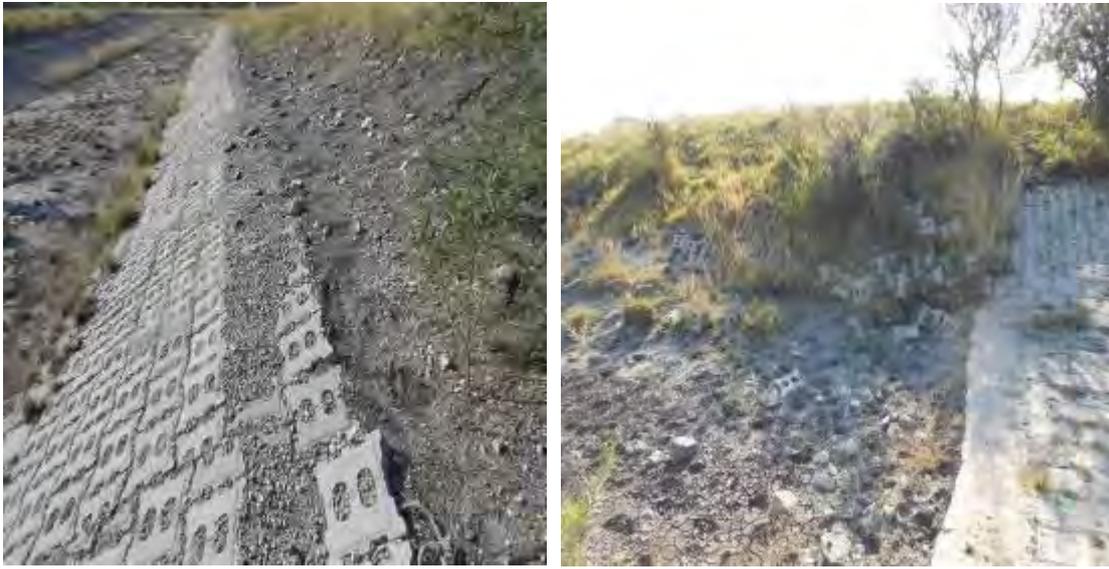
Site number: 38a/38b	Coordinates: 25°42'01.47"S 27°25'02.04"E - 25°42'10.61"S 27°24'56.85"E
Crossing Type: River diversion	
Site Photo:

Present Ecological State	C
Wetland type	River
Morphology	Wide, paved and shallow channel. Dry river bed.
Riparian and in Stream Habitat	Dry at the time of the assessment.
Vegetation	<i>Acacia karroo</i> , <i>Eragrostis curvula</i> , <i>Hyparrhenia hirta</i>
System Modifiers	Diversion, pavement, alien vegetation invasion, slight erosion on the diversion banks.
Potential impacts of water use on environment	The diversion will redirect the flow of water and cause drying up in areas where there used to be flowing water or water available to users.
Socio-economic impacts of water use	The diversion will result in lack of water in certain areas as a result of water not being able to flow to those areas.
Socio-economic advantages of water use	The diversion will not significantly negatively impact on any water users

Potential impacts of water use on water resource	Alterations to streamflow patterns during flow periods.
Summary of proposed impact on water use will have on other users	The diversion will impact water supply on other water users.
Mitigation and Rehabilitation plan	Control alien vegetation species.

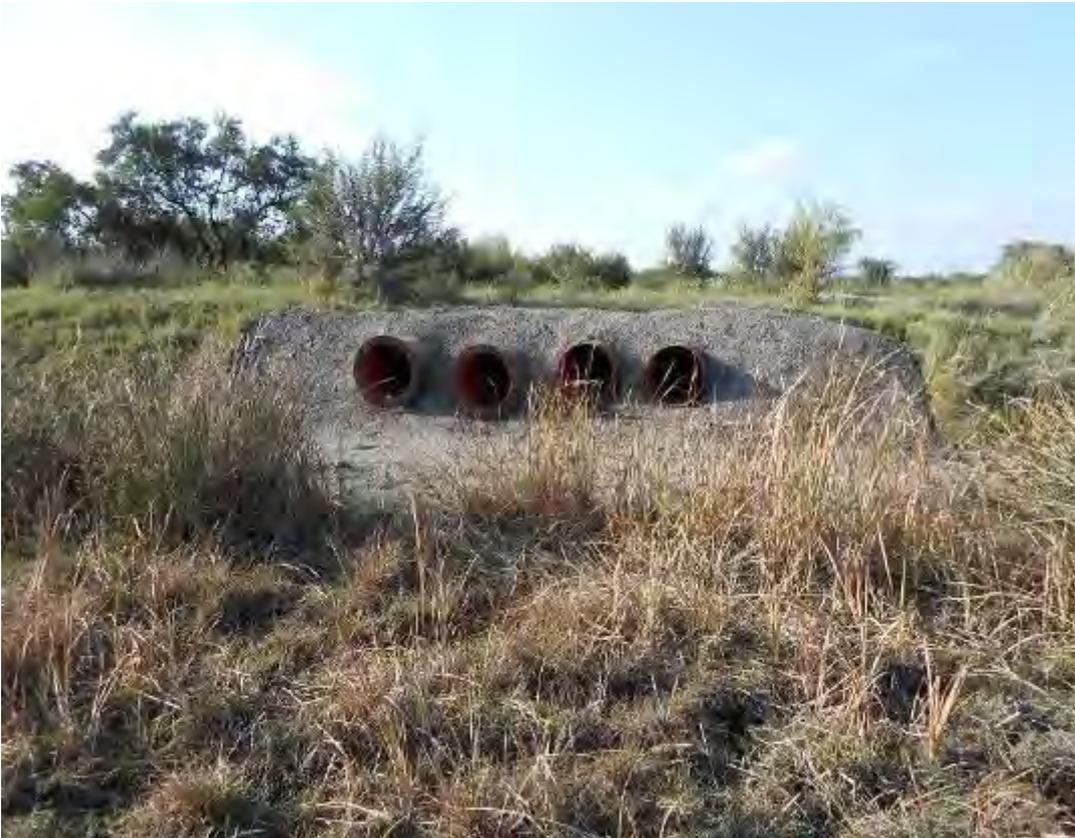
Site number: 38c	Coordinates: 25°42'14.56"S 27°24'50.81"E
Crossing Type: Road culvert/pipeline	
Site Photo:

Present Ecological State	C
Wetland type	River
Morphology	Wide, relatively shallow channel, Dry river bed.
Riparian and in Stream Habitat	<i>Acacia karroo</i> dominated the bushveld. Dry at the time of the assessment.
Vegetation	<i>Cyperus sexangularis</i> , <i>Conyza bonariensis</i> , <i>Melinis repens</i> , <i>Setaria sphacelata</i> , <i>Sesbania sesban</i> , <i>Verbena bonariensis</i> , <i>Themeda triandra</i> , <i>Acacia karroo</i>
System Modifiers	Road/pipeline increasing water input. Alien vegetation
Potential impacts of water use on environment	The road/pipeline crossing will not significantly negatively impact on the receiving environment.
Socio-economic impacts of water use	The road/pipeline will not significantly negatively impact on any water users.
Socio-economic advantages of water use	The road crossing is necessary for connectivity.

Potential impacts of water use on water resource	Since the road/pipeline is located adjacent a stream there will be no obstruction or impact on water flow. However, there might be increased water input coming through the pipes into the stream.
Summary of proposed impact on water use will have on other users	These structures will not impact significantly on other water users.
Mitigation and Rehabilitation plan	Control alien vegetation species.

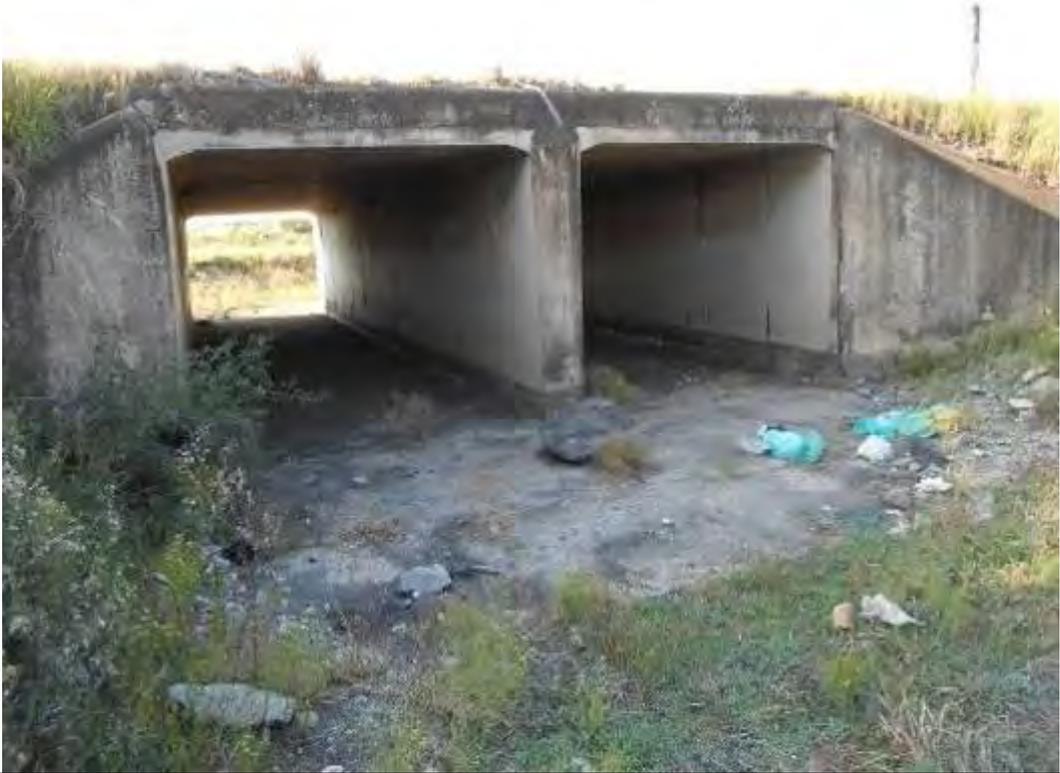
Site number: 39	Coordinates: 25°41'41.51"S 27°25'54.36"E
Crossing Type: Road culvert	
Site Photo:

Present Ecological State	C
Wetland type	River
Morphology	Wide, and diffuse. Dry river bed.
Riparian and in Stream Habitat	Dry at the time of the assessment.
Vegetation	<i>Sesbania sesban</i> , <i>Sporobolus pyramidalis</i> , <i>Helichrysum spp</i> , <i>Persicaria lapathifolia</i> , <i>Tagetes minuta</i>
System Modifiers	Culvert. Livestock grazing and trampling. Erosion.
Potential impacts of water use on environment	The road crossing will not significantly negatively impact on the environment.
Socio-economic impacts of water use	The road crossing will not significantly negatively impact on any water users.
Socio-economic advantages of water use	The road crossing plays an important role in providing connectivity in the area.
Potential impacts of water use on water resource	The road will result in increased runoff, the culvert will result in some alterations to streamflow patterns during flow periods; however these are not deemed to have a significant impact on downstream resources.

Summary of proposed impact on water use will have on other users	The road crossing will not impact significantly on other water users.
Mitigation and Rehabilitation plan	Control erosion, remove litter.

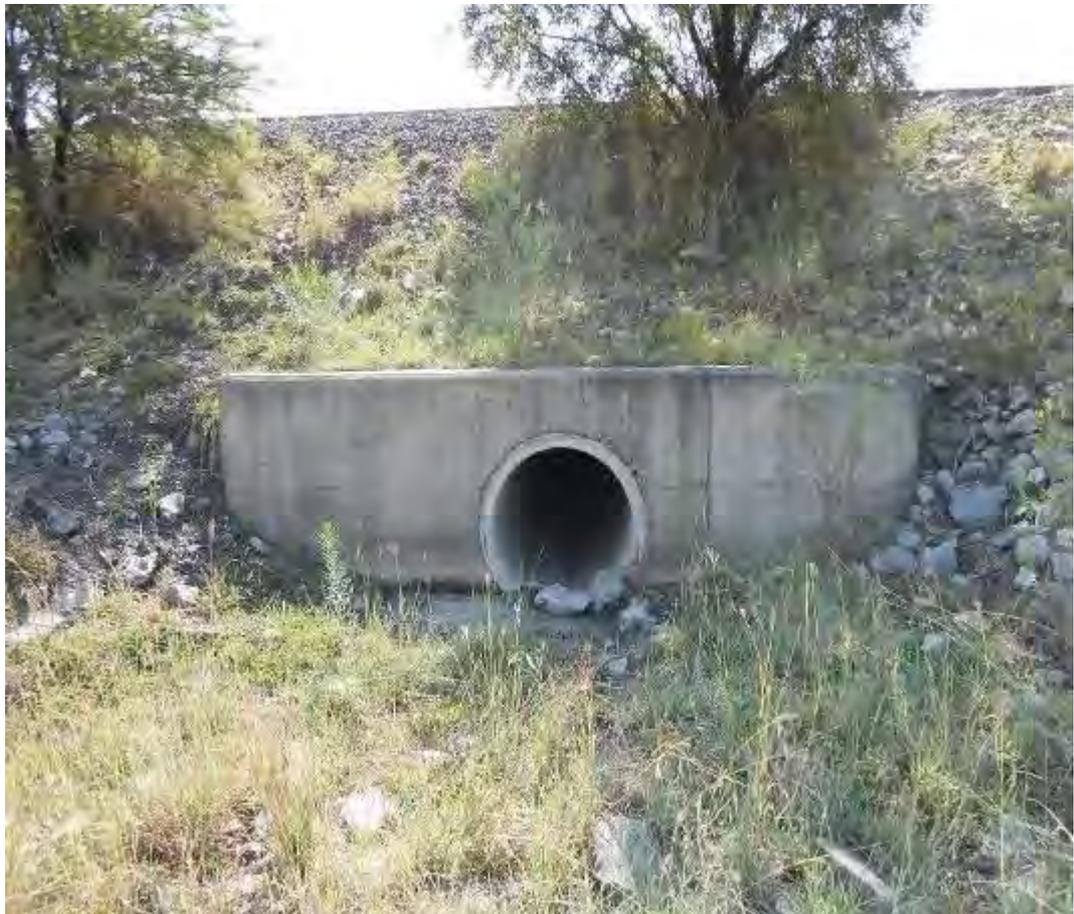
Site number: 40a	Coordinates: 25°40'52.00"S 27°24'20.43"E
Crossing Type: Railway culvert	
Site Photo:

Present Ecological State	C
Wetland type	River
Morphology	Very diffuse area. Dry river bed.
Riparian and in Stream Habitat	Mostly grass species dominating the area. Instream ecology: riverbed dry at the time of the study.
Vegetation	<i>Chloris virgata</i> , <i>Melinis repens</i> , <i>Setaria sphacelata</i> , <i>Asclepias fruticosa</i>
System Modifiers	Erosion.
Potential impacts of water use on environment	The railway crossing will not significantly negatively impact the environment.
Socio-economic impacts of water use	The railway crossing will not significantly negatively impact on any water users.
Socio-economic advantages of water use	The railway crossing will not significantly negatively impact on any water users.
Potential impacts of water use on water resource	Alterations to water flow patterns during flow periods; however these are not deemed to have a significant impact on downstream resources.

Summary of proposed impact on water use will have on other users	The railway crossing will not impact significantly on other water users.
Mitigation and Rehabilitation plan	Monitor erosion.

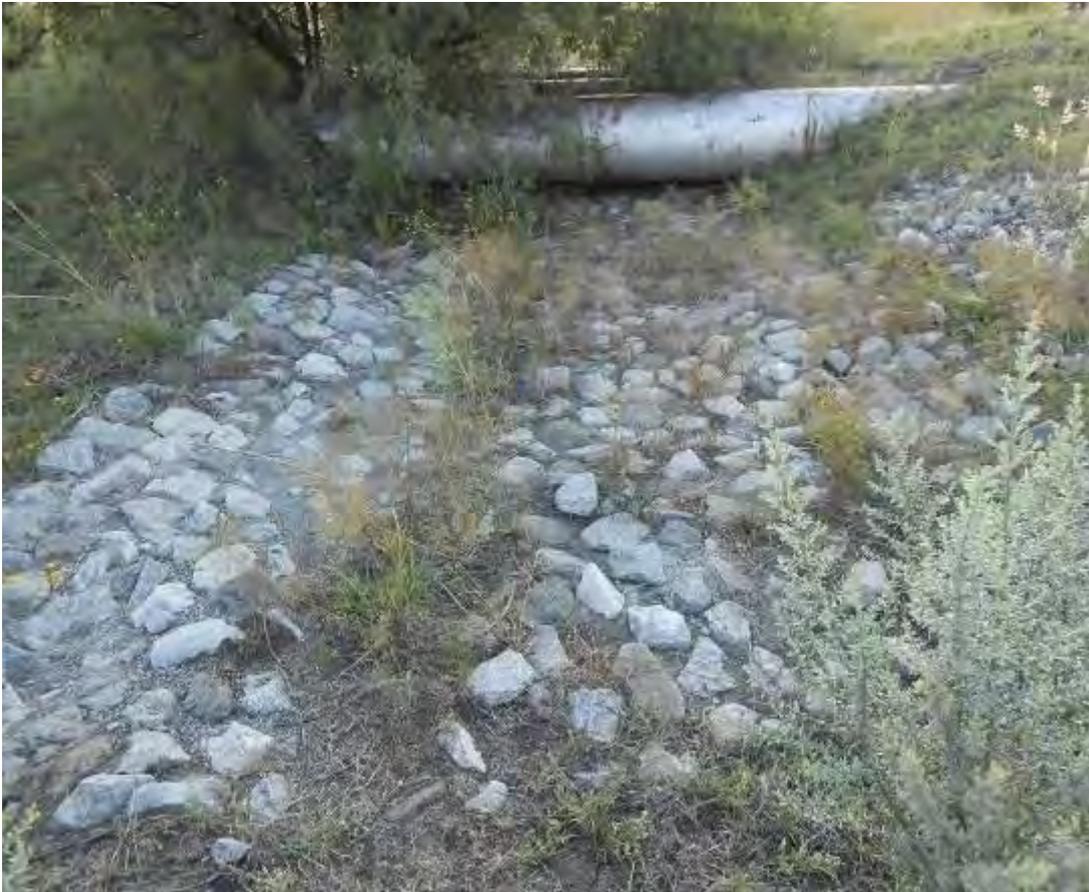
Site number: 40c	Coordinates: 25°42'11.92"S 27°24'24.54"E
Crossing Type: Pipeline	
Site Photo:

Present Ecological State	C
Wetland type	River
Morphology	Narrow, shallow channel. Dry river bed.
Riparian and in Stream Habitat	Dry at the time of the assessment. Alien vegetation within the stream channel.
Vegetation	<i>Flaveria bidentis</i> , <i>Conyza bonariensis</i> , <i>Hyparrhenia hirta</i> , <i>Asclepias fruiticosa</i>
System Modifiers	Pipes obstructing water flow
Potential impacts of water use on environment	The pipeline will not significantly negatively impact on the receiving environment: provided it is adequately maintained.
Socio-economic impacts of water use	The pipeline is very low/ close to the ground, therefore it will obstruct water flow during heavy rainfall events.
Socio-economic advantages of water use	The pipeline will not significantly negatively impact on water users.
Potential impacts of water use on water resource	The presence of the pipeline as well as rocks within the channel will alter water flow patterns during flow periods.

Summary of proposed impact on water use will have on other users	The pipeline will not impact significantly on other water users.
Mitigation and Rehabilitation plan	The pipes should in fact be underground so that it doesn't inhibit the flow of water.

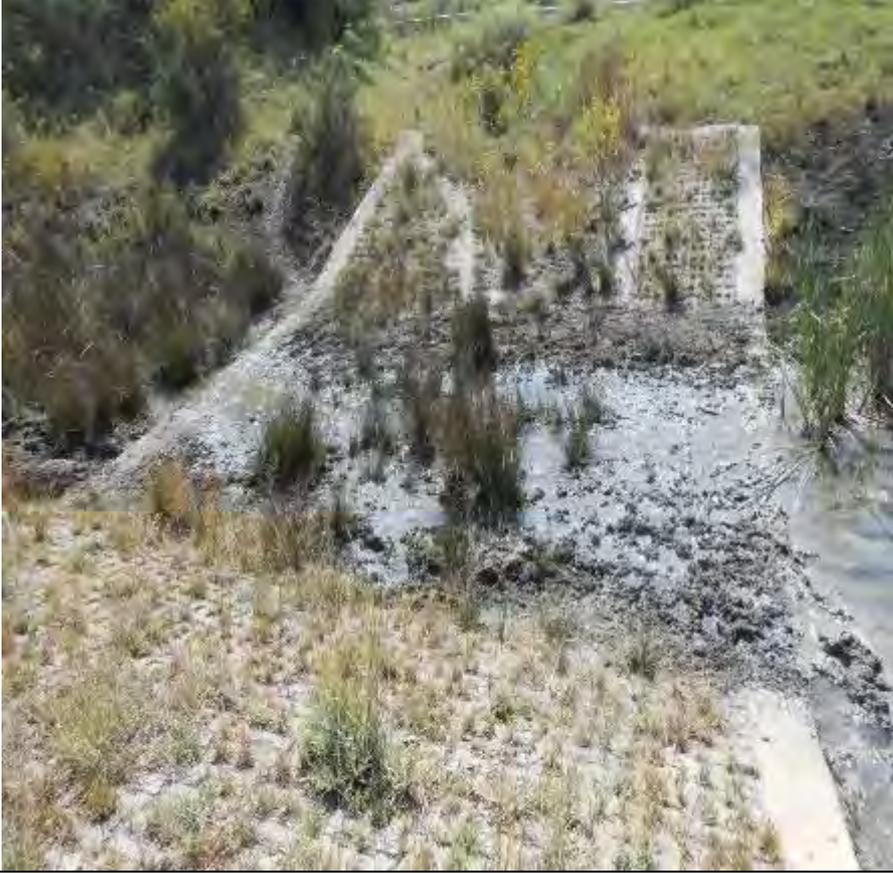
Site number: 40d-40h	Coordinates: 25°40'52.00"S 27°24'20.43"E - 25°40'17.92"S 27°25'51.60"E
Crossing Type: Diversion	
Site Photo:

Present Ecological State	C
Wetland type	River
Morphology	Wide, shallow paved channel
Riparian and in Stream Habitat	Acacia spp dominated the bushveld.
Vegetation	<i>Heteropogon contortus</i> , <i>Bothriochloa insculpta</i> , <i>Andropogon eucomus</i> , <i>Themeda triandra</i> , <i>Setaria sphacelata</i> , <i>Conyza bonariensis</i> , <i>Asclepias fruticosa</i> ,
System Modifiers	Eroded banks where there's a culvert. Trampling and grazing.
Potential impacts of water use on environment	The diversion will redirect the flow of water and cause drying up in areas where there used to be flowing water or water available to users.
Socio-economic impacts of water use	The diversion will result in lack of water in certain areas as a result of water not being able to flow to those areas.

Socio-economic advantages of water use	The diversion will not significantly negatively impact on any water users
Potential impacts of water use on water resource	Alterations to streamflow patterns during flow periods.
Summary of proposed impact on water use will have on other users	The diversion will impact water supply on other water users.
Mitigation and Rehabilitation plan	Monitor erosion.
