**WETLAND DELINEATION IN THE RUSTENBURG
PLATINUM MINE PROJECT AREA AND A HIGH
LEVEL ASSESSMENT OF SELECTED RIVER
CROSSINGS, NORTH-WEST PROVINCE**

SRK Consulting (Pty) Ltd

May 2015

Prepared by:	Scientific Aquatic Services
Report author:	M. Aphane
Report Reviewer	S. van Staden (Pri. Sci. Nat)
Report Reference:	SAS 215053
Date:	May 2015

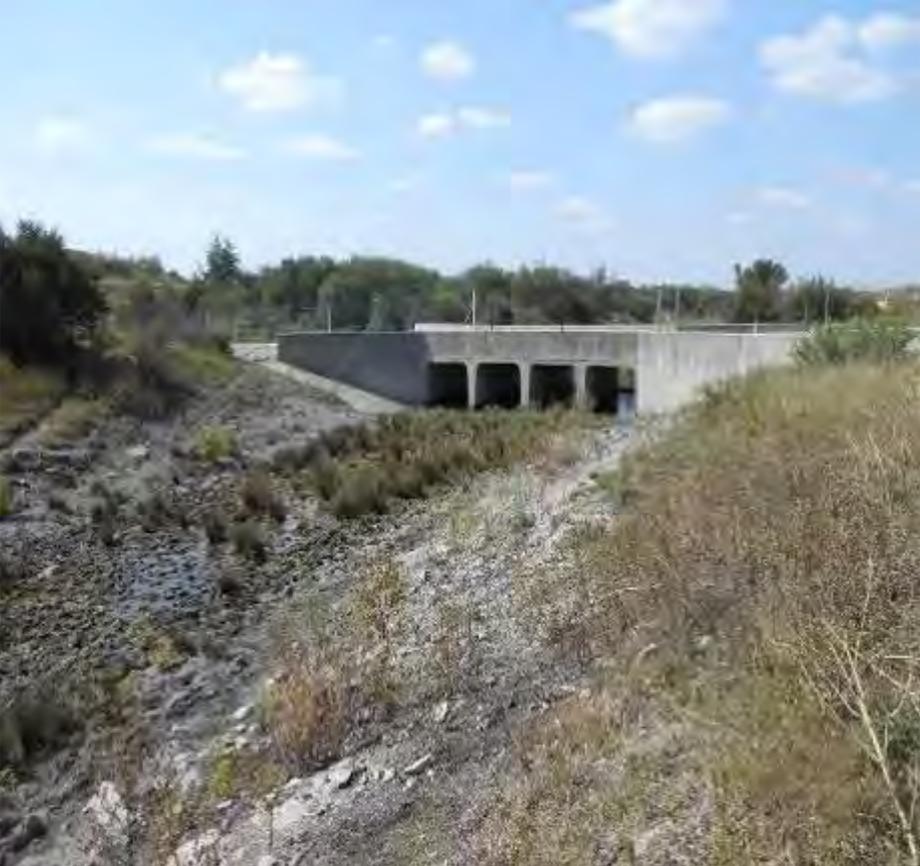
Site number: 40e	Coordinates: 25°40'55.27"S 27°24'49.78E
Crossing Type: Road culvert	
Site Photo:

Present Ecological State	C
Wetland type	River
Morphology	Wide, shallow channel. Dry river bed. The channel has been artificially paved.
Riparian and in Stream Habitat	<i>Dichrostachys</i> dominated bushveld vegetation. Instream ecology: riverbed dry at the time of the study.
Vegetation	<i>Sesbania sesban</i> , <i>Flaveria bidentis</i> , <i>Setaria sphacelata</i> , <i>Asclapias fruticosa</i> , <i>polygala hottentota</i> , <i>Themeda triandra</i> , <i>Melinis repens</i> , <i>Brachiaria brizantha</i>
System Modifiers	Erosion. Runoff from the adjacent development deposits sediment into the feature since the banks are unvegetated.
Potential impacts of water use on environment	The road crossing will not significantly negatively impact on any water users.
Socio-economic impacts of water use	The road crossing will not significantly negatively impact on any water users.

Socio-economic advantages of water use	The road crossing is necessary for providing connectivity in the area.
Potential impacts of water use on water resource	The paved channel as well as the culvert have altered water flow patterns.
Summary of proposed impact on water use will have on other users	The road crossing will not impact significantly on other water users.
Mitigation and Rehabilitation plan	Monitor erosion.

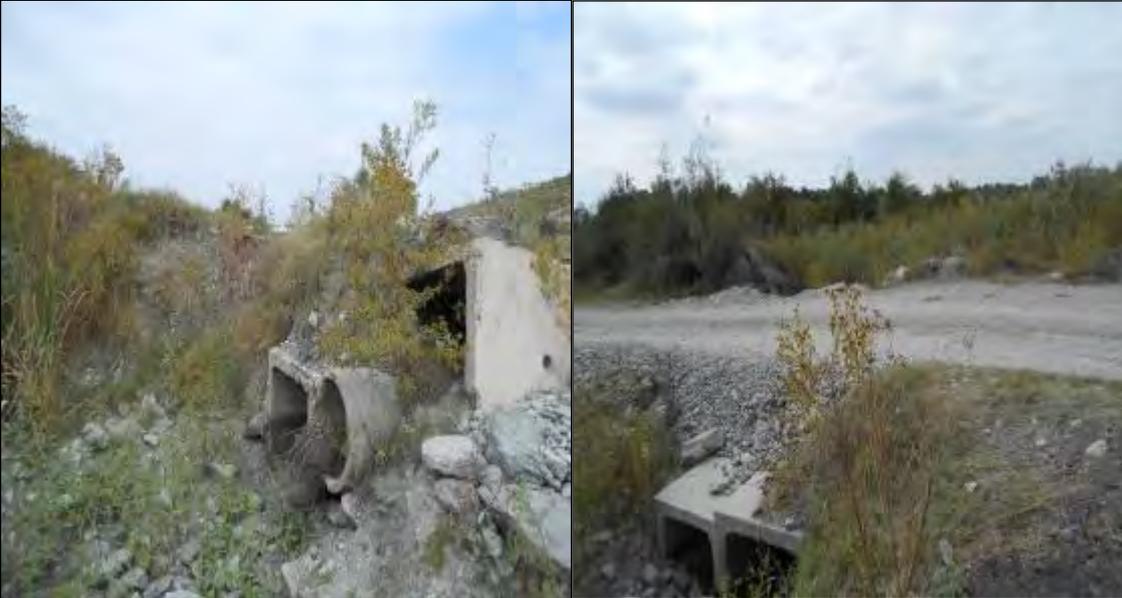
Site number: 41	Coordinates: 25°39'54.60"S 27°19'51.80"E
Crossing Type: Road crossing	
Site Photo:

Present Ecological State	C
Wetland type	River
Morphology	Narrow, shallow channel. Dry river bed.
Riparian and in Stream Habitat	Riverbed dry at the time of the study.
Vegetation	<i>Acacia karroo</i> , <i>Cynodon dactylon</i> , <i>Conyza bonariensis</i> , <i>Phragmites australis</i> , <i>Flaveria bidentis</i> <i>Bothriochloa insculpta</i>
System Modifiers	Partially collapsed culvert. Erosion. Stockpiling.
Potential impacts of water use on environment	The road crossing will not significantly negatively impact on any water users.
Socio-economic impacts of water use	The road crossing will not significantly negatively impact on any water users.
Socio-economic advantages of water use	The road crossing plays a role in providing connectivity in the area thereby allowing economic activity in the area.
Potential impacts of water use on water resource	The culvert is very low and it might constrict water flow during heavy rainfall events.

Summary of proposed impact on water use will have on other users	The road crossing will not impact significantly on other water users.
Mitigation and Rehabilitation plan	Reconstruct the collapsed culvert. Insert erosion control berms. Control alien vegetation species.

- Collapsed culverts must be reconstructed immediately to enhance and maintain the flow of water as well as migration corridors;
- Implement effective waste removal measures below culverts and along streams to avoid further deterioration of water quality within streams;

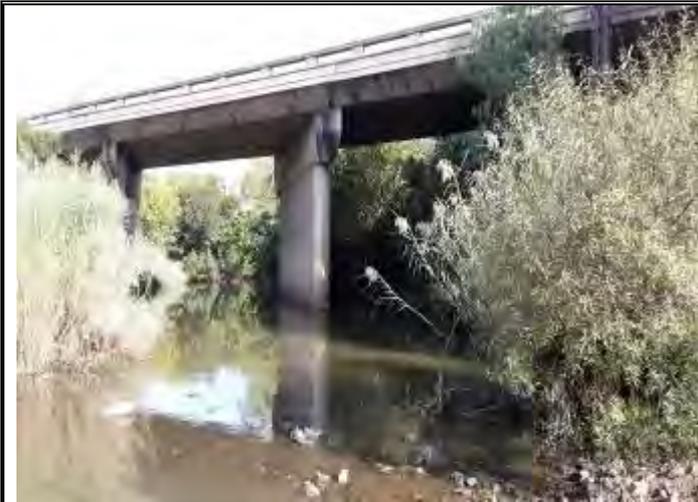
Figure 47: Upstream view of the SASS 22 site indicating the low flow at the time of the assessment.

- The upstream (SASS 22) and downstream (SASS 29) sites of the Hex River may be considered to be in a Class E/F (severely impaired) condition according to the Dallas (2007) classification system. Both sites can be classified as a Class E (seriously impaired) conditions according to the Dickens & Graham (2001) classification system. Site SASS 26 can be considered as Class D (largely impaired) according to the Dallas (2007) classification, and as a Class C (moderately impaired) condition according to the Dickens & Graham (2001) classification system. Site SASS 27A can be considered as Class C (moderately impaired) according to the Dallas (2007) classification, and as a Class B (largely natural) condition according to the Dickens & Graham (2001) classification system;

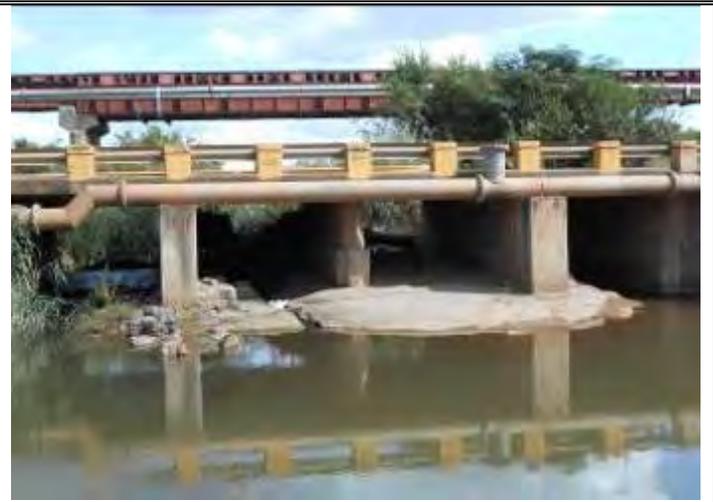
Figure 48: Upstream view of the SASS 26 site indicating the turbid water present at the time of the assessment.

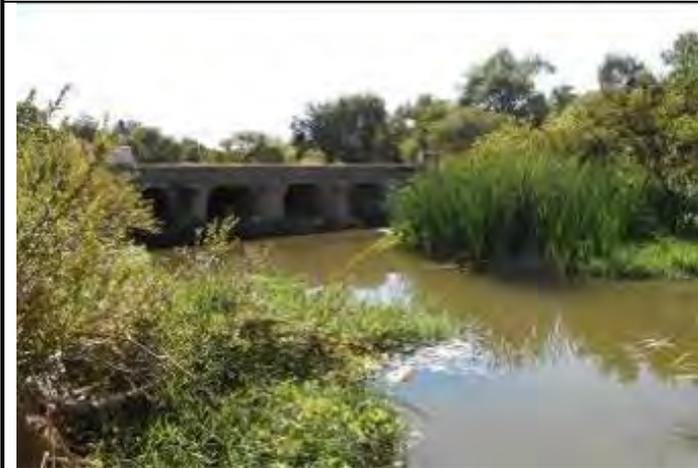
Figure 49: Downstream view of the SASS 27A site indicating the presence of turbid water at the time of the assessment.

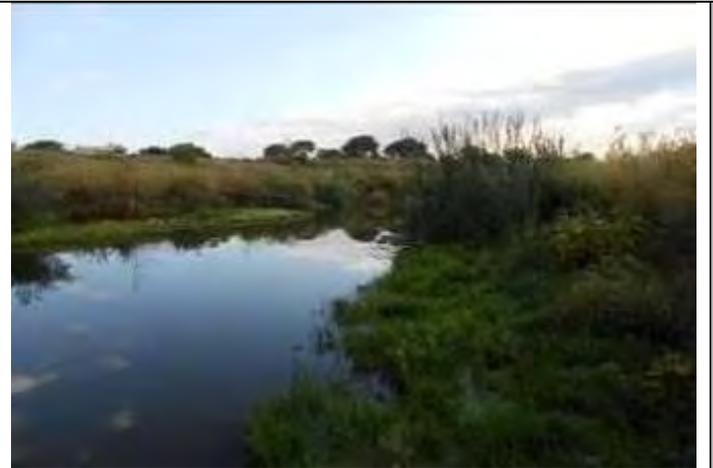
Figure 50: Downstream view of the SASS 29 site indicating the presence of abundant aquatic vegetation at the time of the assessment.

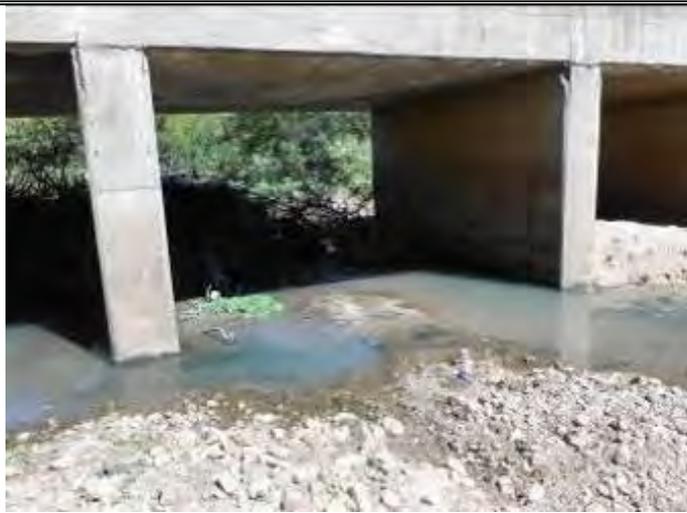
Figure 51: Upstream view of the SASS 31 site indicating the low flow and discoloured water at the time of the assessment likely due to presence of untreated sewage effluent.

- Both the upstream (SASS 31) and downstream (SASS 32) sites of the Dorpspruit may be considered to be in a Class E/F (severely impaired) condition according to the Dallas (2007) classification system. Both sites can be classified as a Class E (seriously impaired) conditions according to the Dickens & Graham (2001) classification system.

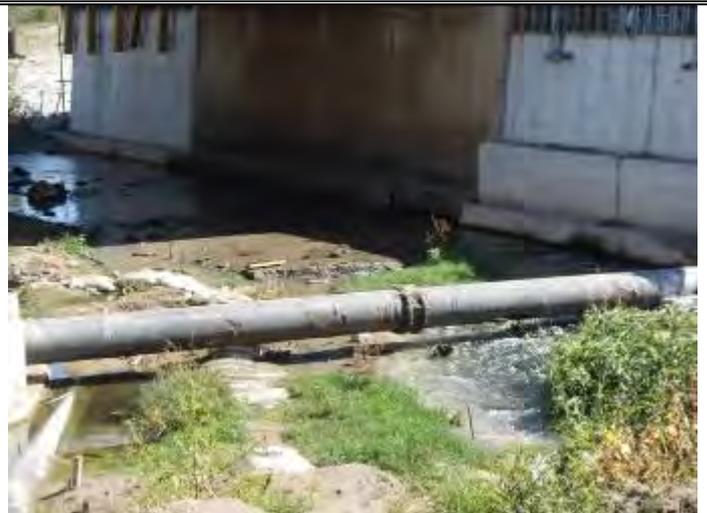
Figure 52: Upstream view of the SASS 32 site indicating the low flow present at the time of the assessment.

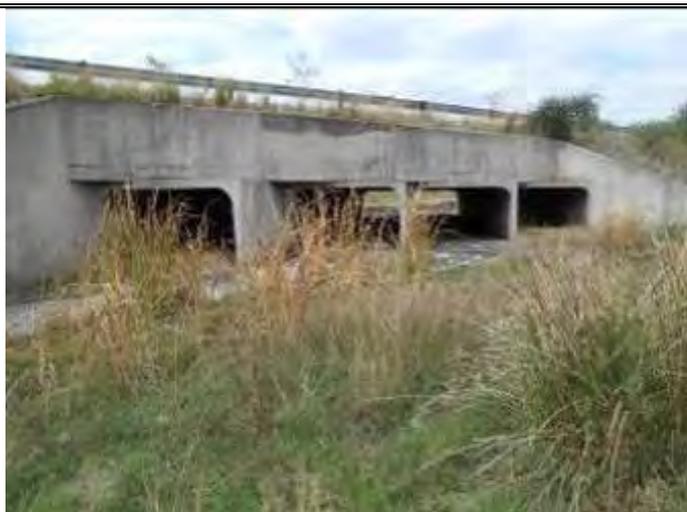
Figure 53: Local view of the SASS 4 site indicating the lack of flow at the time of the assessment.

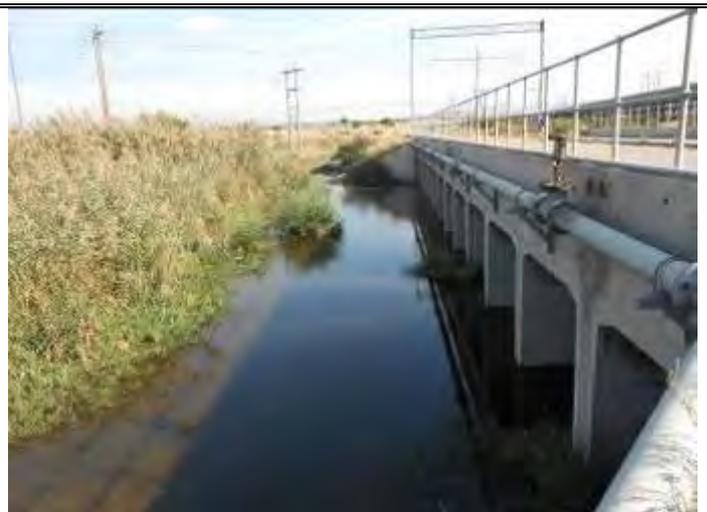
Figure 54: Downstream view of the SASS 9 site indicating the low flows and turbid water present at the time of the assessment.

- The EC value at site SASS 9 is critically elevated from natural conditions and is the highest EC recorded at the time of the assessment. It is possible that the run-off from the UG2 Concentrator and surrounding RPM activities are reaching the Klipfonteinspruit;

- The SASS 9 site of the Klipfonteinspruit may be considered to be in a Class C (moderately impaired) condition according to the Dallas (2007) classification system. The site can be classified as a Class C (moderately impaired) conditions according to the Dickens & Graham (2001) classification system;

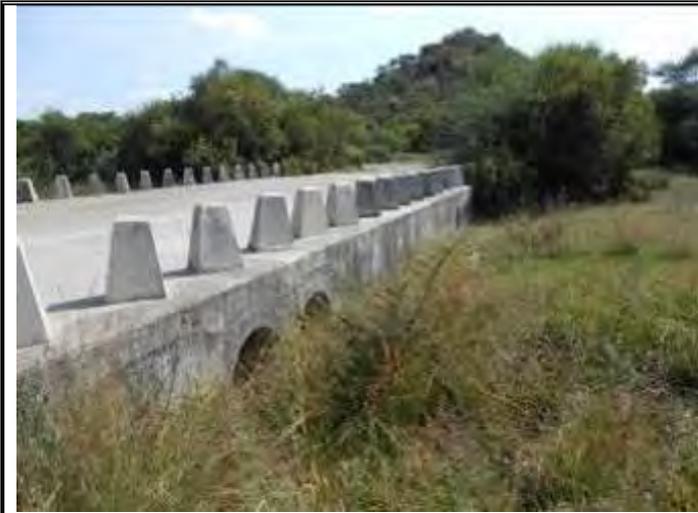
Figure 55: Local view of the SASS 19 site indicating the lack of flow at the time of the assessment.

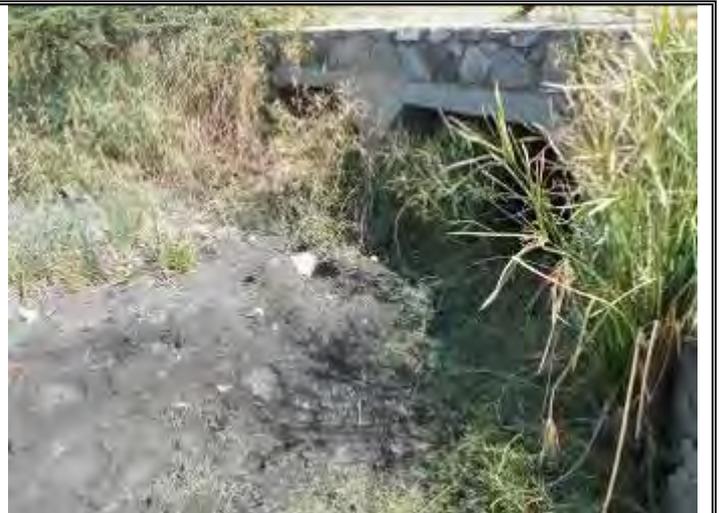
Figure 56: Downstream view of the SASS 15 site indicating the lack of flow at the time of the assessment.

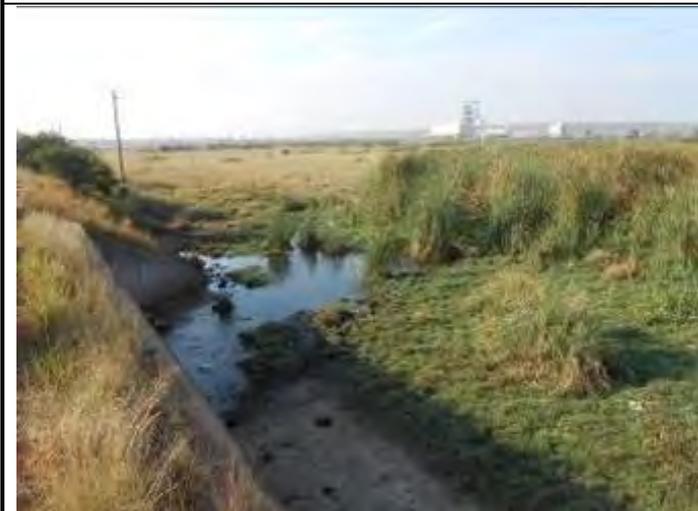
Figure 57: Upstream view of the SASS 21 site indicating the low flow at the time of the assessment.

- The EC recorded at site SASS 21 is elevated from natural conditions, indicating that dissolved salts are entering the system. Run-off and/or seepage from the

- The SASS 21 site of the Paardekraalspruit may be considered to be in a Class D (largely impaired) condition according to both the Dallas (2007) and Dickens & Graham (2001) classification systems.

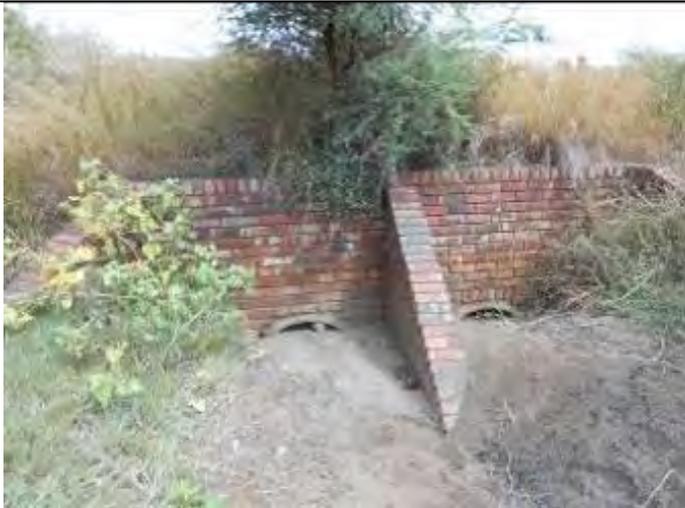
Figure 58: Upstream view of the SASS 35A site located on the Wildebeesfonteinspruit. The site was dry at the time of the assessment and culverts largely silted up.

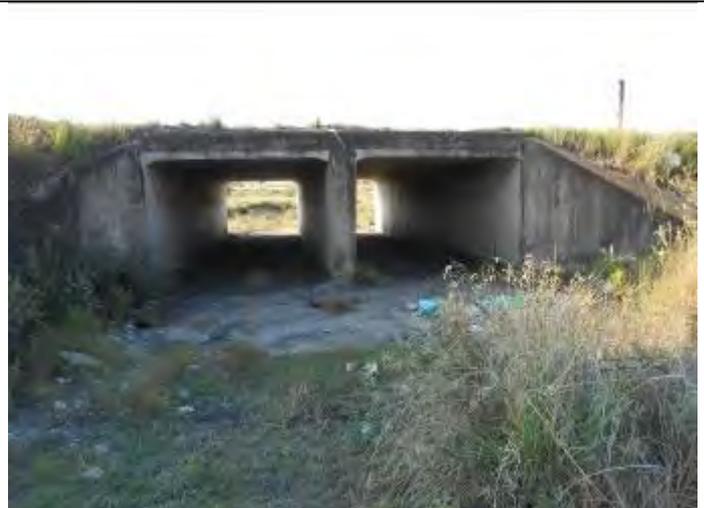
Figure 59: Downstream view of the SASS 39 site located on the Brakspruit. The site was dry at the time of the assessment.

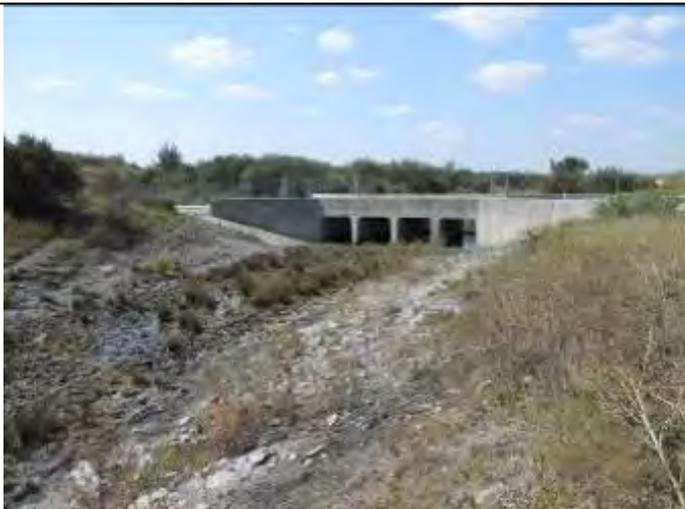
Figure 60: Upstream view of the SASS 40E located on the Hoedspruit. The site was dry at the time of the assessment.

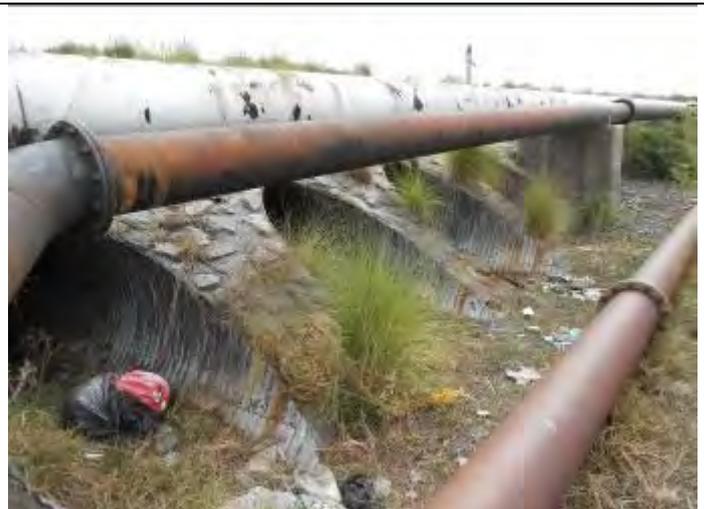
Figure 61: Downstream view of the SASS 12A site located on the Klippgatspruit. The site was dry at the time of the assessment.

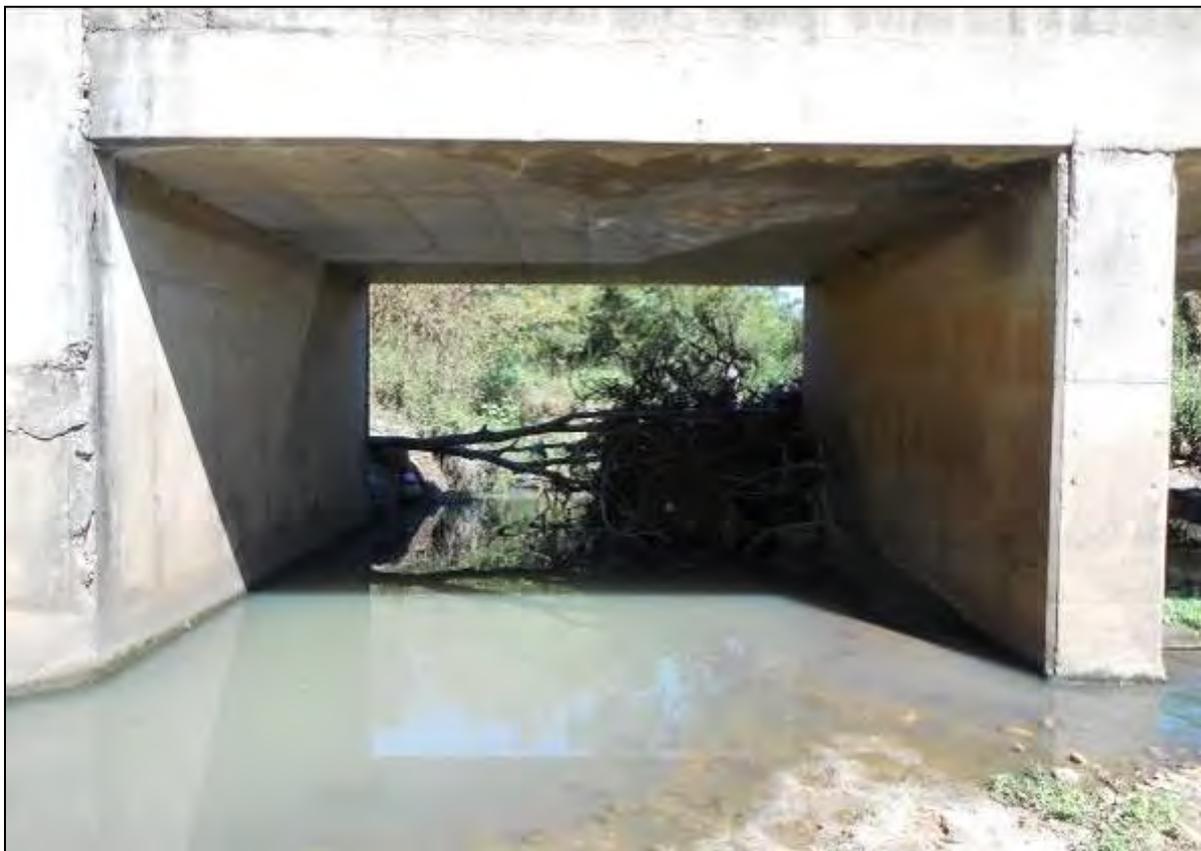
Large, woody debris is an important component of stream ecosystems. Where crossing structures restrict the ability of woody debris to pass downstream, crossings can inhibit or prevent the formation of natural debris dams and deflectors that are important habitat features for fish and wildlife, and play an important role in shaping channel characteristics.

Figure 70: Blockages present at monitoring sites, restricting movement of debris downstream.

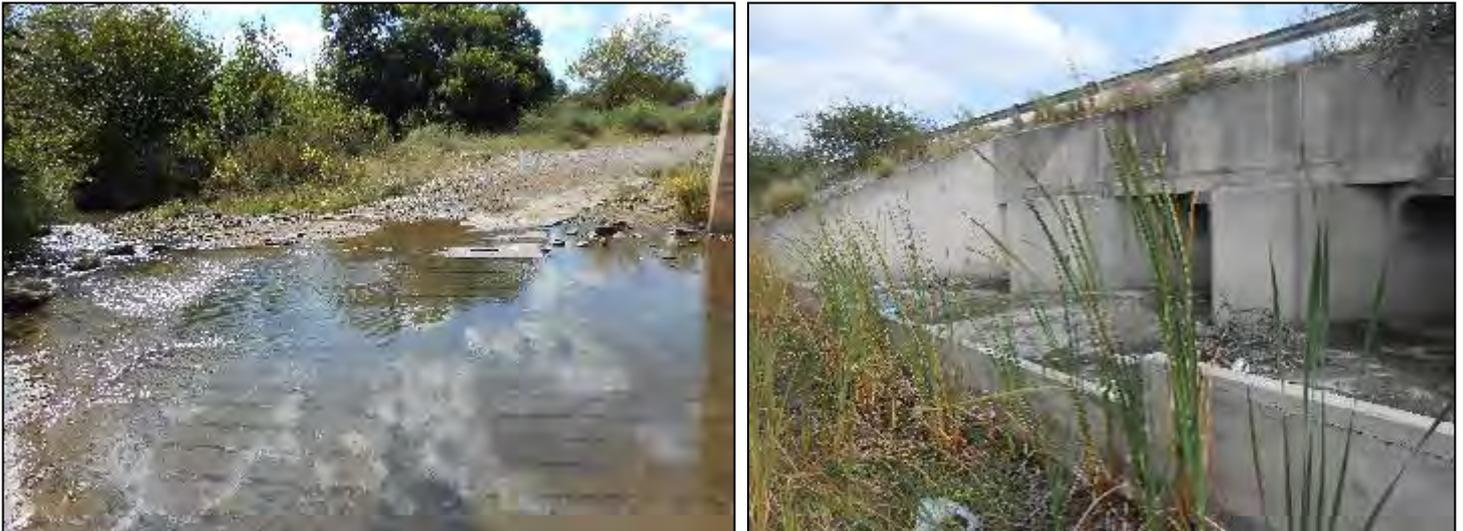
Figure 72: Discontinuity of natural stream substrate and physical migration barriers present at monitoring sites.

- Any areas where bank failure is observed, due to the effects of bridge crossings, should be immediately repaired by reducing the gradient of the banks to a 1:3 slope and where deemed necessary, installing support structures;

- Clear out any overgrown or alien vegetation reducing the flow of water within the watercourse; and
- Conduct regular inspections to maintain the overall conditions of the crossing structures.
