Slope failure at the Paraná shoreline, Argentina

Alejo O. Sfriso

Juan Larrague

A 80000 m², 3.5 m high embankment for a container yard was constructed on the right margin of the Paraná de las Palmas River in Zárate, Argentina. An additional temporary embankment, 3.5 m high, was put on top of it to speed up the consolidation process of underlying soft Postpampeano clays and organic soils. The construction of the preload embankment took about four months. The preload was delayed in a small area of 6000 m² because of harbour activities. Several months later, and using the same equipment, the contractor completed the preload embankment of this small area within ten days. One day after completion of the preload, a massive slope failure occurred. In this paper, the results of the analyses of the slope failure, the remediation action undertaken and some comments on the behavior of the soils at the Paraná shoreline are presented.

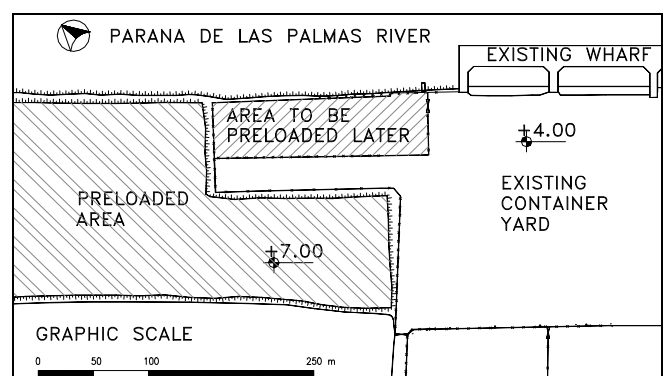
A 80000 m², 3.5 m high preload embankment (PE) was put on top of the permanent fill for ground improvement purposes. Because of operational requirements of the terminal, the PE construction was delayed in a 6000 m² area, just beside of the existing yards and wharf, as shown in Figure 1.

Figure 1. Plan sketch of the project.

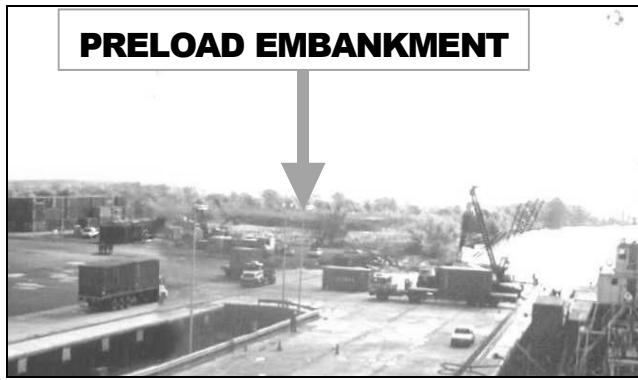
Figure 2 shows a view of the preloaded area as it could be seen from the existing wharf. The embankment area not preloaded at the first stage is at the center of the picture.

Figure 2. Preload embankment as seen from the wharf.

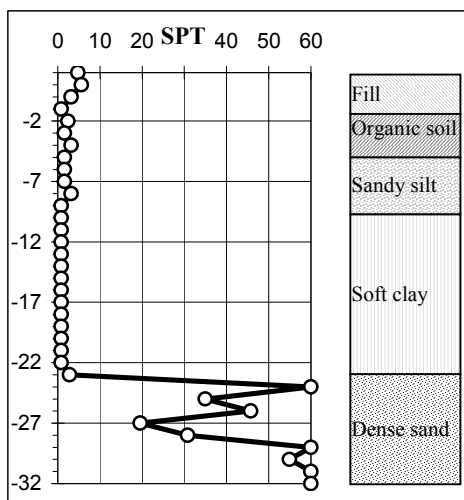
Figure 3 shows a typical boring log, obtained after completion of the permanent fill and before placement of the preload embankment.

Figure 3. Boring log and soil profile.
