Skoenmakers River Maintenance

River rehabilitation

DRAFT REPORT Rev 1

June 2015

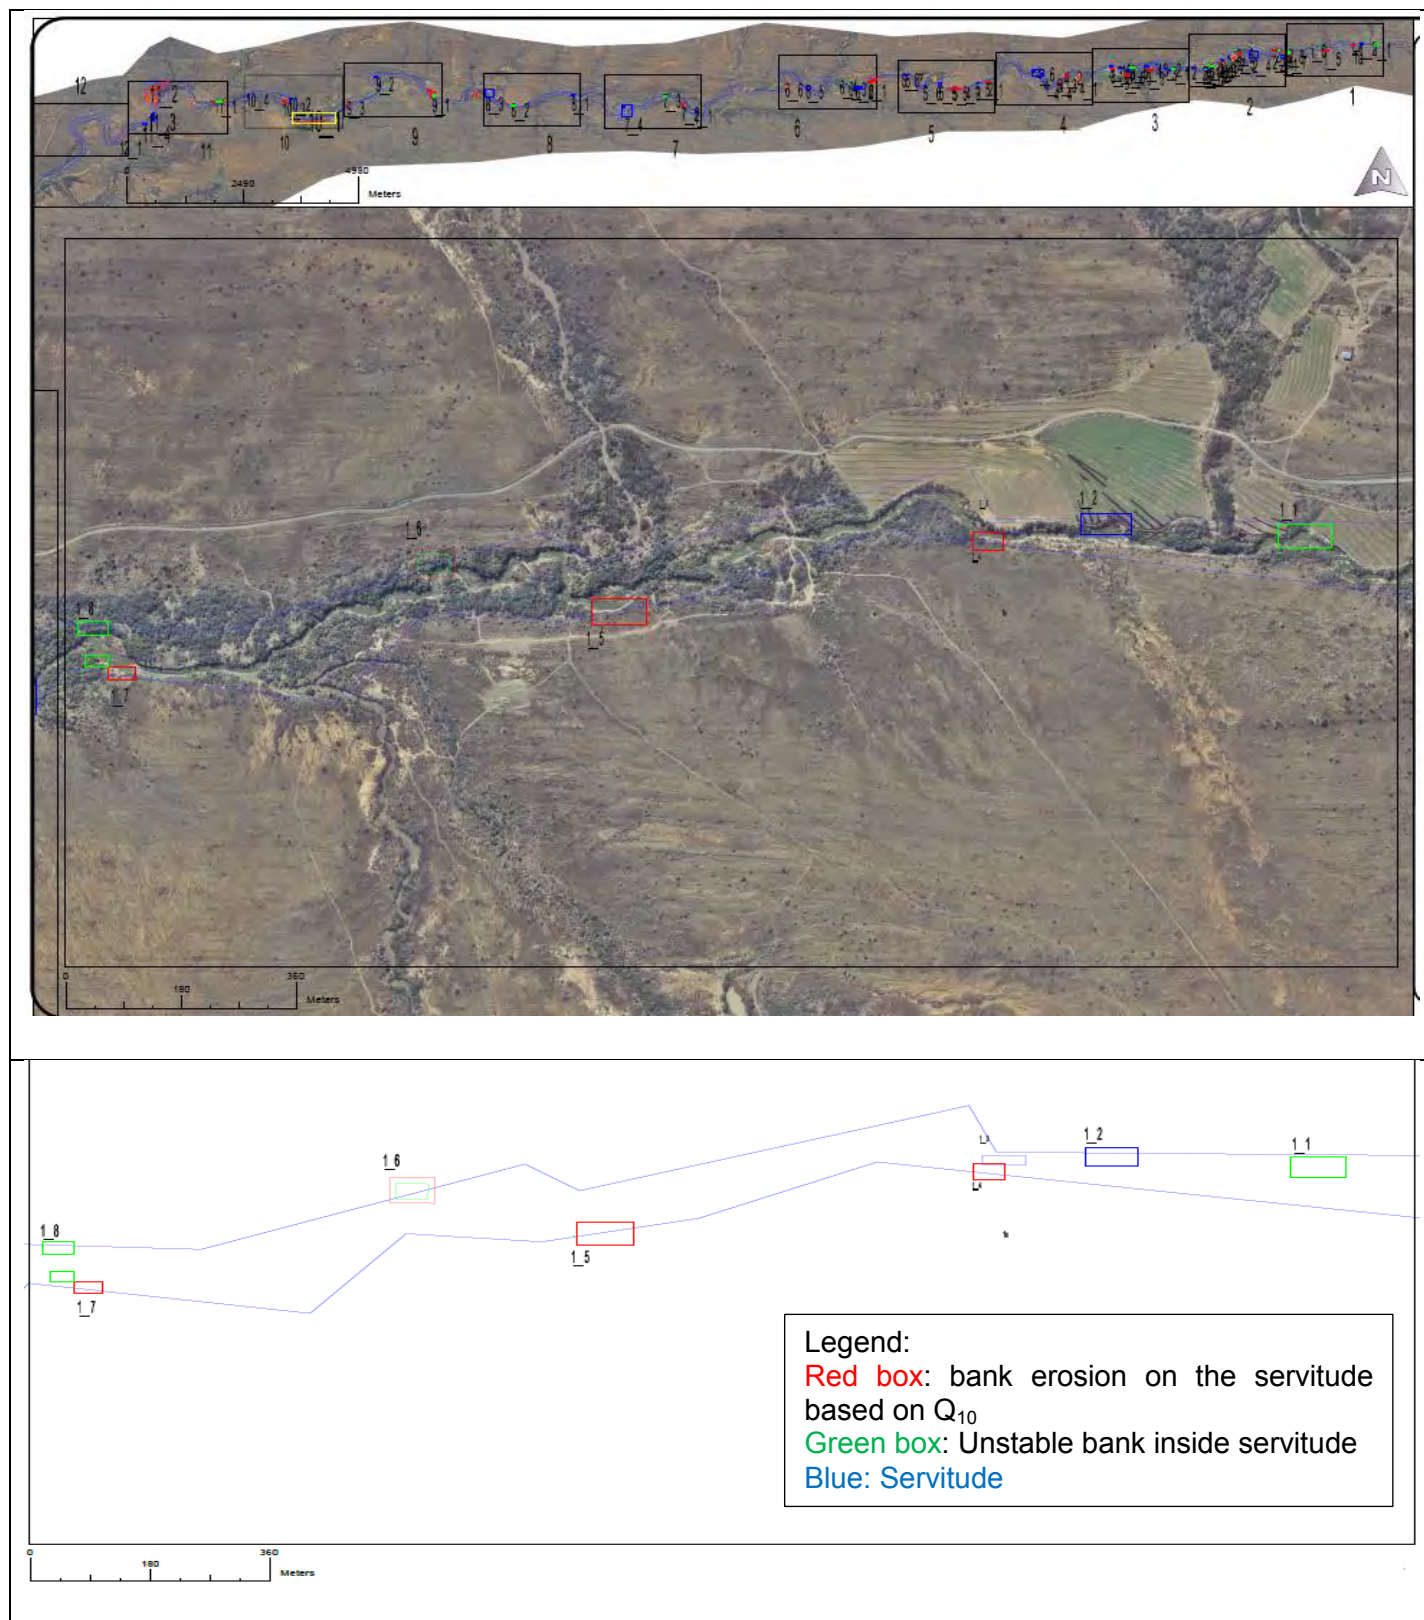
Appendix 2: Zone 1_1 Q10 flood peak scour pattern and proposed scour protection

This area is within the servitude and has unstable banks encroaching farmland. Riprap $d_{50} = 0.45$ m was found to be appropriate. A typical layout and elevations are shown in Appendix 2.

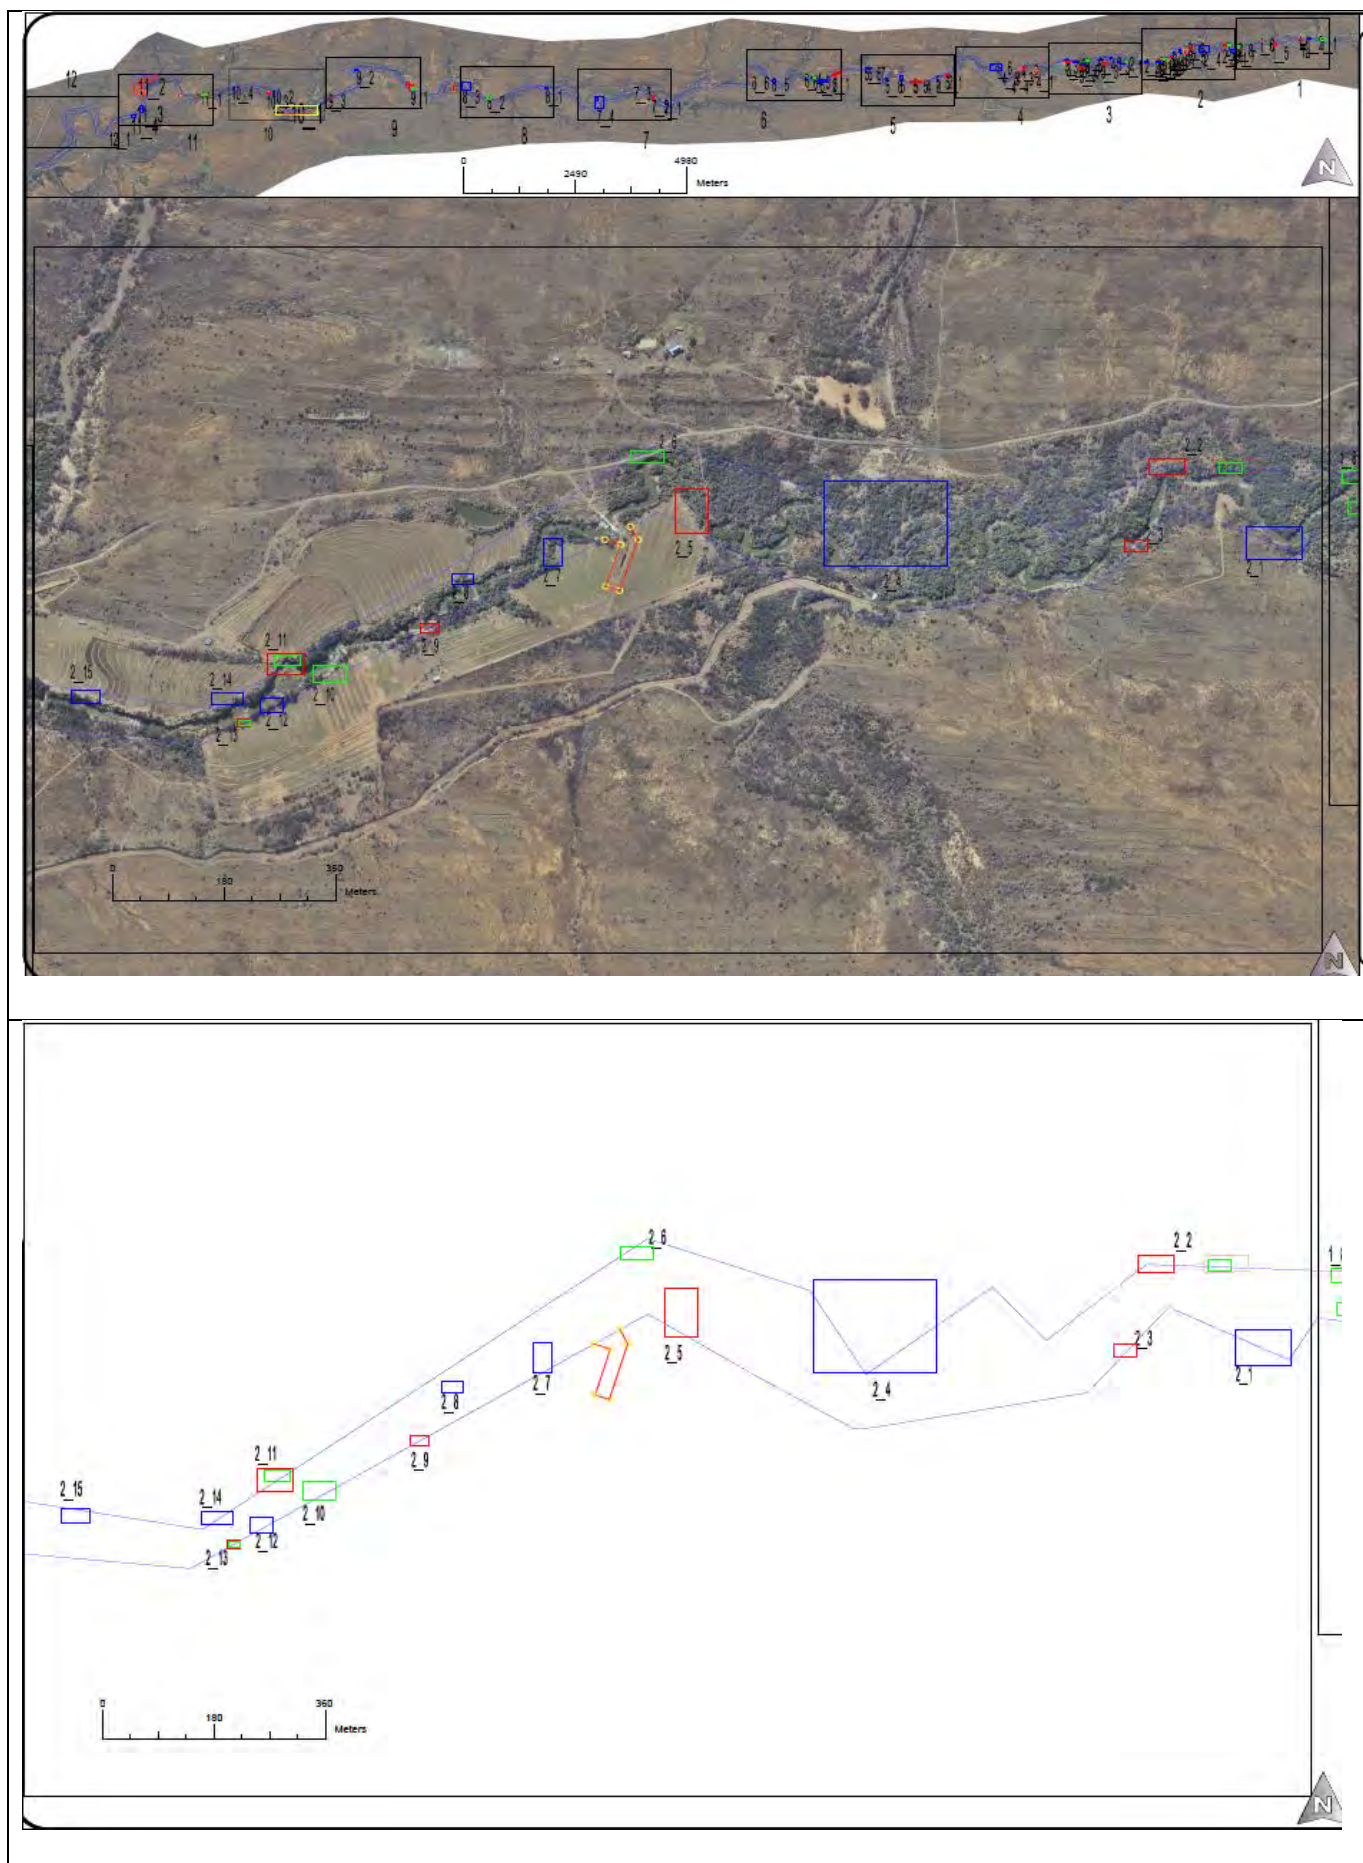
Appendix 10: Zone 2_2 Q10 flood peak scour pattern and proposed scour protection

This area has unstable banks crossing the servitude. $d_{50} = 0.45$ m and $d_{50} = 0.6$ m was found to be appropriate. A typical layout and elevations are shown in Appendix 10.

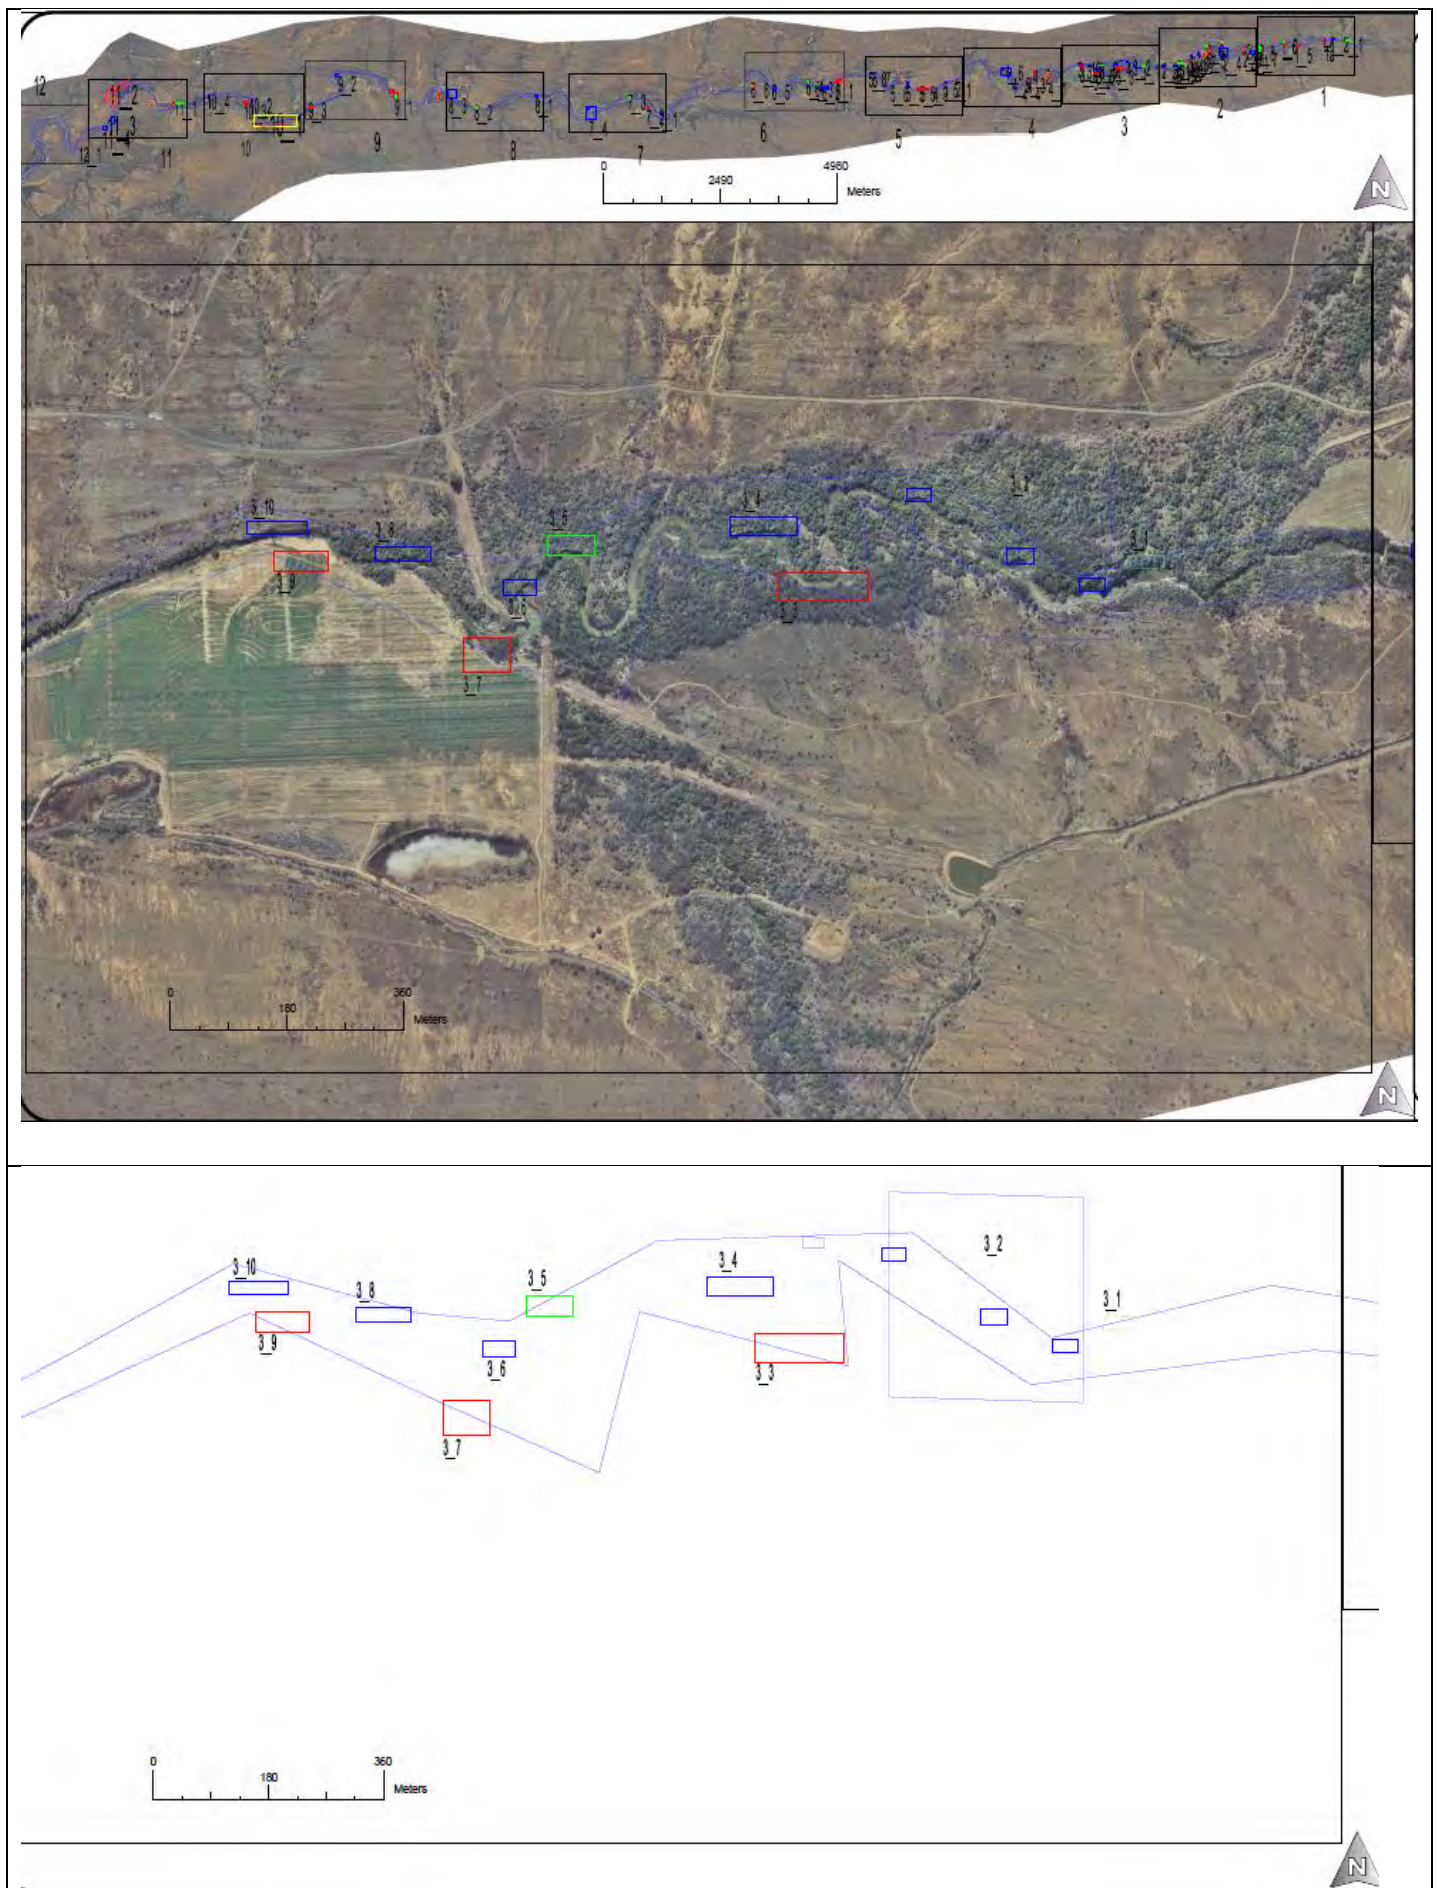
Appendix 20: Zone 3_1 Q10 flood peak scour pattern and proposed scour protection

The zone has unstable banks crossing the servitude. $d_{50} = 0.45$ m was found appropriate. This area is shown in Appendix 20.

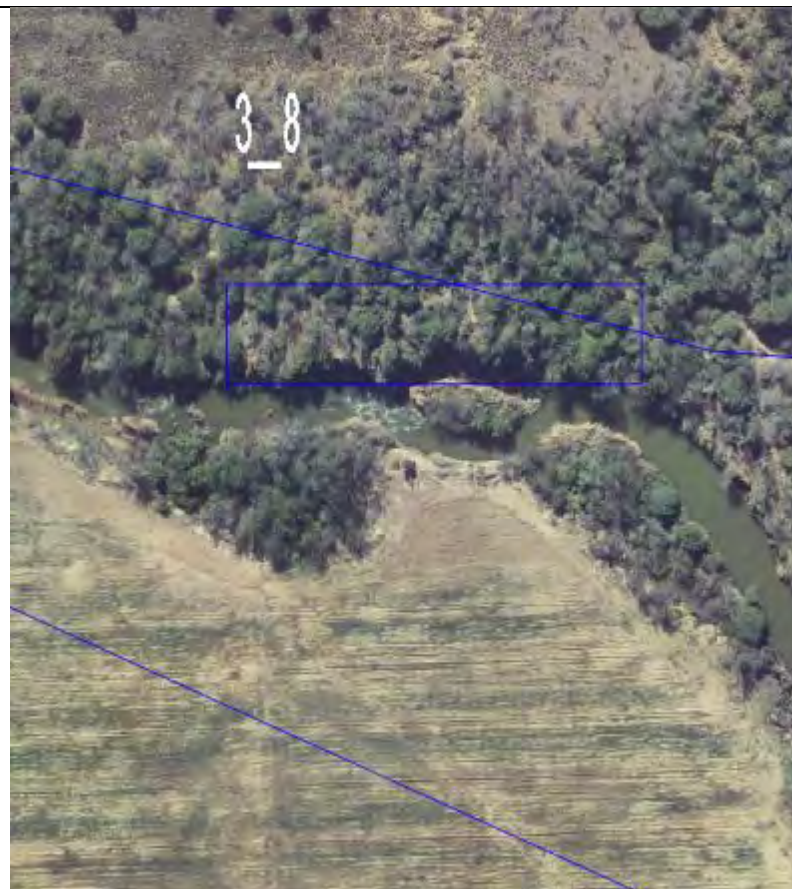
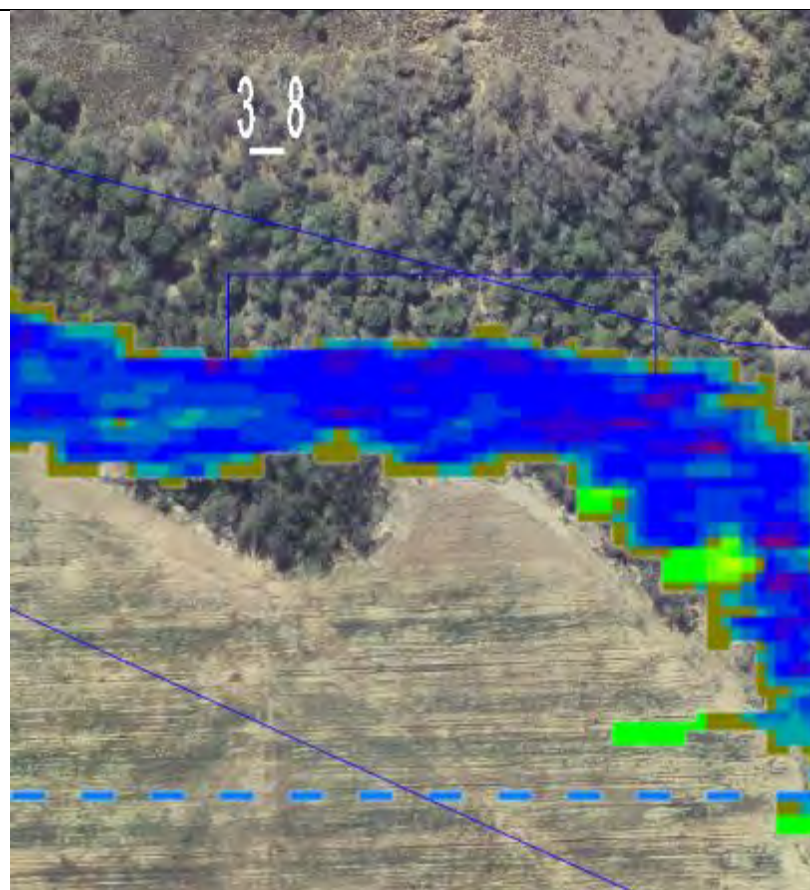
Appendix 26: Zone 3_9 and 3_10 Q10 flood peak scour pattern and proposed scour protection

The zone has unstable banks encroaching the servitude and farmland $d_{50} = 0.15$ m was found appropriate. This area is shown in Appendix 26.

The zone has unstable banks within the servitude. Protection was found not necessary. This area is shown in Appendix 26.

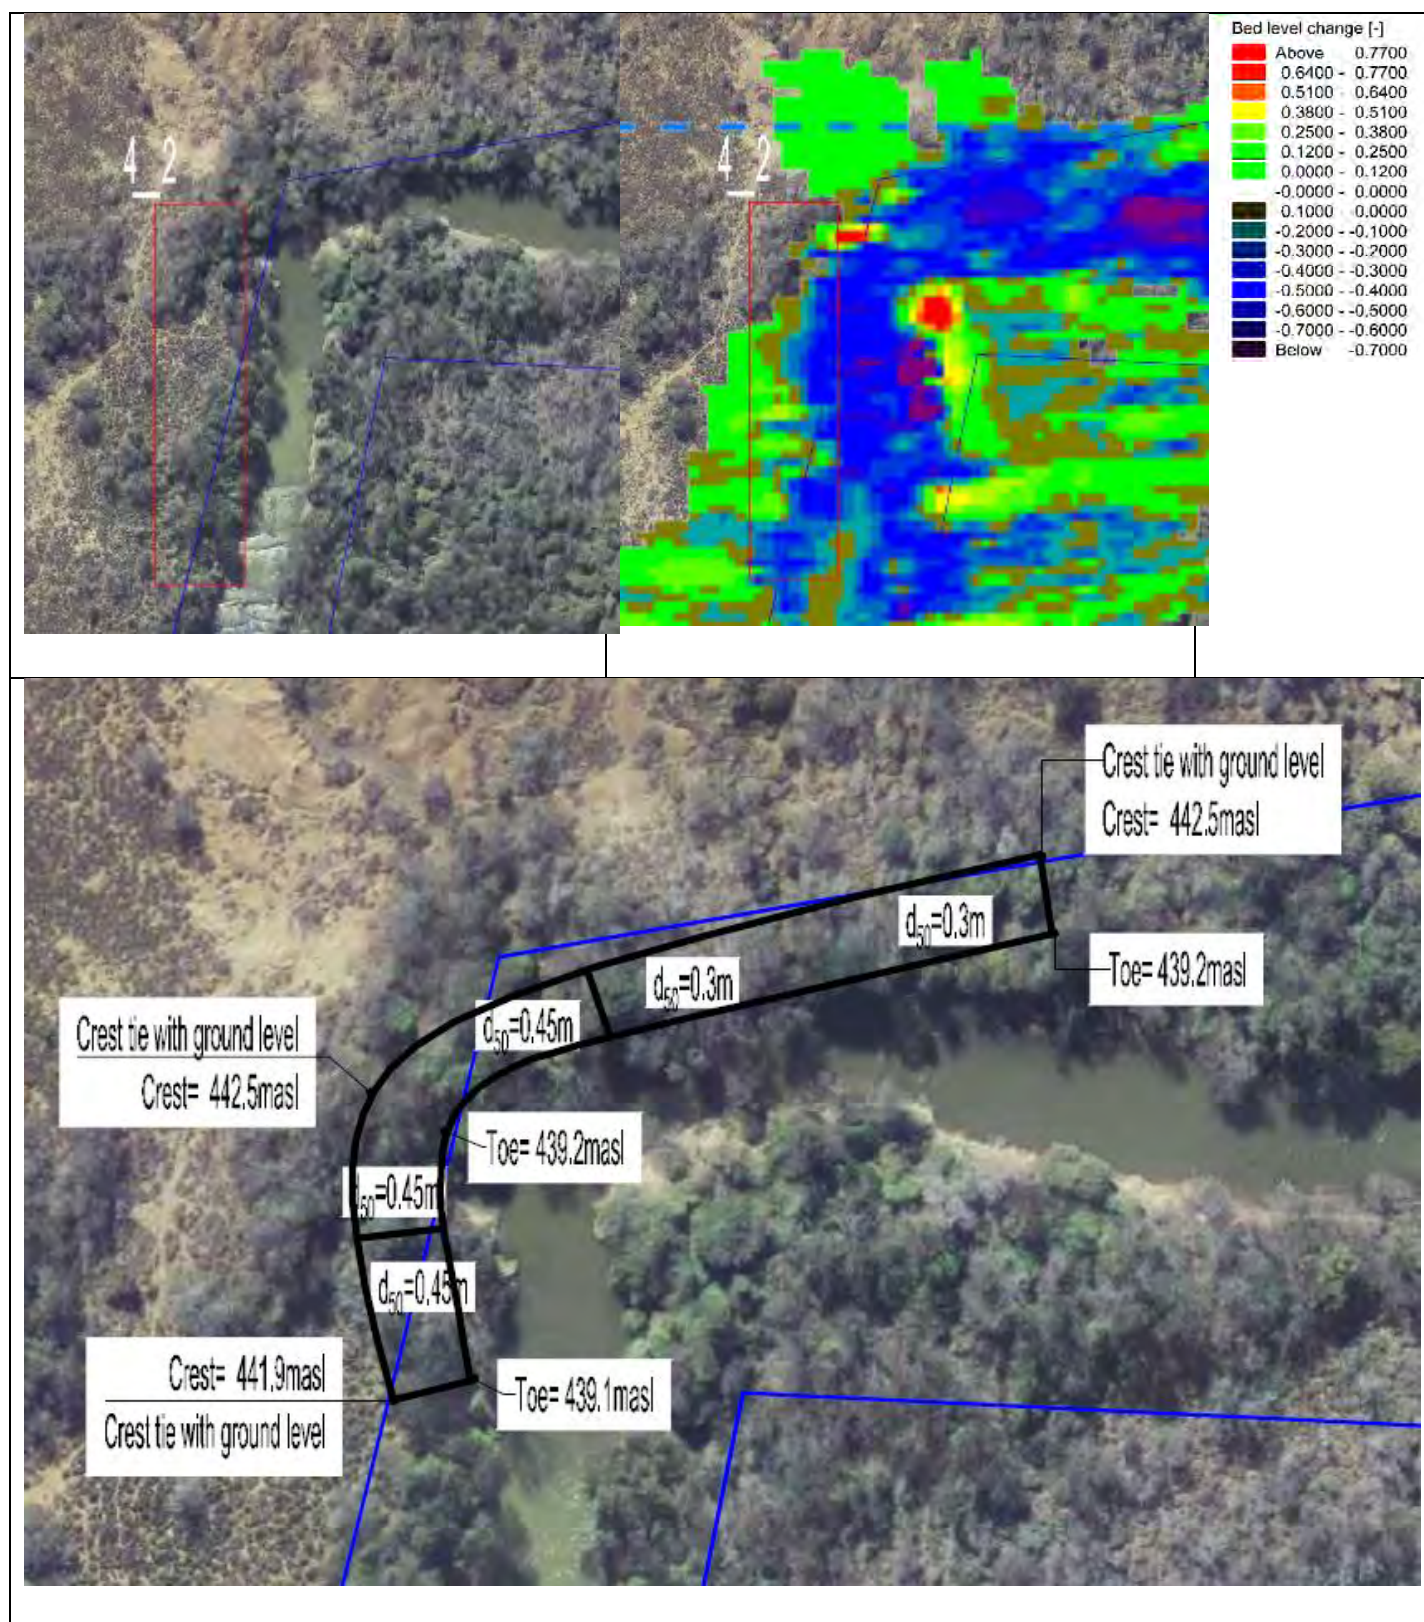
Appendix 30: Zone 4_3 Q10 flood peak scour pattern and proposed scour protection

The zone has unstable banks crossing the servitude. $d_{50} = 0.3$ m, $d_{50} = 0.45$ m and $d_{50} = 0.6$ m was found appropriate. This area is shown in Appendix 30.
