## **FROZEN CORE DAM PERFORMANCE: FOUR YEARS POST CONSTRUCTION**

Megan Miller, PEng, SRK Consulting (Canada) Inc., Vancouver, BC, Canada  
Maritz Rykaart, PhD, PEng, SRK Consulting (Canada) Inc., Vancouver, BC, Canada

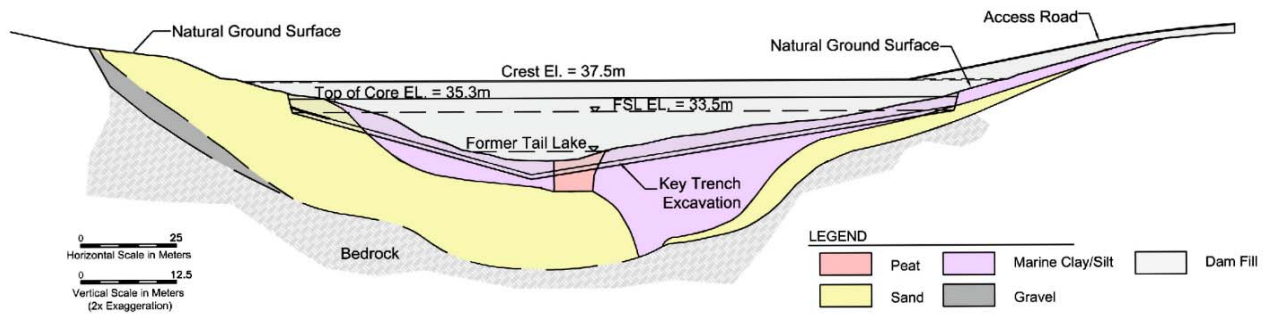
The North Dam is located in a narrow valley approximately 200 m downstream of the northernmost extent of the former Tail Lake, over the former lake outflow. The stratigraphy under the dam has two distinct zones; the southwest side is dominated by ice-saturated sand deposits 10 to 15 m thick, overlain by up to 3 m of silt and clay, while the northwest side is dominated by ice-saturated marine clayey silt with a maximum thickness of 15 m. A thin layer of sand and gravel overlies the bedrock surface in the upper portions of the valley. In addition, a peat unit was encountered near the center of the dam, in the area of the lake outflow.

Figure 1: Long section of North Dam, displaying the complex foundation conditions

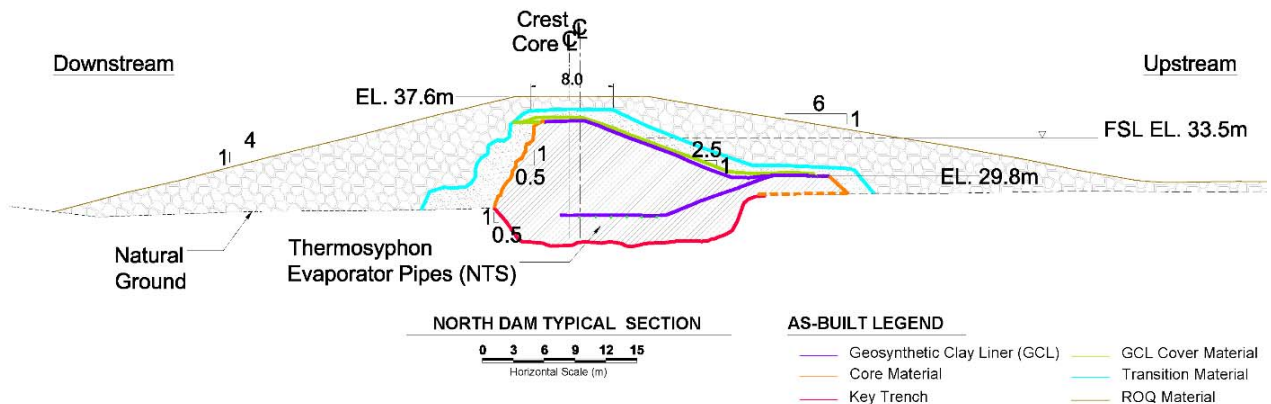
Figure 3: Typical as-built cross section of the North Dam

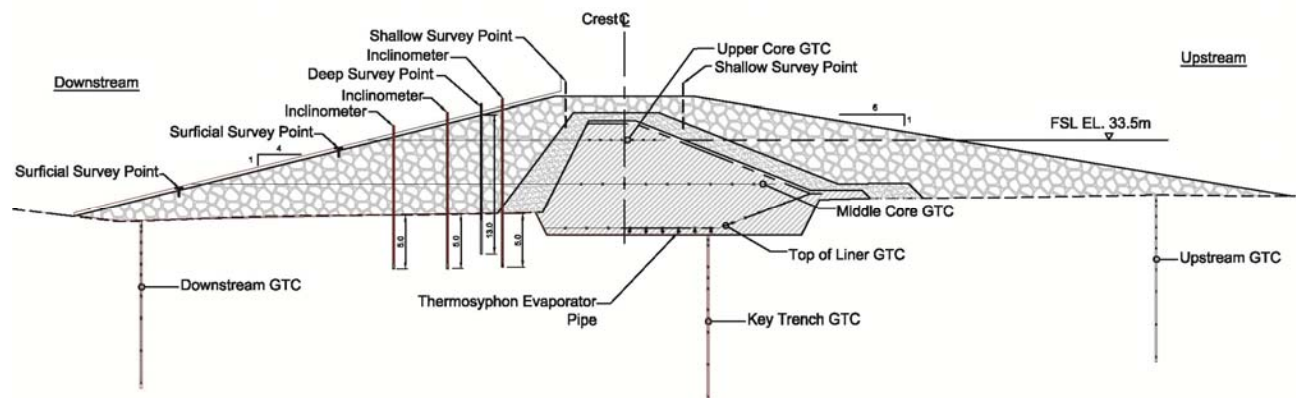
Performance of the North Dam is dependent on the core and foundation maintaining design temperatures. Thermal performance of the dam is monitored with a series of thirteen horizontal GTCs, and eleven vertical GTCs. Figure 4 provides a typical dam cross section, including the location of these GTCs. Three horizontal GTCs are positioned at the top, middle and base of the core; while vertical GTCs are positioned along the foundation on the upstream side, in the center of the dam (key trench) and on the downstream side.

Figure 4: North Dam Typical Instrumentation
