# Subway station retaining walls: case-histories in soft and hard soils

**ABSTRACT.** In the last twenty years, sixteen pile-supported metro stations have been built in Buenos Aires in a wide range of geotechnical conditions. After an initial design of the construction procedures including partial open-trench (in two cases), all subsequent fourteen stations were excavated employing cut&cover techniques. In all cases, vertical bored piles were employed both to support the lateral ground pressure and the loads acting on the roof slab. This paper revisits the geotechnical conditions in Buenos Aires City, describes the procedures employed for the design and numerical analysis of pile-supported excavations and presents the behavior of five recent cases located in widely different geotechnical profiles. The paper ends with a summary of lessons learned which are relevant both for design and construction.

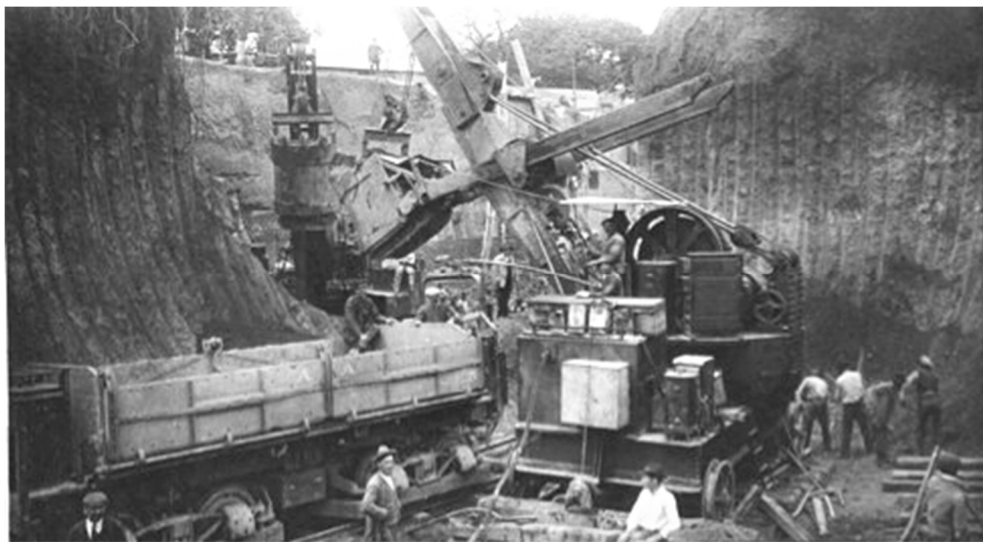
Figure 1. Excavation of Line A in 1911 (SBASE 2017).

Buenos Aires metro network opened in 1913, being the first one in the southern hemisphere. Figure 1 shows the excavation procedure for Line A in 1911 (SBASE 2017). Expansion was fast until the 40's, when it halted for until it was resumed in the late 90's. The network is formed by six lines, 55km of tunnels and 86 stations, and complemented by two surface lines (Figure 1).

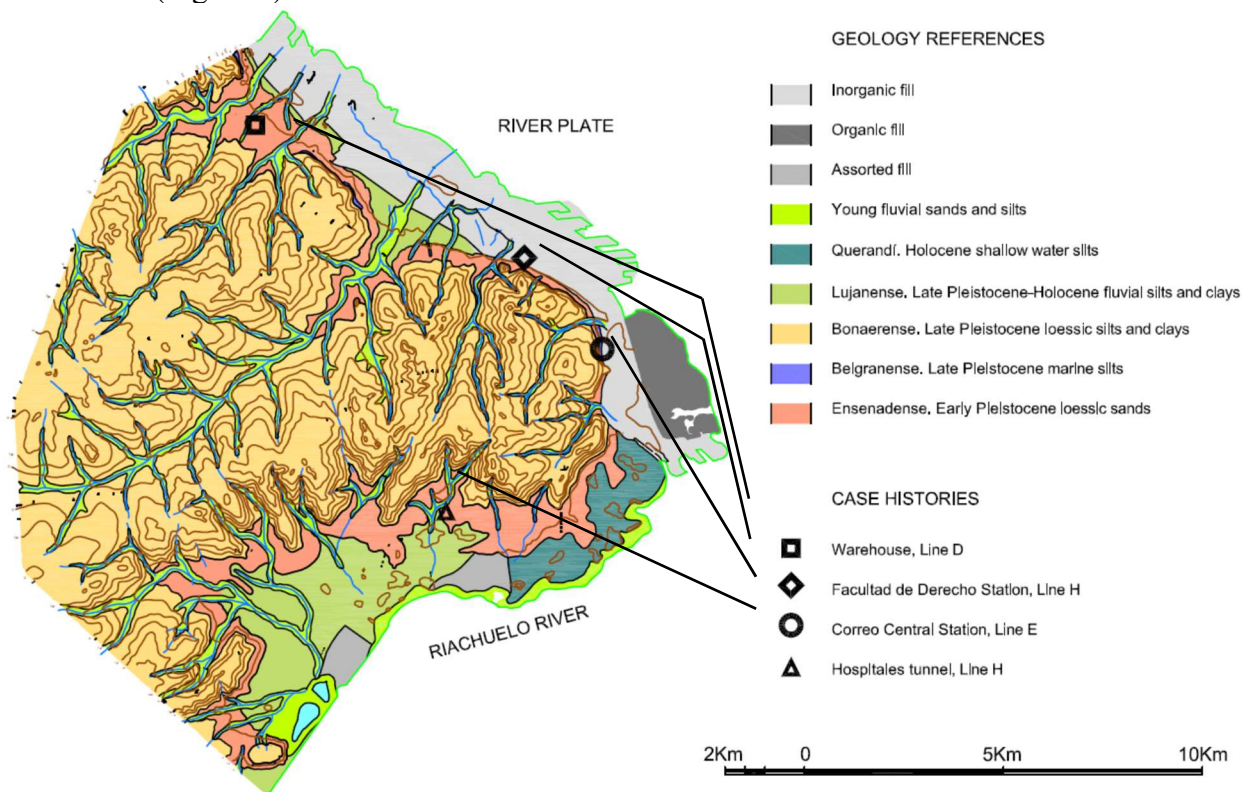
Figure 2. Buenos Aires Geological map; location of projects described in this paper.

Buenos Aires City can be divided in two different areas: upper plains, and lowlands located on the margins of the Riachuelo river and River Plate. The Pampeano formation underlying the center of the city is a modified Loess, overconsolidated by dessication and cemented with calcium carbonate in nodule and matrix impregnation forms. The Postpampeano formation that lies on the river margins is a holocene fluvial deposit of normally consolidated or slightly overconsolidated soft silts and clays and loose silty sands. Man-made fills have covered most of the margin of the River Plate (Figure 2).

The stratigraphic profile can be summarized as follows (Figure 2 and Figure 3): i) man-made fills (base depth: 1m/3m); ii) Upper Pampeano (1m/3m to 8m/12m): medium plasticity stiff silts and clays, eolic deposition, calcareous nodules in a poorly cemented matrix; iii) Middle Pampeano (8m/12m to 25m/30m): medium plasticity very stiff silts and clays, eolic deposition, strong oxide cementation and calcareous nodules. iv) Lower Pampeano (25m/30m to 35m/40m): medium and high plasticity clays, fluvial deposition, poorly cemented matrix, no fissures; v) Puelche (35m/40m to 48m/53m): clean to silty fine to medium grained dense to very dense pliocene sands; and vi) older soils with no effect on excavations and tunnels for metro projects.

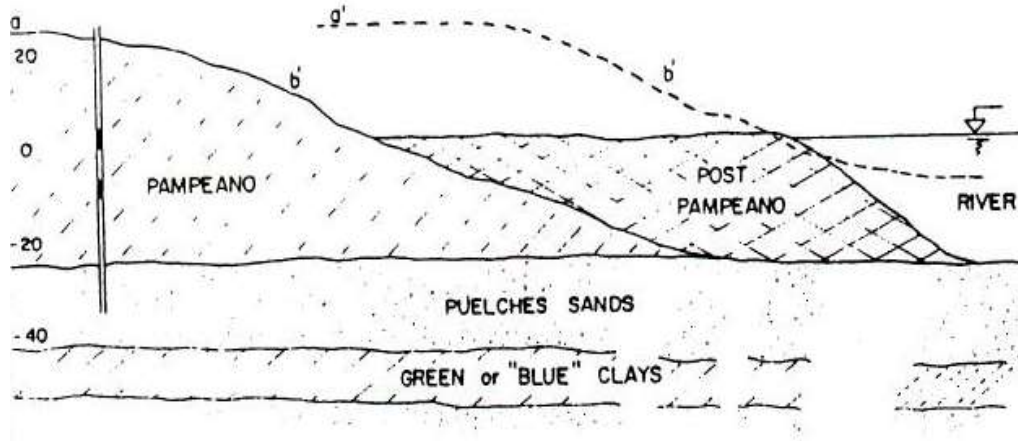
Figure 3. Stratigraphic profile of Buenos Aires City. The project described in this paper lie in the contact between “Pampeano” and “Postpampeano” formations (Núñez 1986).

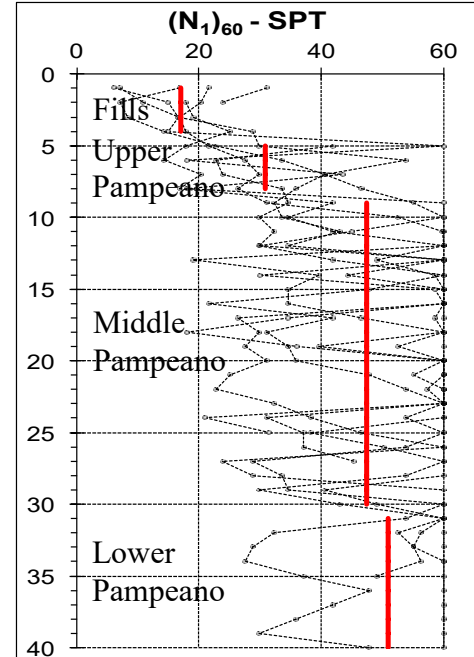
Figure 4. Typical SPT results in the Pampeano Fm. and average values.

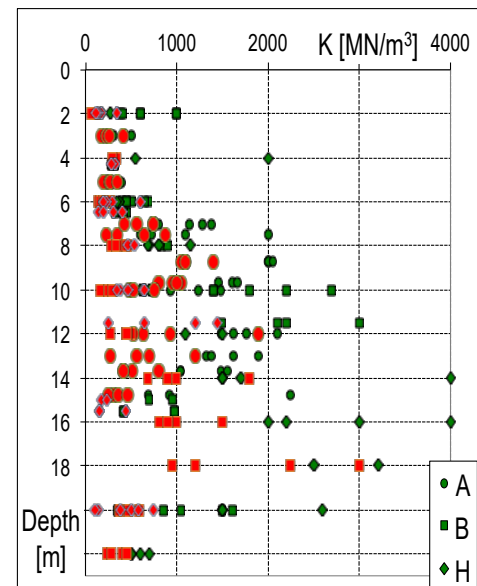
Figure 5. Coefficients of subgrade reaction measured. Red: primary loading. Green: un-reloading.

Plate load tests have been extensively employed for measuring the in-situ soil stiffness. Coefficients of subgrade reaction for a 12" circular plate, measured during the construction of three metro lines, are shown in Figure 5. Average values in un-reloading are  $K = 500\text{MN/m}^3$  in the Upper Pampeano and  $K = 1200\text{MN/m}^3$  in the Middle Pampeano. Using elasticity formulas, a secant Young's modulus  $E = 110\text{MPa}$  and  $E = 260\text{MPa}$  can be calculated for both strata.

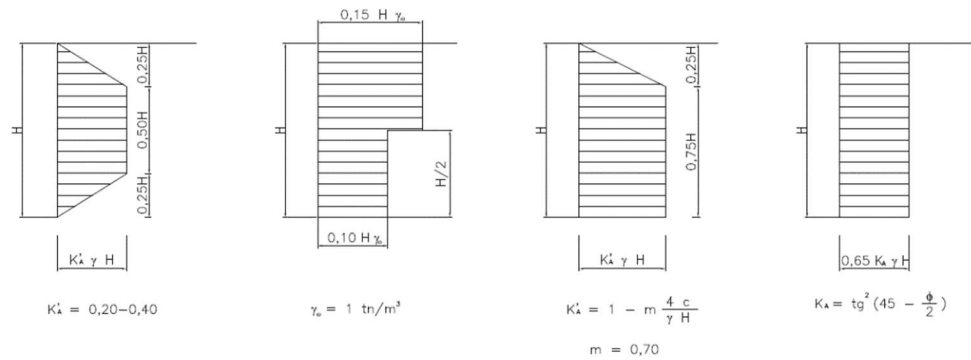
Figure 6. Diagrams of minimum earth pressure for strutted excavations after Building code.  
i) Stiff clays; ii) Pampeano Fm.; iii) Soft clays; iv) Sands.

The Building Code of Buenos Aires requires that strutted excavations be designed with a minimum earth pressure which depends on ground conditions and excavation depth (Figure 6).

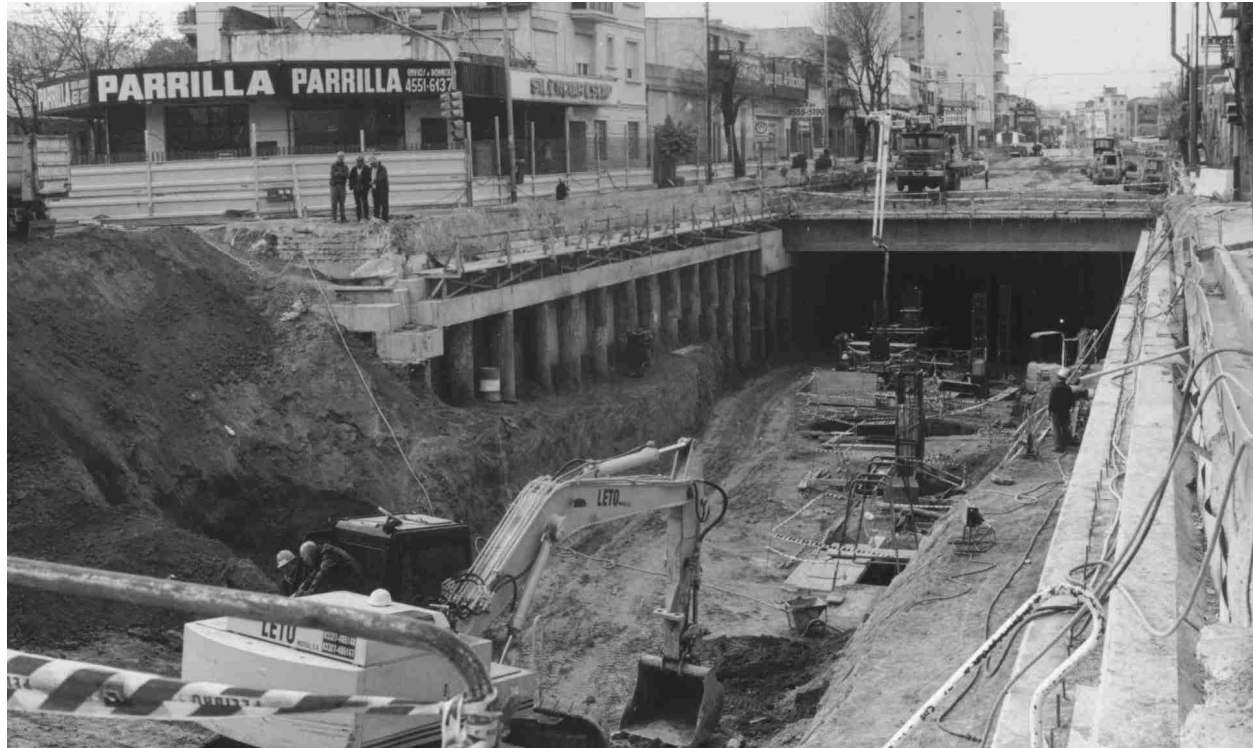
Figure 7. Tronador Station. Note piles with no head support working in cantilever mode.

Line B Tronador and Los Incas stations were excavated in 1997 to 1999 using open trench excavation techniques. 1.2m diameter bored piles, 22.0m long and separated 2.8m between axes were employed to support precast beams which in turn supported precast formwork slabs. A cast-in-place concrete layer completed the roof slab. Space between piles was covered by a thin arch of shotcrete. A final, non-structural wall covered both the piles and the shotcrete arches. The construction procedure was designed to minimize bending moments in the piles and to allow for the use of precast elements: i) open excavation to a depth of 4.0m using the piles to support the lateral ground acting in cantilever mode; ii) installation of precast beams and formwork slabs; iii) cast of the entire roof slab, which act as a groundlevel strut; iv) reopening of the street to transit; and v) the excavation continued under the slab using the piles to support the ground in propped mode, down to a depth of 12m. Due to delays in the provision of the beams, the open excavation was advanced to a depth of 7m, forcing the piles to work in cantilever mode (Figure 7).

A significant lateral deflection was observed at the pile heads ( $\delta_h \cong 15|25mm$ ) and some minor cracks formed in the pavements, but no major instabilities occurred and the construction was completed to success.

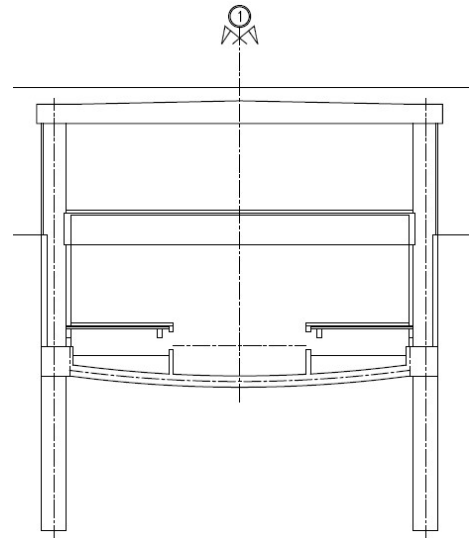
Figure 8. Typical cross-section of a cut&cover station.

The first cut&cover station employing piles to support lateral ground pressures was Ollerros Station, Line D, completed in 1987, shortly followed by Juramento Station. Since 1997, fourteen stations were excavated using cut&cover techniques, namely Line H stations Venezuela, Humberto Primo, Inclán, Caseros, Parque Patricios, Hospitales and Facultad de Derecho; Line A stations Puán, Carabobo, Flores and San Pedrito; and Line E stations Correo Central, Catalinas, and Retiro. The typical cross-section is shown in Figure 8.

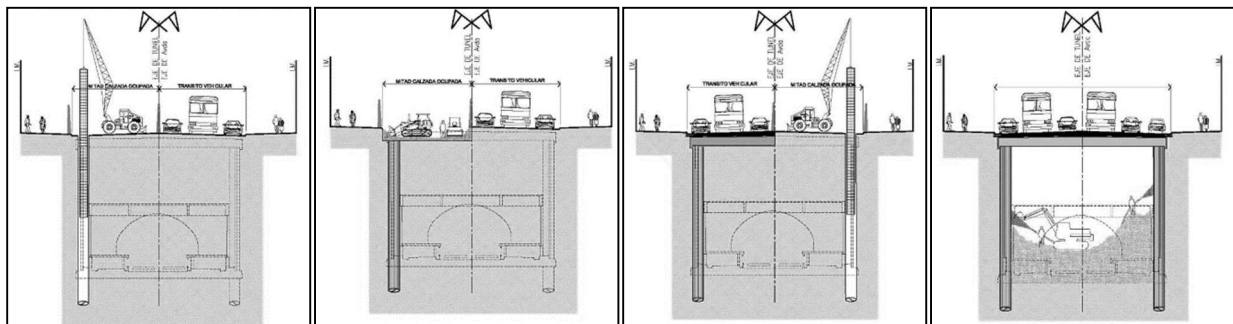
Figure 9. Construction procedure for cut&cover stations.

The construction procedure is depicted in Figure 9: i) transit is diverted to one side while piling and construction of a cast-in-place half slab on ground is performed at the other side; ii) the road is reopened and transit shifts side to allow for constructing the second half of the slab; iii) the excavation is performed underground, with minimal transit disruption.

Using this construction procedure, piles are never forced to work in cantilever mode. Settlements and lateral displacements of the pavements is negligible in excavations in the Pampeano, but could rapidly grow where Post-Pampeano soils are present and not taken into account in the design. The total construction time span is 11 to 14 months for the excavation and installation of all support systems including the floor slab (Figure 10). Disruption to surface transit spans for eight to twelve weeks, depending on logistics and site conditions.

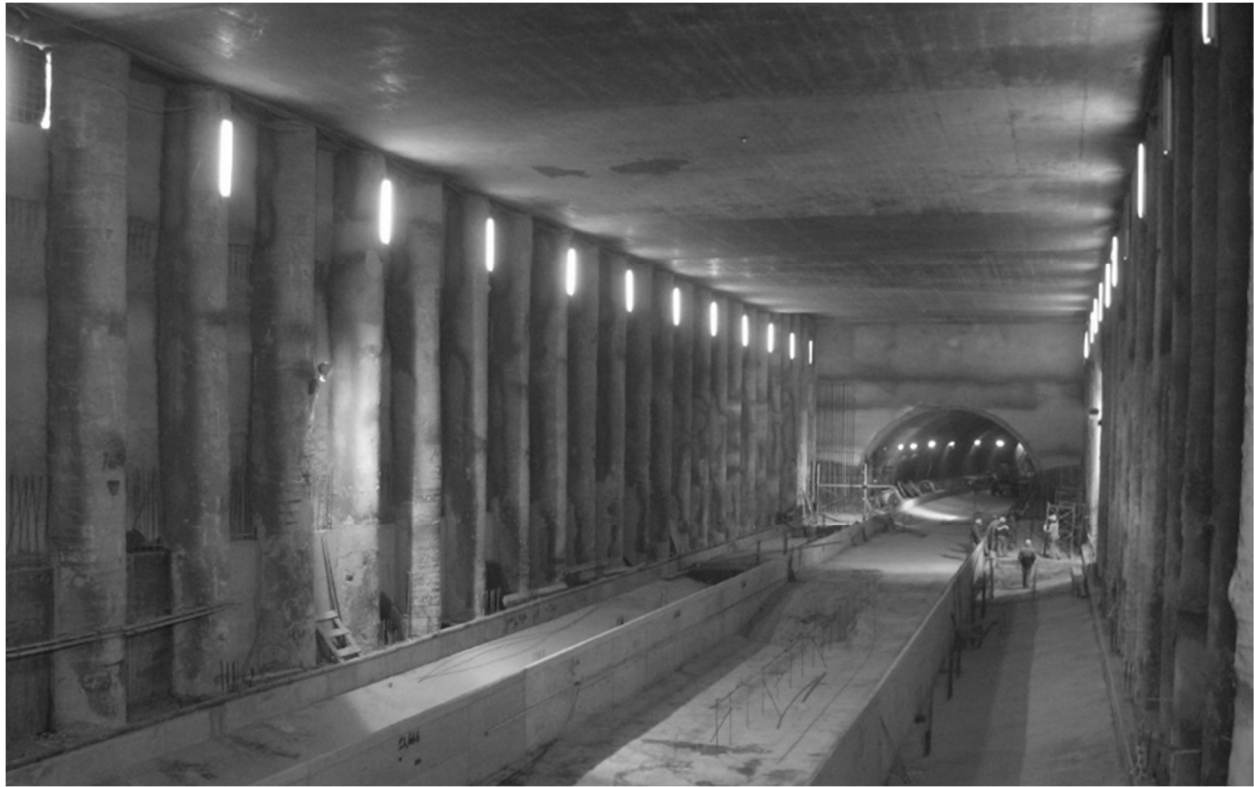
Figure 10. A cut&cover cavern completed..

methodology used ever since. It consists in a NATM full-face excavation using two backhoe equipments located at two benches, producing two independent working faces, but keeping the closure of the structural ring within one diameter of the tunnel face. The complete cycle allows for 6m to 8m advance per week resulting in a total duration of the excavation of seven months in 2007 (Sfriso 2007). The procedure, while challenging, proved sound for an ample range of geotechnical conditions.

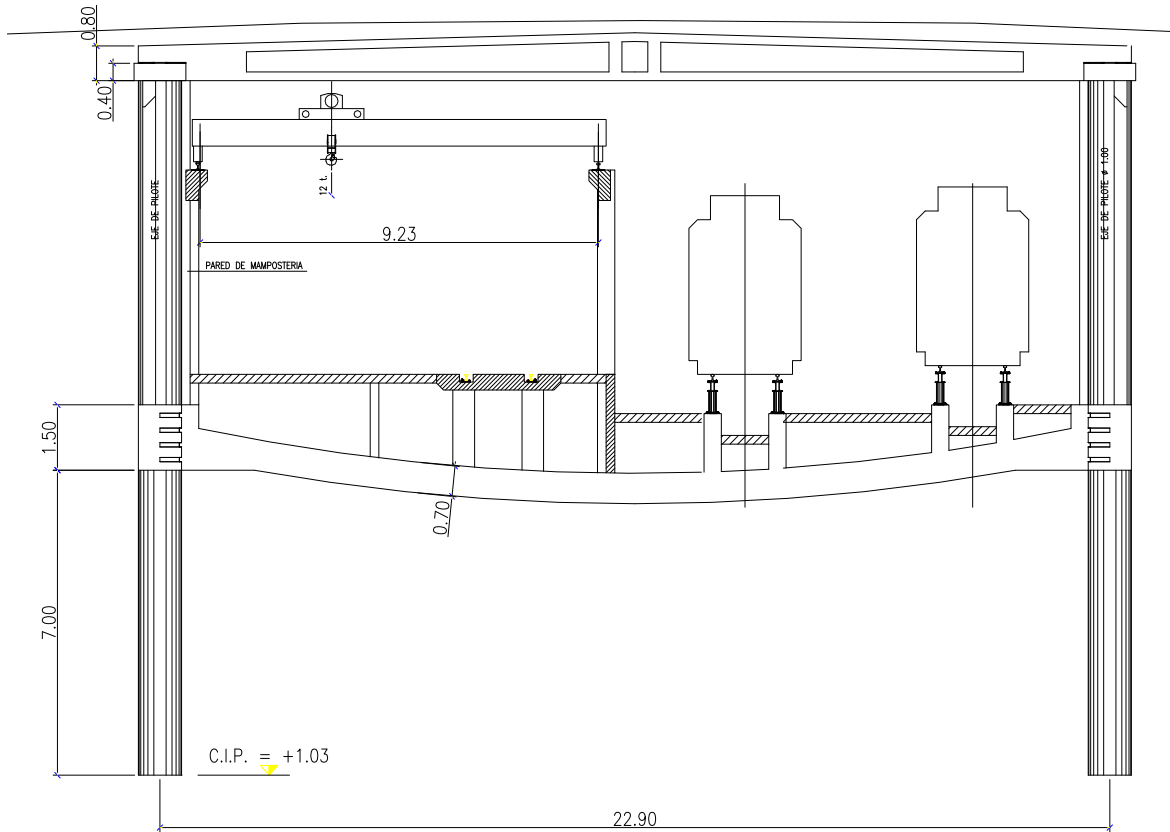
Figure 11. Cross-section of Line D Maintenance Facility.

Line D Maintenance Facility required an excavation 22.9m wide, 51.5m long and 10.2m deep, which was supported on 1.0m dia bored piles, 16.0m long, 7m embedded and separated 2.70m. The roof slab was formed by precast elements, while the curved invert was cast in place and hinged against recesses placed in the pile reinforcement. Only 3.5m of artificial fills overlaid the Pampeano soils and were largely removed during the surface excavation required to install the roof wall. Figure 11 shows the cross-section of the structure. The analysis and design was performed using standard structural engineering procedures, where ground-structure interaction is simulated by Winkler-type springs. Figure 12 and Figure 13 shows two of the structural load cases employed in the numerical model. Figure 14 shows a panoramic view of the structure during the construction of the invert while Figure 15 shows the structural detail of the grooved contact joint between the bored piles and the concrete invert vault. The grooves were made of steel rings welded to the pile reinforcement previously installed during pile construction.

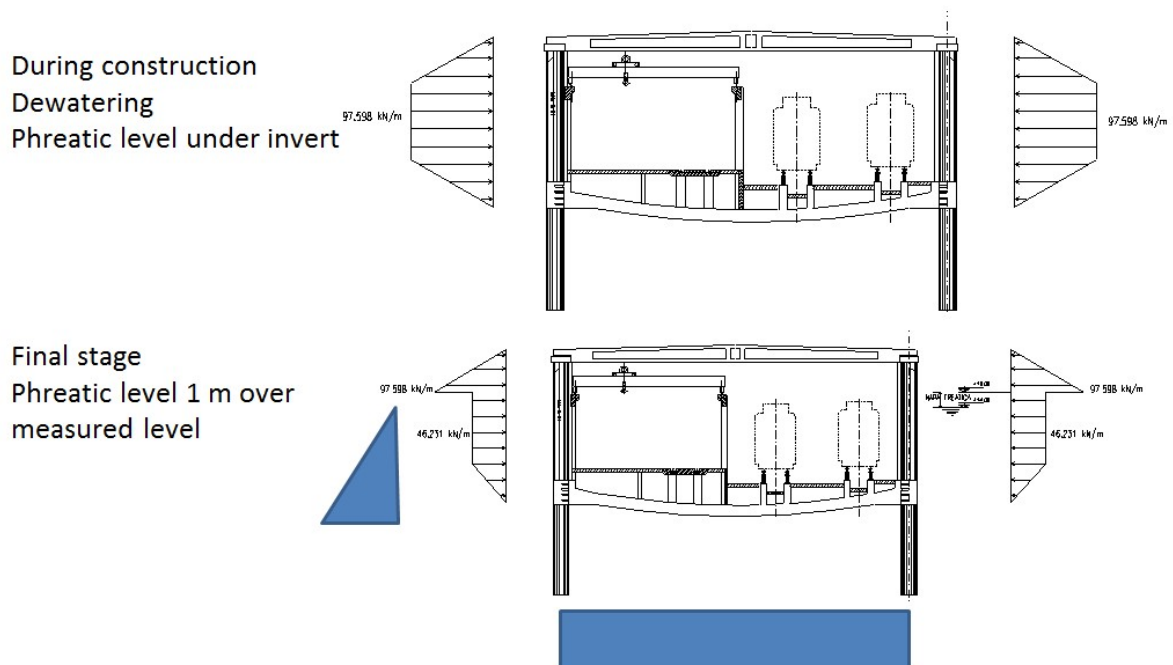
Figure 12. Structural model for designing Line D Maintenance Facility (reproduced with permission from the calculation notes of the project).

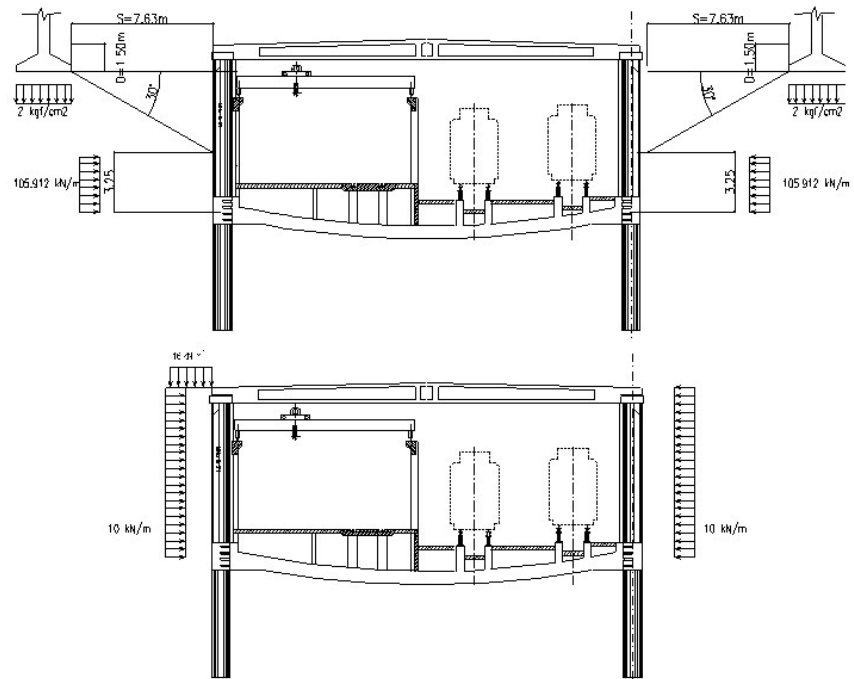
Pressure diagrams  
due to nearby  
buildings

Figure 13. Structural model for designing Line D Maintenance Facility (reproduced with permission from the calculation notes of the project).

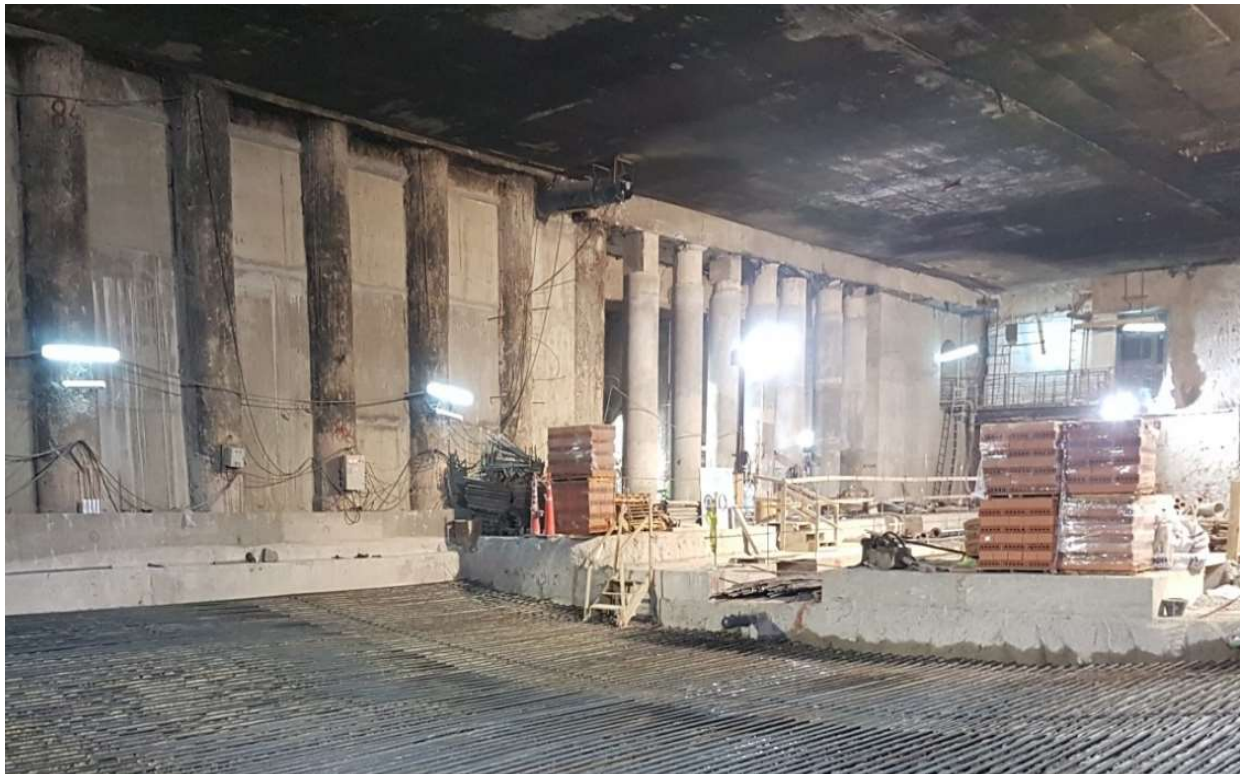
Figure 14. Panoramic view of Line D Maintenance Facility during construction of the invert.

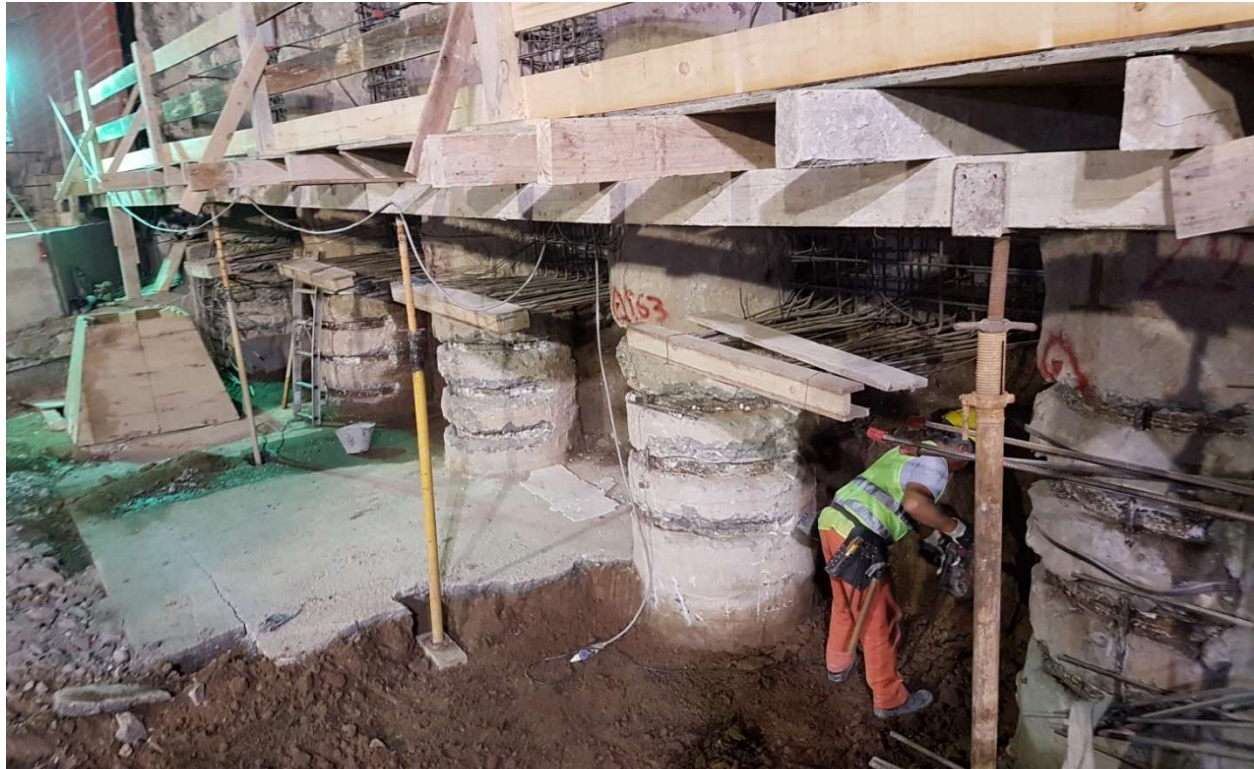
Figure 15. Structural detail of the connection of the invert to the lateral bored piles.

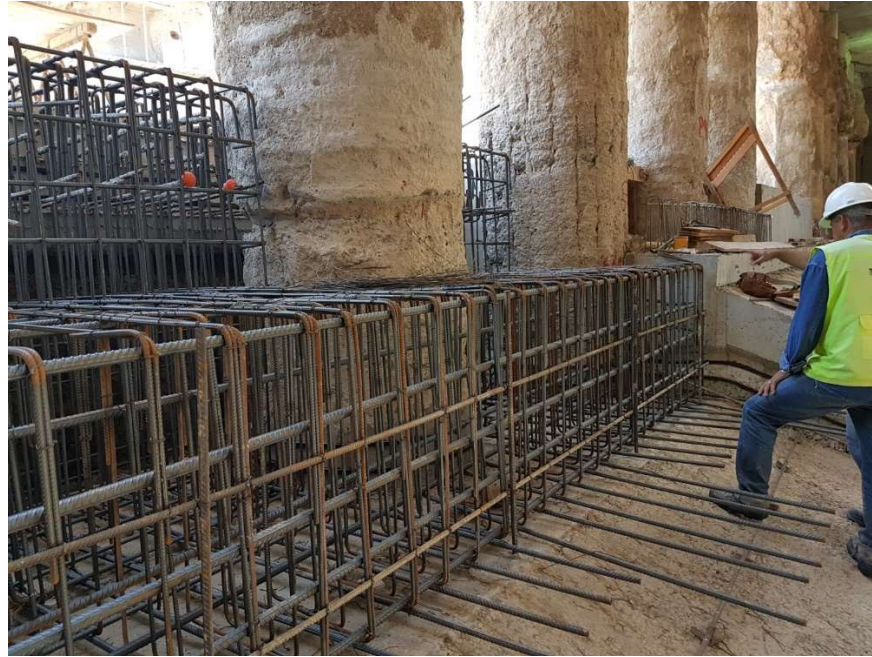
Figure 16. Reinforcement of the slab connected to the (future) wall between the piles.

Being an excavation of moderate depth, it required a low-risk, conventional structural and geotechnical design. A retaining wall made with bored piles, 1.20m in diameter, 18.5m long and separated 2.50m was employed. Piles were reinforced to provide a yield bending moment of 793kNm/m. There are  $\phi 1.60\text{m}$  bored piles bored adjacent to the main entrances to the station from a lateral mezzanine with a yield bending moment of 1460kN/m. The ground between piles was supported by a 10cm shotcrete arch. The invert was connected to the side walls between the piles, with no connection to the piles themselves (Figure 16). This structural detail results in time and cost savings, despite the fact that it requires a heavier slab reinforcement. Figure 17 shows a panoramic view of the main building, the open-trench excavation of the mezzanine and the building of the School of Law.

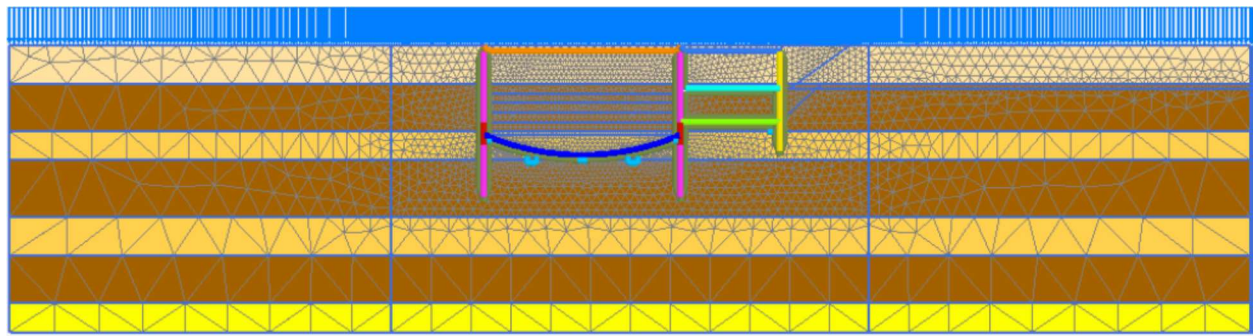
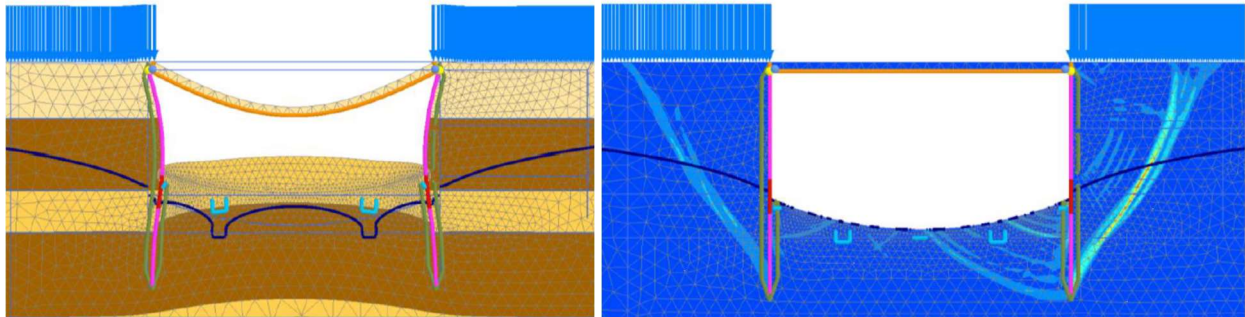
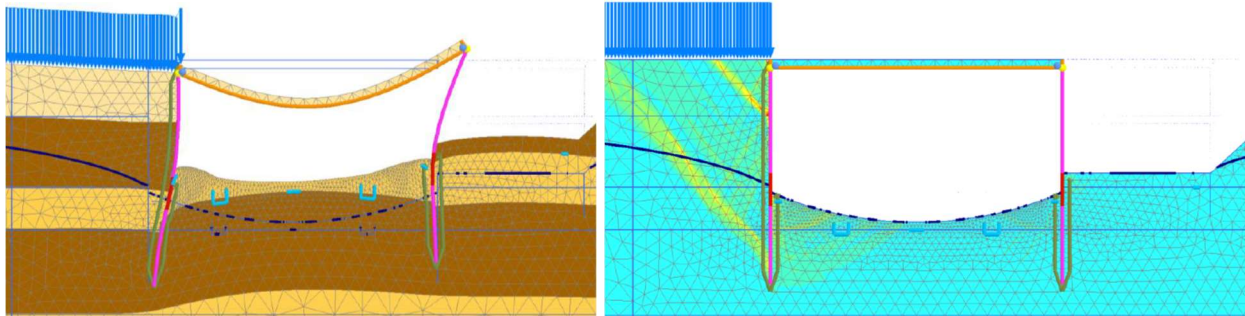
Finite element mesh.

Main excavation. Deformed mesh (left) and failure mechanism (right).

Excavation of Mezzanine. Deformed mesh (left) and failure mechanism (right).

Figure 18. Numerical analysis of the construction sequence of Facultad de Derecho Station.

The construction sequence, geotechnical and structural design were performed using numerical models, see Figure 18. Structural design was also verified to comply with earth-pressure diagrams provided by the Buenos Aires construction code, see Figure 19.

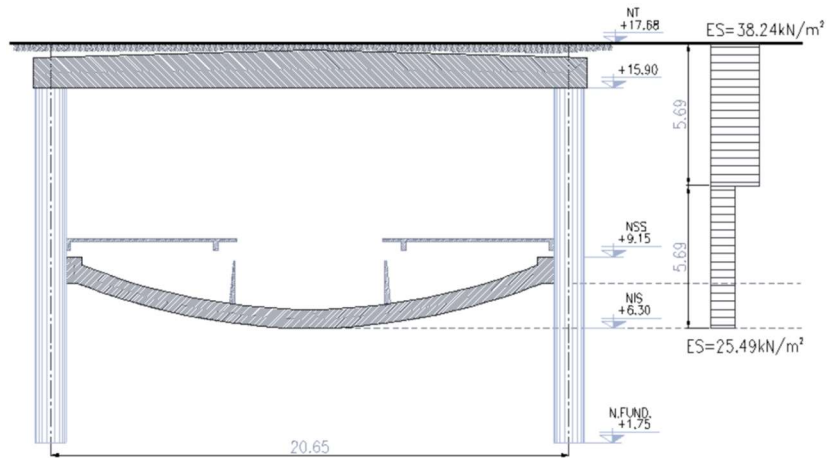
Figure 19. Minimum lateral earth pressure diagram, Buenos Aires construction code.

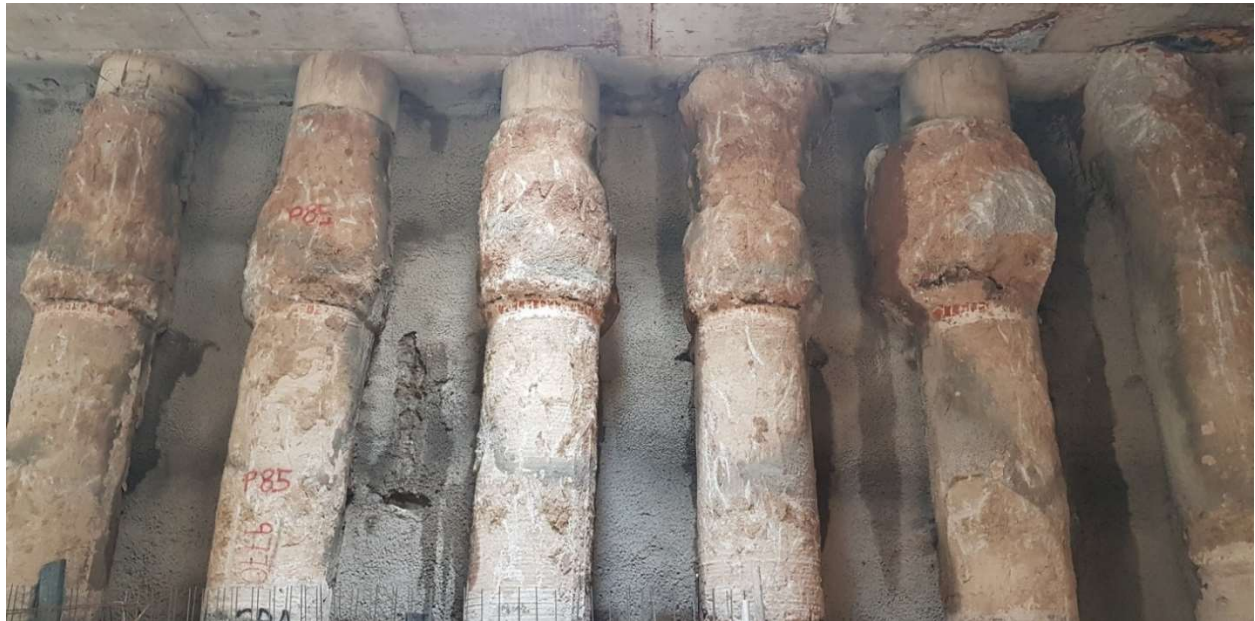
Figure 20. Construction defects in the upper portion of the bored piles.

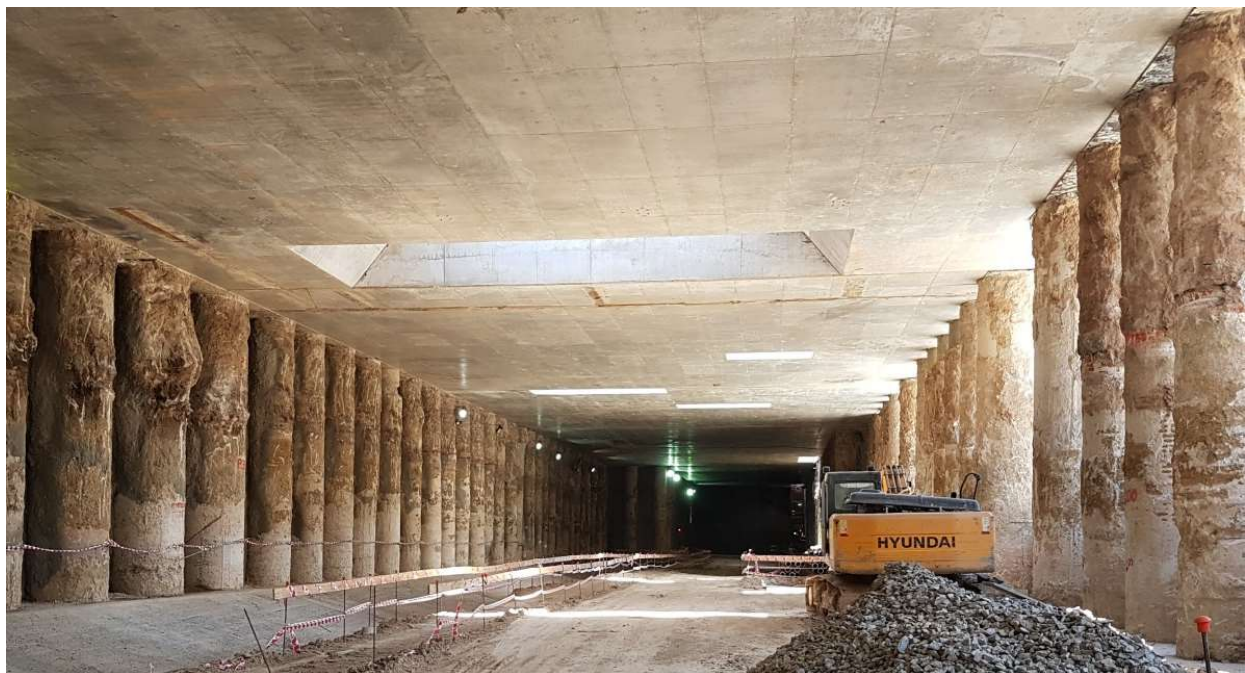
Figure 21. Construction defects in the portion of the bored piles excavated in the man-made fills and superficial soft soils. Note the systematic over-excavations and exposure of reinforcement.

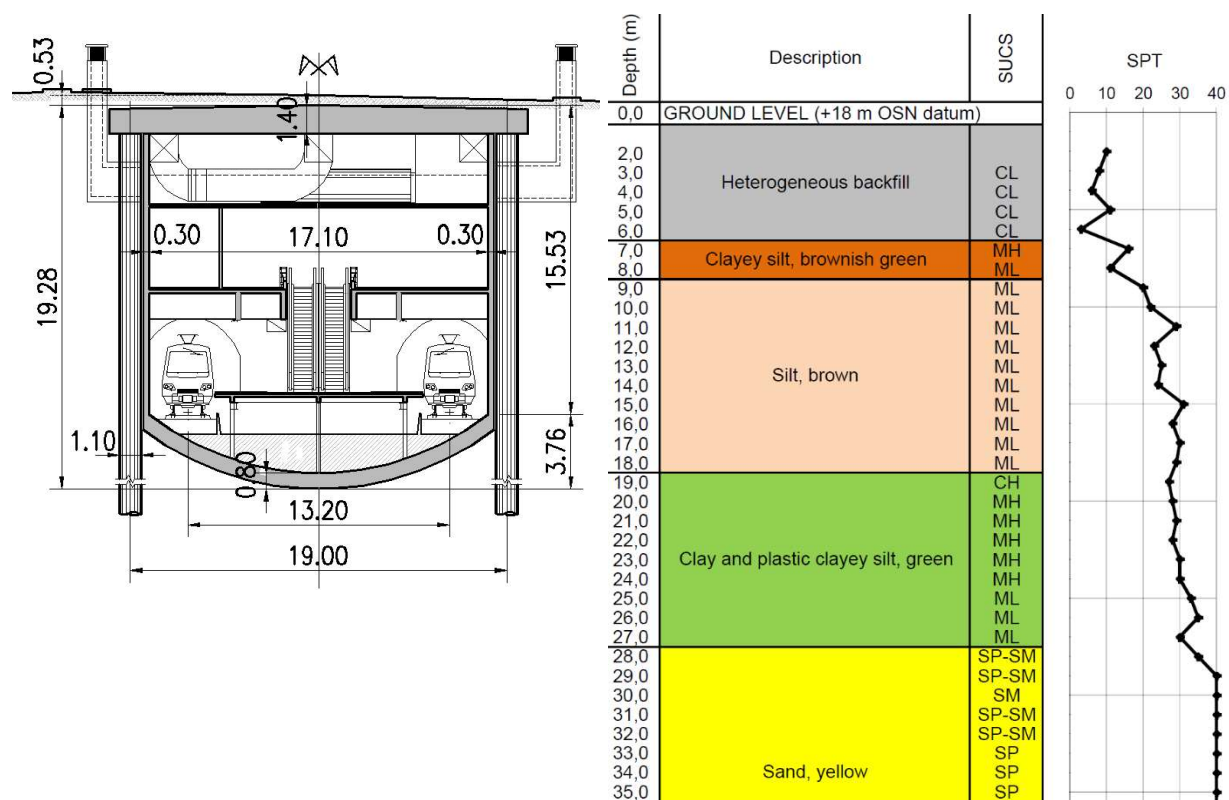
Figure 22. Correo Central Station. Cross-section and geotechnical profile.

The structure was designed to have an all-around PVC geomembrane for watertightness. Piles were designed to support just the lateral ground pressure while a inner wall was installed to resist the water pressure, supported in the floor slab, cast-in-place invert and the mezzanine slab. The cross-section of the structure and the geotechnical profile are shown in Figure 22 (Laiun et al 2014).

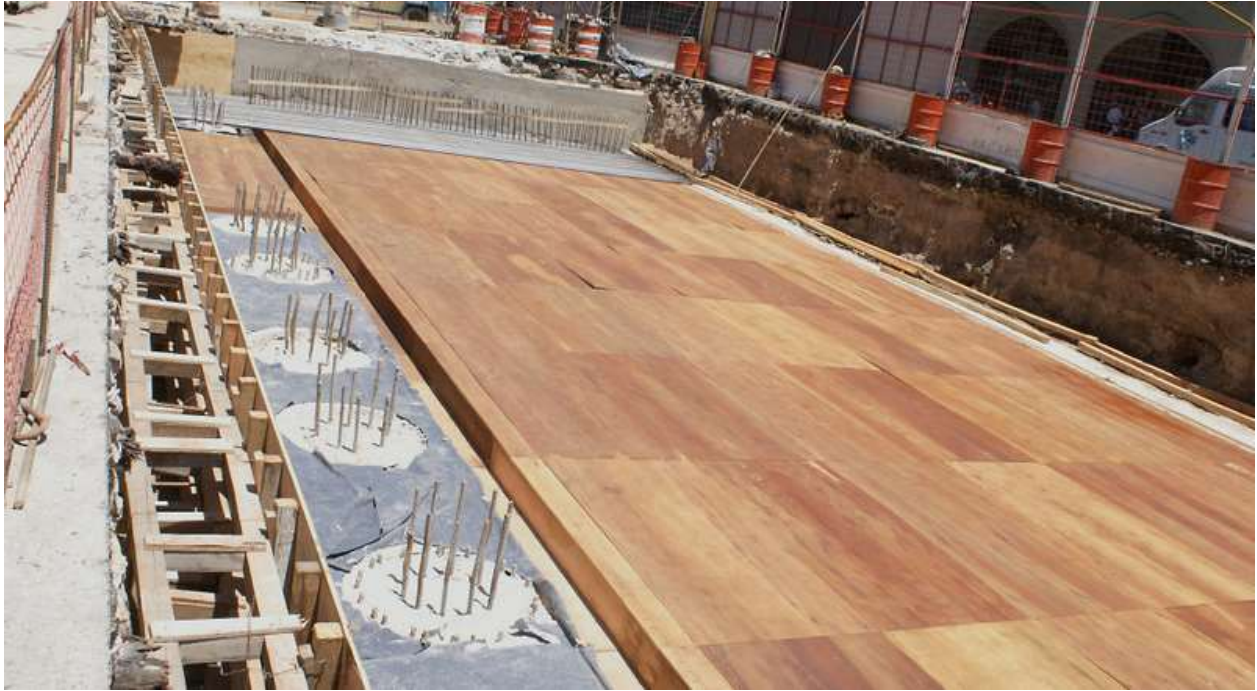
Figure 23. Correo Central Station. Construction procedure of the roof slab-on-piles.

The construction procedure was as shown in Figure 9 and Figure 23 but adapted to overcome the adverse geotechnical conditions at the bottom of the excavation. Underground excavation was performed as follows: i) a safe level for general excavation was determined and reached in two stages; ii) two drainage pipes were installed in open trenches; iii) the excavation of the invert was advanced in 2.2m strips and supported with lattice girders welded to the pile reinforcement and shotcrete; iv) the geomembrane was installed; and v) the final invert was cast-in-place. Figure 24 shows the construction sequence, Figure 25 shows the piles, the open box and the concrete invert vault during construction, and Figure 26 shows all stages of the invert construction simultaneously, from ground removal to final cast-in-place invert (Sfriso and Laiún 2012, Laiún et al 2014).

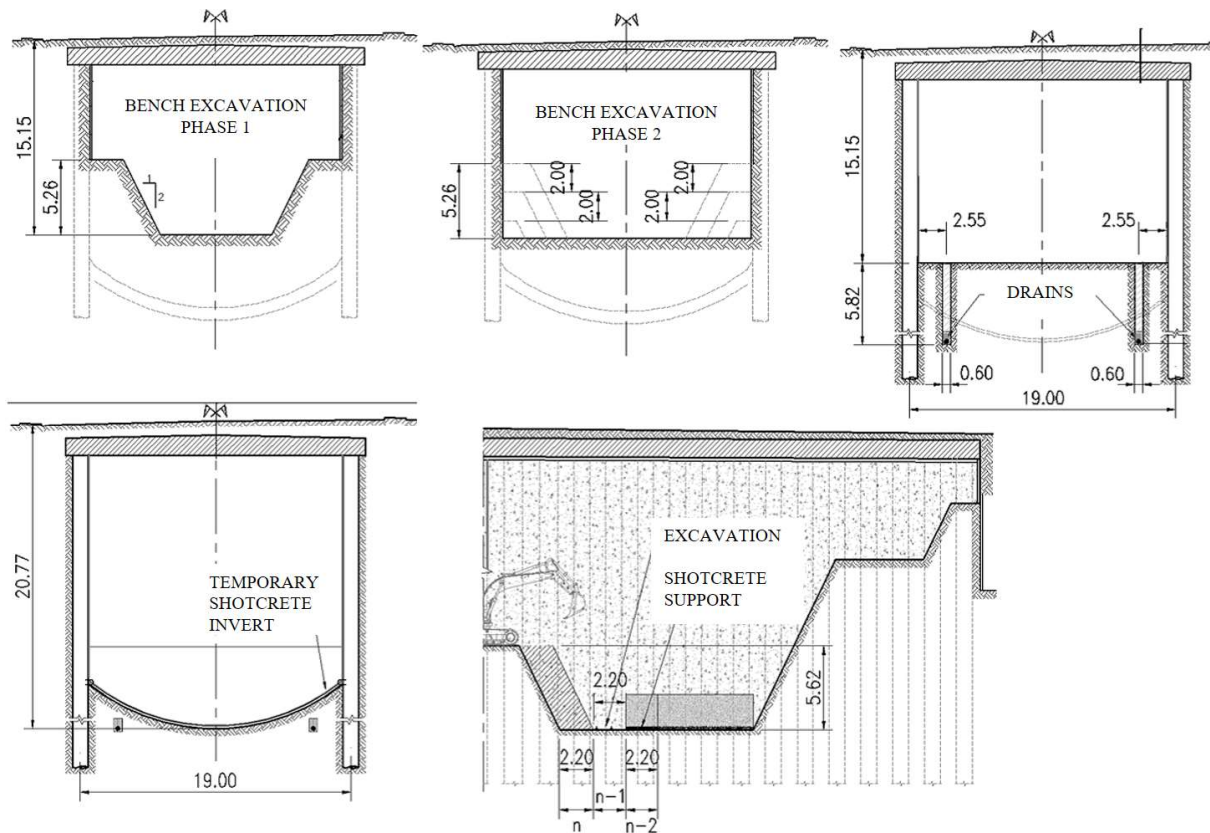
Figure 24. Correo Central Station. Construction procedure for the invert.

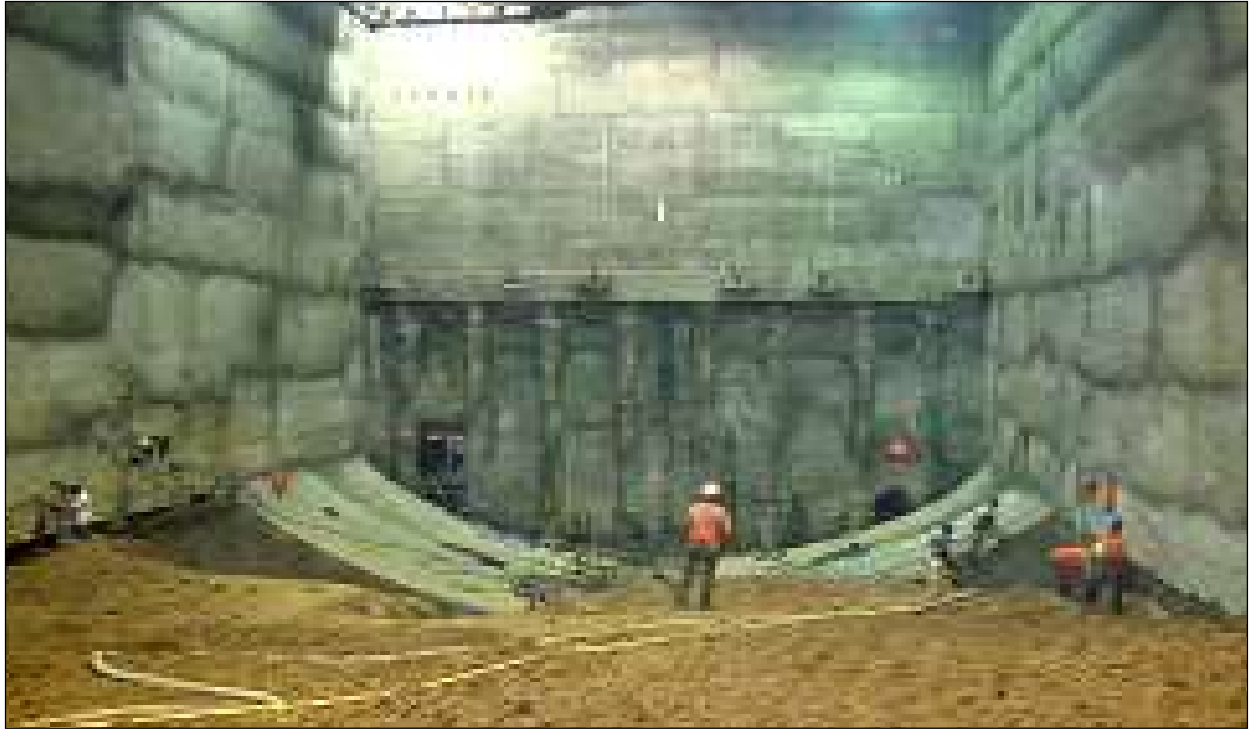
Figure 25. Correo Central Station. Phase 2 excavation, pile-supported wall and invert.

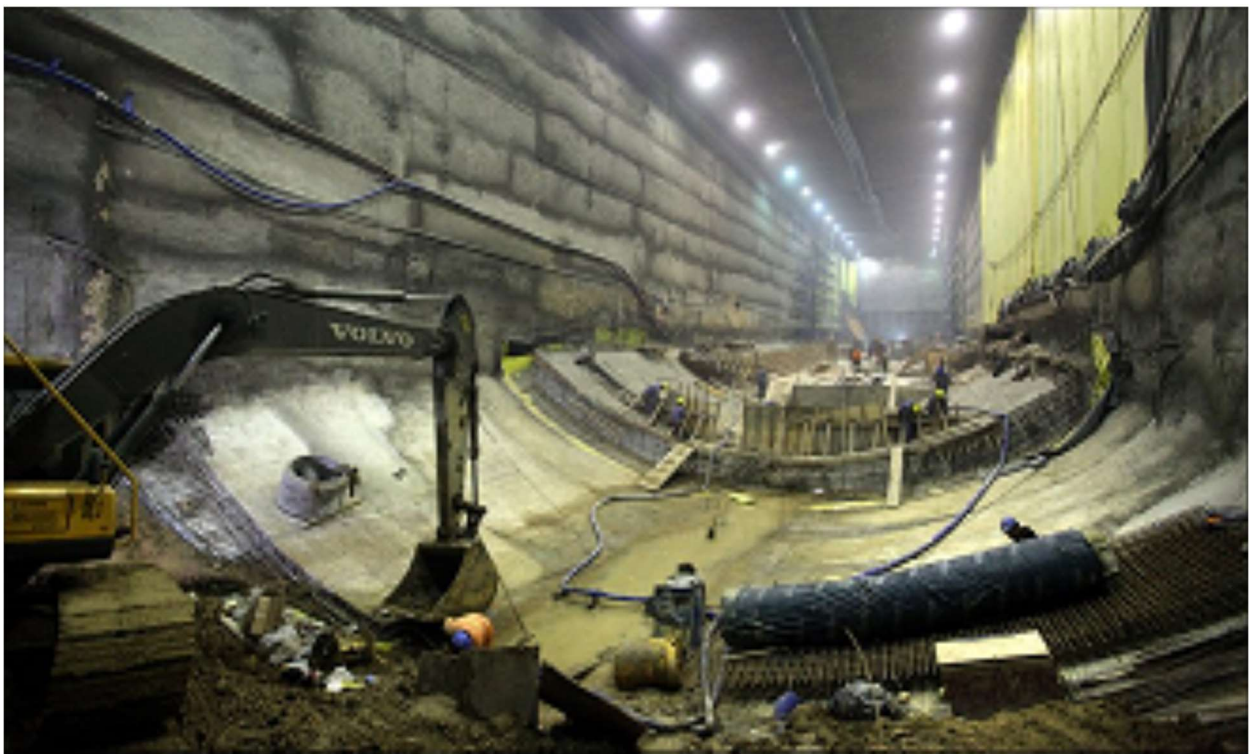
Figure 26. Correo Central Station. All construction stages of the invert including the installation of the geomembrane and the casting of the final invert.

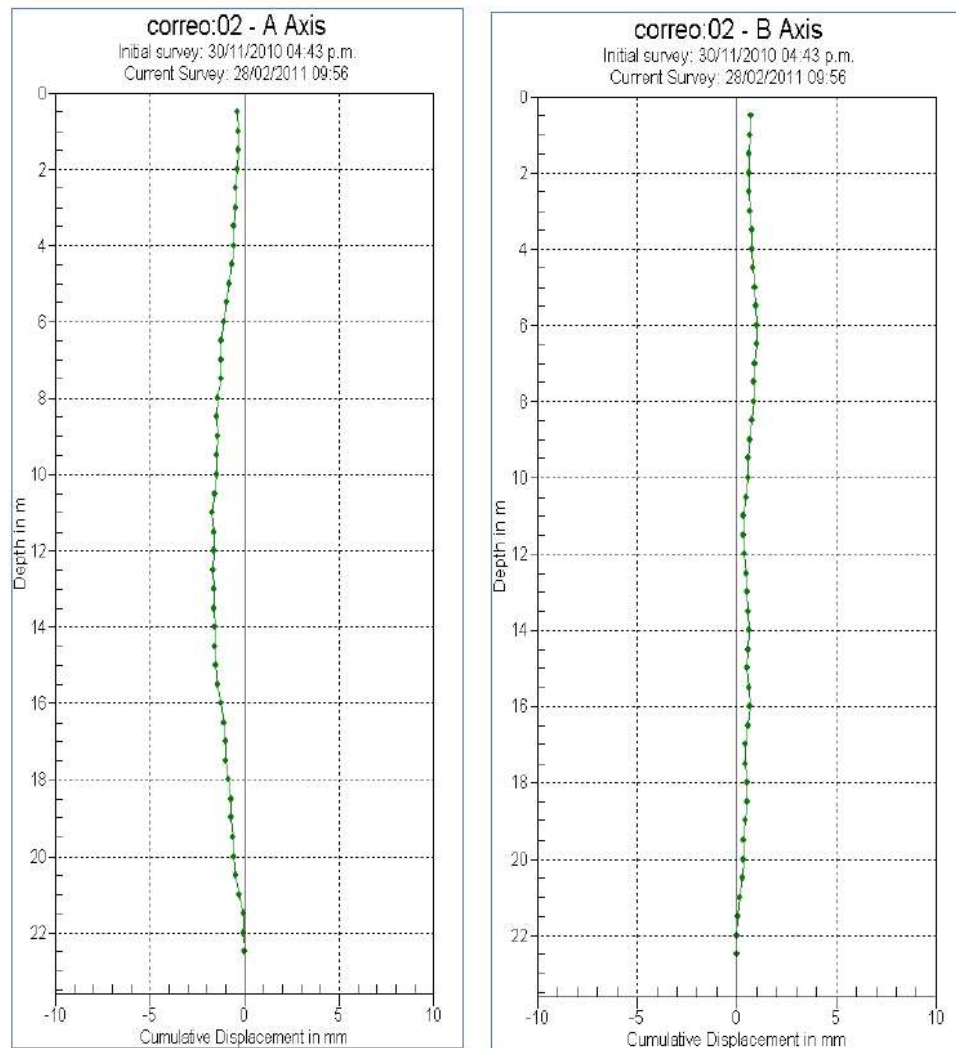
Figure 27. Inclinometer measurements. A-axis is perpendicular to the station axis, B-axis is parallel to it.

The construction was successfully completed with minor delays, mainly due to logistics of the extraction of the excavated soil and transit diversion. The overall behavior was excellent. Nearby buildings showed vertical displacements less than 5 mm. There was no observed distress in ground at the excavation bottom and no water ingress. No cracks, fissures or noticeable tilting of above-ground structures and facilities was observed. An inclinometer was installed between the station and the Correo Central building (nowadays a major concert hall) showed a maximum horizontal displacement of 2mm (Figure 27).
