# Subway station retaining walls: case-histories in soft and hard soils

**ABSTRACT.** In the last twenty years, sixteen pile-supported metro stations have been built in Buenos Aires in a wide range of geotechnical conditions. After an initial design of the construction procedures including partial open-trench (in two cases), all subsequent fourteen stations were excavated employing cut&cover techniques. In all cases, vertical bored piles were employed both to support the lateral ground pressure and the loads acting on the roof slab. This paper revisits the geotechnical conditions in Buenos Aires City, describes the procedures employed for the design and numerical analysis of pile-supported excavations and presents the behavior of five recent cases located in widely different geotechnical profiles. The paper ends with a summary of lessons learned which are relevant both for design and construction.

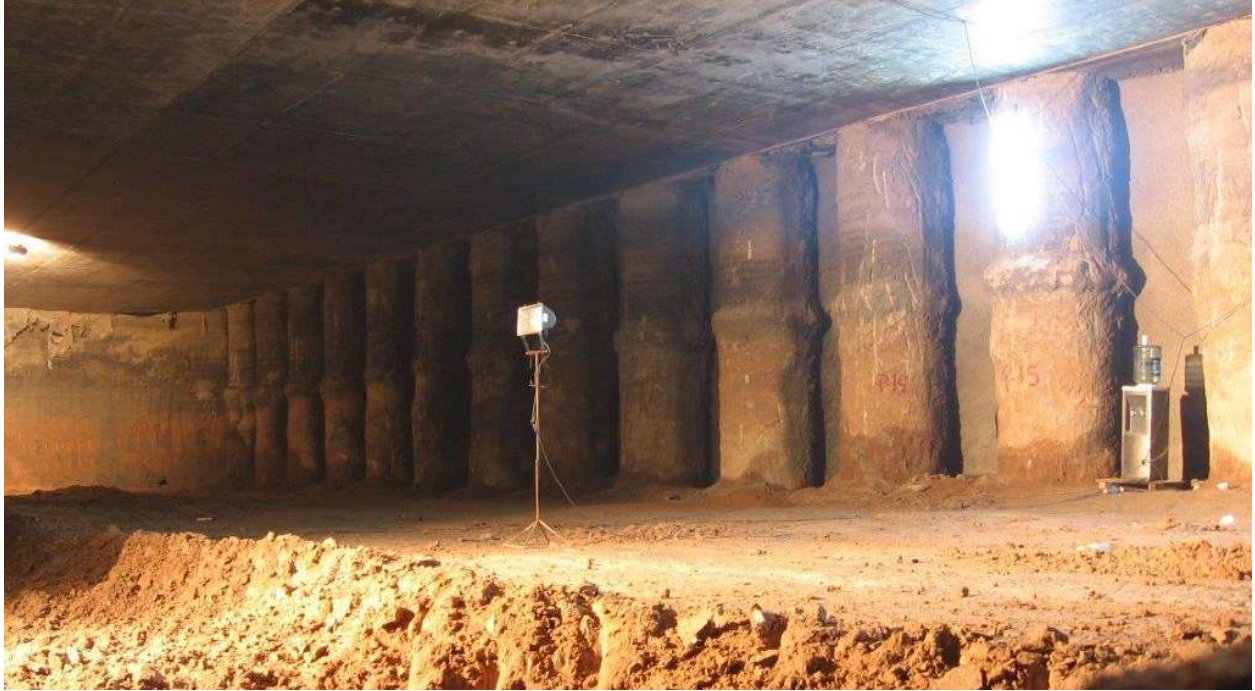
Figure 28. Bulging of piles at the end of the cased portion.

Hospitales Station, the last station in Line H Southbound, encountered geotechnical challenges with soft surface soils, similar to those of Facultad de Derecho Station, and bottom uplift, similar to Correo Central Station. In this case, piles were cased in the upper 4.0m, resulting in a systematic overexcavation and bulging of the piles at the end of the casings (Figure 28). The construction of the invert was performed in 8.0m wide strips excavated from a safe level (Figure 29).

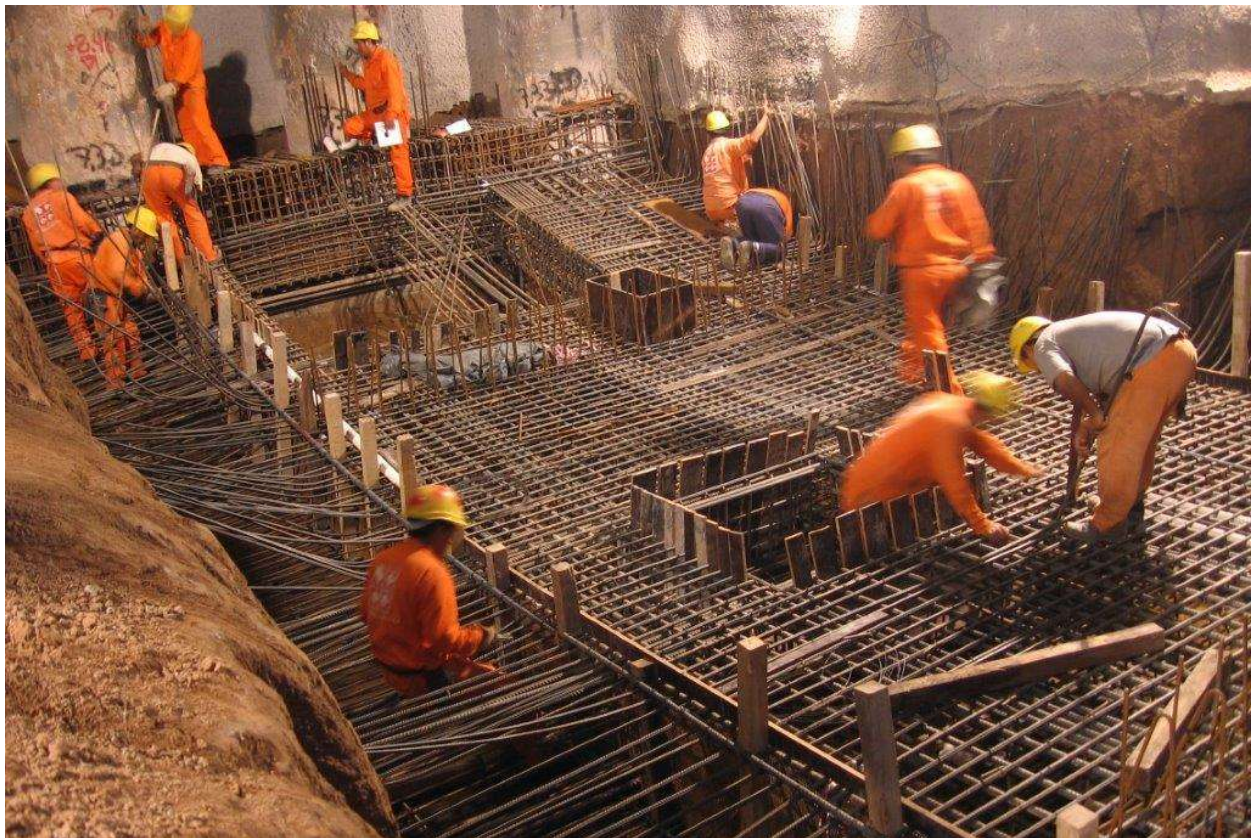
Figure 29. Strip excavation of the invert.

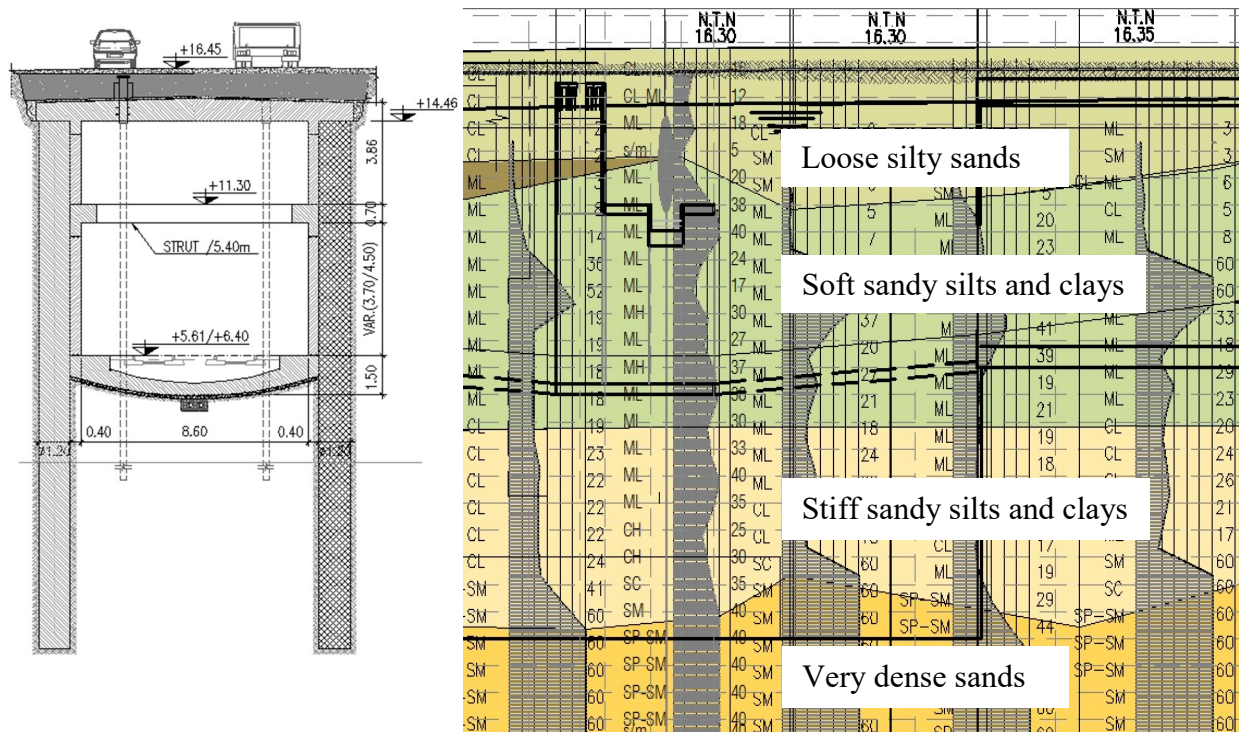
Figure 30. Tunnel pre-Hospitales. Cross section and geotechnical profile.

Geotechnical conditions in the site are poor, as must be expected given the location of the project in the flood valley of the Riachuelo river. Figure 30 shows the longitudinal geotechnical profile which shows an increase of the upper soft soil stratum thickness. A 5m to 14m thick layer of young soft soils of fluvial origin rests on top of heavily eroded and decompressed stiff silts and clays of the Pampeano Formation. Puelche sands are found at 21m depth, again introducing the risk of bottom uplift. The loose sands at the top of the profile could be subject to extreme piping when careless dewatering works are carried out. This geotechnical profile precluded the construction of both NATM tunnels and non-contiguous pile retaining walls.

Figure 30 shows the cross-section of the Pre-Hospitales tunnel and the geotechnical profile where it is located. Note that the secant pile wall barely penetrates into the very dense Puelche sands, as the net vertical load acting on the piles is negligible due to the uplift water pressure acting at the invert.

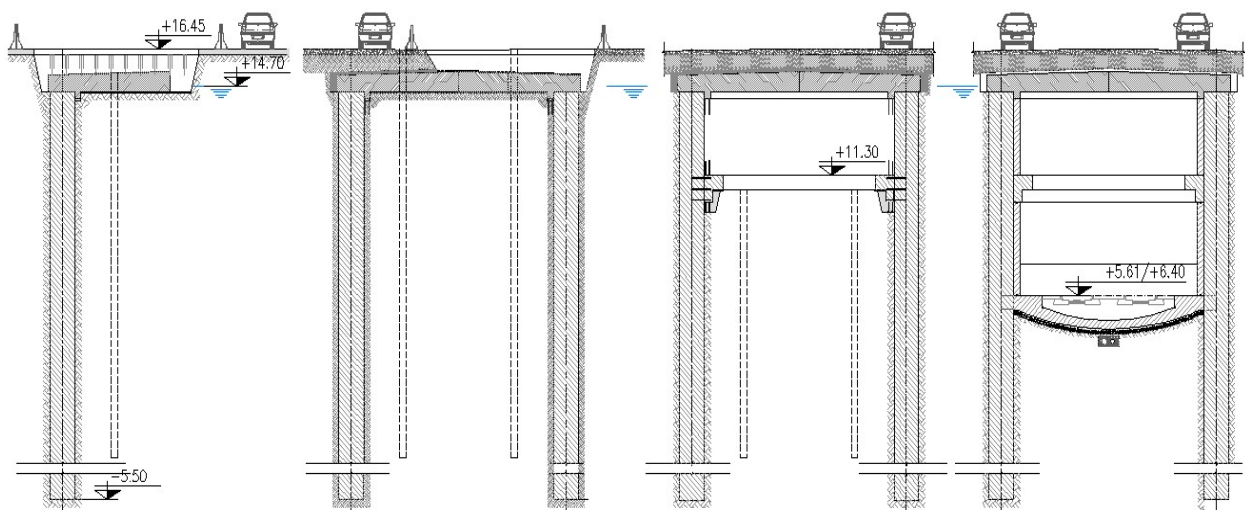
Figure 31. Construction procedure of the Pre-Hospitales tunnel.

The construction procedure is typical of cut&cover excavations with two additions: i) dewatering wells are installed in the inner side of the box and kept operational through the entire excavation; and ii) an intermediate horizontal frame is installed 3.40m below the roof slab before the excavation is advanced to the invert level. This horizontal concrete frame, installed just above the required clearance for the trains is required for two reasons: i) the secant pile wall is not stiff and robust enough to resist the ground and water loads of the full excavation height; and ii) were the piles forced to support the full excavation with poor quality ground they would have required a much deeper embedment and would have high lateral displacements at the bottom of the excavation.

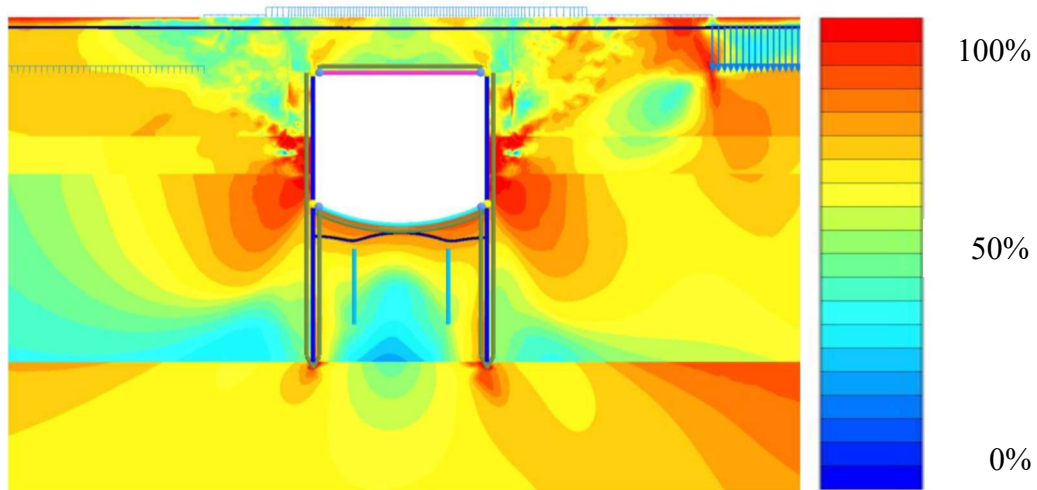
Figure 32. Shear mobilization at end of construction.

The long-term watertightness of the structure required the construction of an inner structural concrete wall, 0.40m thick, supported by the piles by means of epoxy-glued rebars, to be built after the tunnel invert is completed. This structural wall acts also as the support of the invert, and must therefore take the high vertical uplift loads produced by water pressure. Figure 31 shows the construction procedure including the drainage wells, intermediate frame and inner structural wall. Figure 32 shows the ground shear mobilization at the end of the construction.

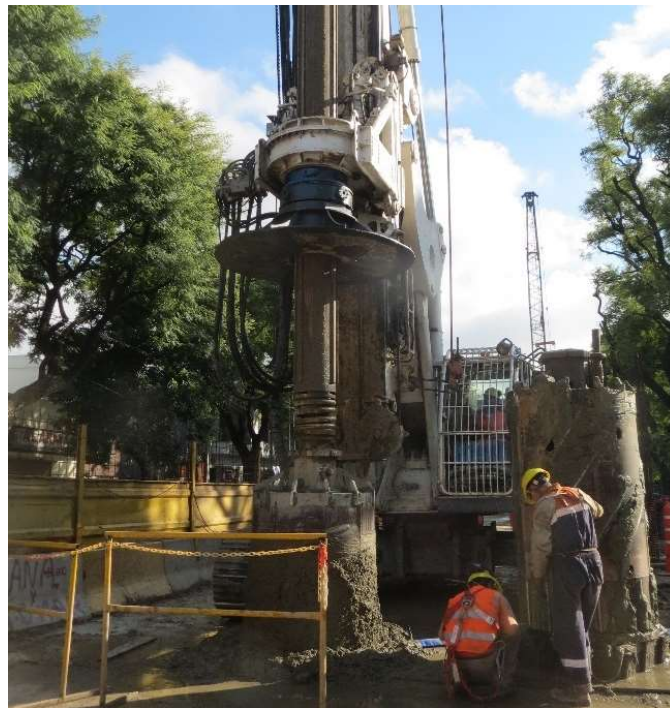
Figure 33. Soilmec SR-70 piling rig provided with two buckets and no casing during the construction of the secant pile wall at Pre-Hospitales tunnel.

Soletanche-Bachy, the foundation specialist contractor, guaranteed that the deviation of verticality would be less than 0.75%. They employed a Soilmec SR-70 equipment with no casing, which is kind of an unconventional installation for performing secant pile walls. Two buckets were employed for the construction of the structural piles: i) an open bucket provided with hardened steel teeth for concrete cutting; and ii) the normal excavation bucket. A concrete template was employed to guide the initial pile excavation. Figure 33 shows the piling rig and the two buckets. Figure 34 shows the concrete template and the secant pile wall completed.

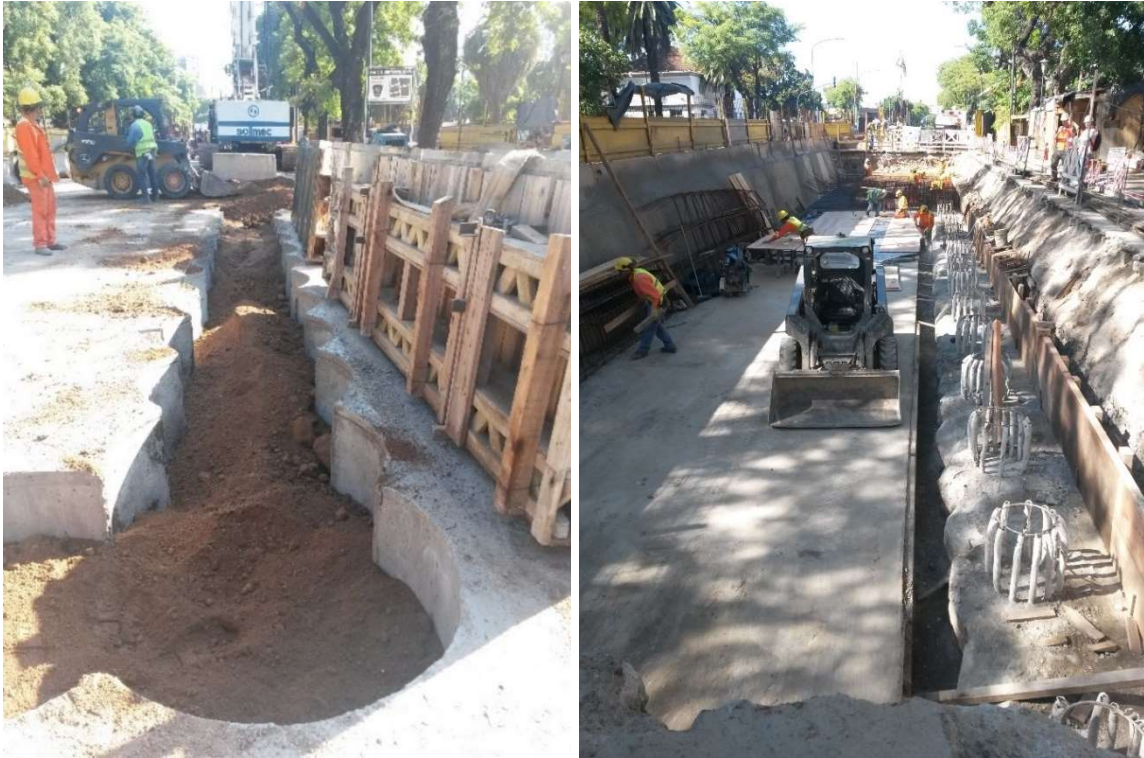
Figure 34. Pre-Hospitales secant wall. Construction of concrete template and finished wall.

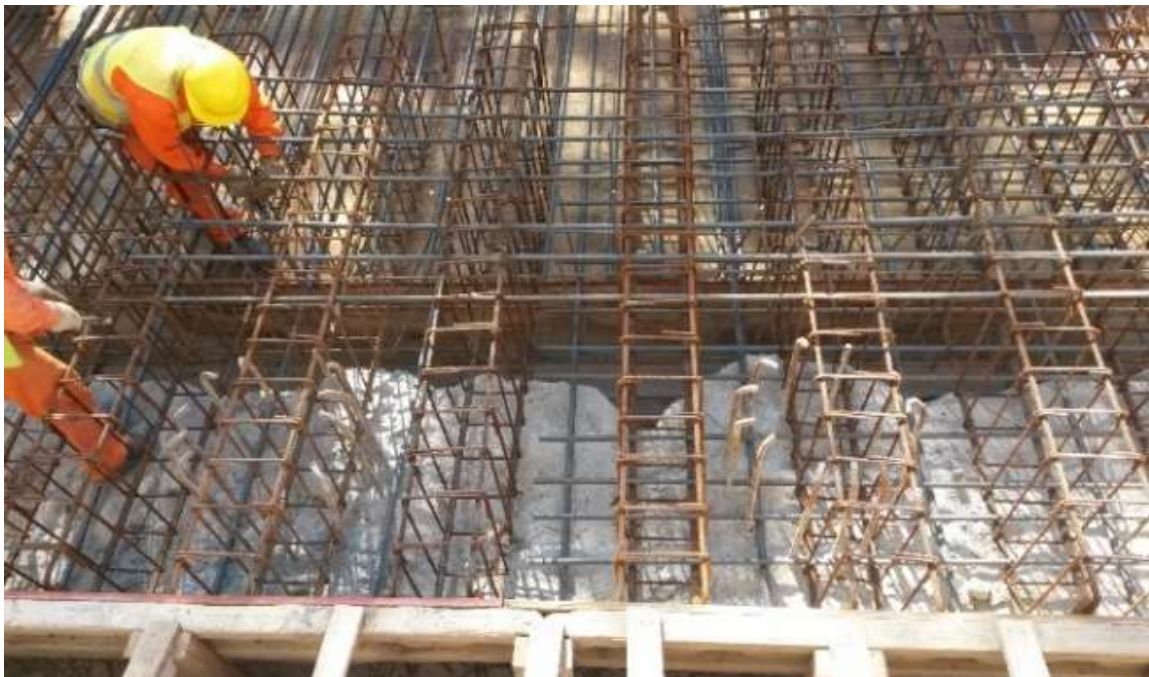
Figure 35. Pre-Hospitales tunnel. Connection of the slab reinforcement to the piles.

Figure 35 shows the connection of the slab reinforcement to the piles. Figure 33 shows a panoramic view of the construction of the roof slab and the placement of a CLSM fill on top of the concrete.

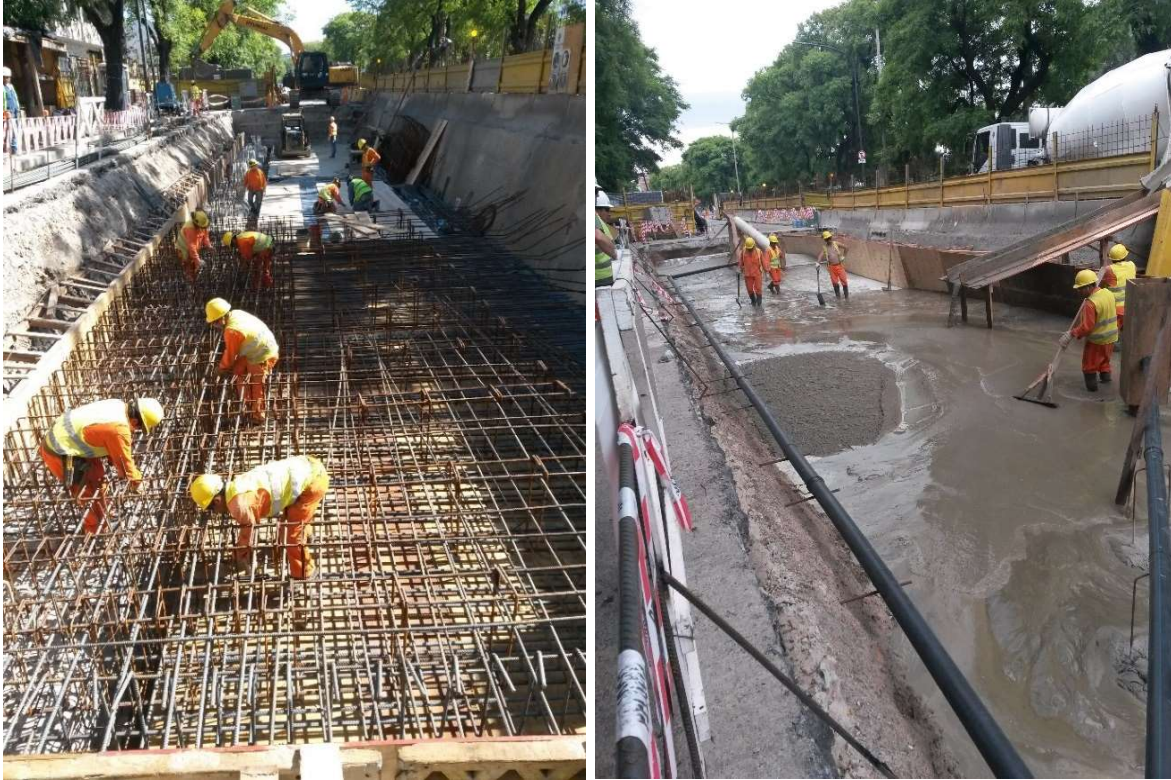
Figure 36. Pre-Hospitales tunnel. Construction of roof slab and filling with CLSM.
